Massachusetts Department of Fish and Game

In-Lieu Fee Program

Eelgrass Restoration Project 2019 Annual Report

Implemented by the Division of Marine Fisheries

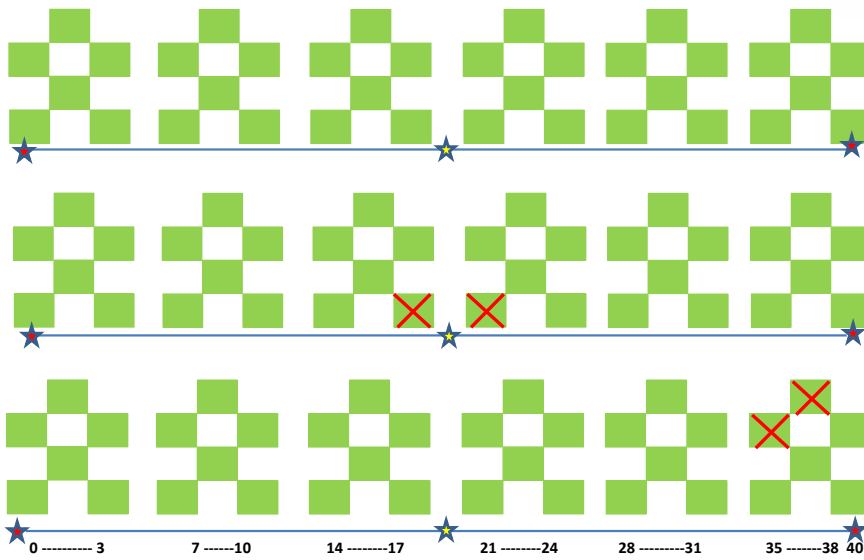
Figure 3: MGW and MGS 2019 square survival.

Middle Ground West
Planted Spring 2017, supplemental planting May 2018

50 shoots per quadrate
300 shoots per plot
5,400 shoots total site

Planted spring 2017
Lost in 2018, replanted 2018

Lost in 2018, not replanted
Lost in 2019

Middle Ground South
Planted May 2018

Planted spring 2018

Lost in 2019

In July 2019, two years post-planting at MGW, 75.6% of the originally planted squares were still vegetated and were growing and expanding (Figure 3). Eelgrass metrics had increased across all three transects compared to the same measurements made in 2018 (Figure 4). Mean shoot density of the plots was 148.6 shoots/m², mean canopy height was 69.0 cm, and mean percent cover was 63.3%. (Figure 4, Table 3) .Between 2018 and 2019, mean canopy height and percent cover also increased at reference sites, while shoot density decreased (Figure 4, Table 3). Mean area of a square within the plot was 2.23 m², a 113.6% increase from 2018 (Table 3, Figure 5). Divers noted abundant hydroid and algal epiphytes on and around the plants, particularly at the middle transect.

In July 2019, one year post-planting at MGS, all plots were still present, but four squares were missing in the middle and southern transects, yielding 96.3% survival of planted squares (Figure 6). Mean shoot density of the plots was 93.6 shoots/m², mean canopy height was 54.7 cm, and mean percent cover was 45.5% (Table 5). Mean area of a square within a plot was 1.56 m², a 167.3% increase from 2018.

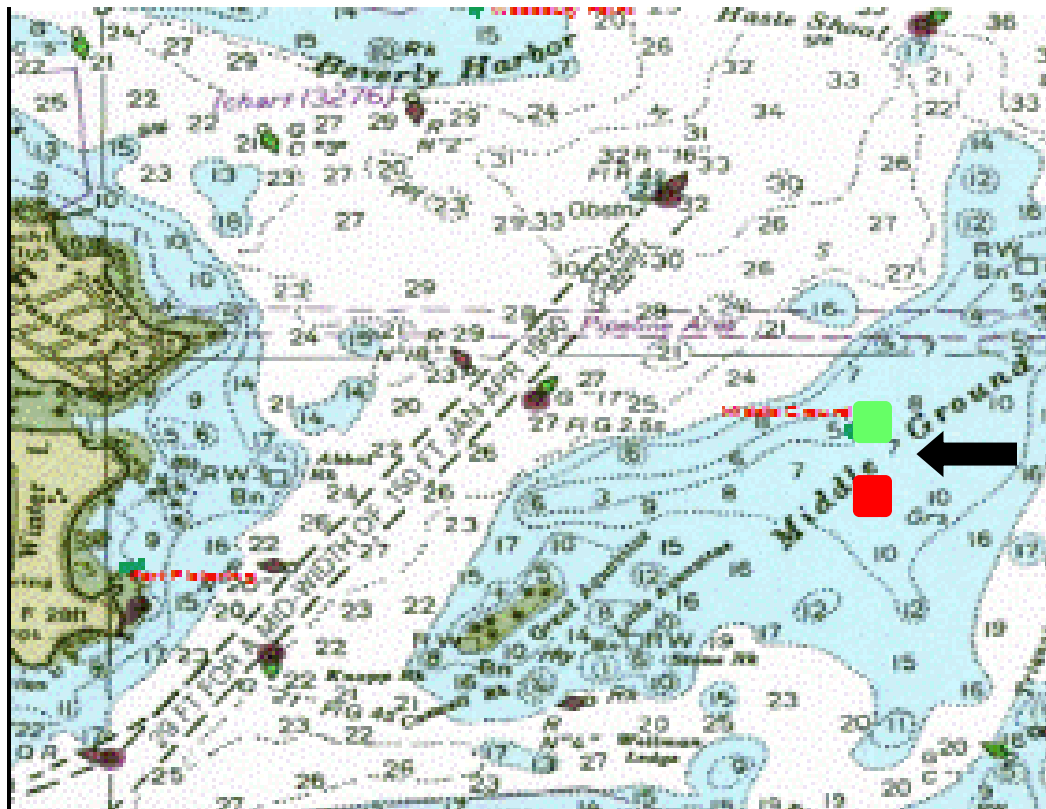
Figure 2. Proposed location of 1/8 acre Restoration site at Middle Ground (green) and hubline restoration site (red)

Middle Ground, also known as Aqua Vite, is the shoal northeast of the mouth of Salem Harbor with depths of 6- 12 feet at MLW (Figure 3). There are anecdotal reports of this area having abundant eelgrass in past decades. We first investigated it in 2011 and found only a few small, scattered eelgrass patches. Light measurements indicated adequate light for eelgrass growth (Evans et. al 2013) and there is extensive area suitable for additional planting.

DMF successfully planted a 1/3 acre area at Middle Ground in 2012. Monitoring in 2015 showed plant growth and plot enlargement both through seeding and lateral expansion. Mean shoot density increased over the two years since transplanting and it is within one standard deviation of the mean of all the reference sites (Evans et. al 2013). A 1/8 acre site will be planted with eelgrass in the first season (e.g., spring) ,

1/8 acre in the second season (e.g., fall of the same year), and will be augmented as needed in the third season (e.g. spring of the following year).

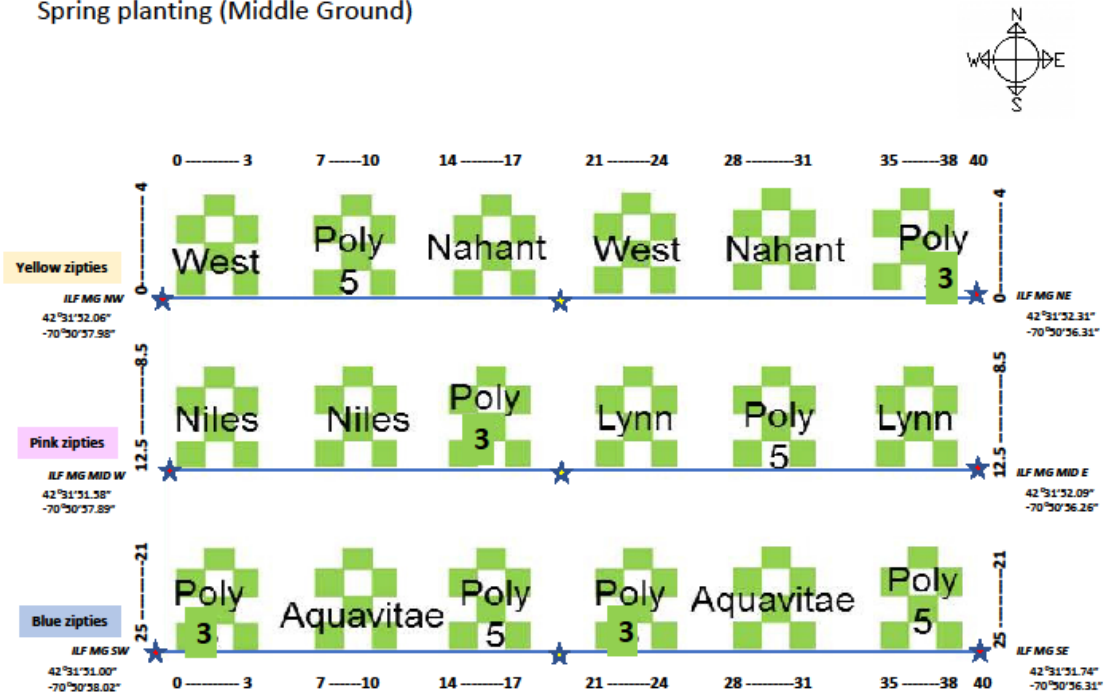
Figure 6. Layout for 1 site, approximately ¼ acre area. Eighteen plots each in a checkerboard pattern of 6 planted and unplanted 1 m² squares for a total of 5,400 shoots. Two sites will be planted adjacent to each other at Middle Ground in Salem

At Middle Ground we propose to plant approximately 1/2 acre of eelgrass in the first year, in two separate ¼ acre sites adjacent to each other. Each site will have 5,400 transplanted shoots arranged in a checkered pattern of 18 12m² plots of 6 planted and 6 unplanted 1 m² squares, for a total of 108 planted squares spread across each ¼ acre site (Figure 6). We will use the Burlap Disc method (Pickerell, pers. com.) or a seeding method. When using the burlap disc method, ten shoots are woven into a burlap disk by their rhizomes (Evans et al 2013). The discs are then planted in a shallow hole at five locations within a 1m² quadrat.

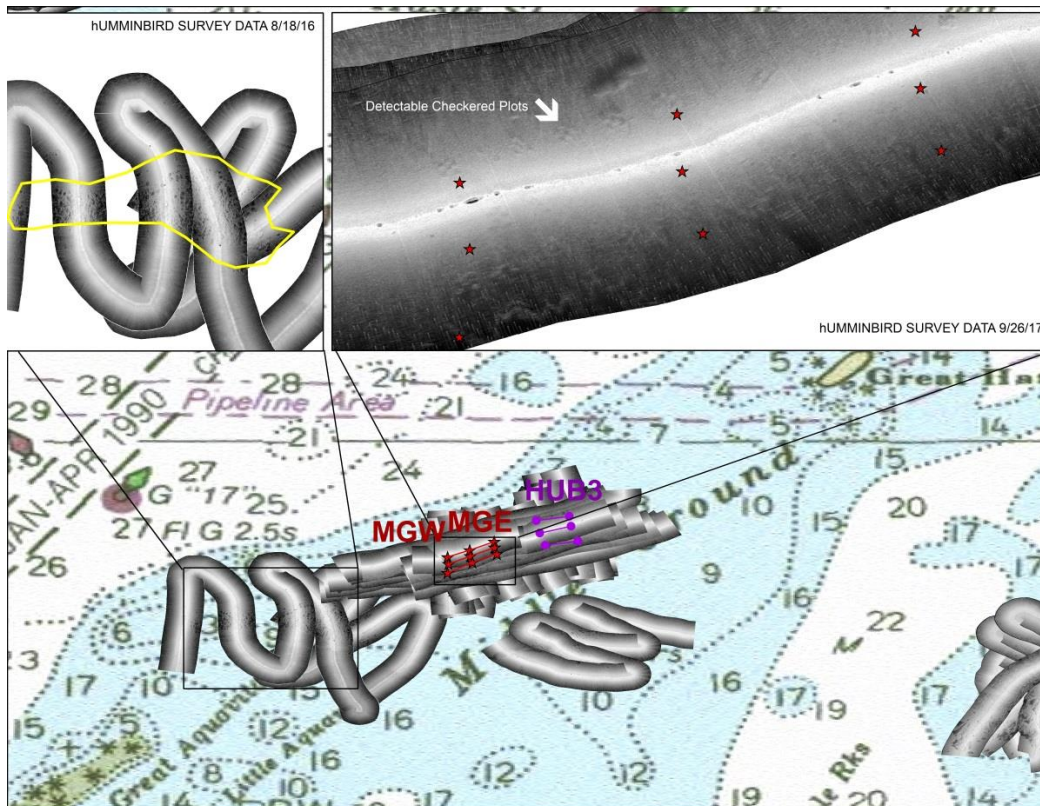
Figure 7: Middle Ground Acoustic Survey Scans.

Acoustic mapping was completed twice in 2017 to capture post-planting conditions: MGW was surveyed on June 8, 2017 and both restoration sites were surveyed on September 26, 2017. Restored and reference meadows will be mapped using hydroacoustic methods in the two planting years and again at the conclusion of the five year monitoring period, using a Humminbird 999CI HD SI unit, or a Humminbird HELIX 9 CHIRP MEGA SI GPS G2N, each with an 800 kHz high resolution transducer. Surveys are conducted with overlapping lines for 150% sonar coverage. The resulting sonar files have the water column removed and then are slant range and beam angle corrected in SonarTRX Pro release 15. The resulting lines are exported and mosaicked in ArcGIS 10.4. In ArcGIS, areas within the mosaic that have the signature appearance of eelgrass will be delineated. The area of the meadow will then be quantified and compared to the mapped area from previous years.

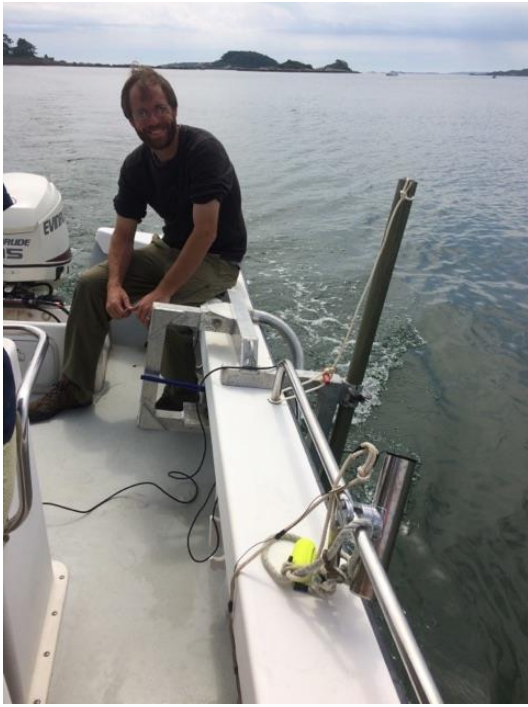
Figure 5: (clockwisw from left): Humminbird acoustic transponder mounted to the side of DMF's Maritime skiff; Planted eelgrass plots visible on acoustic survey at ILF West (red dots mark the boundaries of the site, the track in the middle is the disturbance from the boat and does not include useable acoustic data); the Humminbird display screen showing the acoustic return on the left (note light puffy looking areas are eelgrass) and location on a chart on the right.
