**September 2021**

**Report No. 21-021**

# Effectiveness of Bike Boxes in Massachusetts

**University of Massachusetts Amherst**

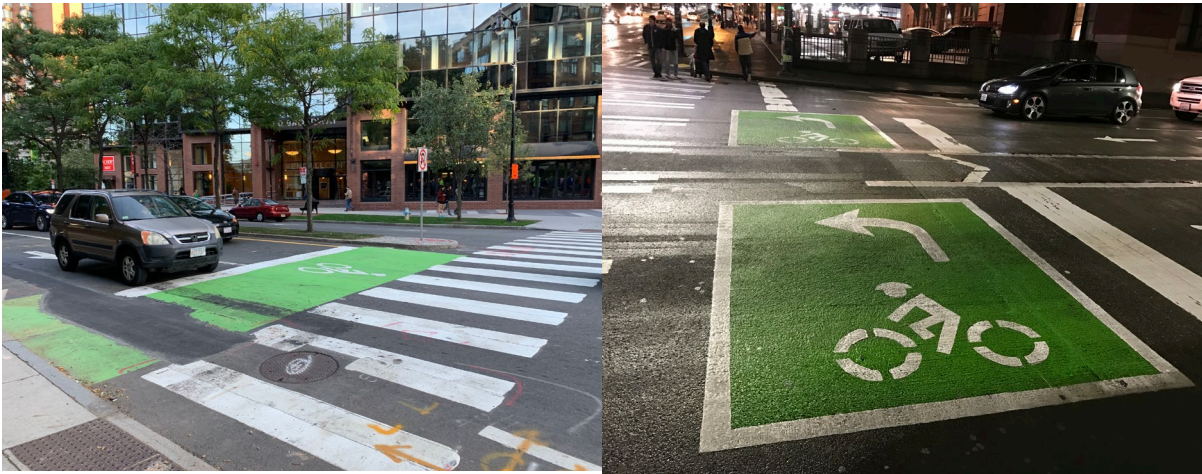
**Figure 1.1: Examples of bike box and two-stage turn queue box**

Bicycle or bike boxes are a dedicated area for bicyclists located ahead of traffic lanes, just upstream of signalized intersections, where bicyclists can get ahead of a car queue and wait during a red signal phase (1,2,3). Figure 1.1a presents an example of a bike box in Cambridge, Massachusetts. Bike boxes are often also referred to as advanced stop boxes, advanced stop lines, advanced stop bars, head start areas, or bicycle storage boxes. They are placed in front of the stop line and usually upstream of pedestrian crosswalks (2). They are defined by pavement markings denoting the outline of the box and are usually supplemented by colored pavement (most frequently green) (4). Bike boxes are not to be confused with turn queue boxes that are implemented specifically for facilitating safe left-turn movements for bicyclists; see Figure 1.1b for an example of a turn queue box in Seattle, Washington.

(a) Bike box in Cambridge, MA

(b) Two-stage turn queue box in Seattle, WA

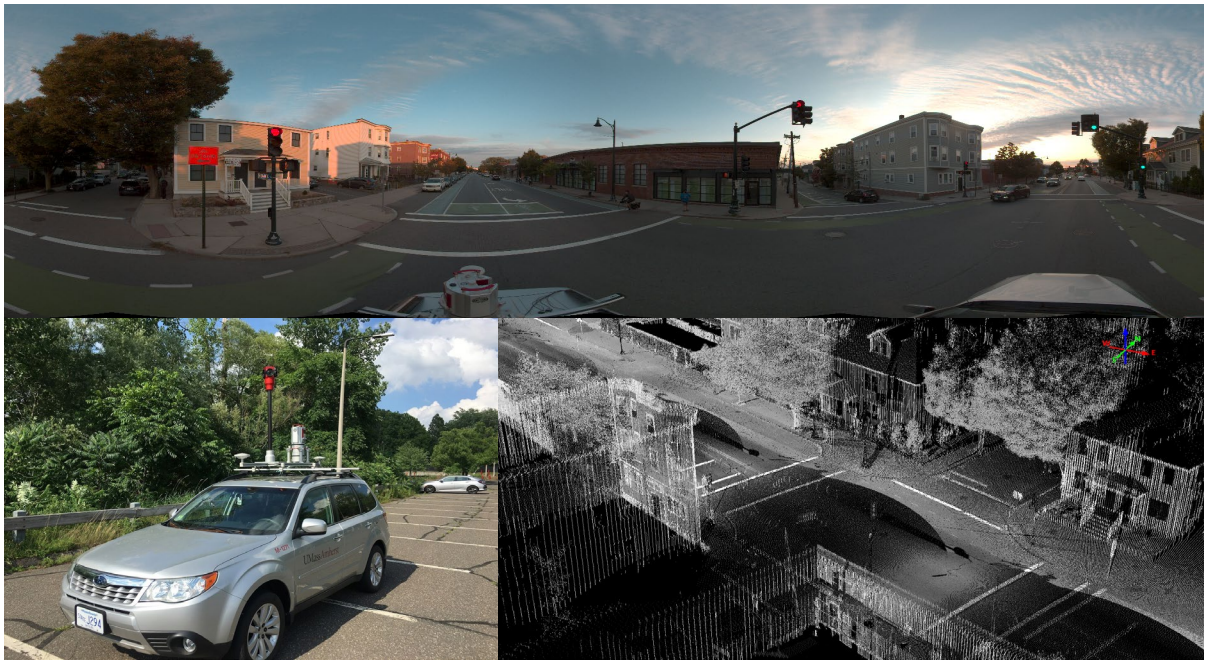
**Figure 2.2: LiDAR sensing vehicle (bottom L), video log imagery (top), and point cloud data (bottom R)**

The field bike box inventory data consists of mobile LiDAR data and street video logging imagery collected using an integrated sensing vehicle developed at the University of Massachusetts. Figure 2.2 shows the outlook of the sensing vehicle and examples of the captured LiDAR point cloud data and video logging imagery.

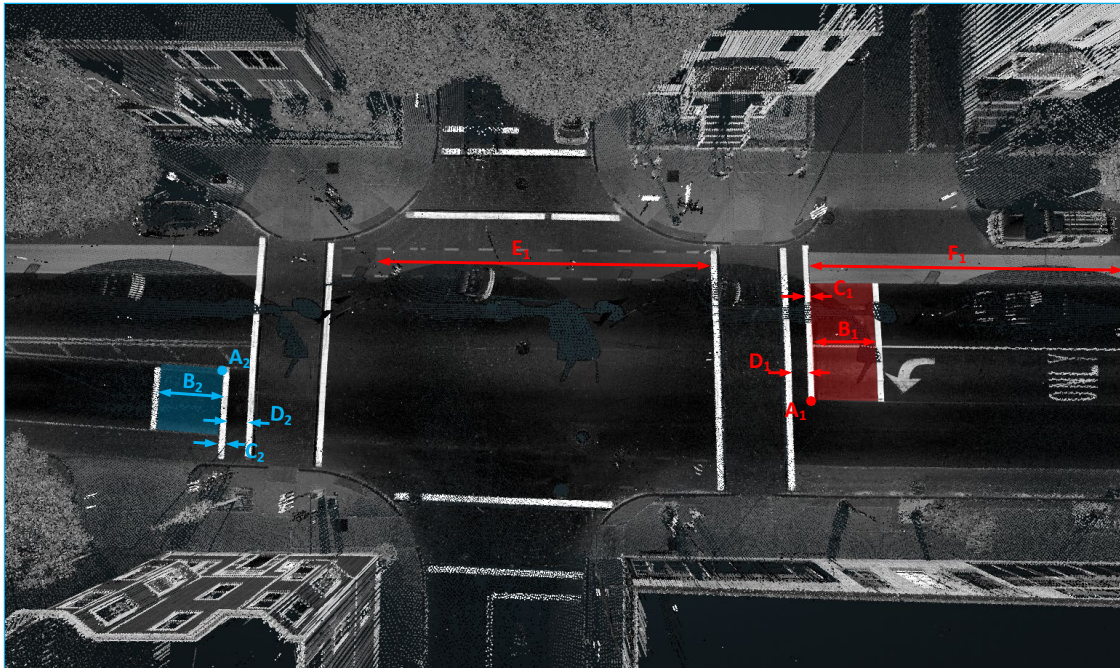
**Figure 2.3: Illustration of bike box dimensions using LiDAR point cloud**

With the integrated measurement tools in the LiDAR point cloud data viewer, detailed geometry measurements were conducted and verified by the research team and MassDOT. Figure 2.3 shows an illustration of the geometry measurements for two bike boxes captured from the point cloud data, and Table 2.1 explains in detail how geometries were defined and measured.

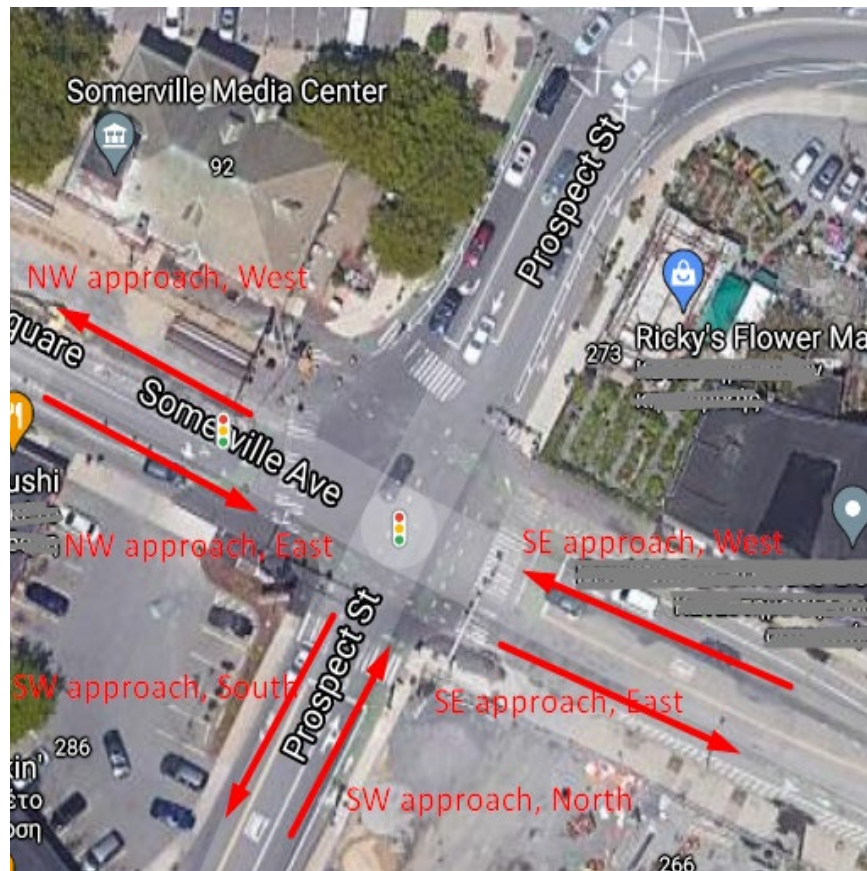
Figure 2.4: Example of approach naming convention

Average daily bicycle traffic and average daily vehicle traffic were obtained from Streetlight Data (21) through MassDOT by month for the period of January 2018 to November 2020. Streetlight Data obtains location data from smart phone and navigation devices and uses them to estimate trips passing through specific locations. The benefit of such data is that they include nonmotorized users, whose demand data is otherwise challenging to obtain. The Streetlight data were queried for the intersections where crashes had been reported. Demand data for a total of 30 intersections were obtained. Zones were created in the Streetlight interface to allow for obtaining the car and bicycle demands by direction. It should be noted that it was not always possible to obtain demand data for all intersection approaches and all intersections. In addition, in many cases, the demand for a certain direction is measured at the downstream end, as shown in Figure 2.4 for the intersection of Somerville Ave. and Prospect St., Somerville.

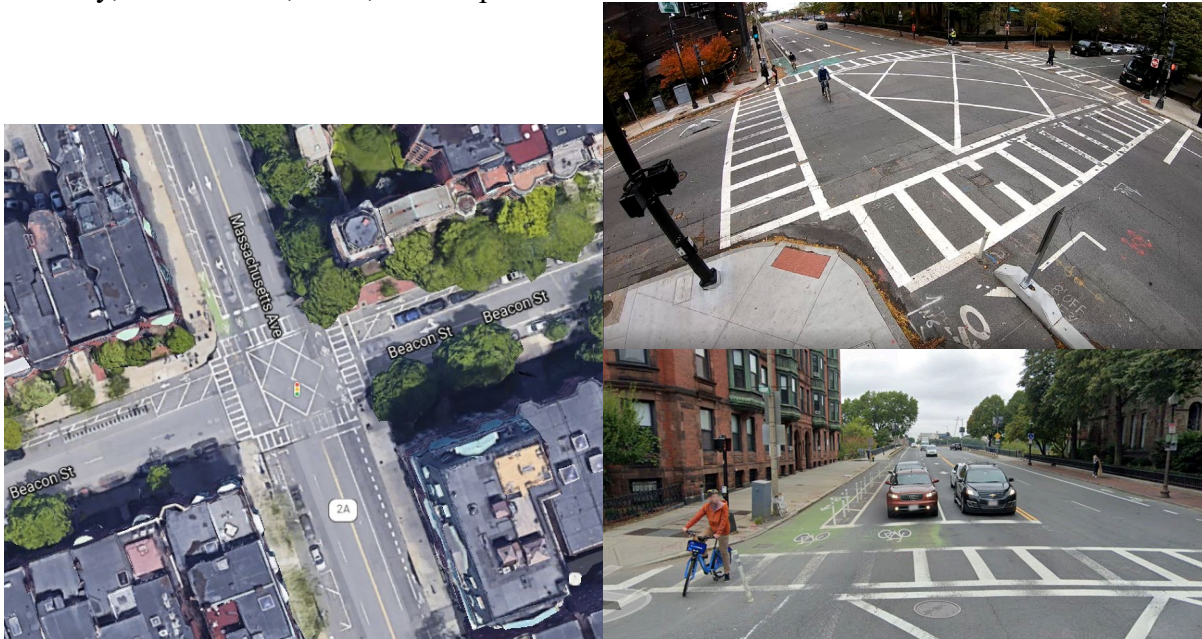
**Figure 2.6: Intersection layout and camera views for Beacon St. at Massachusetts Ave.**

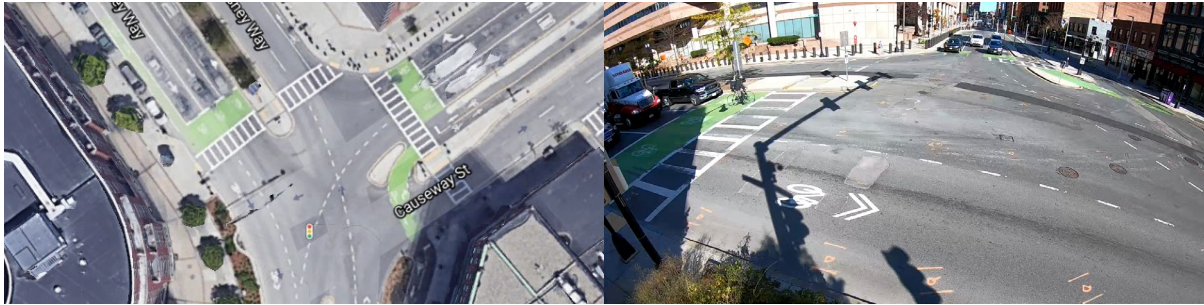
**Figure 2.7: Intersection layout and camera view for Causeway St. at Lomasney Way**

Causeway Street at Lomasney Way is a three-way signalized intersection with Causeway Street approaching from the northeast, Lomasney Street approaching from the northwest, and Staniford Street approaching from the south. The approach from Lomasney Street consists of a left-turn-only lane, two through lanes, and a conventional painted bicycle lane. The approach from Causeway Street consists of a right-turn-only lane, two left-turn-only lanes, and a two-way protected bicycle track. The northbound approach consists of a through lane, a shared through and right-turn lane, and a two-way protected bicycle track with a dedicated bicycle signal. There are bicycle boxes located at the Lomasney Street and Causeway Street approaches. Figure 2.7 shows photos of this study site.

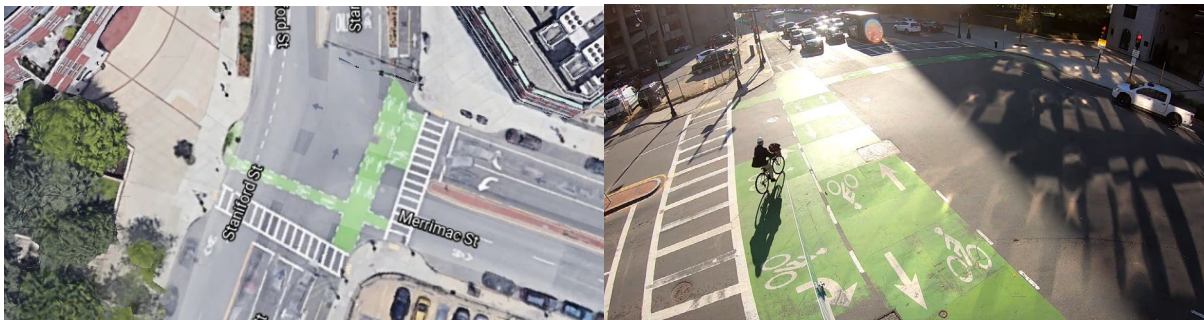
**Figure 2.8: Intersection layout and camera view for Causeway St. at Merrimac St.**

Causeway Street at Merrimac Street is a three-way signalized intersection, with Merrimac Street approaching from the east, Staniford Street approaching from the south, and Causeway Street approaching from the north. The approach from Causeway Street consists of one through lane and a shared through and left-turn lane. The northbound approach consists of two through lanes, a right-turn-only lane, and a two-way protected bicycle track with a dedicated bicycle signal. The westbound approach consists of a right-turn-only lane and a left-turn-only lane. The only bicycle box at this intersection is located on the westbound approach; however, there is a left-turn bicycle queue box located in the southbound approach. Figure 2.8 shows photos of this study site.

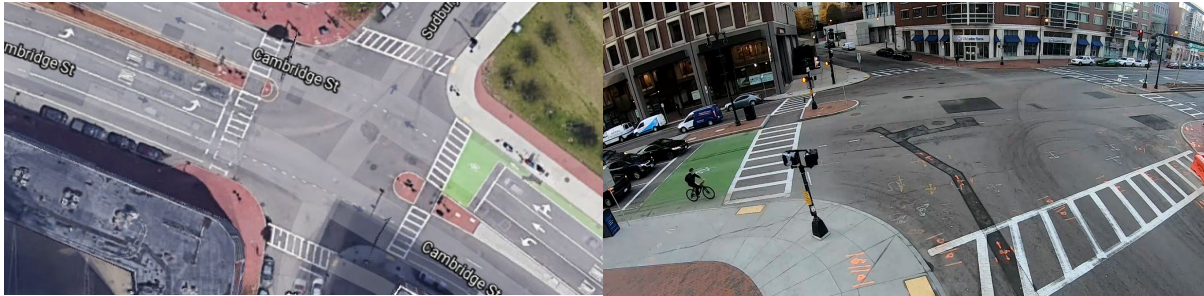
**Figure 2.9: Intersection layout and camera view for Cambridge St. at Somerset St.**

Cambridge Street at Somerset Street is a four-way signalized intersection, with Cambridge Street approaching from the east and west, Somerset Street approaching from the south, and Sudbury Street acting as a one-way street away in the north direction. The eastbound approach contains two left-turn-only lanes, a through lane, and a shared through and right-turn lane. The westbound approach contains a left-turn-only lane, a through lane, a shared through and right-turn lane, and a conventional painted bicycle lane. The northbound approach has a shared through, left- and right-turn lane. The only bicycle box at this intersection is located on the westbound approach. Figure 2.9 shows photos of this study site.

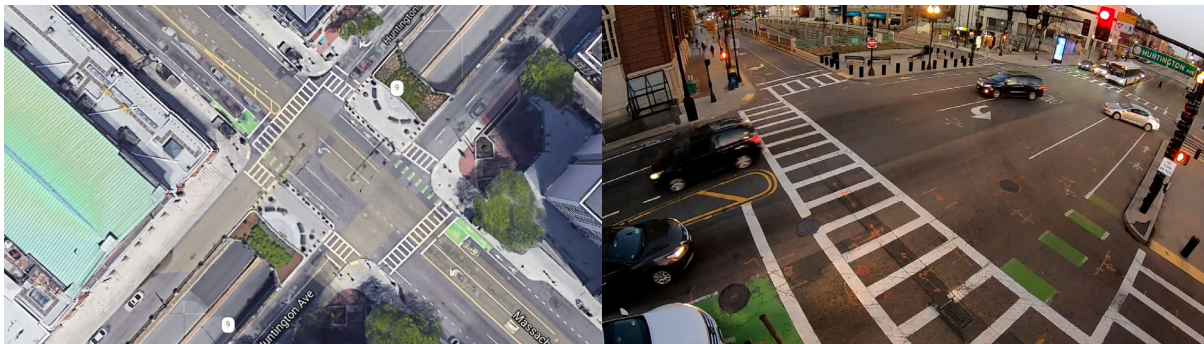
**Figure 2.10: Intersection layout and camera view for Massachusetts Ave. at Huntington Ave.**

Massachusetts Avenue at Huntington Avenue is a four-way signalized intersection, with Huntington Avenue approaching from north and south, and Massachusetts Avenue approaching from the east and west. The eastbound approach consists of a through lane, a shared through and right-turn lane, and a conventional painted bicycle lane. The westbound approach consists of a left-turn lane, a through lane, a shared through and right-turn lane, and a conventional painted bicycle lane. The northbound and southbound approaches act as on/off ramps for Huntington Avenue. The southbound approach consists of a shared through and left-turn lane, and a right-turn lane. The northbound approach consists of a shared left-turn and through lane, and a shared right-turn and through lane. There are two bicycle boxes at this intersection, located on the westbound and eastbound approaches of Massachusetts Avenue. Figure 2.10 shows photos of this study site.

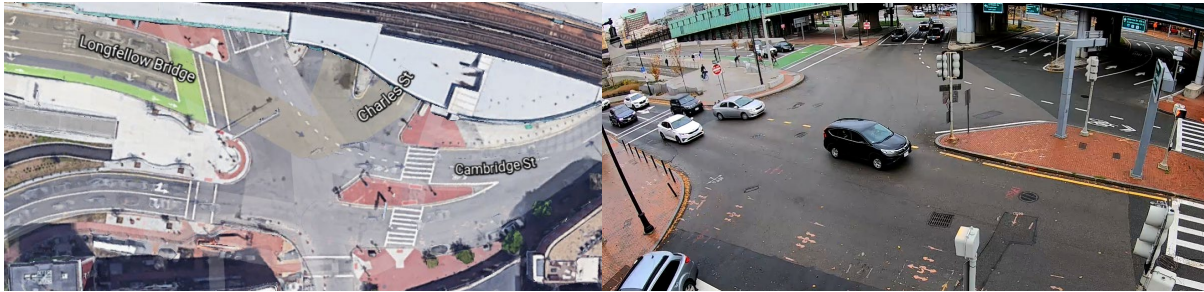
**Figure 2.11: Intersection layout and camera view for Longfellow Bridge at Charles St.**

Longfellow Bridge at Charles Street is a complex five-way signalized intersection, with Longfellow Bridge approaching from the west, Cambridge Street approaching from the west, Charles Street approaching from the north and south, as well as a secondary eastbound approach considered as an off-ramp of Storrow Drive. The Longfellow Bridge approach consists of a left-turn lane, a through lane, a shared through and right-turn lane, and a conventional painted bicycle lane. The southbound approach consists of two dedicated left-turn lanes and a through lane. The Storrow Drive off-ramp approach consists of a shared through and left-turn lane, and a shared through and right-turn lane. The only bicycle box at this intersection is located on the eastbound approach from the Longfellow Bridge. Figure 2.11 shows photos of this study site.

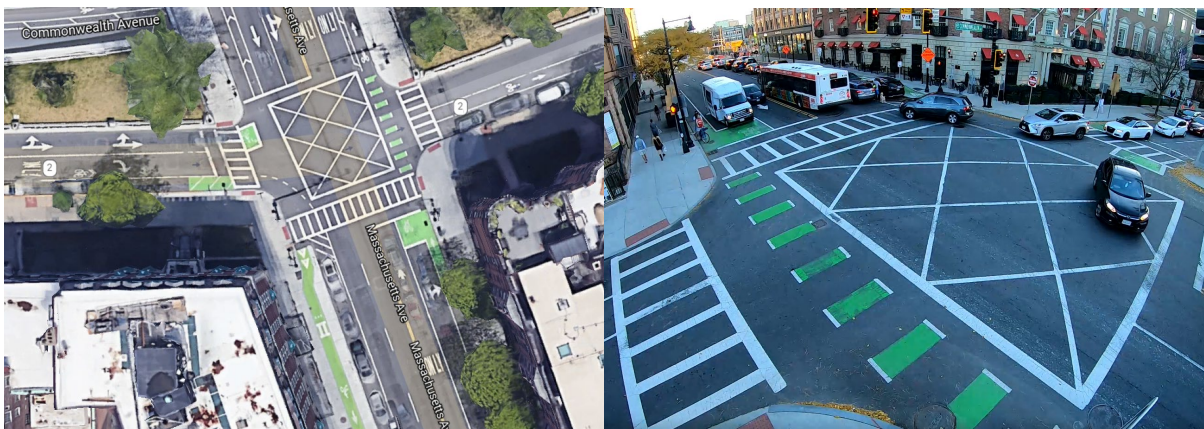
**Figure 2.12: Intersection layout and camera view for Massachusetts Ave. at Commonwealth Ave.**

Massachusetts Avenue at Commonwealth Avenue is a four-way signalized intersection, with Massachusetts Avenue approaching from the north and south, and Commonwealth Avenue acting as a one-way street traveling in the eastbound direction. The southbound approach consists of a through lane, a shared through and left-turn lane, and a buffered bicycle lane that extends into a separated painted bicycle lane in the southbound direction. The northbound approach consists of a through lane, a shared through and right-turn lane, and a conventional painted bicycle lane. The eastbound approach consists of a shared left-turn and through lane, a right-turn lane, and a conventional bicycle lane extending through Commonwealth Avenue traveling eastbound. The only bicycle box at this intersection is located on the northbound approach. Figure 2.12 shows photos of this study site.

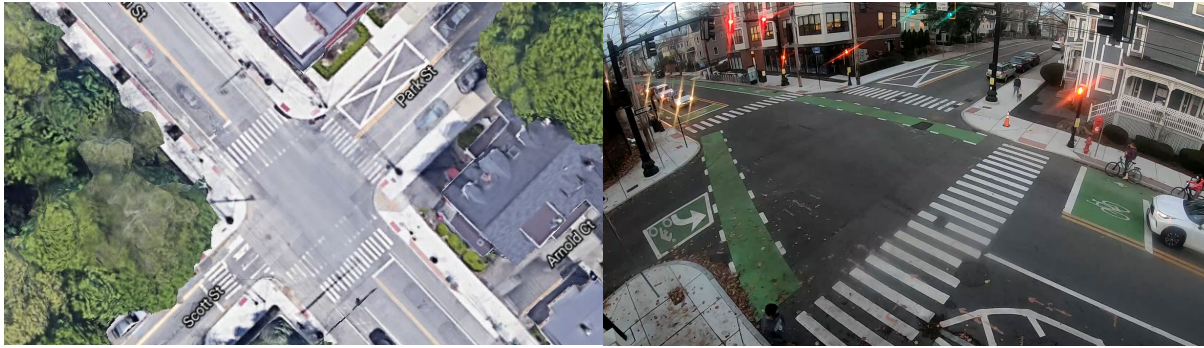
**Figure 2.14: Intersection layout and camera view for Beacon St. at Park St.**

Beacon Street at Park Street is a four-way signalized intersection, with Beacon Street approaching from the east and west, Park Street approaching from the north, and Scott Street approaching as a one-way from the south. The eastbound approach consists of a shared through and left-turn lane, and a conventional painted bicycle lane that continues eastbound as a raised/separated bicycle lane. The westbound approach consists of a shared through and right-turn lane, and a raised/painted bicycle lane. The southbound approach consists of a shared left- and right-turn lane, and a conventional bicycle lane. The northbound approach consists of a shared through, left- and right-turn lane. This intersection contains three bicycle boxes, located on the southbound, eastbound, and westbound approaches. A notable characteristic of this intersection is that for the westbound approach on Park Street, there is a blocked area downstream of the bike box and before the intersection, prohibiting vehicles from entering the intersection (Figure 2.14). This could potentially lead to higher vehicle compliance rates and fewer right-hook near misses.

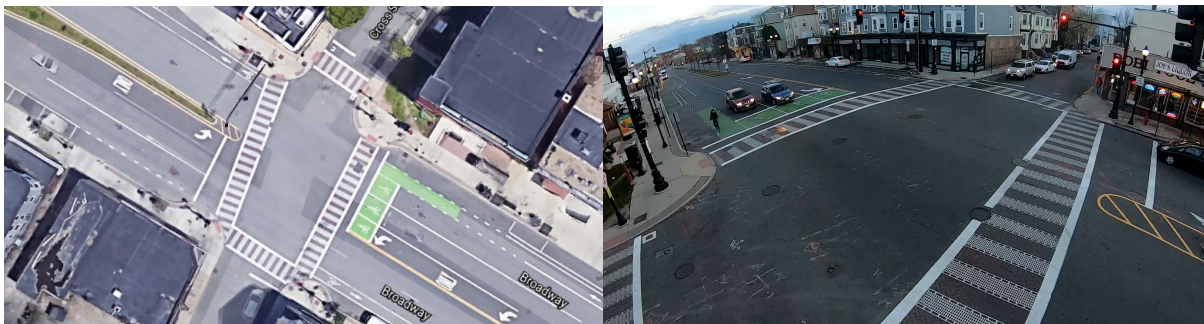
**Figure 2.15: Intersection layout and camera view for Broadway at Cross St.**

Broadway at Cross Street is a four-way signalized intersection, with Broadway approaching from the east and west, and Cross Street approaching from the north and south. The eastbound approach consists of a left-turn lane, a through lane, and a shared through and right-turn lane. The westbound approach consists of a left-turn lane, a through lane, a shared through and right-turn lane, and a conventional painted bicycle lane. The northbound and southbound approaches consist of a shared through, left- and right-turn lane. The only bicycle box at this intersection is located on the westbound approach of Broadway (Figure 2.15).

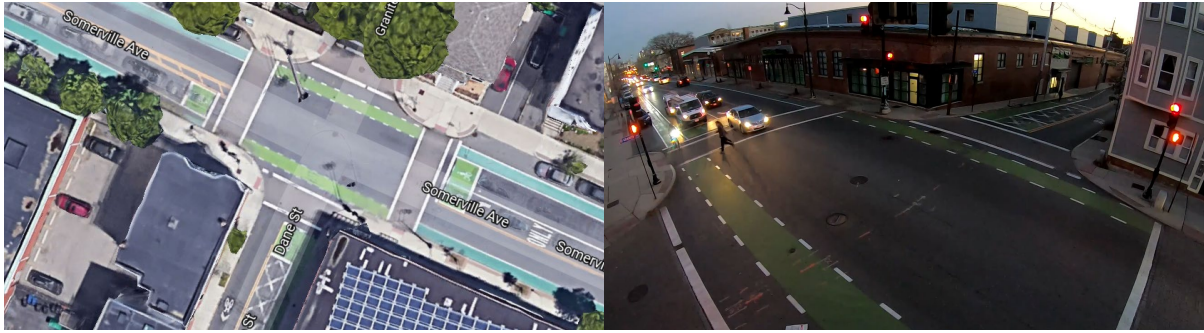
**Figure 2.16: Intersection layout and camera view for Somerville Ave. at Dane St.**

Somerville Avenue at Dane Street is a four-way signalized intersection, with Somerville Avenue approaching from the east and west, Dane Street approaching from the south, and Granite Street from the north. The westbound approach consists of a left-turn lane, a shared through and right-turn lane, and a conventional painted bicycle lane. The eastbound approach consists of a shared through, left- and right-turn lane, and a conventional painted bicycle lane. The southbound approach consists of a shared through, left- and right-turn lane. The northbound approach consists of a shared through, left- and right-turn lane, and a conventional painted bicycle lane. This intersection contains three bicycle boxes, located on the northbound, eastbound, and westbound approaches (Figure 2.16).

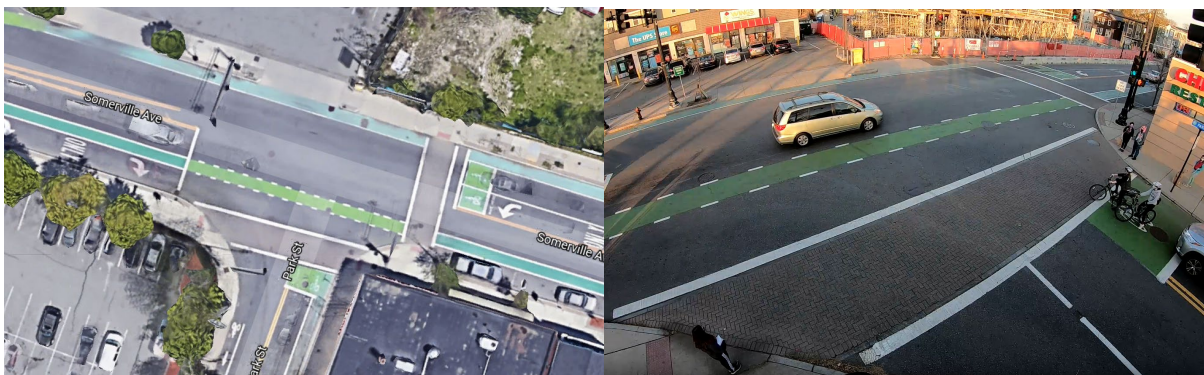
**Figure 2.17: Intersection layout and camera view for Somerville Ave. at Park St.**

Somerville Avenue at Park Street is a four-way signalized intersection, with Somerville Avenue approaching from the east and west, Park Street approaching from the south, and a very low volume driveway approaching from the north. The eastbound approach consists of a right-turn lane, a shared through and left-turn lane, and a conventional bicycle lane splitting the two vehicle travel lanes. The westbound approach consists of a left-turn lane, a shared through and right-turn lane, and a conventional painted bicycle lane. The northbound approach consists of a shared through, left- and right-turn lane, and a conventional painted bicycle lane. This intersection contains two bicycle boxes located on the westbound and northbound approaches (Figure 2.17).

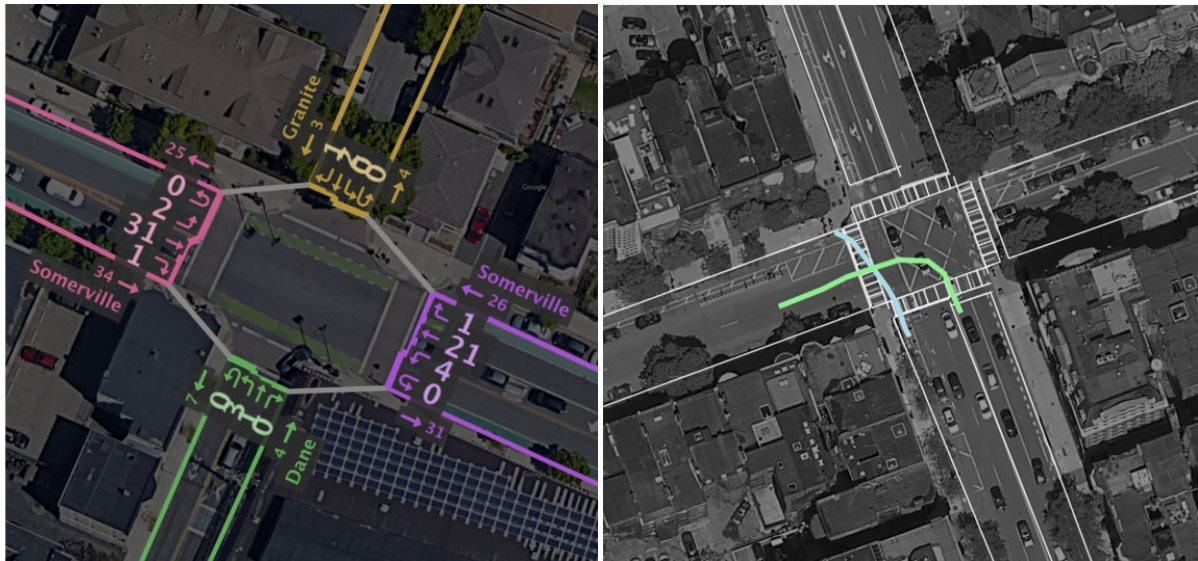
Importantly, near misses can be queried by user sequence. For the focus of this study, this meant that near misses could be queried based on whether the bicyclist or the motorist arrived first at the conflict point. This is important, especially for vehicle-bicycle crashes, as it could be used to infer the level of severity of that crash, e.g., a crash where the car was first and the bicycle second is expected to be associated with low risk for the bicyclist. However, this is not always true, as there are cases where the car is the first user by cutting off the bicyclist, which could result in a severe crash. Near misses can also be queried by approach, movement, time period, speed for either of the two users involved in the near miss, severity, PET, and speed. Furthermore, near misses are also illustrated via images illustrating the trajectories that are involved in the near miss as well as the potential conflict point; see Figure 2.18b.

(a) Bicycle turning movement counts

(b) Near miss between a car (green) and a bicycle (light blue)

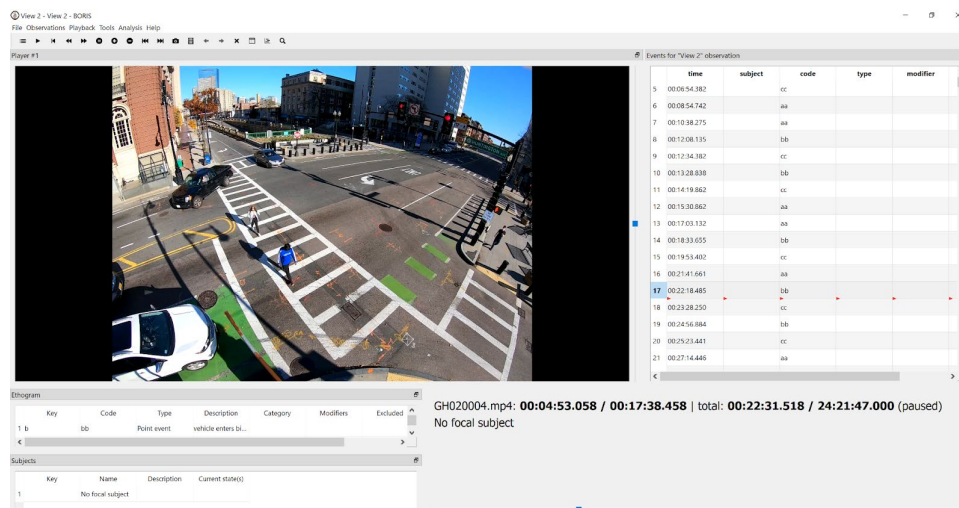
**Figure 2.19: BORIS interface**

The analysis of motorist behavior focused on driver compliance. Data on driver compliance were collected manually with the use of the Behavioral Observation Research Interactive Software (BORIS) tool (22). This tool provides an interface that allows the user to record events of interest while watching a video recording. Figure 2.19 shows the interface; the left side of this interface shows the video and controls for the video recording, while the window to the right includes the recorded observations. Additional information about the predefined behavior (e.g., vehicle encroachment) and the video are shown at the bottom of the interface.

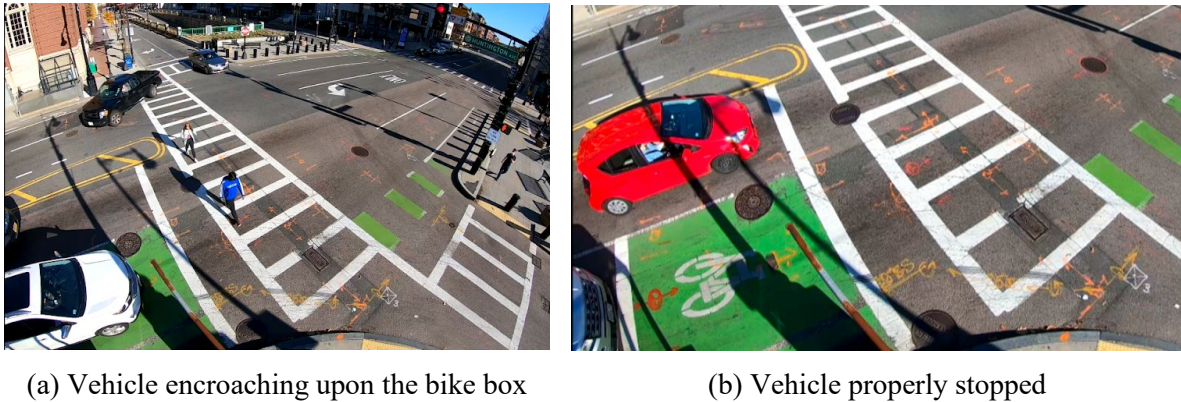
**Figure 2.20: Examples of vehicles stopped at bike box approaches**

Given the objective of this study to determine how motorists are using bike boxes, the manual field data processing focused only on data during the red signal indication for each approach and movement. More specifically, the focus was on recording whether each of the motorized vehicles that stopped during the red signal indication stopped properly (i.e., in advance of the bike box). A vehicle was considered not complying, i.e., encroaching upon the bike box if any part of the vehicle protruded past the white bike box perimeter line, as shown in Figure 2.20. These events were obtained for each bike box that was visible in each video and each traffic lane upstream of the bike box, for a total of 11 bike boxes at the six intersections mentioned previously.

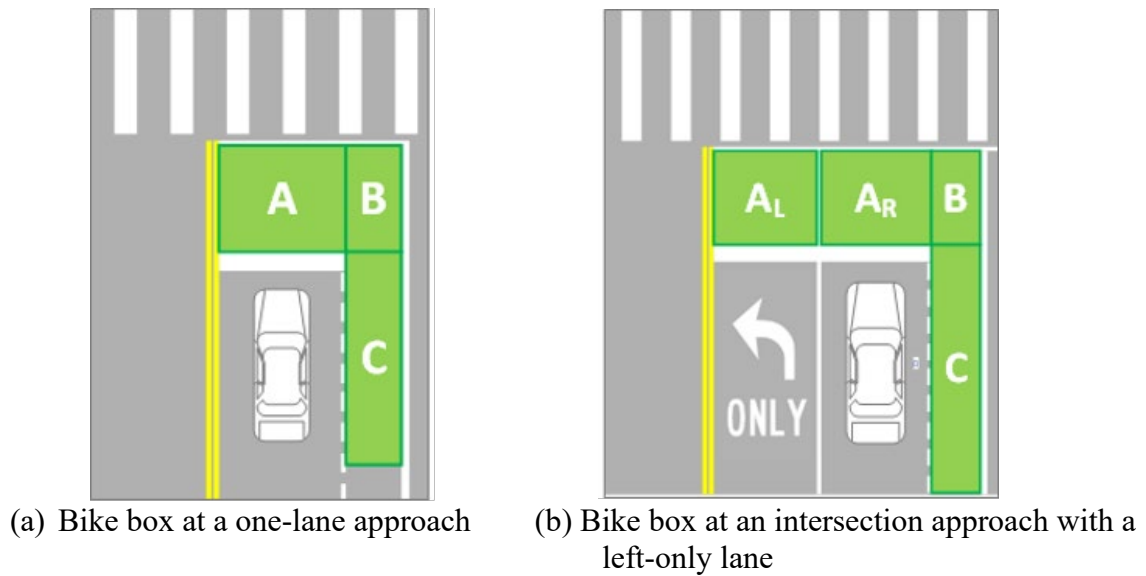
**Figure 2.21: Bike box stopping locations**

The bicyclist behavior analysis was conducted by analyzing bicycle trajectories at the 11 bike boxes of the six intersections mentioned above. Observations were collected for the duration of the red signal throughout the data collection period at each bike box approach. By analyzing the concentration of bicycle trajectories in the identified regions, the team could infer how bicyclists understand and utilize bike boxes.

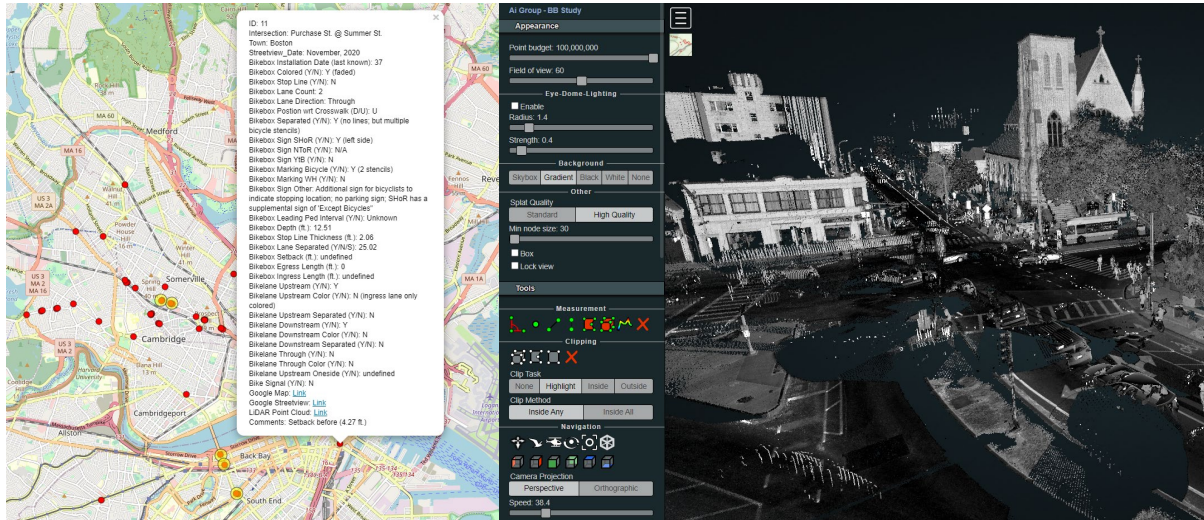
As a deliverable, the research team developed a GIS web page to facilitate the subsequent analysis and improve the visualization of the bike box inventory results. All the inventory data can be accessed through <http://massdot.ecs.umass.edu/Bikebox/>. This web page includes all 91 bike boxes inventoried in this study. Figure 4.1 shows an example of the GIS web page and the corresponding LiDAR point cloud data viewer page.

(a) GIS bike box inventory

(b) LiDAR point cloud data viewer

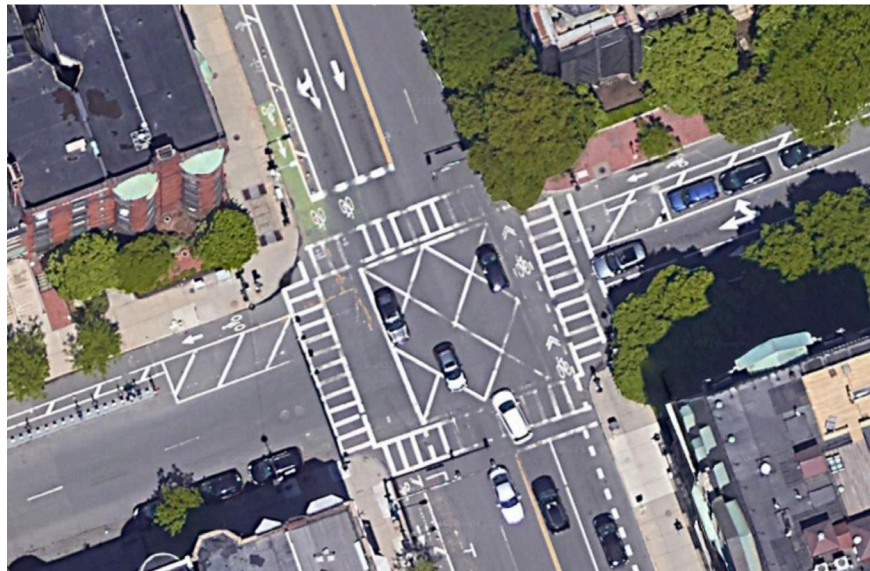
**Figure 4.2: Bike box spanning one of two traffic lanes (Massachusetts Ave. at Beacon St., Boston)**

Of the bike boxes identified, 86% feature green-colored pavement. Bike boxes that are not colored are mainly concentrated in the town of Melrose. Northampton, Chicopee, and Newton also each present one without green-colored pavement. Approximately half of the bike boxes (52%) are installed at single-lane intersection approaches, while 79% of them are installed at intersection approaches that allow for a left-turning movement regardless of the number of lanes. There are four bike boxes that span four traffic lanes, one on Main St. with New South St. at State St. in Northampton and the other on Boland Way Southbound at West Columbus Avenue in Springfield. It should be noted that in some cases, the width of the bike box does not expand across all available traffic lanes, most likely in an effort to facilitate certain movements; see Figure 4.2 for an example of an approach with two traffic lanes, but a bike box covering only one of them.

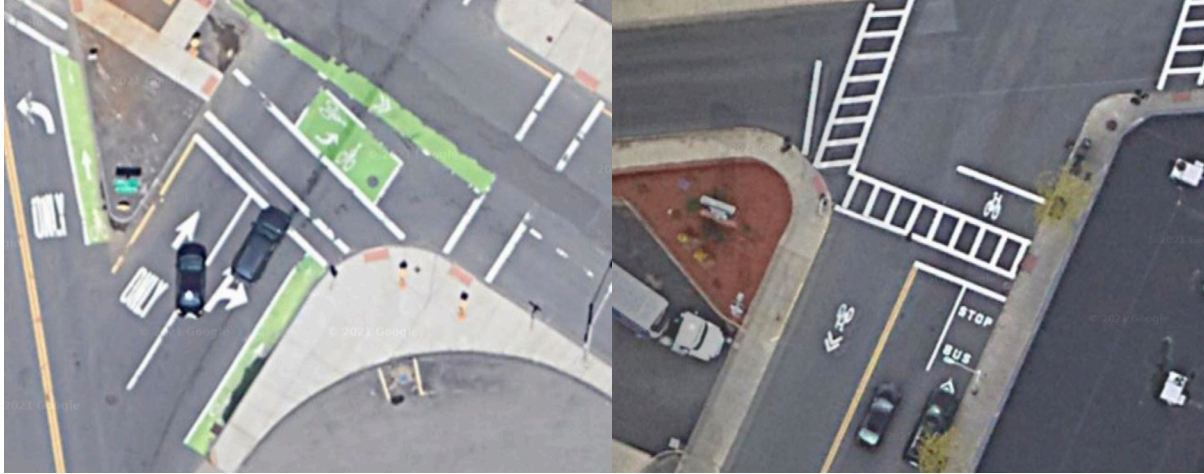
Only 4% have the bike boxes located downstream of the crosswalk; see Figure 4.3 for examples. In one of those four cases, the bike box serves as both a bike box and a two-stage turn queue box for vehicles coming from the cross street and wanting to turn left (see Figure 4.3a).

(a) Somerville Ave. at Medford St., Somerville

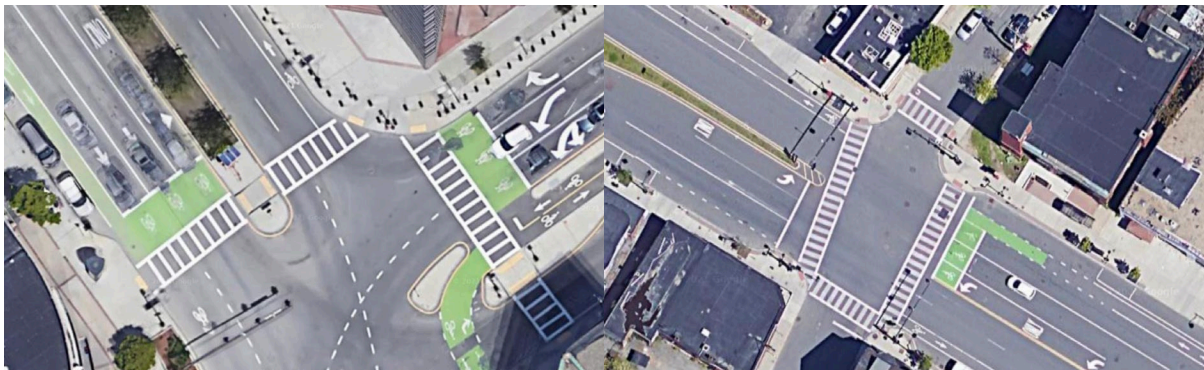
**Figure 4.4: Bike boxes with separated sections with (a) no lines and (b) lines**

Out of the multilane bike boxes, about 41% are separated in the sense that multiple bicyclist stencils are on the bike box to indicate the different lanes. In 33% of those cases, lines also exist to separate the lanes within the bike box; see Figure 4.4 for examples. None of the bike boxes have been installed at intersections where the bike lane transitions from one side to the other, which is a common reason for implementing them.

(a) Lomasney Way at Causeway St., Boston

(b) Broadway at Cross St. East, Somerville

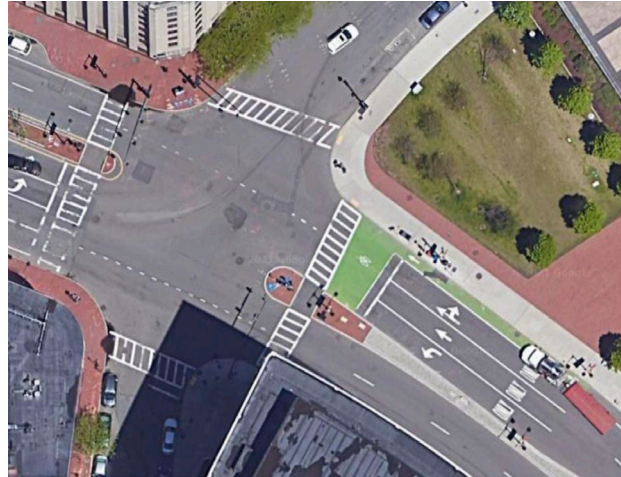
**Figure 4.5: Bike box with additional stop line (Cambridge St. and Somerset St., Boston)**

While an additional stop line (in advance of the bike box white line) can improve motorist compliance, only 3 out of the 82 bike box approaches that locate the bike box upstream of the crosswalk (or in the absence of a crosswalk) feature this additional stop line; see Figure 4.5 for an example.

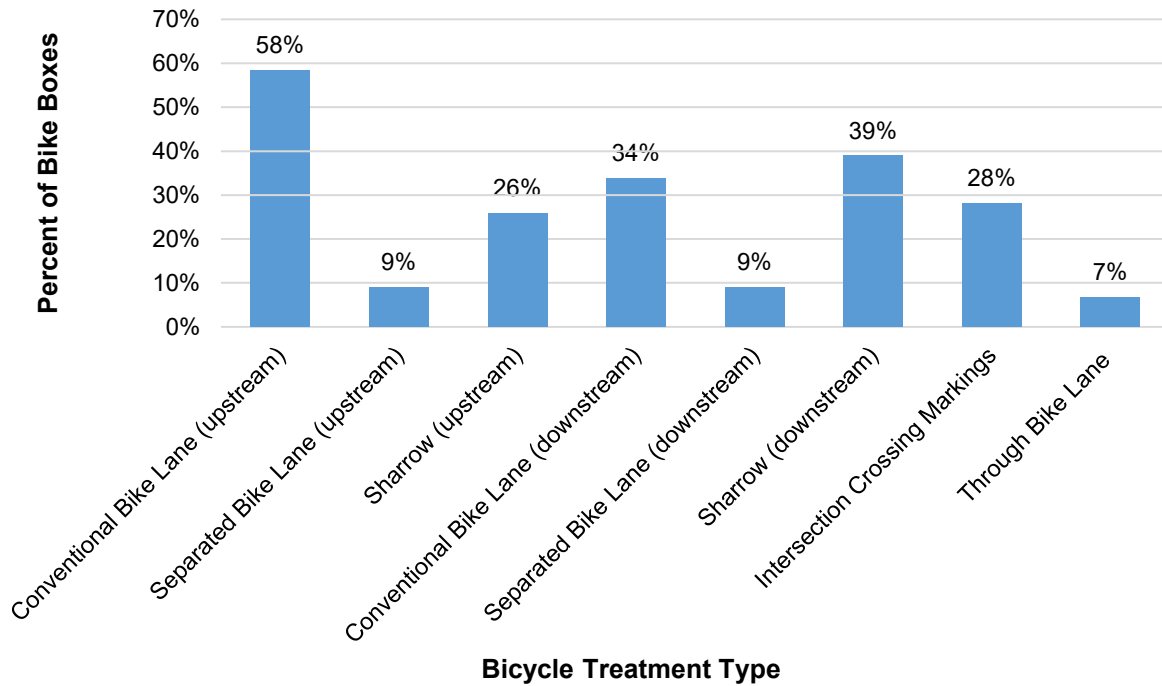
**Figure 4.6: Percentage of bike box locations featuring various types of bicycle treatments**

Bike boxes were not always accompanied by upstream or downstream bicycle infrastructure such as bike lanes. Figure 4.6 shows the percentage of bike boxes that were accompanied by certain types of bicycle treatments, such as bike lanes and sharrows (V-shaped road markings), both upstream and downstream of the bike box location. As shown in the figure, 58% of all locations present a conventional bike lane upstream, 9% a separated bike lane, and 26% sharrows. The rest, 7%, do not present any type of bicycle treatment upstream, and about 17% do not present any type of bicycle treatment downstream. The fact that it is more likely to present bicycle infrastructure upstream of the bike box compared to downstream can be attributed to the fact that implementation of bike boxes is encouraged when downstream bicycle infrastructure (e.g., bike lanes) is absent and at intersections with high numbers of right-hook crashes. The majority of bike box locations are characterized by sharrows downstream (39%), followed by conventional bike lanes (34%) and a few separated bike lanes (9%). Only eight bike boxes were installed at locations where protected bike lanes exist upstream and eight at locations where protected bike lanes exist downstream (not all overlapping), which could, however, be related to the fact that protected bike lanes are not as common as conventional bike lanes.

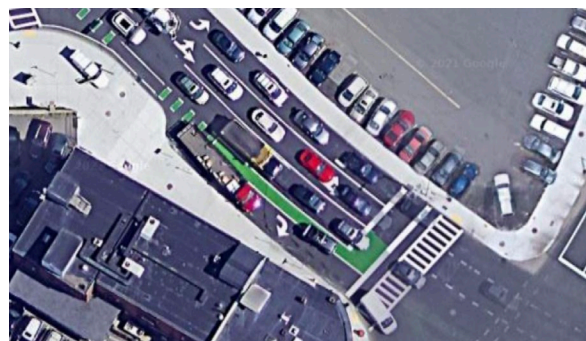
**Figure 4.7 Through bike lane (Maffa Way at Cambridge St., Somerville)**

For those bike box locations that featured a conventional bike lane upstream of the bike box, a green-colored ingress lane was present in almost 76% of the cases. Ingress lanes are recommended by both MUTCD (5) and the NACTO *Urban Bikeway Design Guide* (15). Intersection crossing markings are present in only 28% of the cases and are green colored (i.e., egress lanes) in 80% of the cases. Literature reveals that the need for a bike box diminishes when colored intersection crossing markings exist (1). Finally, only 7% of the intersection approaches present bike through lanes (i.e., the bike lane is located to the left of the right-turning lane); see Figure 4.7. This is to be expected, as bike boxes are often installed to mitigate right-hook crashes, which would not be an issue in the presence of through bike lanes.

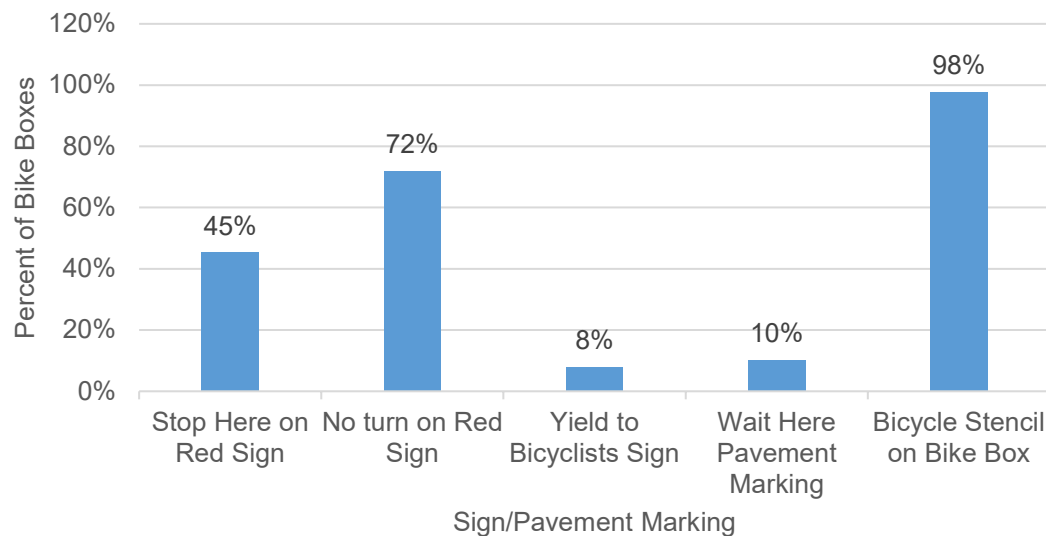
**Figure 4.8: Percentage of bike boxes featuring various types of signage and pavement markings**

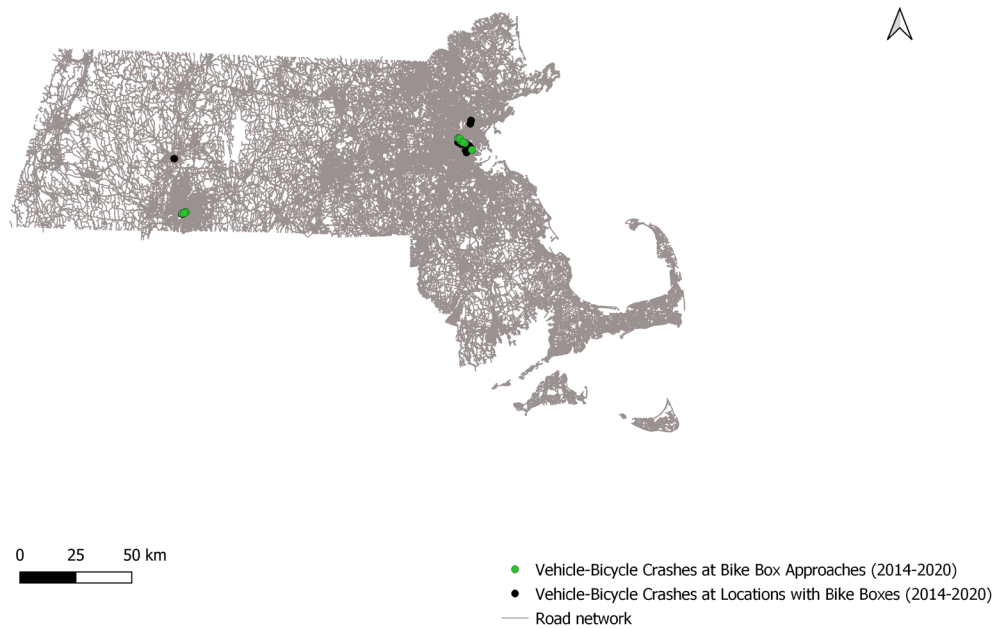
**Figure 4.9: Motorized vehicle-bicycle crashes at bike box locations in Massachusetts (2014–2020)**

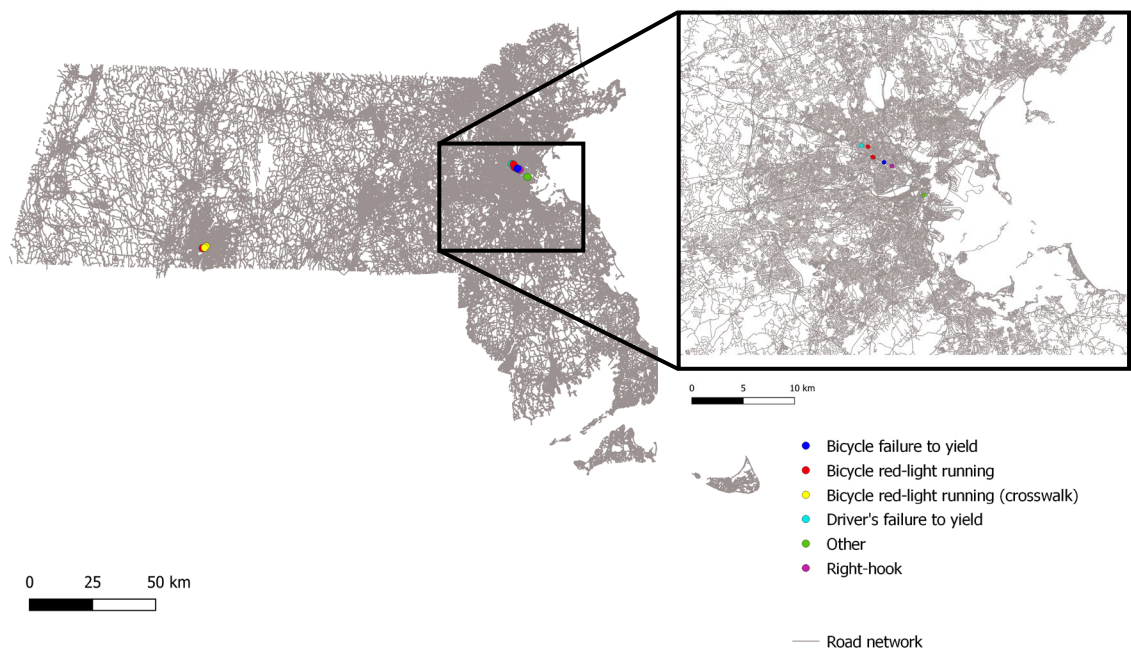
**Figure 4.10: Motorized vehicle-bicycle crashes at bike box locations in Massachusetts by type (2014–2020)**

Figure 4.10 shows the crashes that occurred at bike box approaches by type of crash for the whole state and the Boston metropolitan region.

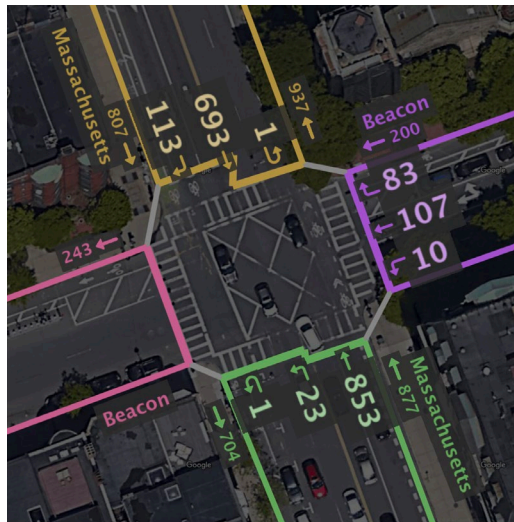
**Figure 4.11: Bicycle turning movement counts at Beacon St. and Massachusetts Ave. (11/2/2020 at 12:30 p.m. to 11/3/2020 at 1:15 p.m.)**

The intersection of Beacon Street and Massachusetts Avenue was found to operate under an average daily count of 17,012 and an average daily bicycle count of 1,827 bicyclists, with a distribution as shown in Figure 4.11. The video data revealed 693 through-going bicyclists and 113 right-turning bicyclists for the bike box approach (i.e., southbound approach) for the time period of data collection.

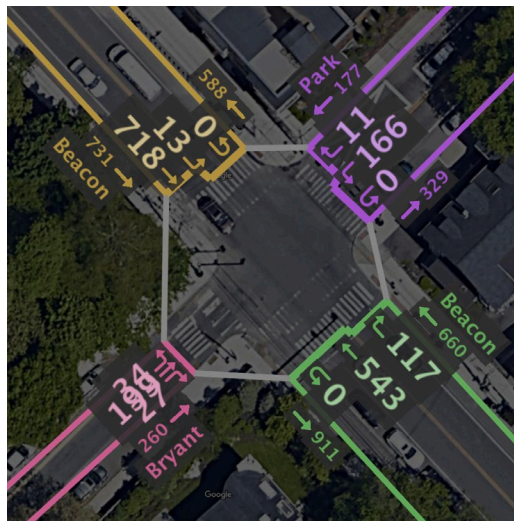
**Figure 4.12: Bicycle turning movement counts at Beacon Street and Park Street (11/16/2020 at 3:00 p.m. to 11/17/2020 at 3:45 p.m.)**

The intersection of Beacon St. and Park St. was found to operate under an average daily count of 10,190 and an average daily bicycle count of 1,773 bicyclists, with a distribution shown in Figure 4.12. While the overall bicycle demand for that intersection and the through-going bicyclists for two of the three bike box approaches is comparable with the intersection at Beacon Street and Massachusetts Avenue, Boston, described earlier, no near misses were observed based on a  $PET < 5.0$ . Notably, no crosswalk-related near misses were observed. One hypothesis that should be investigated in the future is whether the presence of intersection pavement markings discourages the use of crosswalks by bicyclists, as it is perceived as a designated and, therefore, safe space to cross the intersection, which simultaneously encourages compliance with the traffic control devices (i.e., traffic signals); in the absence of such intersection pavement markings, bicyclists are motivated to use the crosswalks, often during the red pedestrian signal.

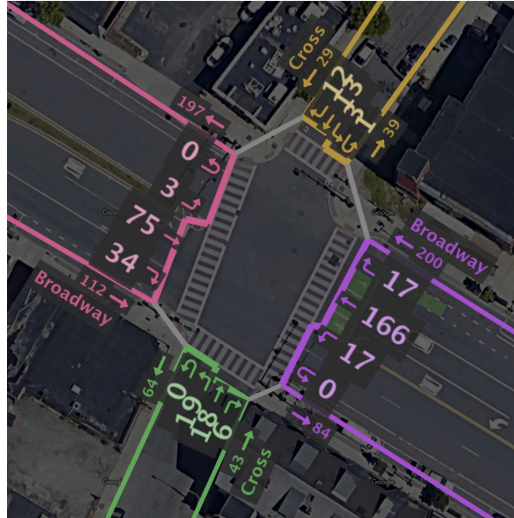
**Figure 4.13: Bicycle turning movement counts at Broadway and Cross Street East, Somerville (11/16/2020 at 3:45 p.m. to 11/17/2020, 4:15 p.m.)**

The intersection of Broadway and Cross Street operates under an average daily count of 10,372 and an average daily bicycle count of only 376, with a total count of 200 bicycles for the bike box approach during the observation period (Figure 4.13). These bicycle volumes are very low, especially compared to the other intersections that were studied. The observation period resulted in zero bicycle-vehicle near misses, based on a PET < 5.0.
