**September 2021**

**Report No. 21-021**

# Effectiveness of Bike Boxes in Massachusetts

**University of Massachusetts Amherst**

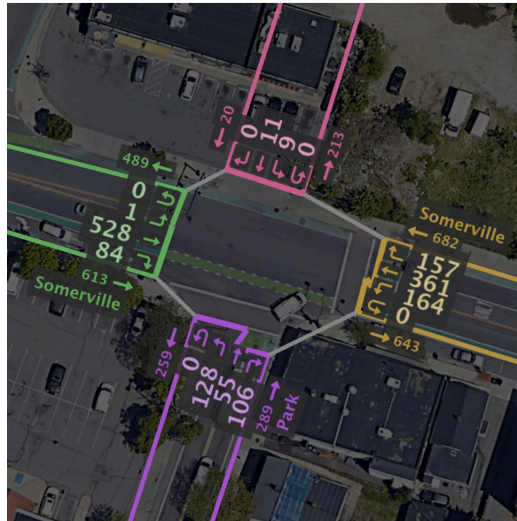
**Figure 4.16: Bicycle turning movement counts at Somerville Avenue and Park Street, Somerville (11/19/2020 at 4:00 p.m. to 11/20/2020 at 4:45 p.m.)**

The intersection of Somerville Avenue and Park St. operates under an average daily count of 13,520 and an average daily bicycle count of 1,555, with a distribution shown in Figure 4.16. While the overall bicycle demand for that intersection and the through-going bicyclists for two of the three bike box approaches is comparable to that of the intersection at Beacon Street and Massachusetts Avenue, Boston, described earlier, no near misses were observed based on a PET < 5.0.

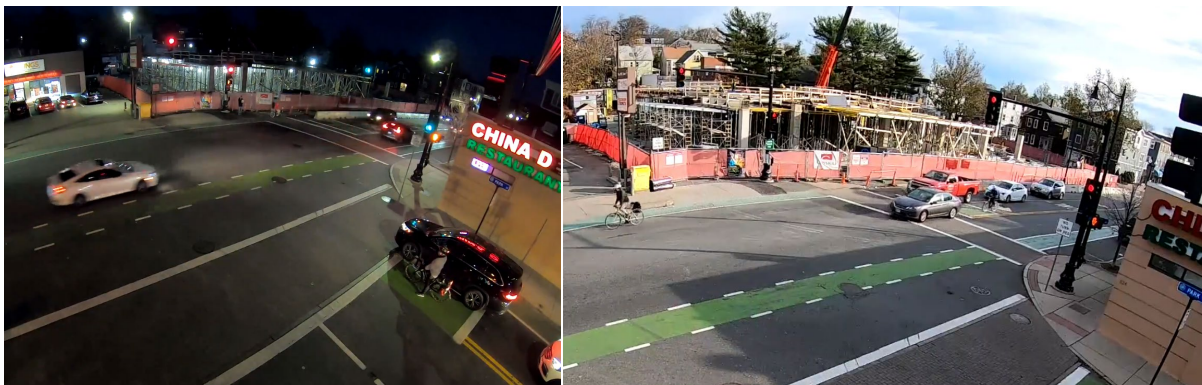
**Figure 4.17: Noncompliant motorist behavior at bike boxes**

Observations of vehicle encroachment at 11 intersection approaches with bike boxes in Boston and Somerville have shown that bike box encroachment is indeed a frequent phenomenon; see Figure 4.17 for two examples.

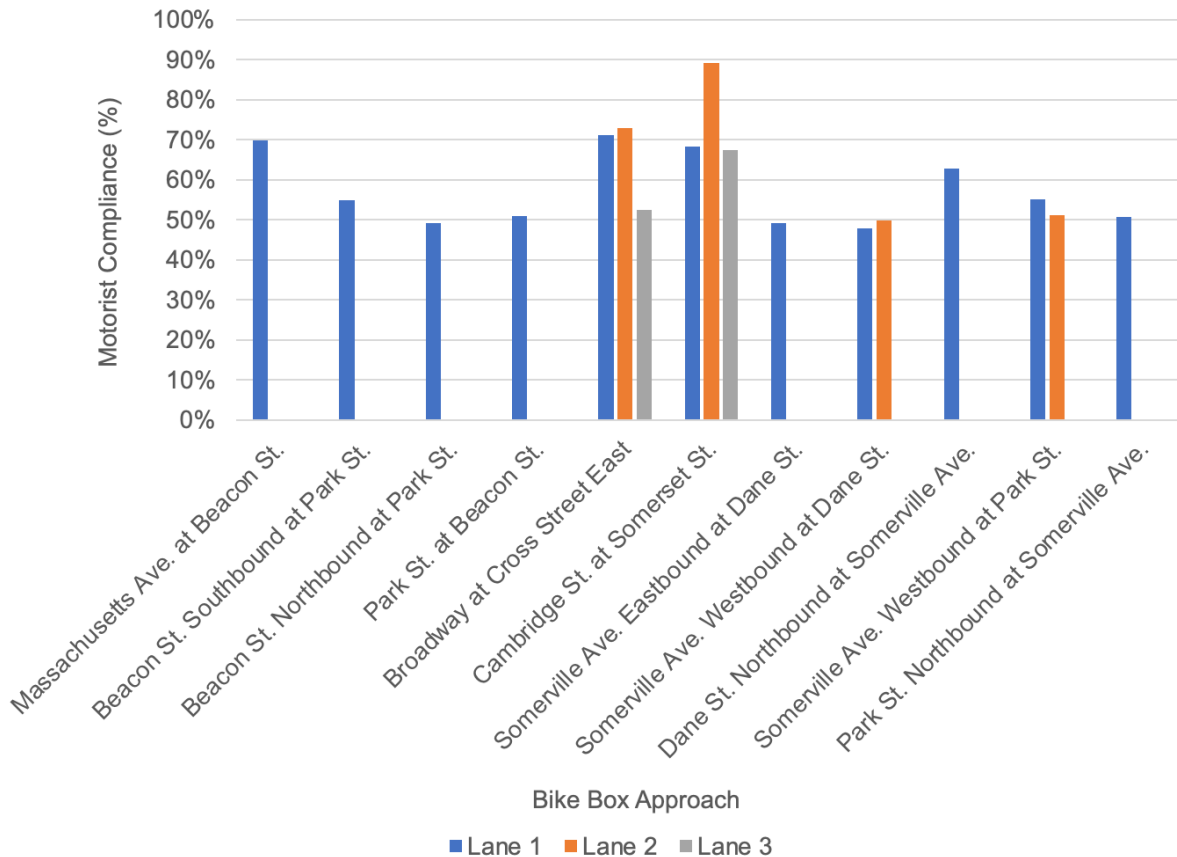
**Figure 4.18: Motorist compliance at 11 bike box locations (\*Lane 1 is left-most lane)**

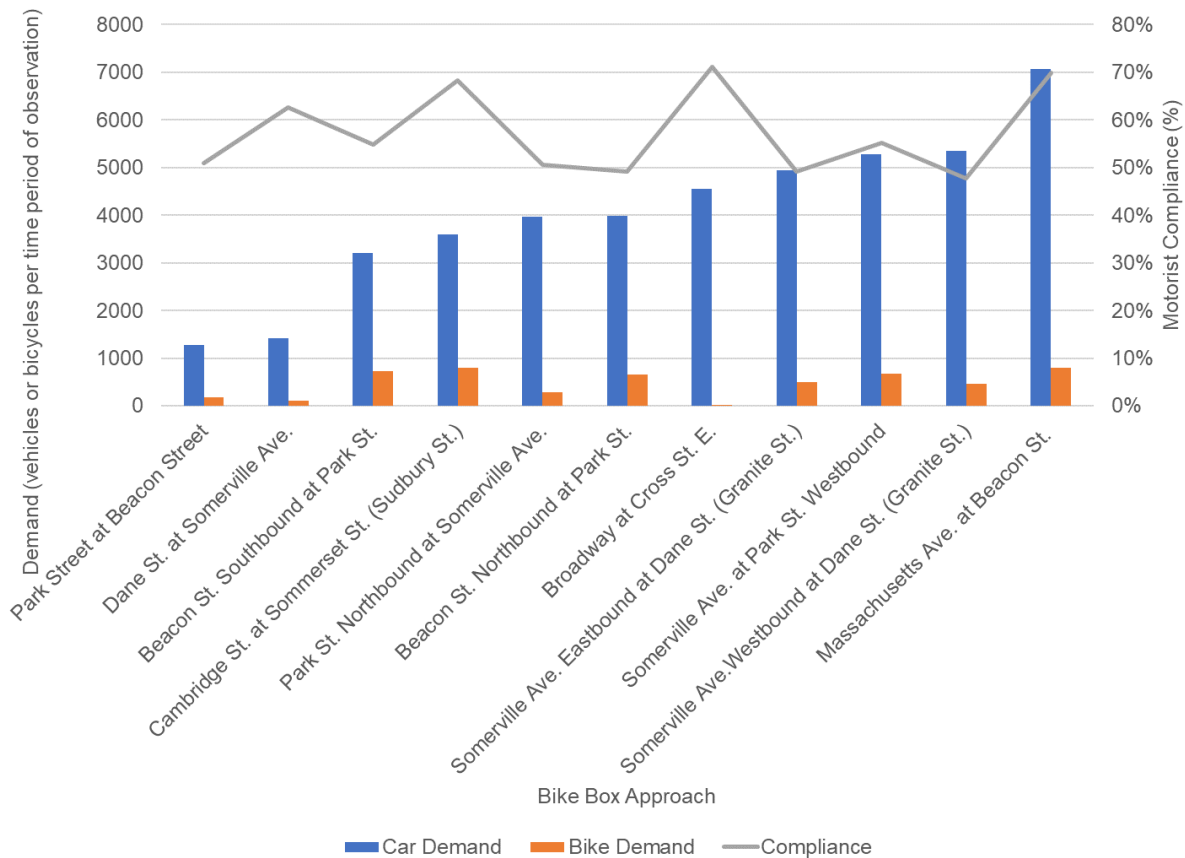
**Figure 4.19: Motorist compliance, car, and bicycle demand (during reporting period for each site) for 11 bike box locations (\*Lane 1 is left-most lane)**

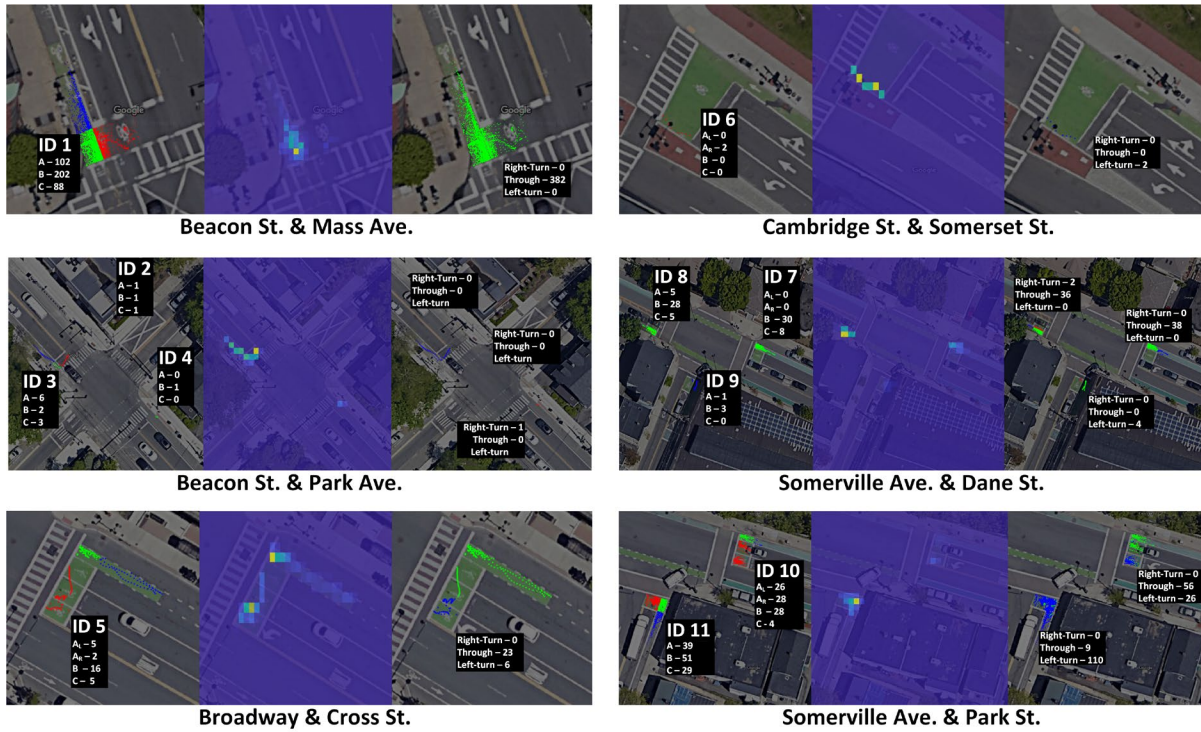
**Figure 4.20: Bicycle trajectory heatmaps for 11 bike boxes at six study intersections**

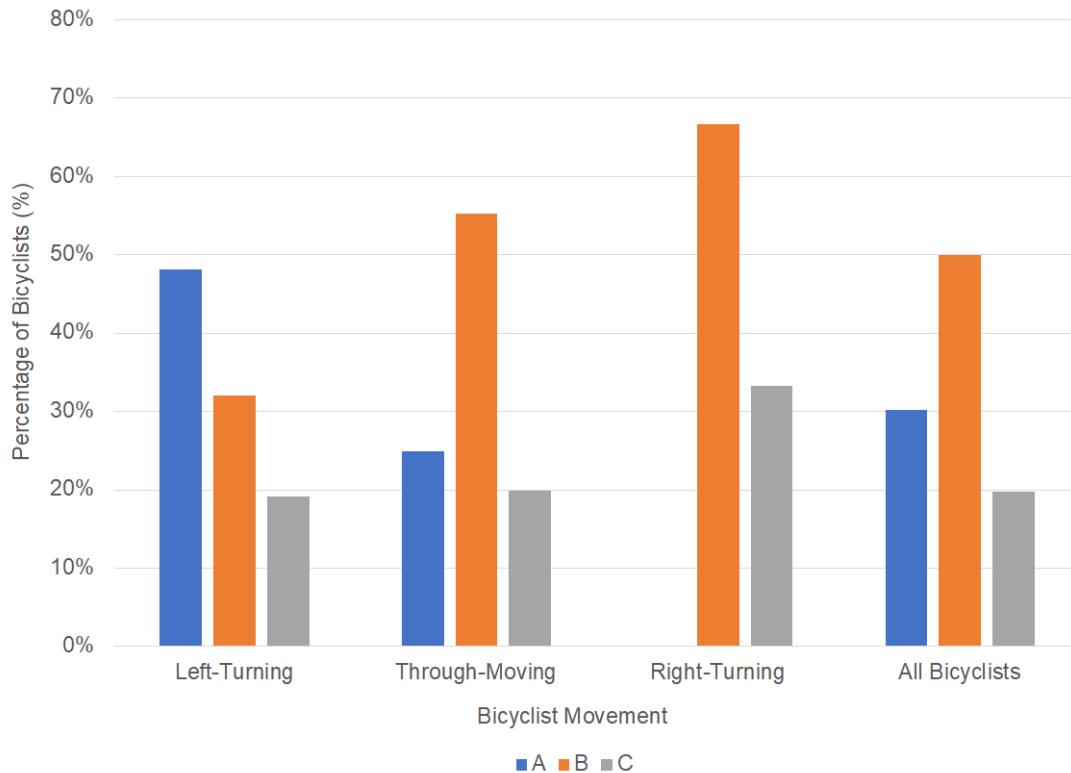
**Figure 4.21: Percentage of bicyclists in each region by turning movement**
