**ENVIRONMENTAL SITE ASSESSMENT  
106 HALE STREET  
BRIDGEWATER, MASSACHUSETTS**

DECEMBER 12, 2012

**RE: Environmental Site Assessment  
106 Hale Street  
Bridgewater, Massachusetts  
GEC Project No. 1424-2350**

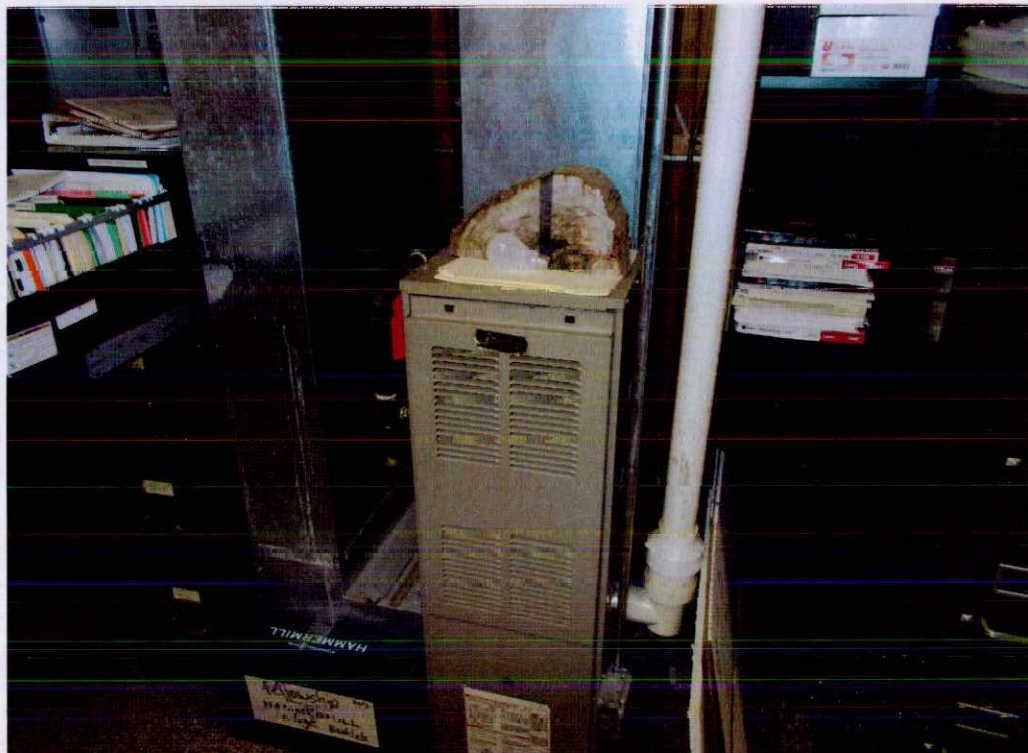
GEC Project No. 1424-2350. November 26, 2012. 106 Hale St. Bridgewater, MA. Gas fired heating unit.

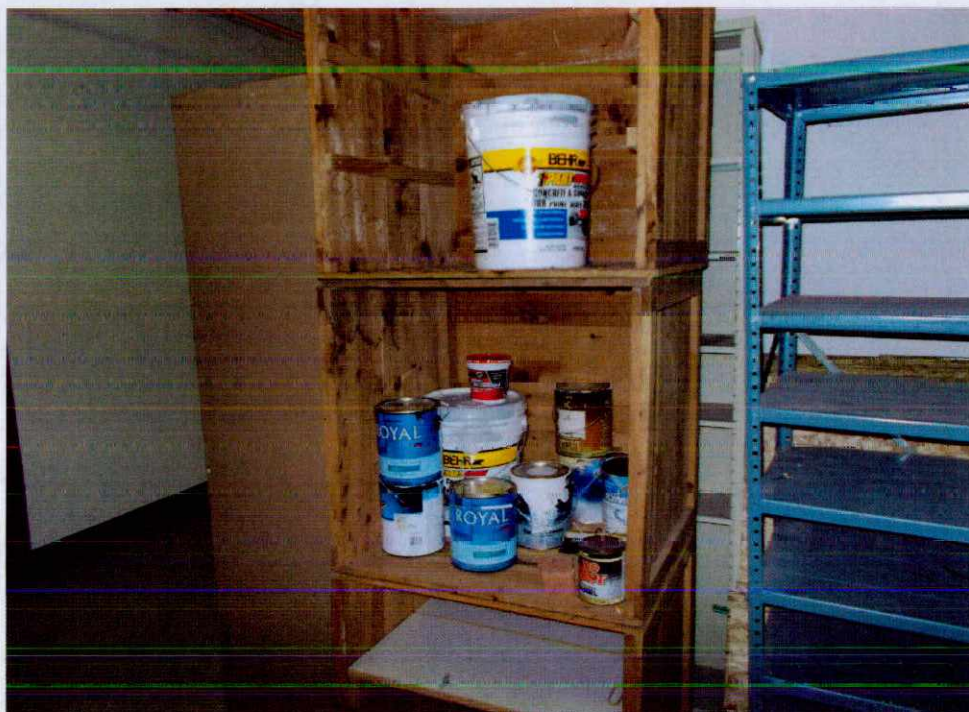
GEC Project No. 1424-2350. November 26, 2012. 106 Hale St. Bridgewater, MA. De minimis paint storage in corridor.

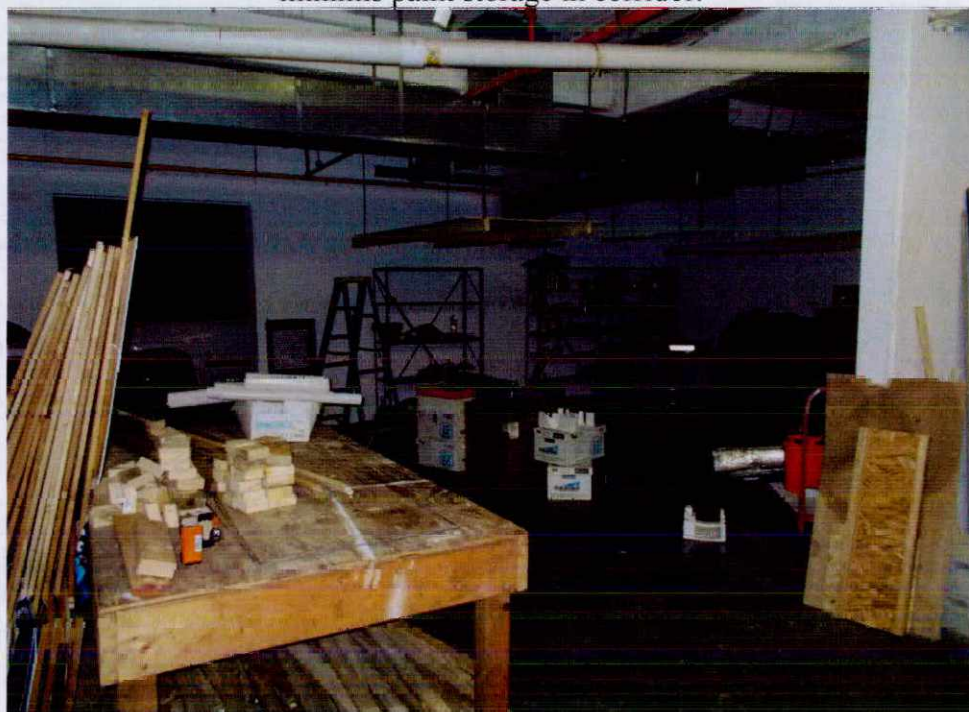
GEC Project No. 1424-2350. November 26, 2012. 106 Hale St. Bridgewater, MA. Political sign assembly area with de minimis paint.

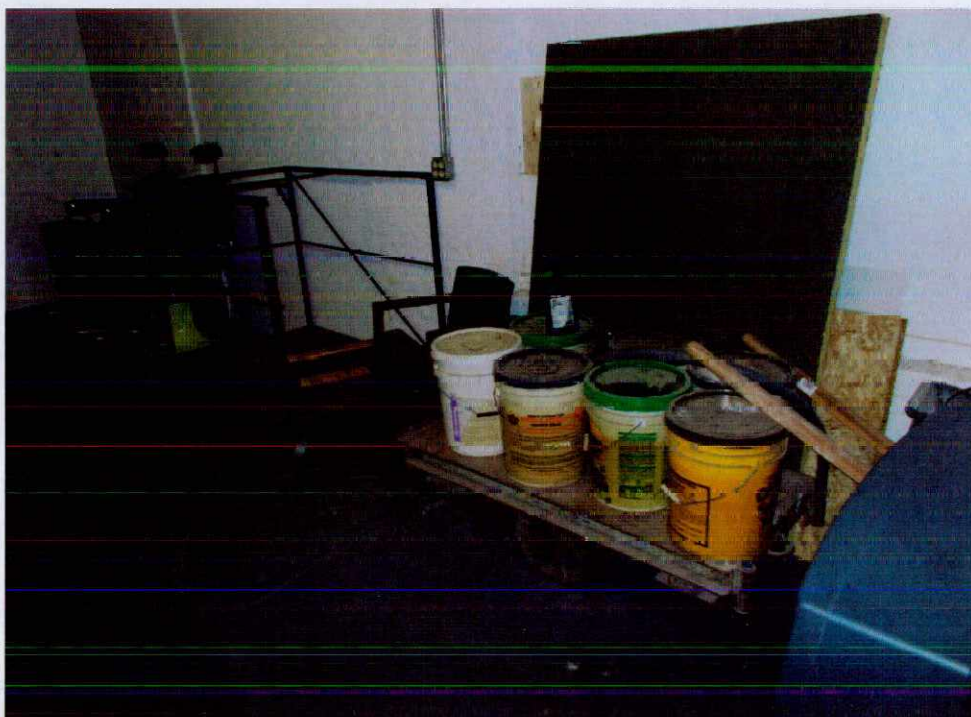
GEC Project No. 1424-2350. November 26, 2012. 106 Hale St. Bridgewater, MA.  
Driveway sealer and motor oil.

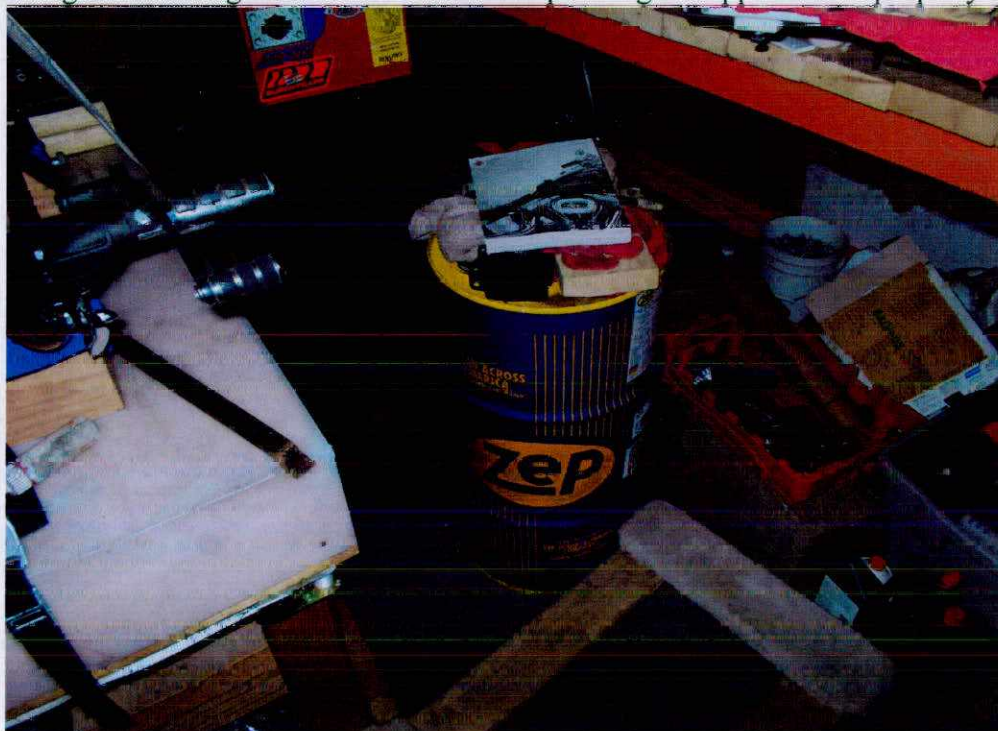
GEC Project No. 1424-2350. November 26, 2012. 106 Hale St. Bridgewater, MA. De minimis automotive chemicals in storage area/workshop.

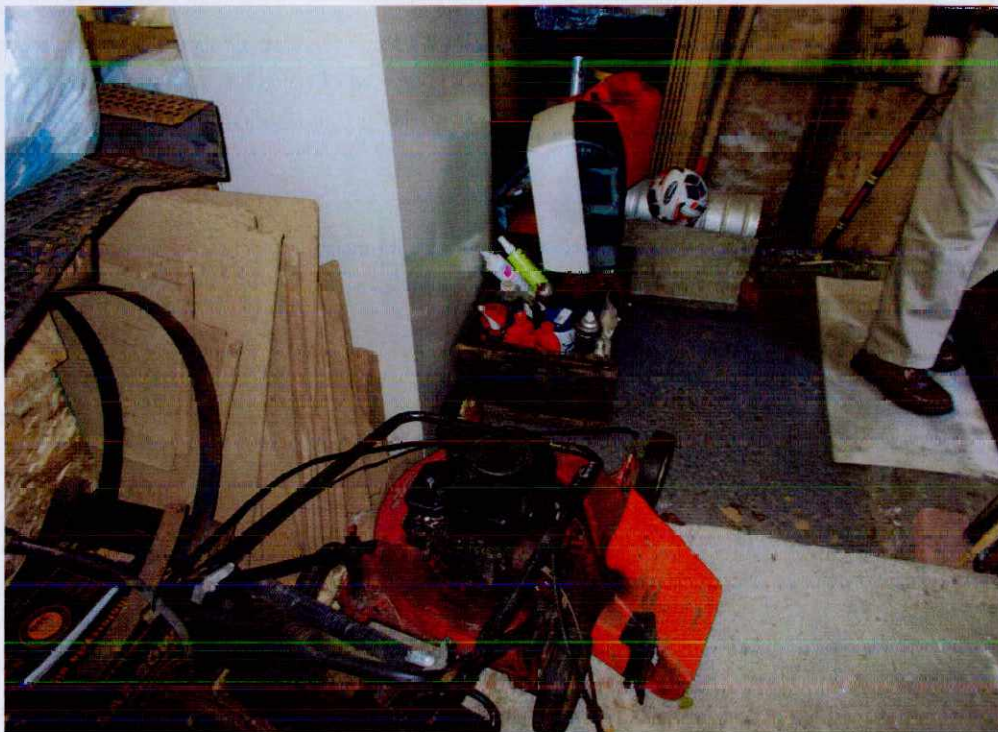
GEC Project No. 1424-2350. November 26, 2012. 106 Hale St. Bridgewater, MA. De minimis petroleum/chemical storage in workshop/storage area.

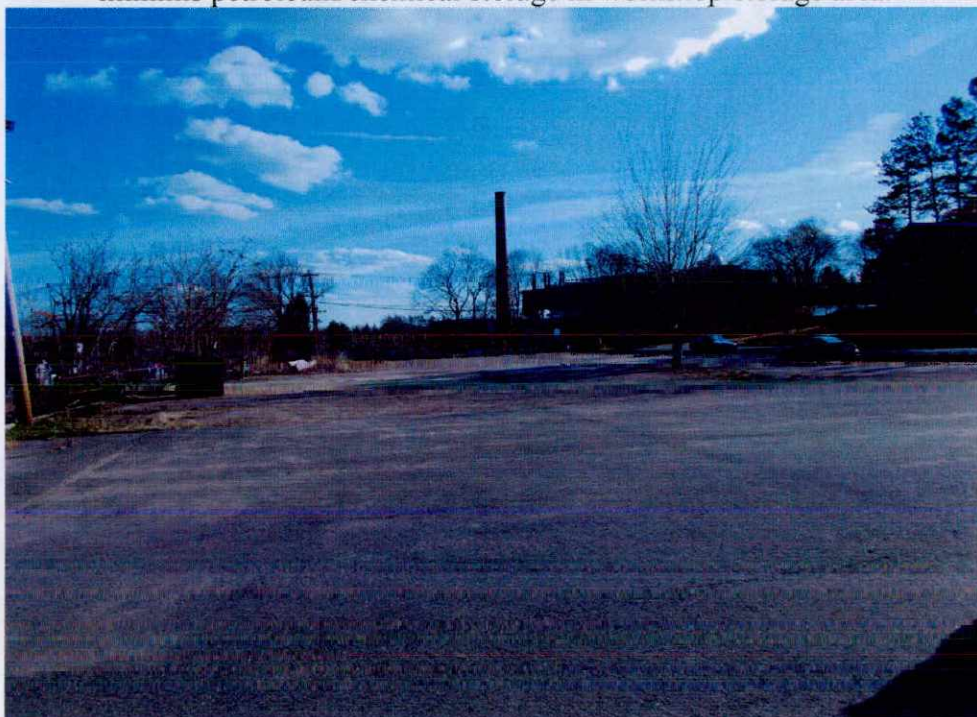
The exterior of the Site consisted of asphalt-paved parking areas with a former building slab on the southeastern end. A narrow vegetated area is located along the northern property boundary. The asphalt pavement was observed to be in relatively good condition, with only minor cracks and staining typical of parked vehicles. GEC did not detect suspicious odors, distressed vegetation or stained soil on-Site during the Site reconnaissance. GEC observed several features in the former building slab including steel plates, a pipe flange, and several possible column footings. In addition, a steel pipe was observed protruding from the ground adjacent to the northern corner of the building located adjacent to the MBTA Commuter Rail right-of-way. A large pad-mounted transformer was observed adjacent to the northwestern corner of the building. No labels indicating PCB content were observed on the transformer. With the (possible) exception of the transformer, GEC did not observe the storage of hazardous/petroleum substances on the exterior portions of the Site.

GEC Project No. 1424-2350. November 26, 2012. 106 Hale St. Bridgewater, MA. Former building location.

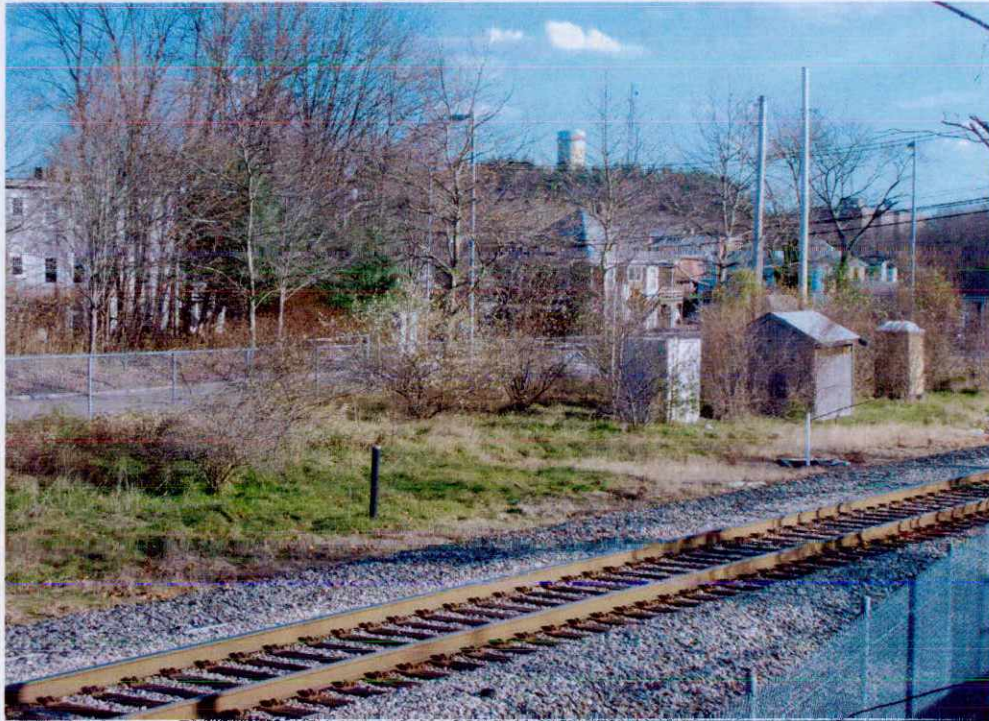
In April of 2002, quench oil was reportedly observed in wetlands adjacent to the south side of the Site which was reportedly related to leaking USTs located on the Site. The release was assigned RTN 4-1187. The disposal site defined by RTN 4-1187 includes much of the area of the Site to the southeast of the current Site building. According to a Class C Response Action Outcome (RAO) Statement filed by Weston and Sampson Engineers, Inc. (W&S) response actions taken to address the release included the removal of suspect USTs and impacted soil, product recovery via removal from wetlands, sumps, monitoring wells; the installation of a product interceptor trench and recovery pump and subsequent monitoring. On November 13, 1996, MassDEP, the MBTA, Bridgewater Corporation (the owner of the Site at the time), and W.H. Maze Company entered into Administrative Consent Order (ACO) ACOP-SE-96-P003 for the Site. It is unclear based on available file information if a penalty was assessed by MassDEP as part of the ACO. On February 28, 2003, DEP issued a Decision to Grant Permit Extension Transmittal #W028914 under ACO (ACO-SE-03-3S-005). This Permit Extension Approval/ACO outlines required submittals of data, and required revisions to the Phase IV RIP (by May 30, 2003), and attainment of Phase V Remedy Operation Status (by August 30, 2003).

The Class C RAO was filed with MassDEP in August of 2003 and operation, maintenance and monitoring of the remediation reportedly continued. On November 23, 2009, MassDEP issued a Notice of Noncompliance (NON) after a five-year periodic review was not filed for the Site. At that time, MBTA reportedly contracted a new Licensed Site Professional (LSP) to achieve compliance. The most recent status report observed in the MassDEP files is dated August 2011, which indicated that Arcadis U.S. had taken over as environmental consultant for MBTA. Inspections conducted for the August 2011 Post Class C Status Report indicated that some of the product recovery equipment was inoperable and needed repair/replacement, and also that significant quantities of product were still present in downgradient monitoring wells and sumps depicted on the Site. MBTA reportedly proposed active excavation and product recovery, in an attempt to achieve a Permanent Solution for the Site, to coincide with railroad tie replacement which was to have been conducted in the summer of 2011; however, these activities were determined to be infeasible as they would require the Commuter Rail line to be taken out of service for an extended period of time. No reports, NONs or other correspondence submitted/issued after the August 2011 Post Class C Status Report were observed in MassDEP electronic files. A limited number of soil and groundwater samples were collected from the Site as part of historic environmental assessment and remedial work associated with the adjacent disposal site. C9-C18 aliphatic hydrocarbons, C19-C32 aliphatic hydrocarbons, C11-C32 aliphatic hydrocarbons, and 1,1,1-Trichloroethane were detected in groundwater samples collected on Site. It should be noted that the Class C RAO Statement states that the Disposal Site is owned by the MBTA, and that the former USTs were located on MBTA property;

GEC Project No. 1424-2350. November 26, 2012. 106 Hale St. Bridgewater, MA.  
Monitoring wells and sheds for LNAPL recovery system.

GEC recommends conducting a Phase II Subsurface Investigation of the Site, including those areas of the Site currently within the disposal site boundary associated with the Class C RAO Statement submitted for the adjacent property, which remains under evaluation per the MCP requirements for properties where a Class C Response Action Outcome has been submitted. This Phase II investigation should include a ground-penetrating radar and/or magnetometer survey of the exterior portions of the Site, and soil and groundwater sampling at strategically placed sampling locations, both to evaluate any USTs identified on-Site, and to evaluate conditions on-Site relative to the Class C RAO. Additionally, GEC recommends performing soil vapor sampling in the lowest interior areas of the Site building, to determine whether organic vapors are migrating into the Site building.

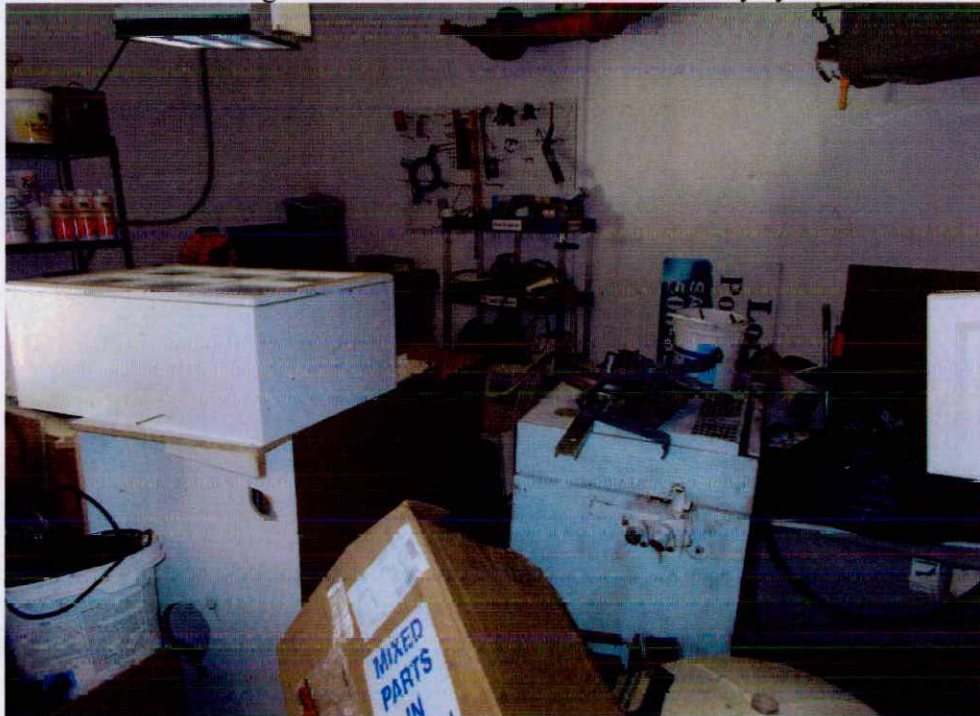
GEC Project No. 1424-2350. November 26, 2012. 106 Hale St. Bridgewater, MA.  
Storage including pool chemicals in Loch Ness Pools space.

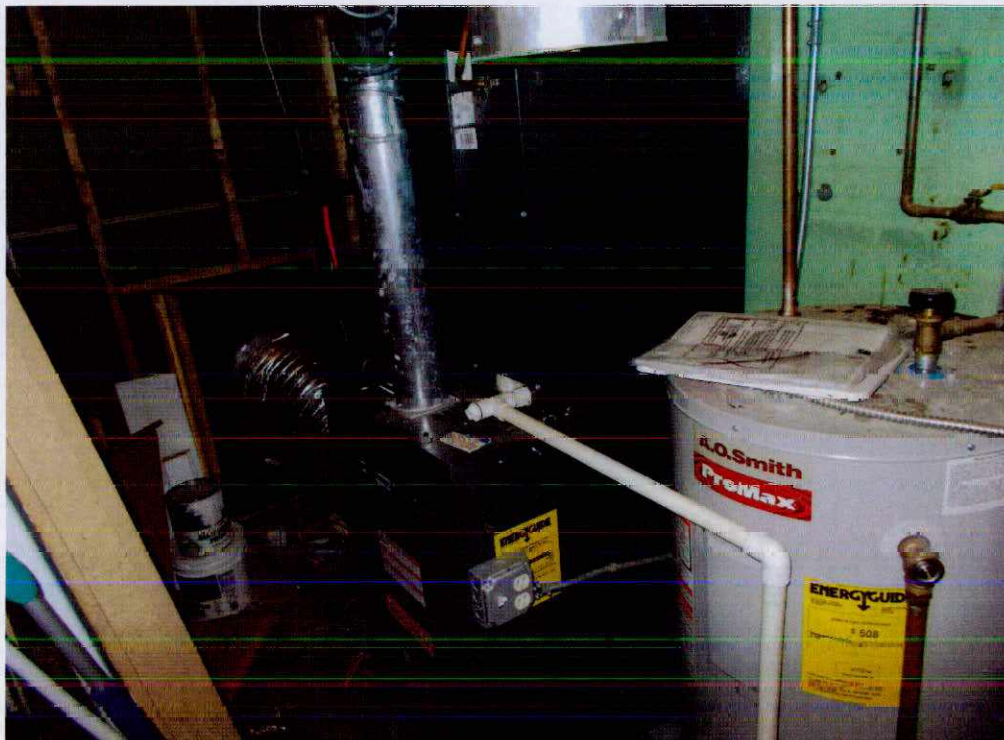
The Site building is reportedly heated by natural gas-powered heating. According to the property owner's representative, the Site building is connected to the publicly

GEC Project No. 1424-2350. November 26, 2012. 106 Hale St. Bridgewater, MA. Utility room with gas fired heating unit and de minimis paint.

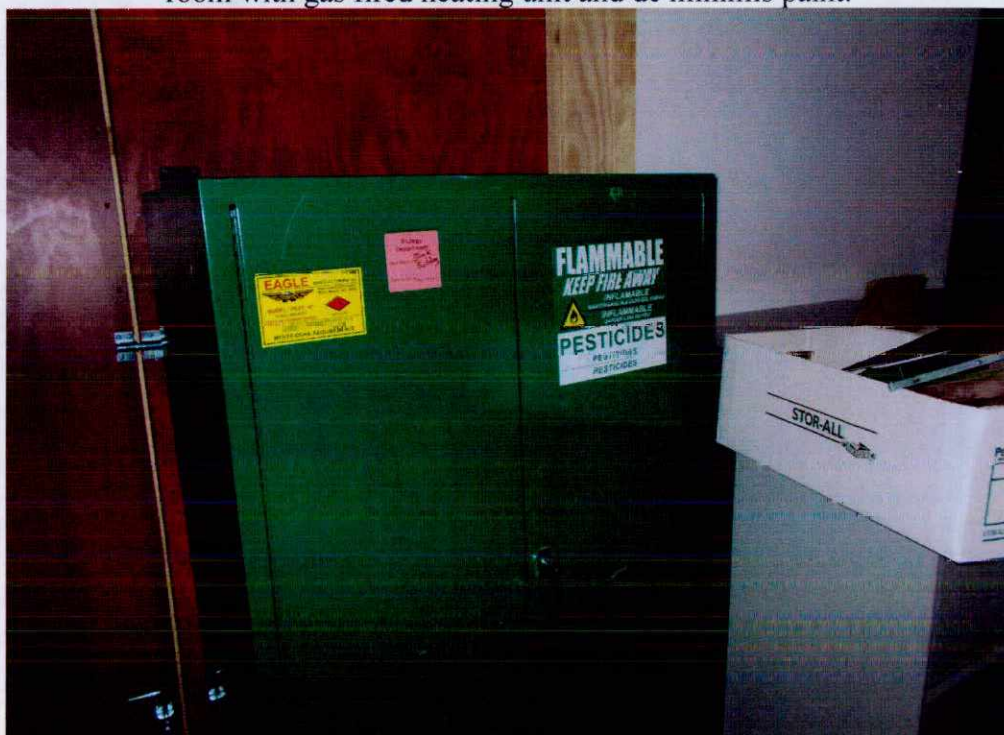
GEC Project No. 1424-2350. November 26, 2012. 106 Hale St. Bridgewater, MA. Pesticides locker in Bridgewater State University Space.

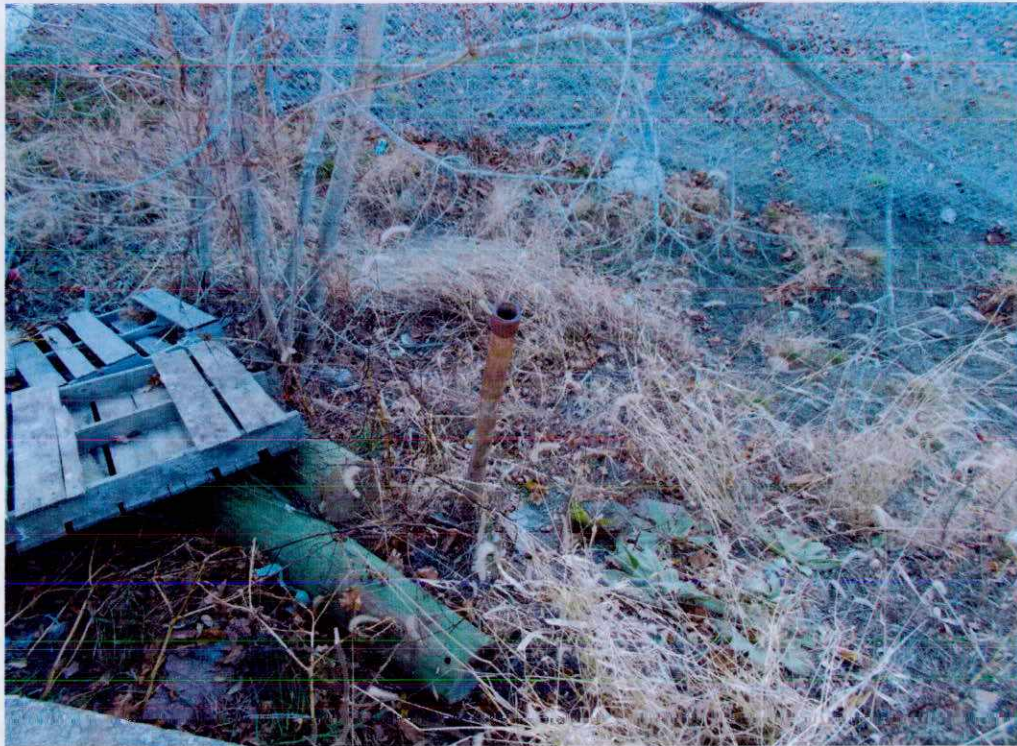
GEC observed several features in the former building slab including steel plates, a pipe flange, and several possible column footings. In addition, a steel pipe was observed protruding from the ground adjacent to the northern corner of the building adjacent to the MBTA Commuter Rail right-of-way during the Site reconnaissance.

GEC Project No. 1424-2350. November 26, 2012. 106 Hale St. Bridgewater, MA. Pipe protruding from ground northern portion of property.

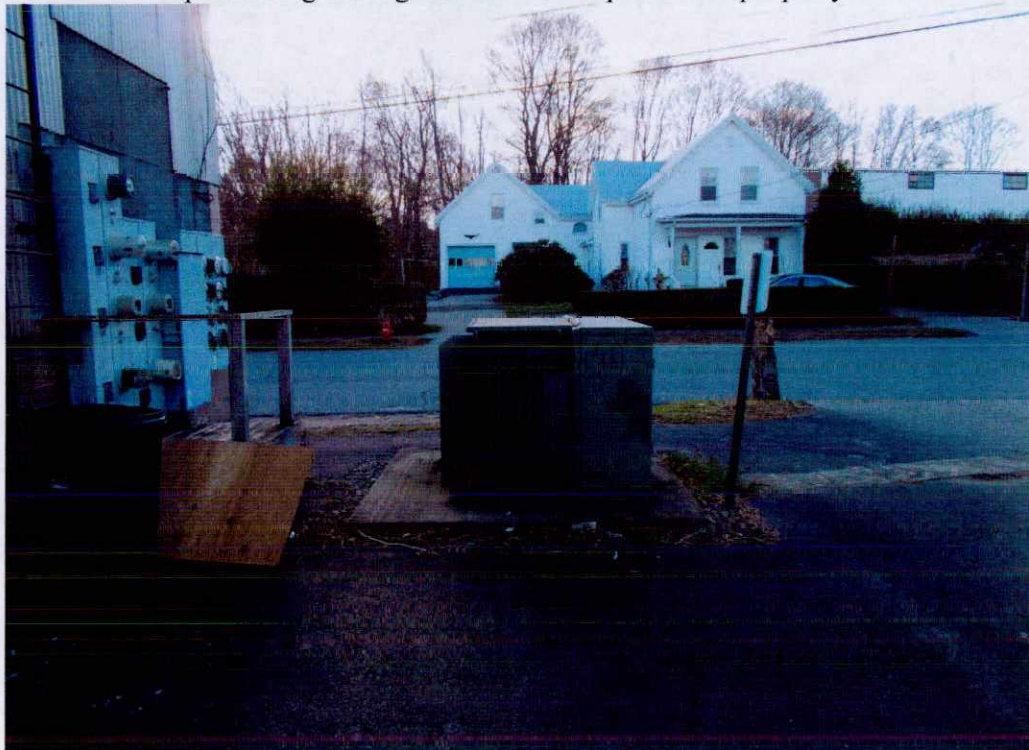
During the Site inspection, GEC made observations for equipment likely to contain PCB oil. Equipment likely to contain PCB oil includes electrical transformers, capacitors, hydraulic equipment and oil switches. Numerous fluorescent light fixtures were observed in the Site building and a pad-mounted electrical transformer was observed adjacent to the northwest corner of the Site building. No labels indicating if the equipment contained PCBs were observed. No additional suspect PCB containing equipment was noted on Site.

GEC Project No. 1424-2350. November 26, 2012. 106 Hale St. Bridgewater, MA. Pad mounted transformer, northern portion of Site.

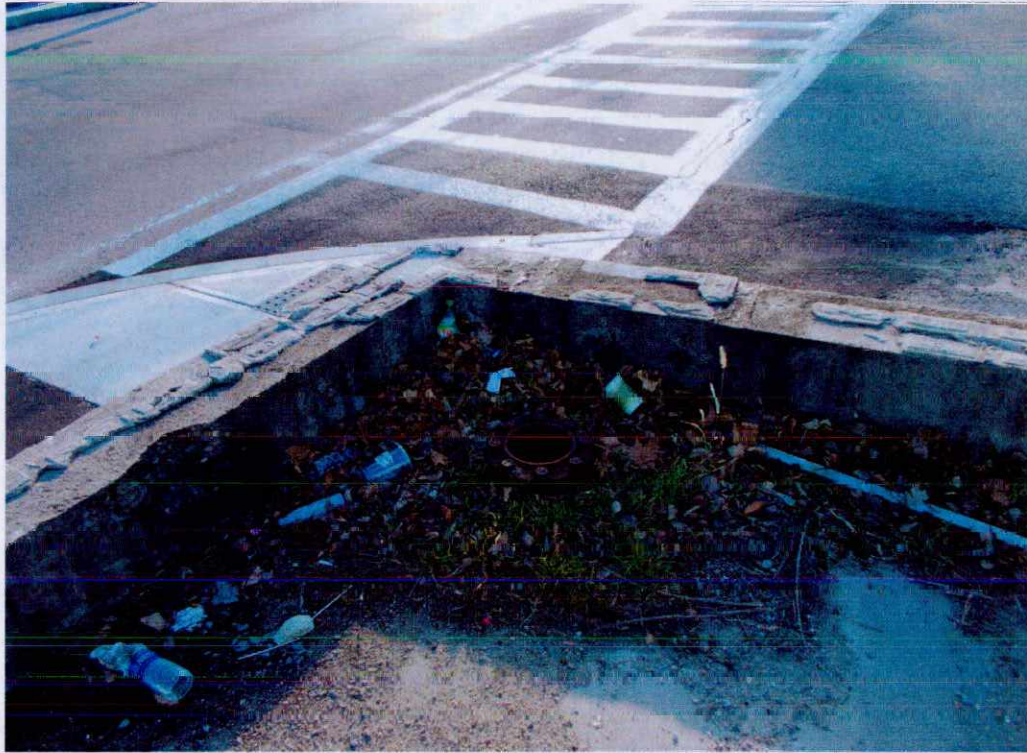
GEC Project No. 1424-2350. November 26, 2012. 106 Hale St. Bridgewater, MA. Pipe flange adjacent to intersection of Hale Street and Plymouth Street.

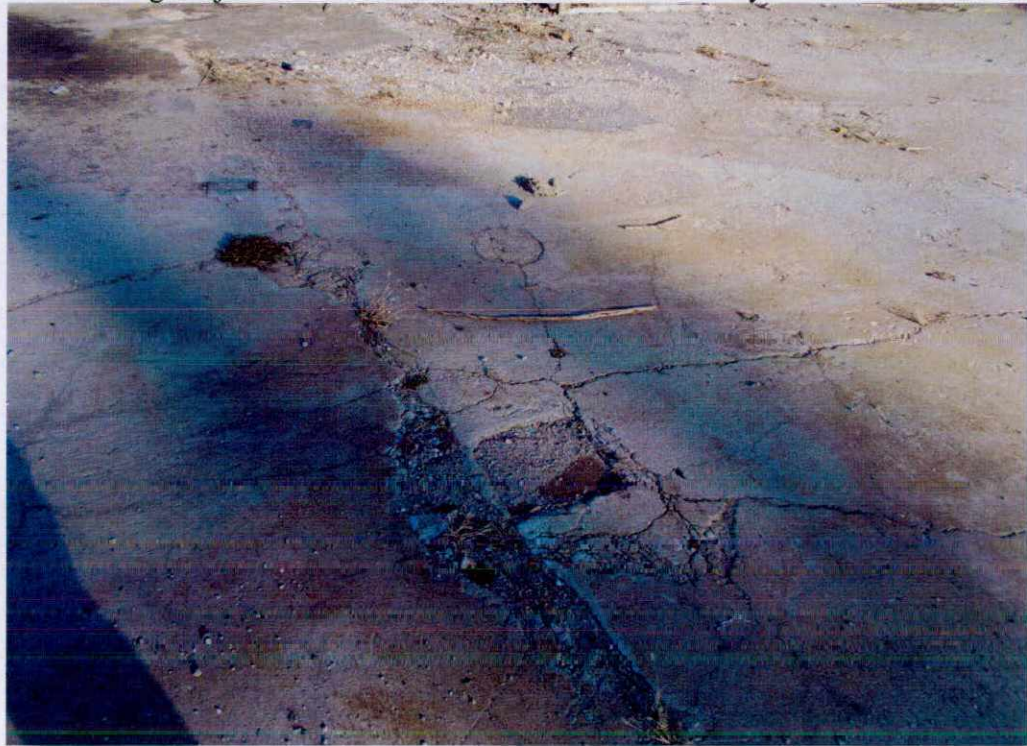
GEC Project No. 1424-2350. November 26, 2012. 106 Hale St. Bridgewater, MA. Former building foundation with likely column footings.
