Massachusetts Youth Killed While Operating Forklift at Seafood Processing Facility

Massachusetts FACE 00-MA-058

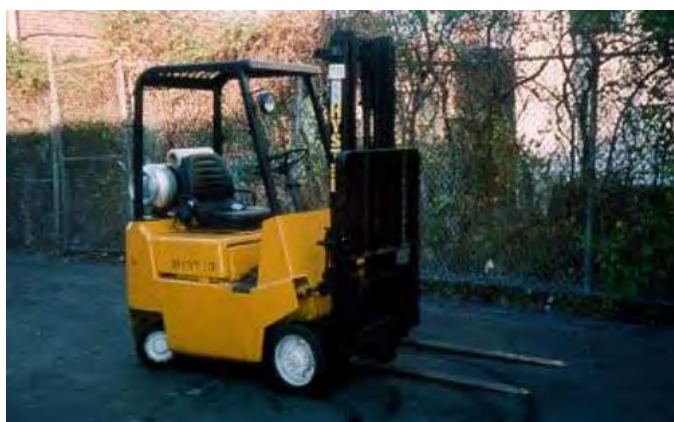
Figure 1 – Forklift involved in the incident

The company owned one forklift that they purchased approximately 6 months prior to the fatality from a local distributor. The forklift was an 11-year-old, propane powered, four wheeled, remanufactured forklift, which was purchased to replace an older, smaller electric forklift. There was no owner/user manual supplied with the forklift upon delivery to the facility. The owners reported that the delivery person showed them the basics of how to operate the forklift before leaving. On the day of the incident, the seatbelt was not being used, due to it being wedged beside the seat.

The victim had been operating the forklift with a load of approximately 70 pounds raised 4½ feet. He was driving the forklift in the forward direction and while making a right-hand turn the forklift started to overturn. As the forklift was overturning, the victim either jumped or was thrown from the operator's seat and the overhead guard landed on his chest, pinning and crushing him.

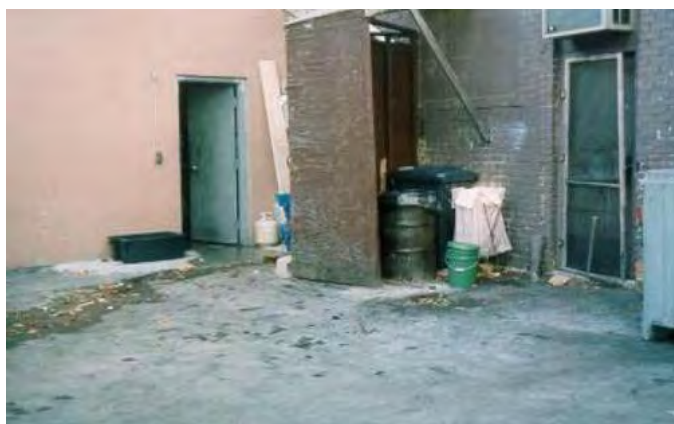
Figure 2 – Facility employee parking / loading dock area.
Location where the incident occurred

The facility parking/loading dock area was located behind an adjoining facility, paved and measured approximately 50 feet long by 35 feet wide, with a driveway along the building leading to the street. Outdoor tasks in this parking/loading dock area included, placing collected trash into containers on wooden pallets and wrapping the pallets and the container with plastic. Unused wooden pallets were stacked and placed in a corner of the parking/loading dock area along with empty tubs and containers. After these tasks are completed, the gate to the yard was locked.

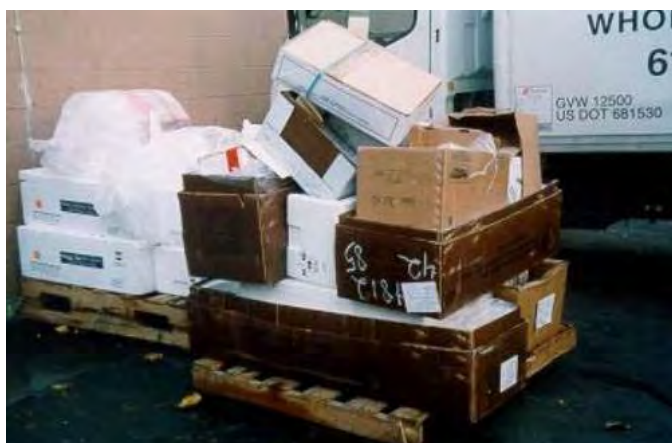
Figure 3 – Wooden pallet loaded with empty cardboard boxes similar to the load on the forklift tines at the time of the incident.
