# Feasibility Analysis for Restoring River Herring to the Fore River

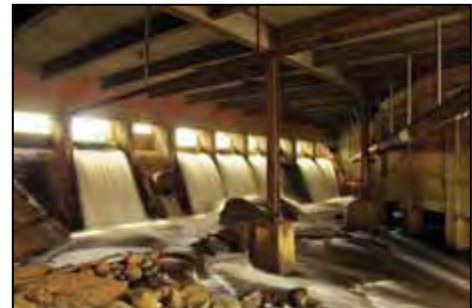
The other issue that must be addressed is related to the building sitting above the dam as shown in the picture. The building and dam are owned by Hollingsworth Pond, LLC. There are concrete vertical columns that transfer the load (weight) from the building to the concrete spillway. Removal of the concrete spillway will result in removing the structural support for the building. We recommend a structural stability analysis to determine potential options that satisfy both removal of the dam to restore fish passage while providing structural support for the building. Clearly, increased communications are needed with

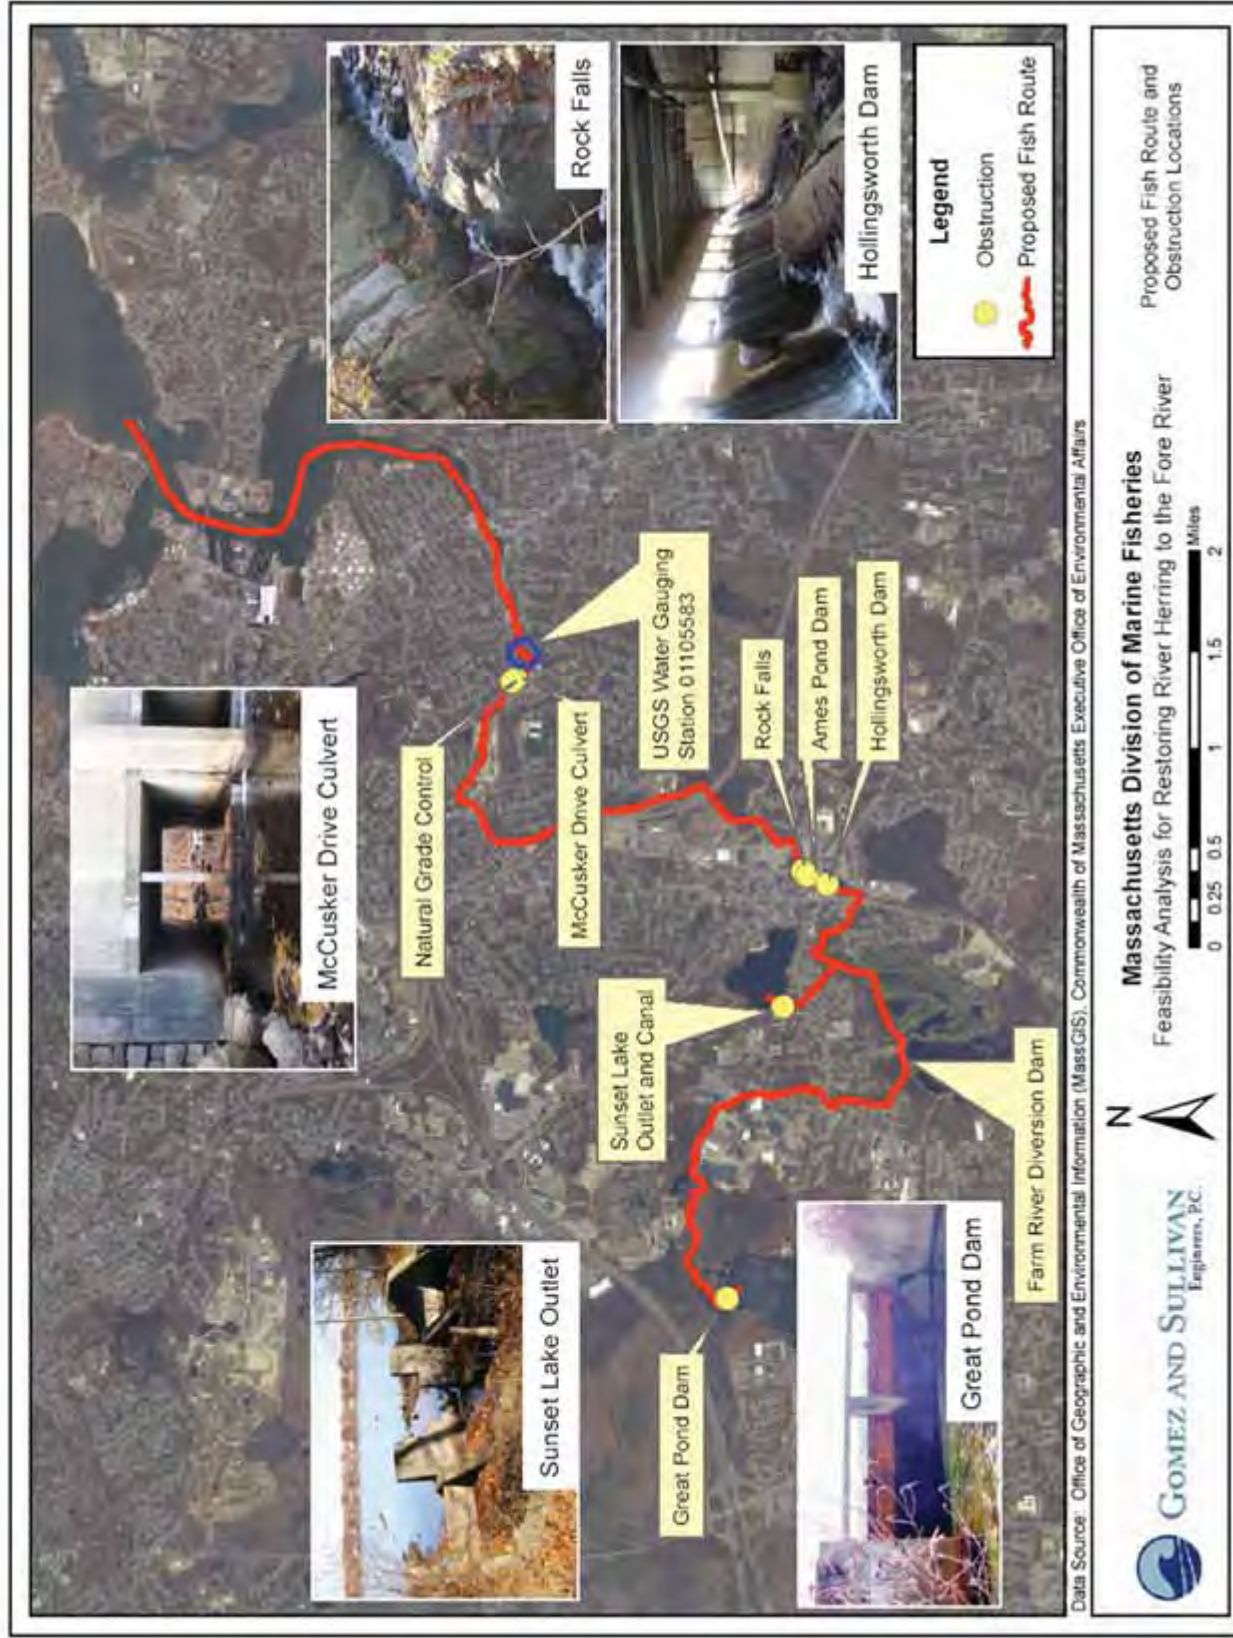
**Figure E-1: Monaquot River Watershed and Proposed Migration Route**

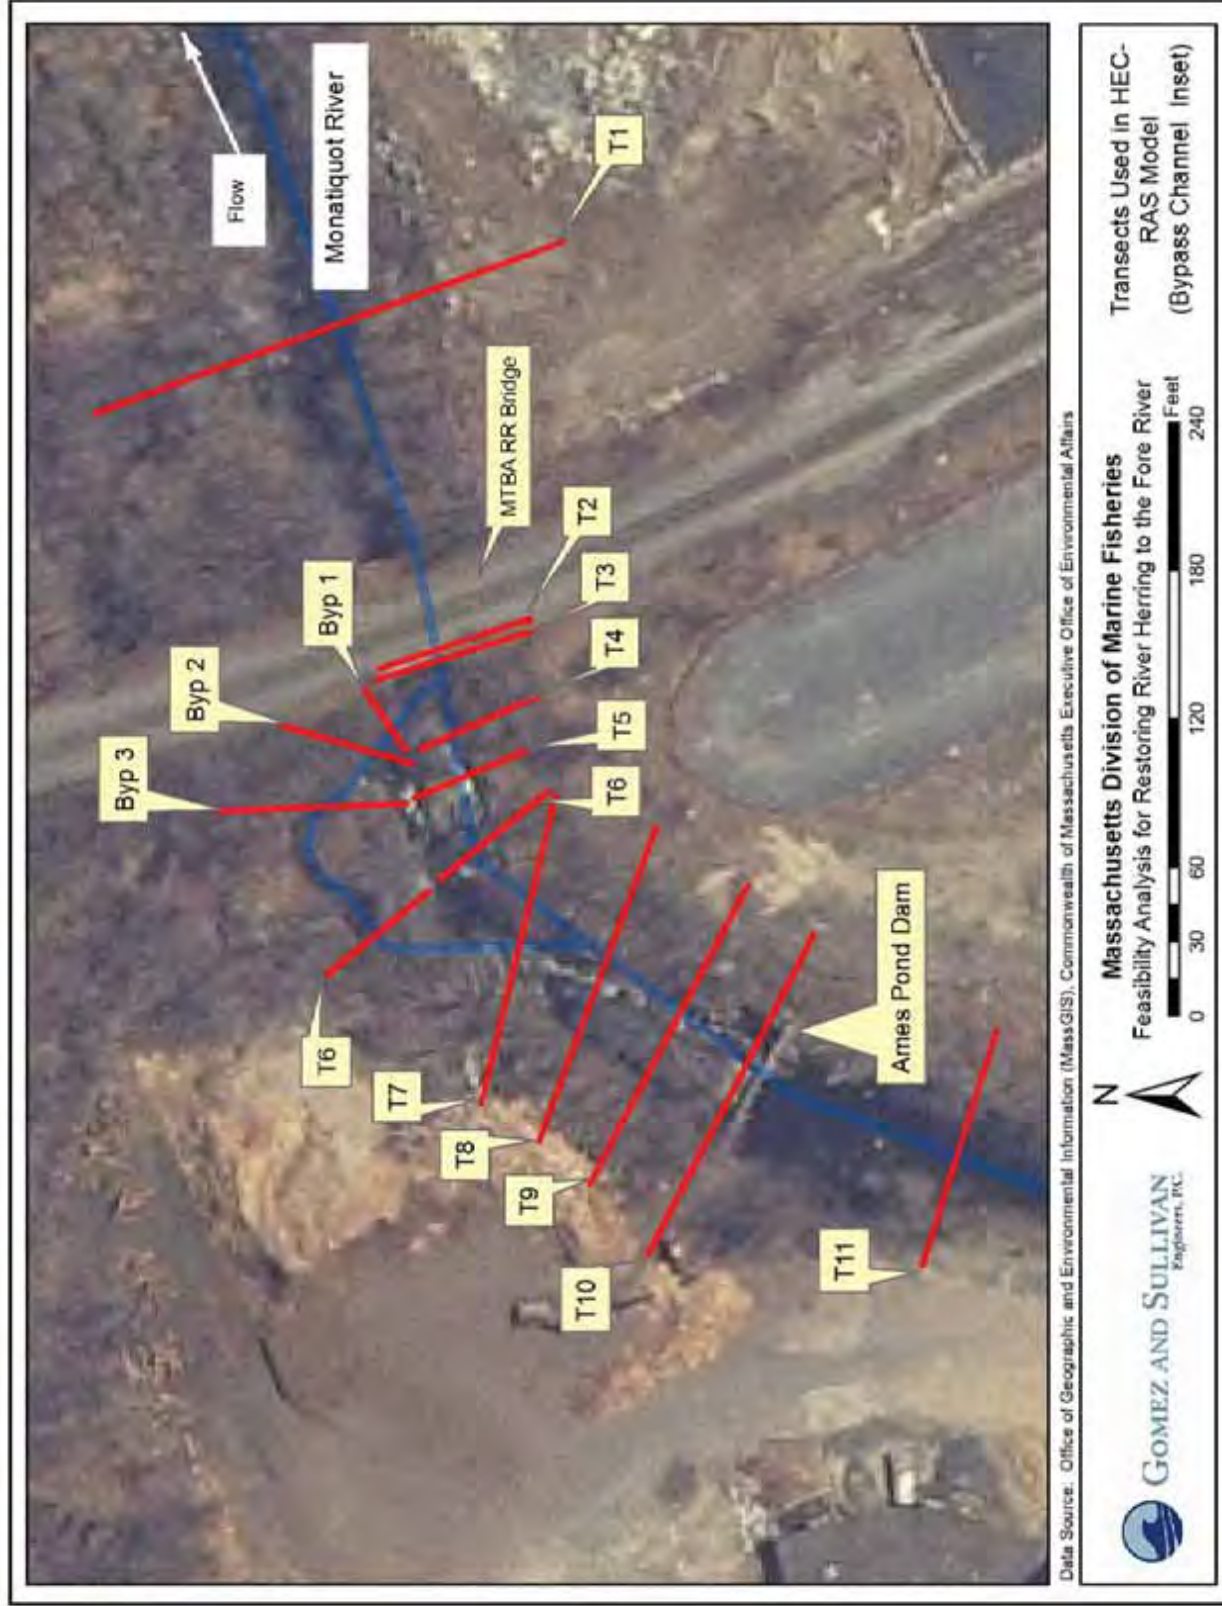
**Figure E-6: Plan Map of Transect Locations Used in Hydraulic Model (2 of 2)**

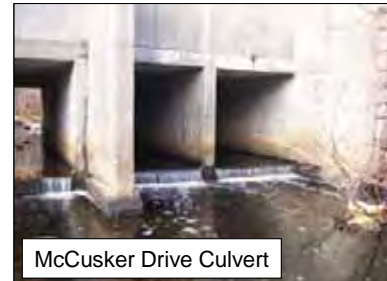
The first minor impediment to upstream passage is the McCusker Drive culvert as shown in Figure 2.0-2. The culvert consists of four “bays” and an elevated concrete sill on the downstream side of the culvert that is evident under low flows as shown in the photograph. It does not appear that the culvert is a barrier to river herring as the FRWA has observed river herring well upstream of McCusker Drive. It is also suspected that under higher spring flows, when river herring are moving upstream, the elevated sill is less pronounced.

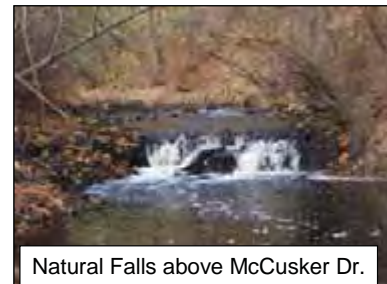
Only a few hundred feet upstream of McCusker Drive is a natural falls (see photograph and Figure 2.0-2). Again, because river herring have been observed upstream of this falls, it is presumed that it is not an impediment to upstream passage. If desired, some minor modifications to the natural falls could be conducted to lower the steep slope of the falls.

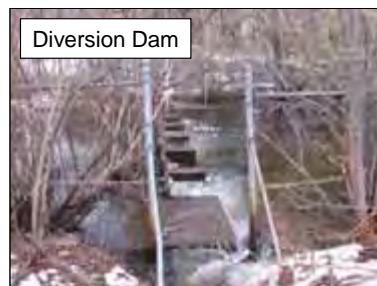
Moving up Farm River toward Great Pond Dam, the next obstacle is a low head Diversion Dam with stoplog slots (see photo). Water can be diverted from Farm River into Richardi Reservoir via gravity (see Figure 2.0-4). If desired, stoplogs can be installed at the Diversion Dam causing the water level behind the dam to rise enough to permit water to flow via gravity through a diversion structure and into Richardi Reservoir. Water is then pumped from Richardi Reservoir to Great Pond or Upper Reservoir for water supply use.

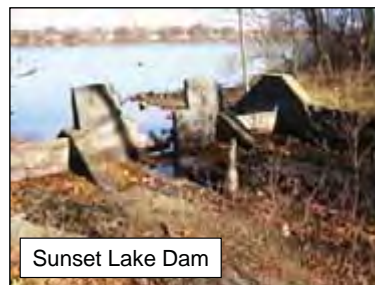
Sunset Lake Dam

Continuing up Farm River, fish passage is being considered into Sunset Lake, which has an old dam at its outlet. Sunset Lake is owned and operated by the town of Braintree. Fish passage into Sunset Lake would require river herring to migrate from the Farm River, up Sunset Lake “canal” (see Figure 2.0-6), through the Pond Street culvert and then the dam. The largest challenge for fish passage to Sunset Lake is maintaining sufficient flow below the dam to permit upstream and downstream passage. Note that there is a pump located near the western shore of Sunset Lake that withdraws water from irrigating the school fields. It is presumed that the withdrawal volume is not enough to trigger a water withdrawal permit. The drainage area at Sunset Lake is 0.5 square miles.

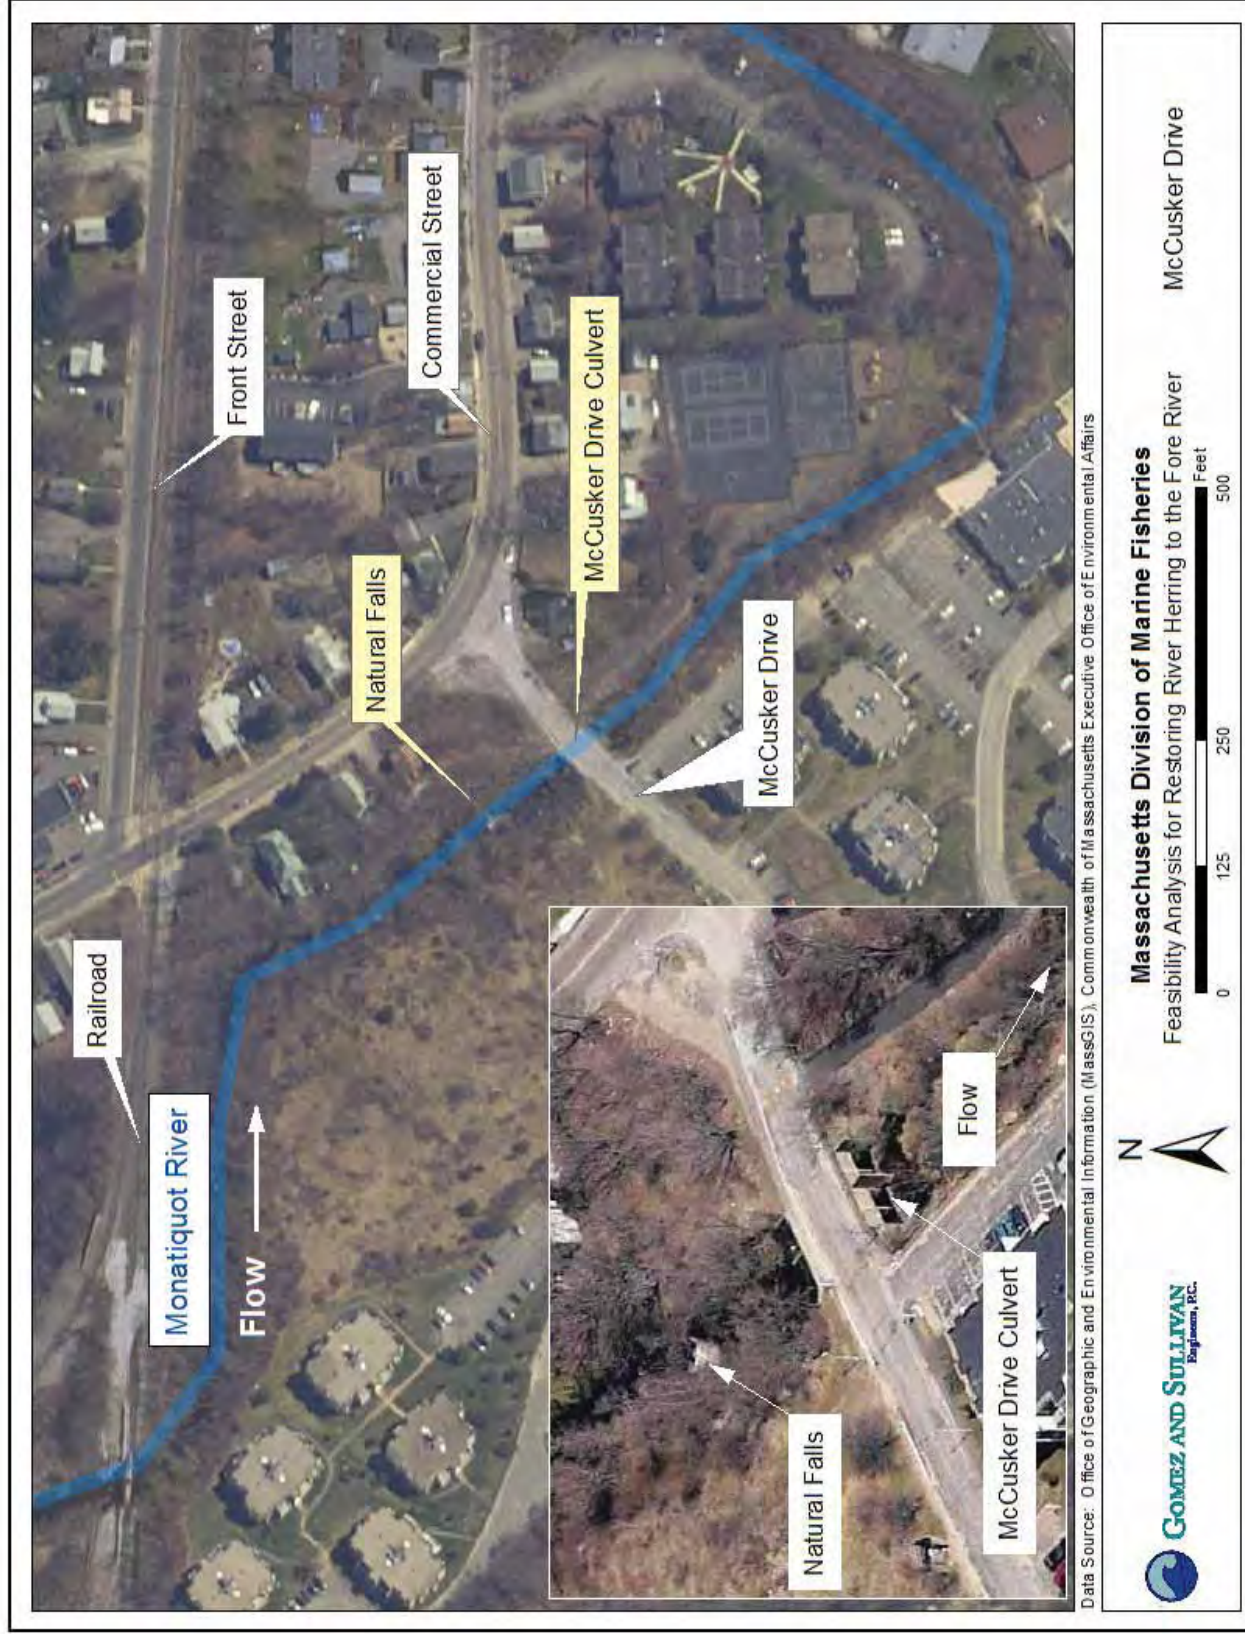
**Figure 2.0-2: Location Map of McCusker Drive Culvert and Natural Grade Control Immediately Upstream**

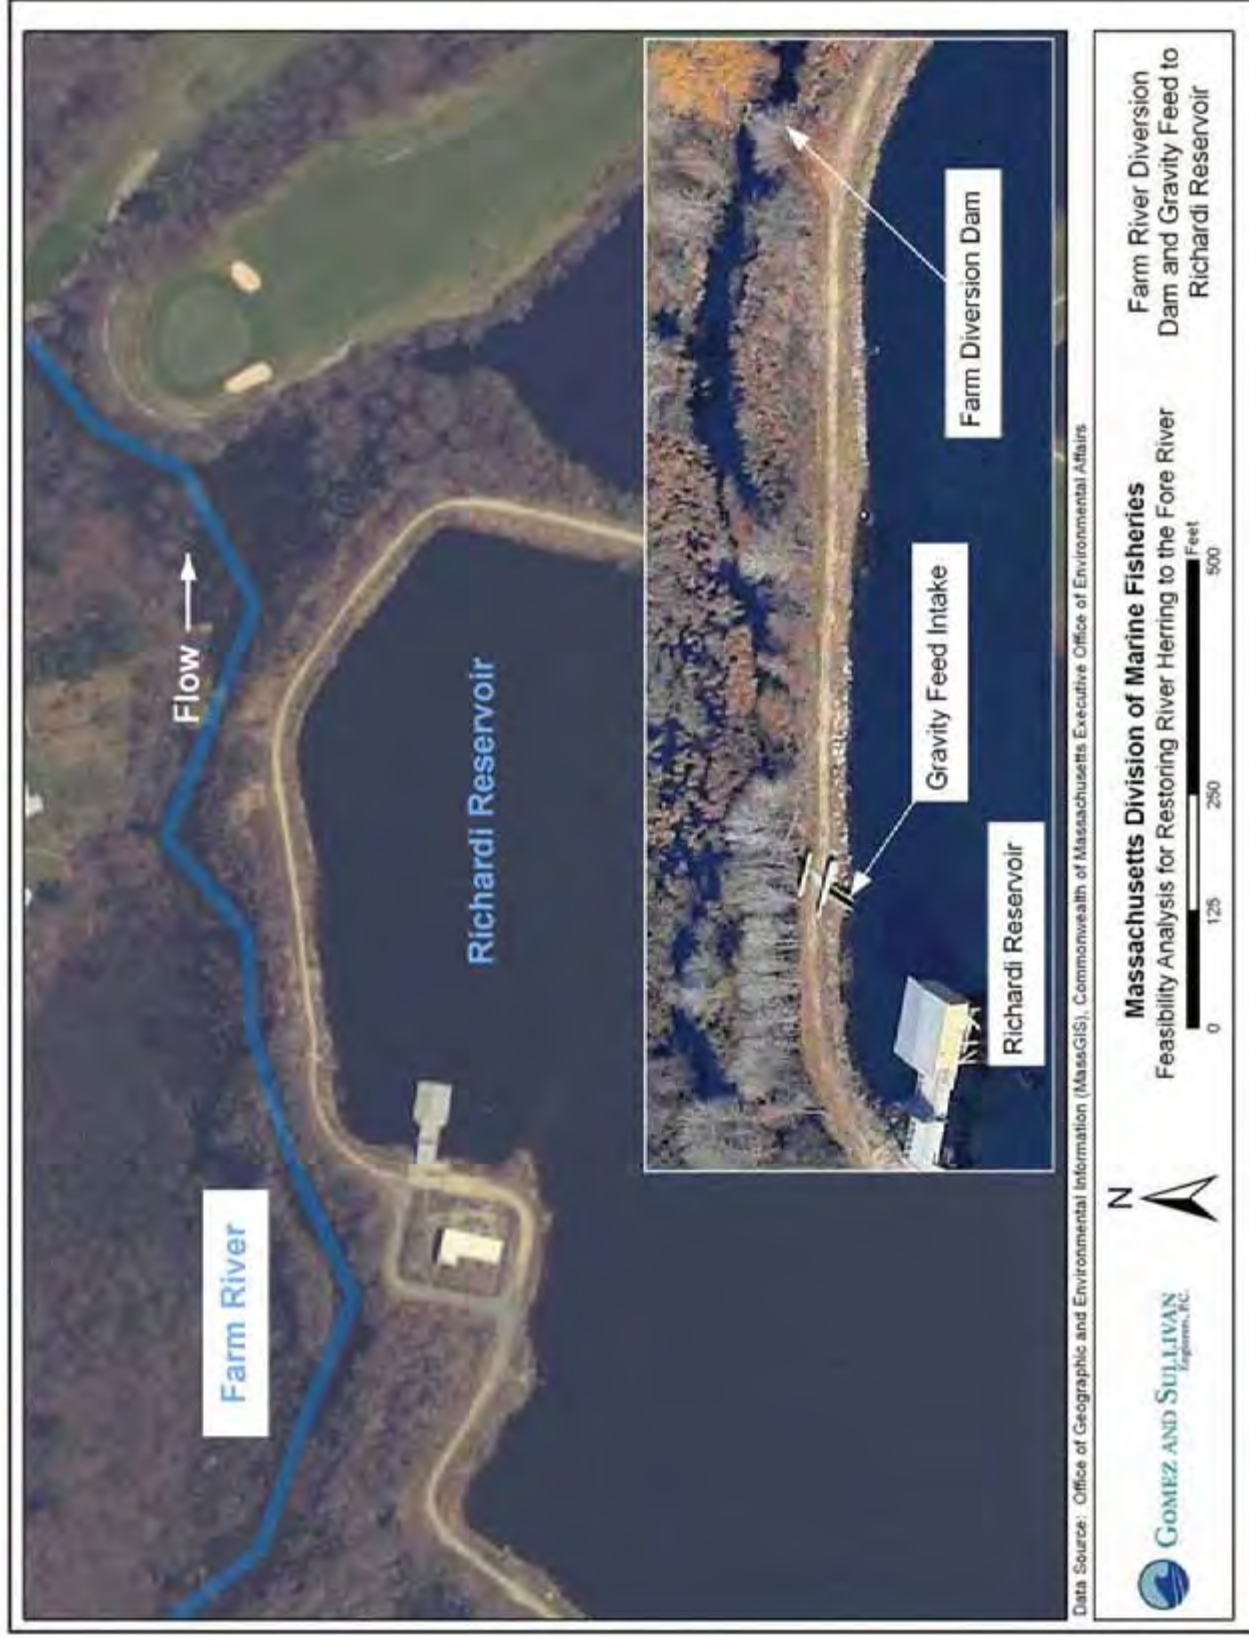
**Figure 2.0-4: Location Map of Farm River Diversion Dam and Gravity Feed to Richardi Reservoir**

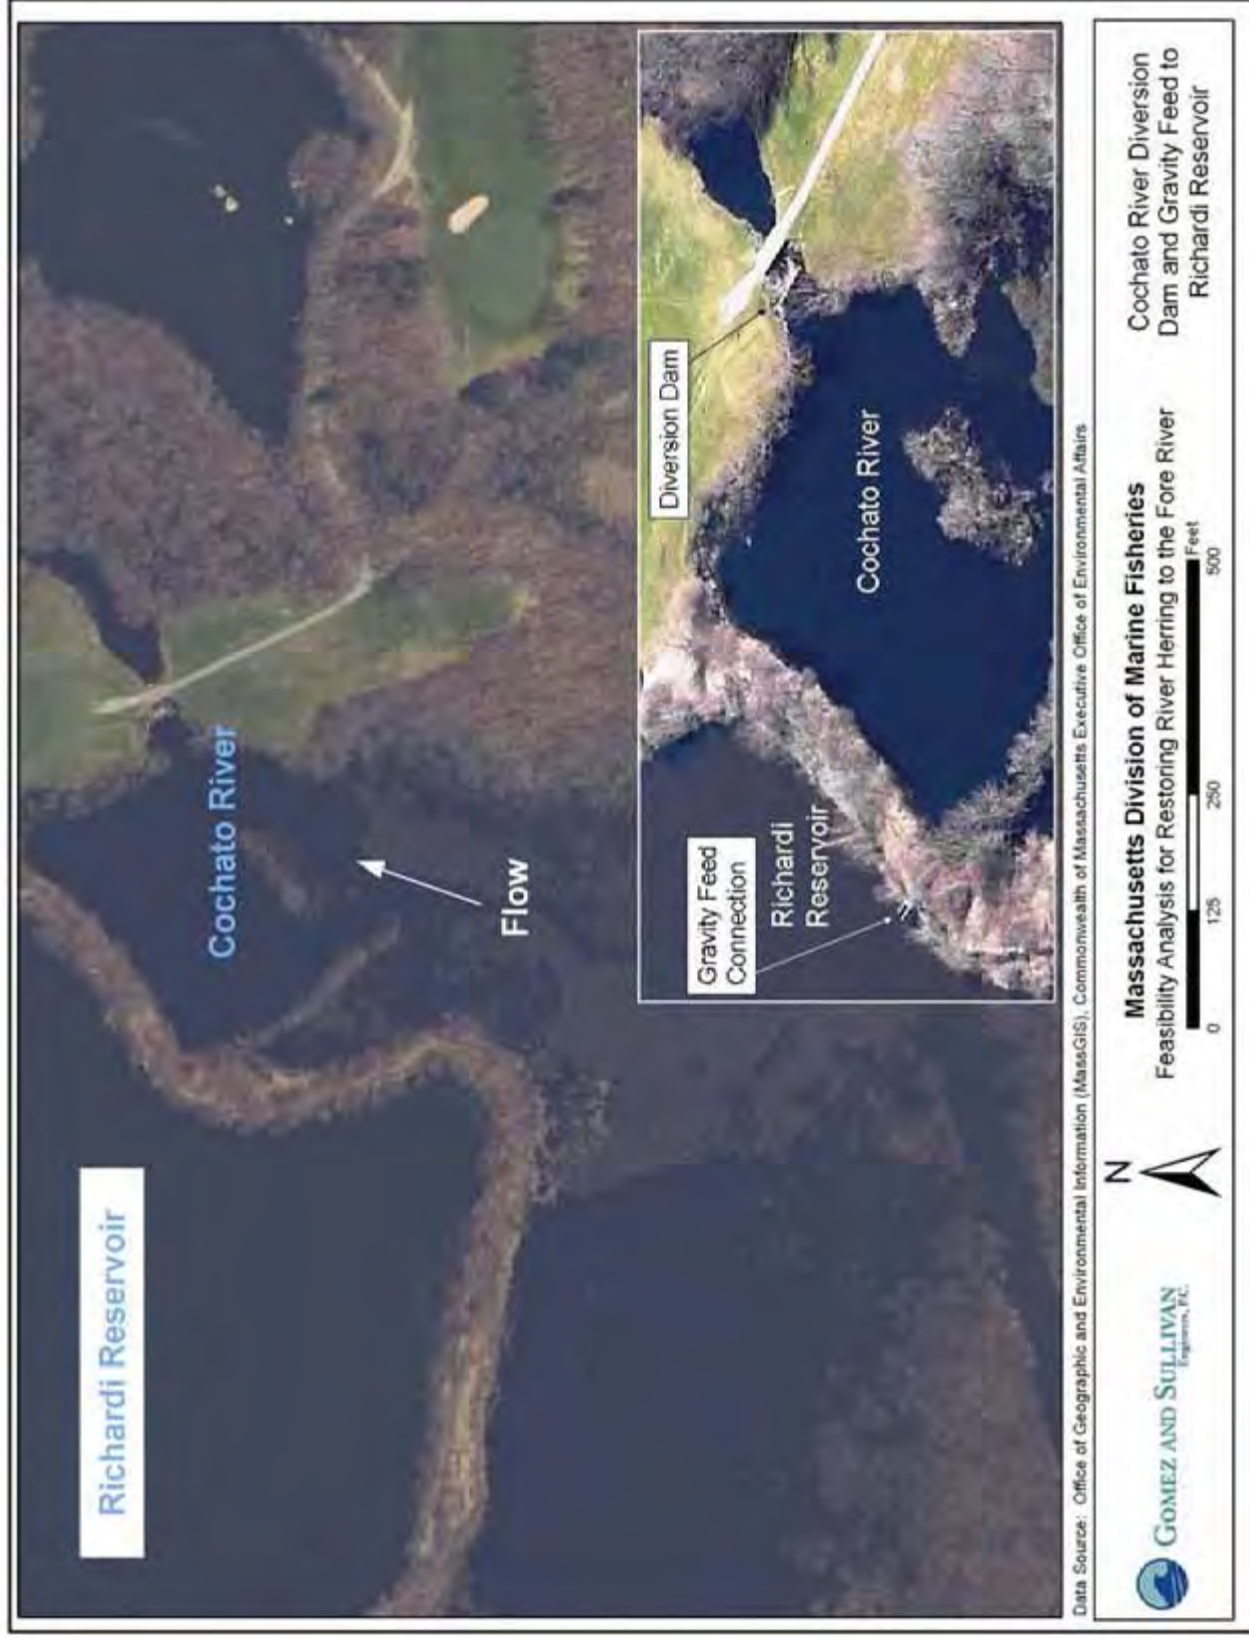
**Figure 2.0-5: Location Map of Cochato River Diversion Dam and Gravity Feed to Richardi Reservoir**

Historically, flow from the Cochato River was also diverted into Richardi Reservoir, but the diversion ceased due to a Superfund site located in the Cochato River headwaters. It has been several years since clean-up at the Superfund site and, as described later, for several reasons we recommend evaluating the potential of restoring diversions from Cochato River to Richardi Reservoir. The Cochato River Diversion Dam and gravity feed intake still exist along the eastern side of Richardi Reservoir (see Figure 2.0-5).

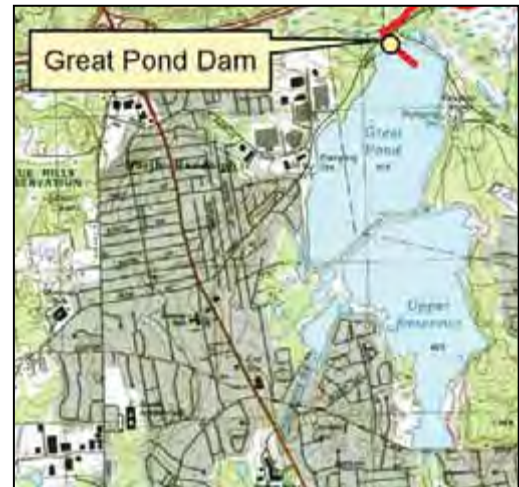
Shown in the aerial photograph are the two discharge locations from Great Pond Dam. Discharge from Great Pond is possible through lifting three 9-foot wide, 18-inch high steel plates at the dam as shown in the photograph below. To convey water downstream, the steel plates must be raised, or if the water level

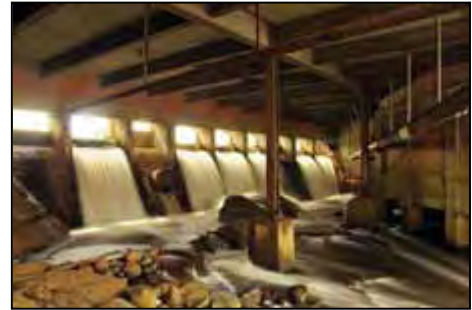
The sill elevation of the building (or top of the bay opening) is at elevation 98.9 ft, while the spillway crest is approximately 94.9 feet; a 4 foot high bay. Affixed to the spillway are slots for stoplogs that can be added or removed to increase or lower the impoundment levels, respectively. In addition to the nine bays, there is a 4-foot diameter low-level culvert with a outlet elevation of 87.9 feet. In front (on the upstream side of the dam) of the culvert are stoplogs that control the depth of flow in front of the culvert. While conducting the site inspection, stoplogs for all nine bays were in place at the same level.

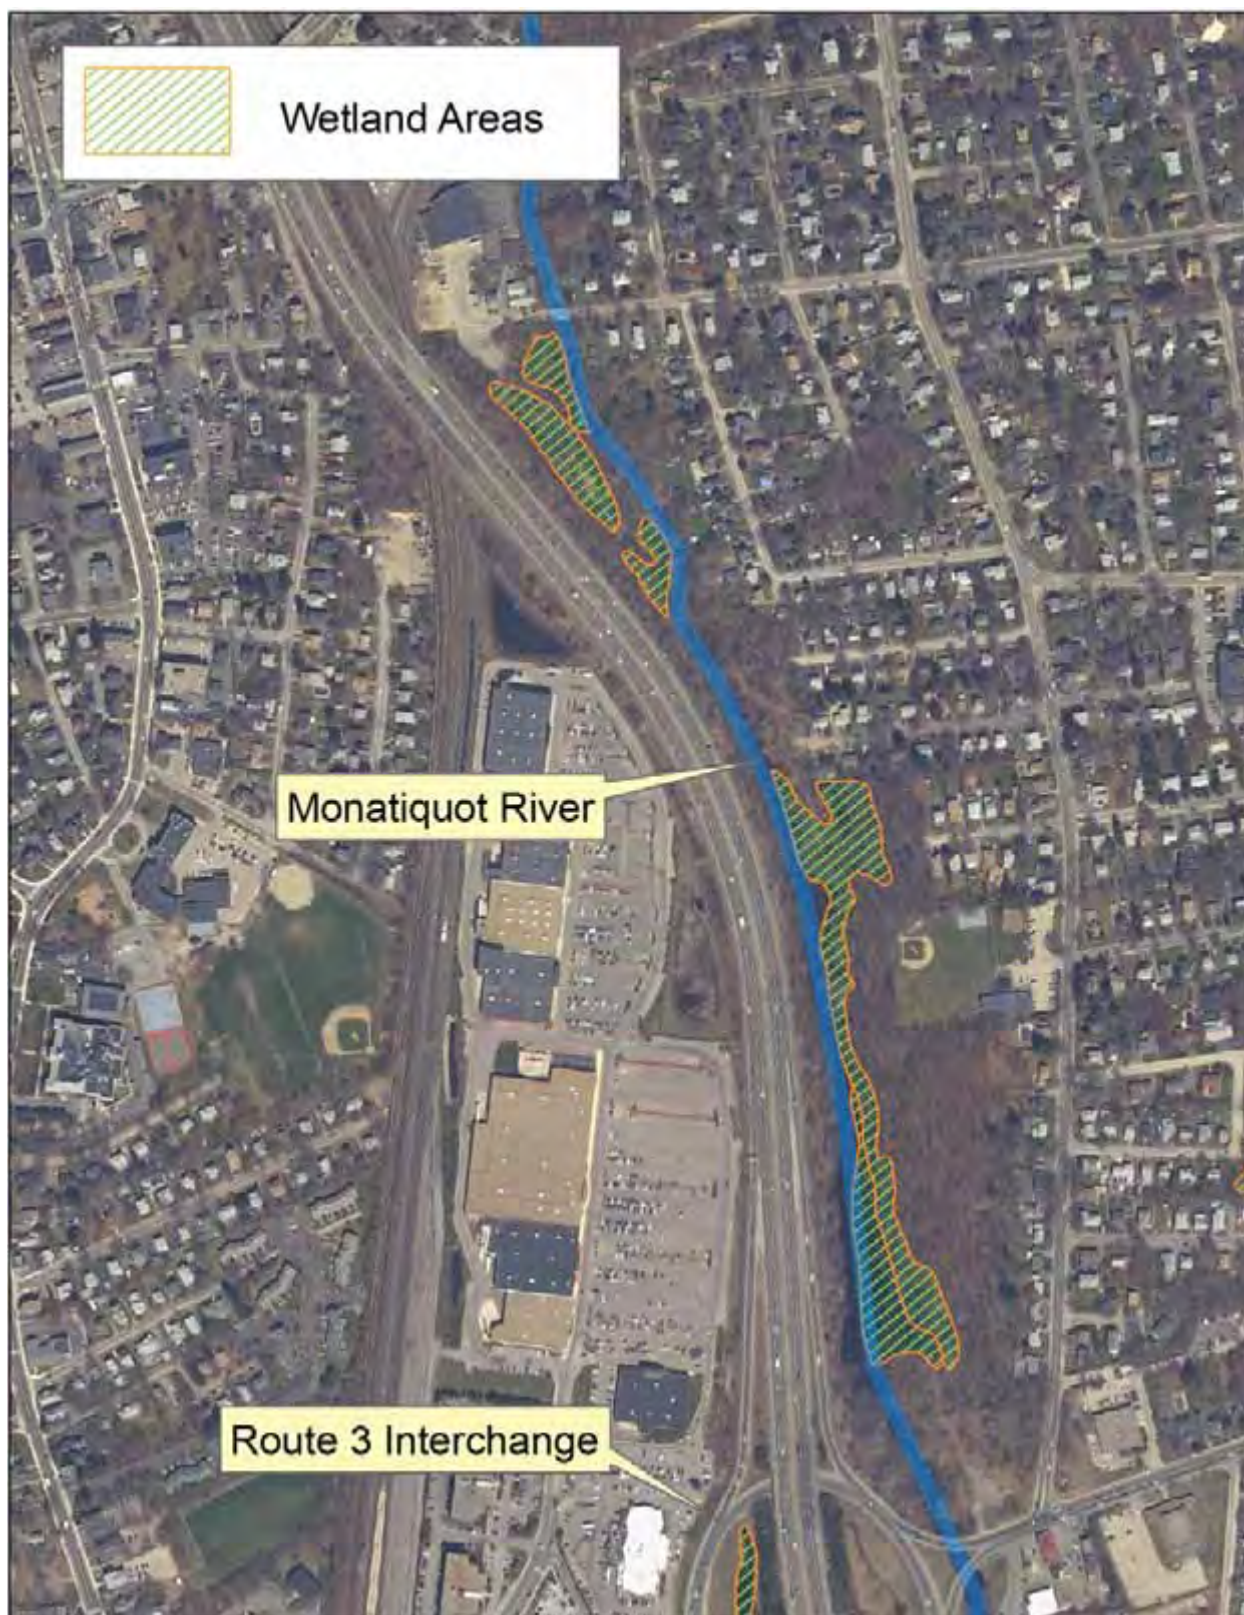
**Figure 9.3-1: MDEP Wetlands in the vicinity of the former Long Pool.**
