# Field Study to Determine Salt Usage Efficiency and Transport to the Surrounding Environment on Two Pavement Types

# Technical Report Document Page

Final Report

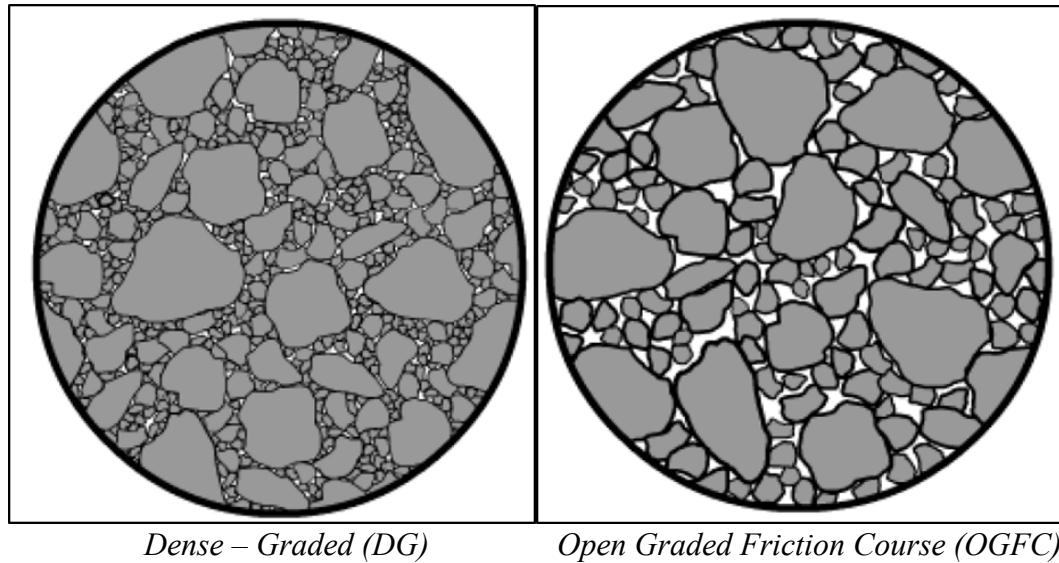
**Figure 1.1: Internal void structure of dense graded and open graded friction course mixtures (1)**

OGFC mixtures differ from DG mixtures in terms of design. While DG mixtures typically contain about 4% air voids, OGFC mixtures are intentionally more permeable, with air void contents of around 15–16% (1). Figure 1.1 illustrates the internal void structures of both pavement types. MassDOT has used OGFC since 1984 because of its many documented benefits, including “reduced water splash and spray, reduced potential for hydroplaning, increased friction, and it helps reduce noise” (2).

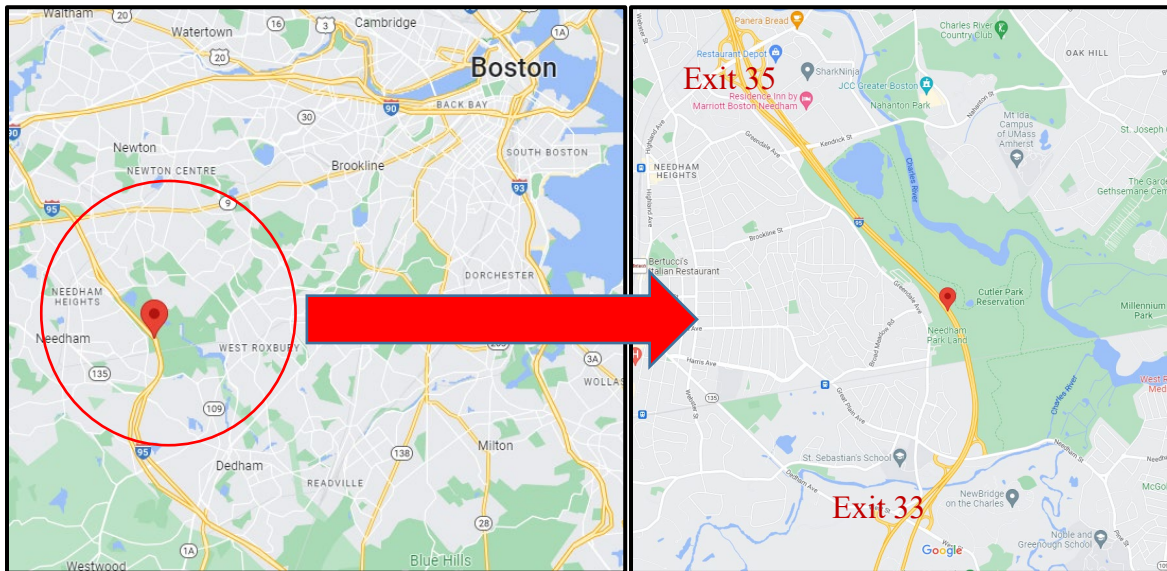
**Figure 2.1: I-95 (Rt 128) southbound in Needham, MA field study location (Coordinates 42.2816342,-71.2019692)**

This research project presented MassDOT a unique opportunity to investigate salt usage efficiency on both OGFC and DG pavement surfaces at an existing field site. As illustrated in Figure 2.1, these pavement sections are located consecutively along I-95 (Rt. 128) Southbound in Needham, Massachusetts, between Exits 33 and 35. Each section is equipped with a U.S. Geological Survey (USGS) highway instrumentation station (Figure 2.2). Because the pavement types are laid out back-to-back, winter maintenance activities such as treatment frequency, material type, and dosage are applied in essentially the same manner to both surfaces. This arrangement, combined with existing instrumentation, made the location ideally suited for evaluating differences in winter salt efficiency between OGFC and DG pavements.

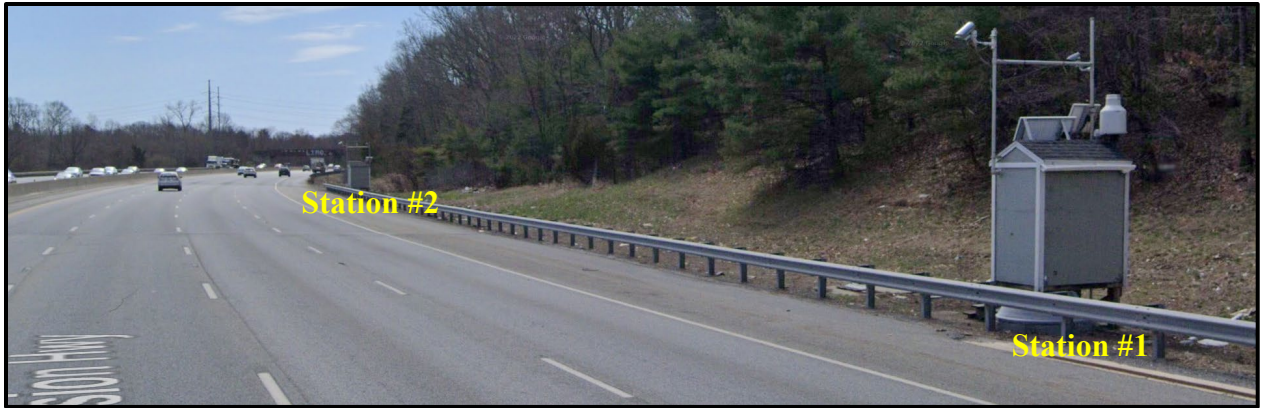
**Figure 2.2: Southbound Google street view of USGS existing highway instrumentation stations (Google.com)**

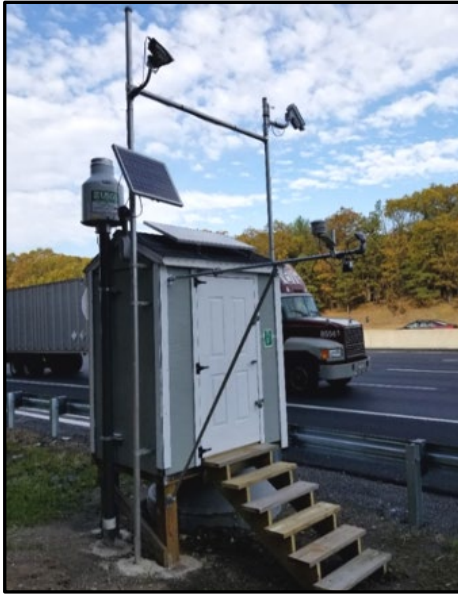
**Figure 2.3: Close up view of existing highway instrumentation station**

WEATHER DATA COLLECTED	
1.	Air Temperature
2.	Snow Depth
3.	Precipitation (Ice, Water, Snow)
4.	Wind Speed & Direction

ENVIRONMENTAL DATA COLLECTED	
1.	Runoff Flow
2.	Water Temperature
3.	Specific Conductance (Salinity)

For the duration of this project, data was to be collected through both existing and newly installed instrumentation at the field location. Prior to this project, the USGS stations already had in place an instrumentation stations (Figure 2.3) outfitted with a non-contact IceSight-2020E sensor (Figure 2.4). The Ice-Sight measures air temperature, relative humidity, pavement temperature, and surface condition, and provides an estimate of friction (grip). Other USGS instruments collected key weather and environmental parameters, including: air temperature, snow depth, precipitation (ice, water, or snow), wind speed and direction, runoff flow, water temperature, and specific conductance (salinity). This data supplemented the ongoing USGS research program and provided critical context for this project.

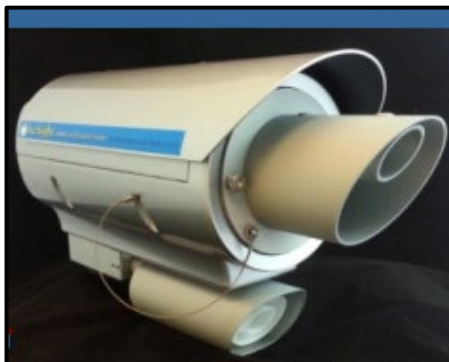
**Figure 2.4: Existing non-contact road surface condition sensor at existing highway instrumentation stations - IceSight-2020E**

DATA COLLECTED	
1.	Air Temperature
2.	Relative Humidity
3.	Pavement Surface Temperature
4.	Surface Conditions
5.	Estimate of Friction (Grip)

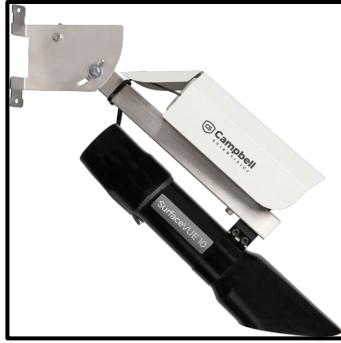
DATA COLLECTED
1. Air Temperature
2. Relative Humidity
3. Pavement Surface Temperature
4. Surface Conditions
5. Estimate of Friction (Grip)
6. Water & Ice Layer Thickness

**Figure 2.5: New non-contact road surface condition sensor installed at existing highway instrumentation stations – Surfacevue10**

For this project, the USGS acquired and installed an additional non-contact sensor (shown in Figure 2.5) called the Surfacevue10. The Surfacevue10 provides measurements of air temperature, relative humidity, pavement temperature, surface condition, estimate of friction (grip), and water/ice layer thickness. According to the USGS, this non-contact sensor provides more reliable data than the existing IceSight-2020E non-contact sensor.

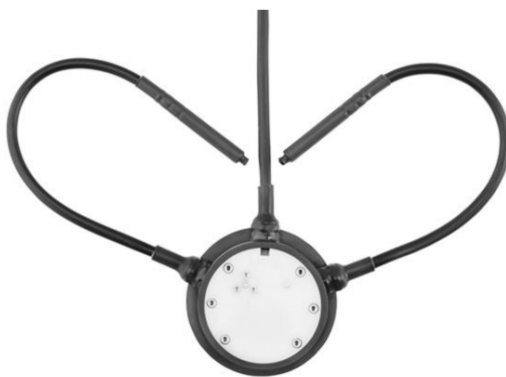
DATA COLLECTED
1. Road Surface Temperature
2. Temperature at Depth (5cm/30cm)
3. Water Film Height
4. Freezing Temperature of De-icing Materials
5. Road Condition
6. Friction
7. Ice Percentage
8. Salt Concentration

**Figure 2.6: First invasive sensor installed – Passive Lufft IRS31PRO-UMB**

Invasive Sensor Data	Details
1. Road Surface Temperature	Directly measured on sensor surface
2. Temperature at Depth	Depth placement is typically 5cm & 30cm (2 inches & 12 inches)
3. Water Film Height (WFH)	Directly measured on sensor surface
4. Freezing Temperature of De-icing Materials	Directly measured on sensor surface
5. Road Condition	Function of surface temperature, WFH & freezing temperature
6. Friction	Scale of 0.2 to 0.9 (worst to best). Function of ice percentage, surface temperature and WFH.
7. Ice Percentage	Scale of 0 to 100%. Function of surface temperature and salt concentration.
8. Salt Concentration (Conductivity)	Only correct if temperature is $\leq 4^{\circ}\text{C}$ ( $40^{\circ}\text{F}$ ) and $\text{WFH} \geq 30\mu\text{m}$

Each pavement type, OGFC and DG, had two sensor sets (consisting of 1- IRS31Pro-UMB and 1- ARS31Pro-UMB) installed to provide redundancy in case of sensor failure or damage during the project. During the nights on October 10<sup>th</sup> & 11<sup>th</sup> 2023, the Hoosier Company, Inc. installed the sensors. The sensors were installed in the first travel lane, between the wheel paths, with final placement approved by MassDOT (Figure 2.8). The IRS31Pro-UMB has two temperature at depth sensors. One was installed at approximately the bottom of the respective dense grade or OGFC layer and the other was installed approximately 18 inches down.

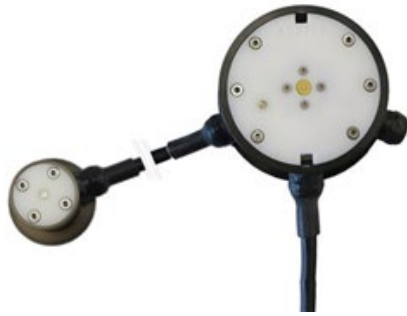
#### DATA COLLECTED

Because non-contact measurements only provide estimates of surface behavior, invasive pavement sensors were installed to directly measure conditions at and below the surface. Based on discussions with the MassDOT PCs and USGS, it was decided to install eight sensors: four passive Lufft IRS31Pro-UMB sensors (Figure 2.6) and four active Lufft ARS31Pro-UMB sensors (Figure 2.7). The IRS31Pro-UMB passive sensor measures road surface temperature, temperature at depth (5 cm and 30 cm), water film height, freezing temperature of de-icing materials, surface condition, friction, ice percentage, and salt concentration (See Table 1). The active ARS31Pro-UMB sensor complements the passive sensor by actively heating and cooling the sensor surface to measure freezing point independently of de-icing materials. This capability addresses limitations of the passive IRS31Pro-UMB sensors, particularly when blended brines, magnesium chloride, or other treatments are used.

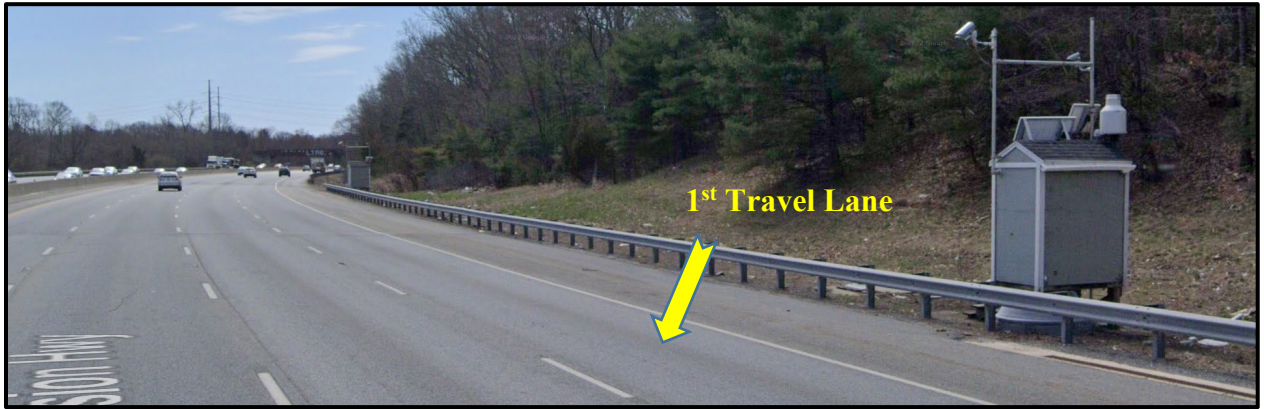
**Figure 2.8: Lane for installation of invasive sensors**

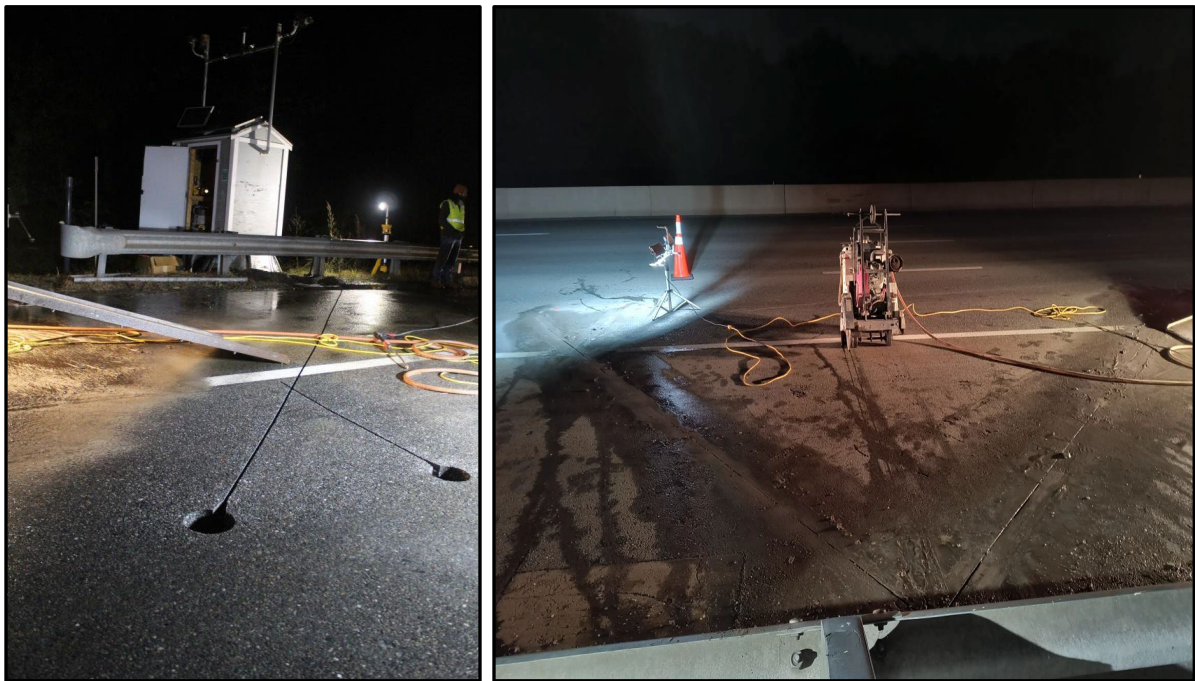
**Figure 2.9: Installation of invasive sensors – Dense graded surface**

Figures 2.9 and 2.10 show the orientation and layout of the sensors during the installation process for DG and OGFC pavement surfaces respectively. They also show the level of coring, cutting and preparation required to imbedded the sensors into the road. Figures 2.11 and 2.12 show the weather station view of the final sensor installation (Note that only one set is within

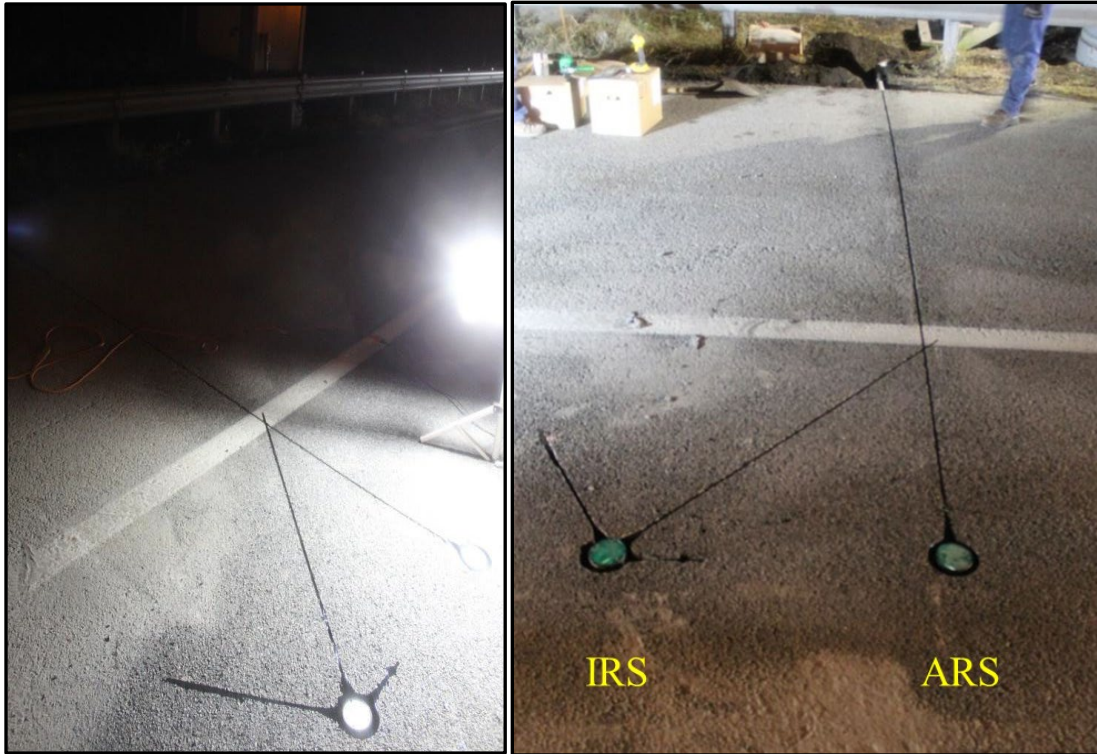
**Figure 2.10: Installation of invasive sensors – OGFC**

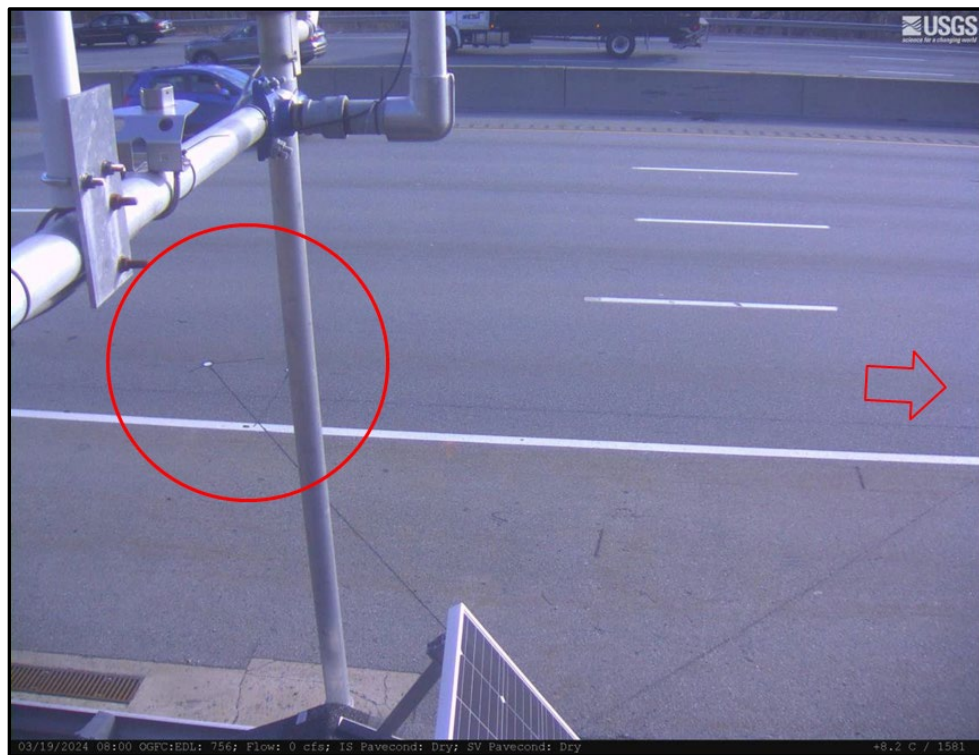
**Figure 2.11: View of sensors from weather station – Dense graded**

the camera view for each station) for DG and OGFC pavement surfaces respectively. In these figures, the arrow indicates both the direction of traffic and the location of the other set of sensors that is not visible in the camera view.

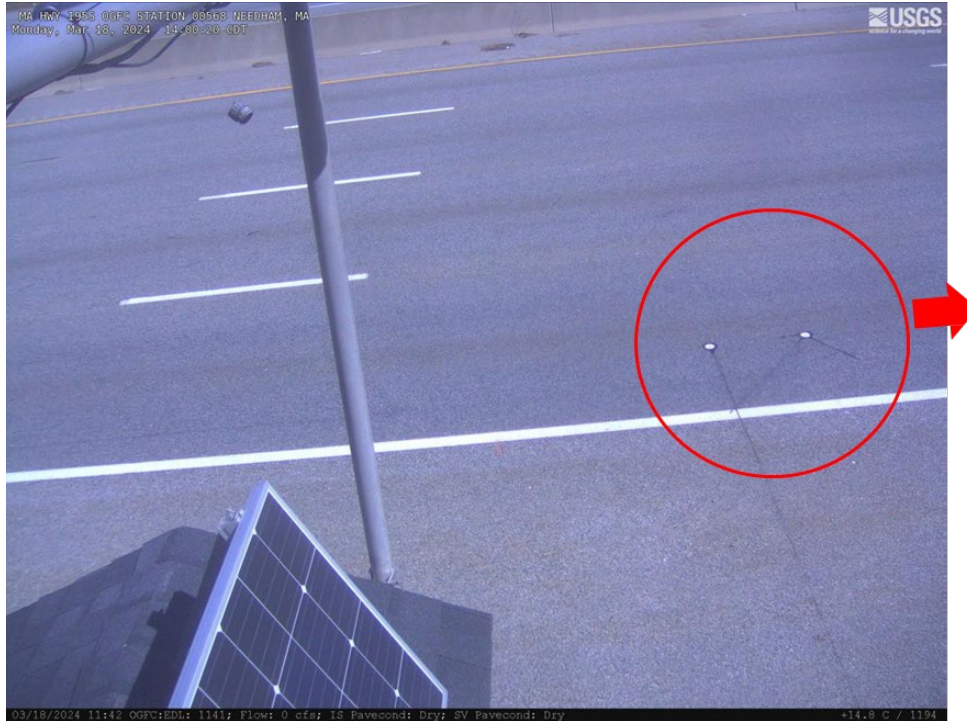
**Figure 2.12: View of sensors from weather station – OGFC**

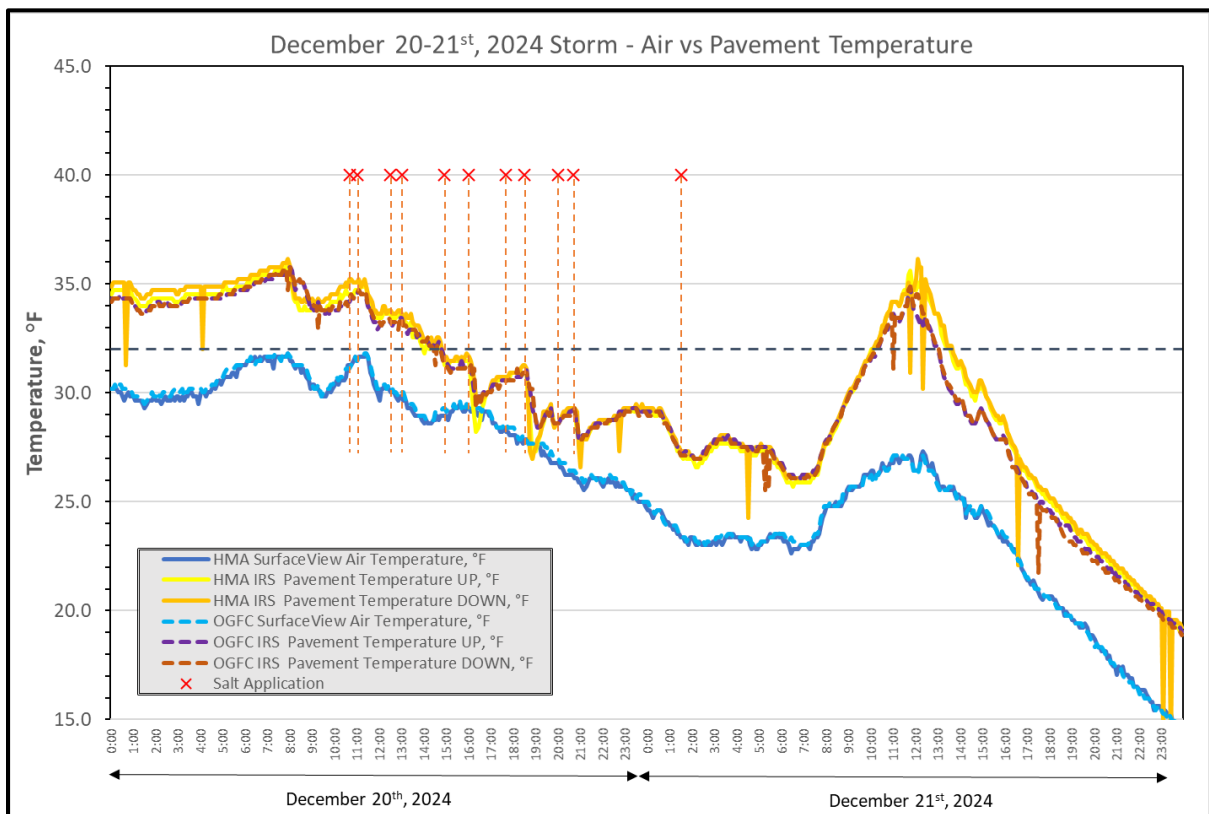
**Figure 4.1: Temperature by sensor type - Air versus Pavement (2024)**

Figures 4.1 and 4.2 show a comparison of air temperature measured by the SurfaceVue10 (non-contact) and the imbedded pavement invasive sensors (IRS) for both DG and OGFC pavement types with respect to salt application. As it can be seen, the air temperature measured by the SurfaceVue10 generally trended colder than pavement temperature measured by the invasive sensors regardless of pavement type.

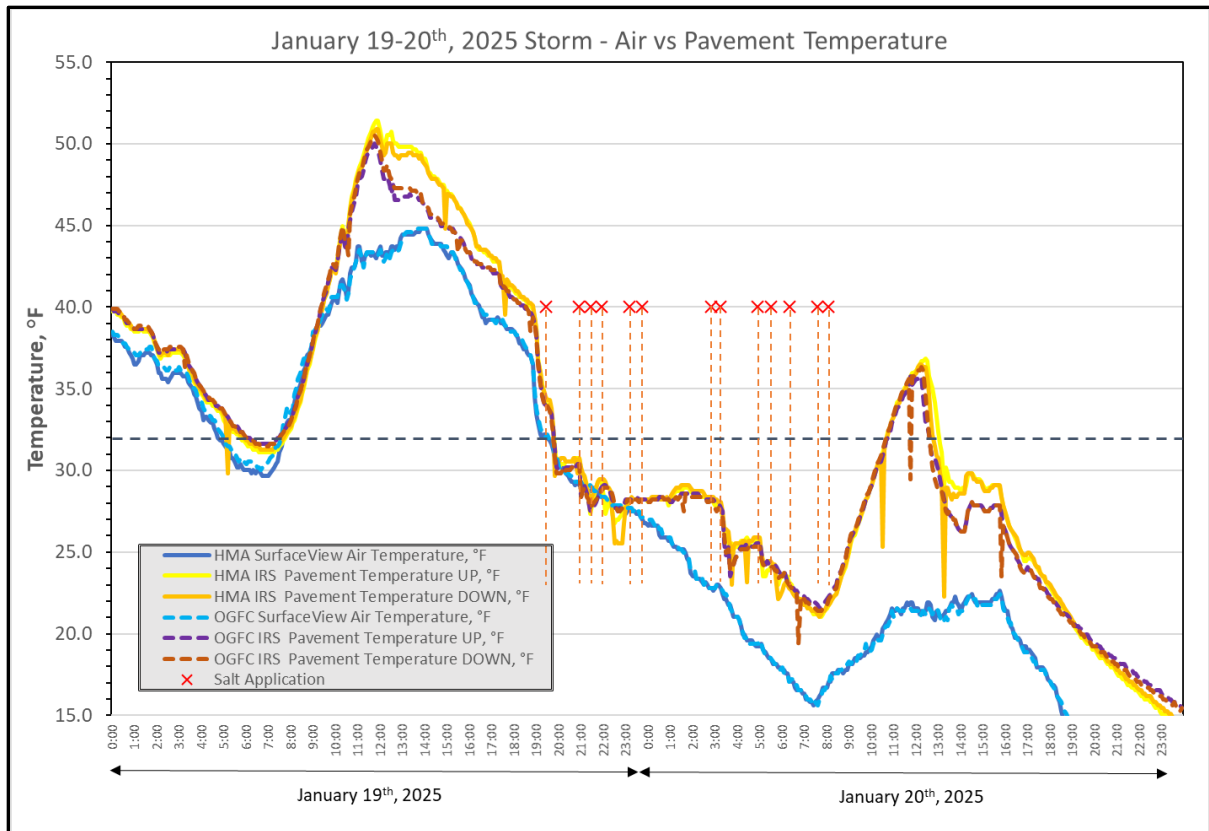
**Figure 4.2: Temperature by sensor type - Air versus Pavement (2025)**

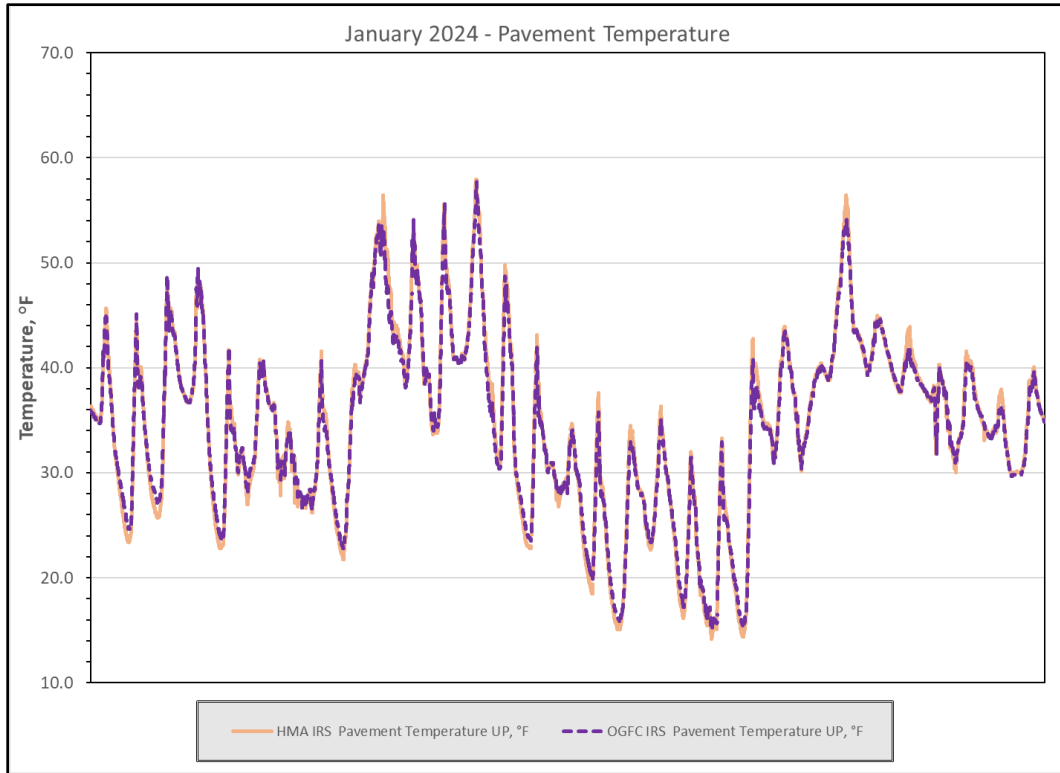
**Figure 4.3: Surface temperature – Dense graded vs. OGFC**

Figure 4.3 shows a comparison of pavement surface temperature from the invasive sensors (IRS) for both DG and OGFC pavement types. The temperature was similar between both the DG and OGFC mixture types. No data indicated one pavement type was freezing faster than the other, as surface temperature data was generally the same. Analysis of other storm data on different dates provided similar results.

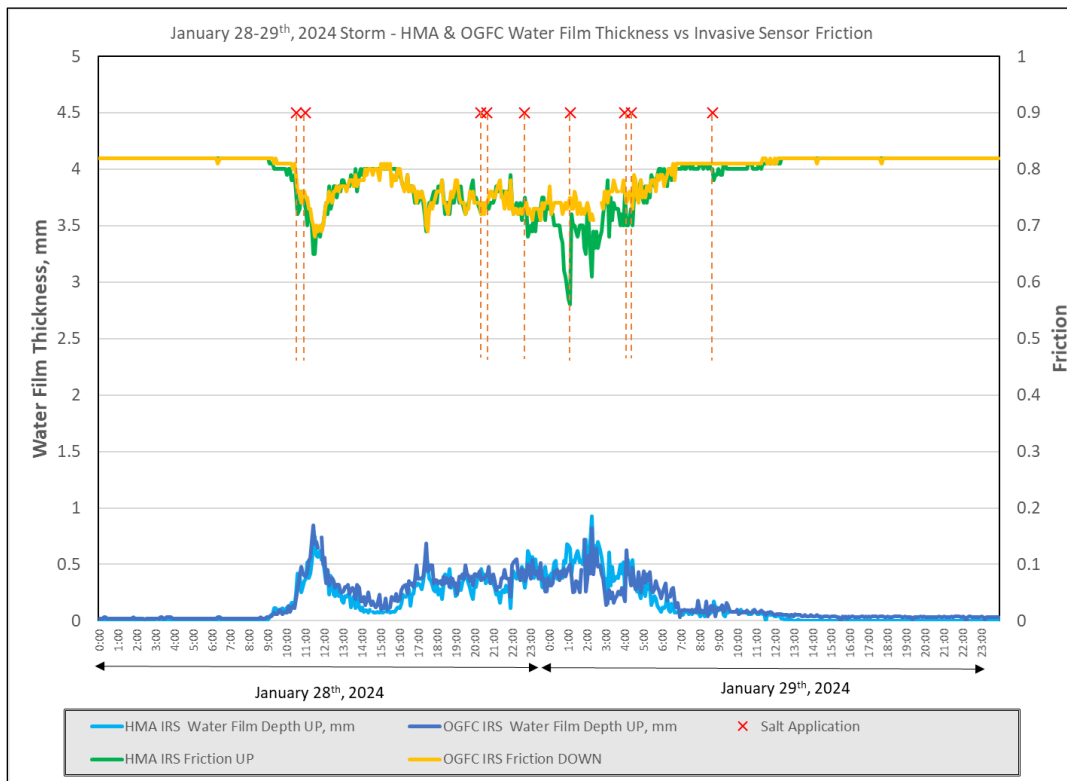
**Figure 4.4: Water film thickness versus invasive sensor friction (2024)**

Figures 4.4 and 4.5 show a comparison of water film thickness versus invasive sensor (IRS) friction by pavement surface type. Friction was only of concern when moisture, or water film, was present at the sensor in the pavement. If the pavement were dry, there would be less potential for reduced friction or an icing condition. The data indicated that the friction characteristics of the DG and OGFC pavement types were similar with respect to salt application, and that the water film experienced on both was similar. In Figure 4.5, the incomplete areas, or gaps, in the friction data were common. In consulting with USGS, these gaps occur when the freezing point estimated by the IRS sensor return an unrealistic value. This could be due to build-up of contaminants on the sensor surface. The unrealistic value of freezing point then affects the calculation of friction, which is based on freezing point. USGS applied filters to the data stream to remove such unrealistic data, and thus these data gaps appear.

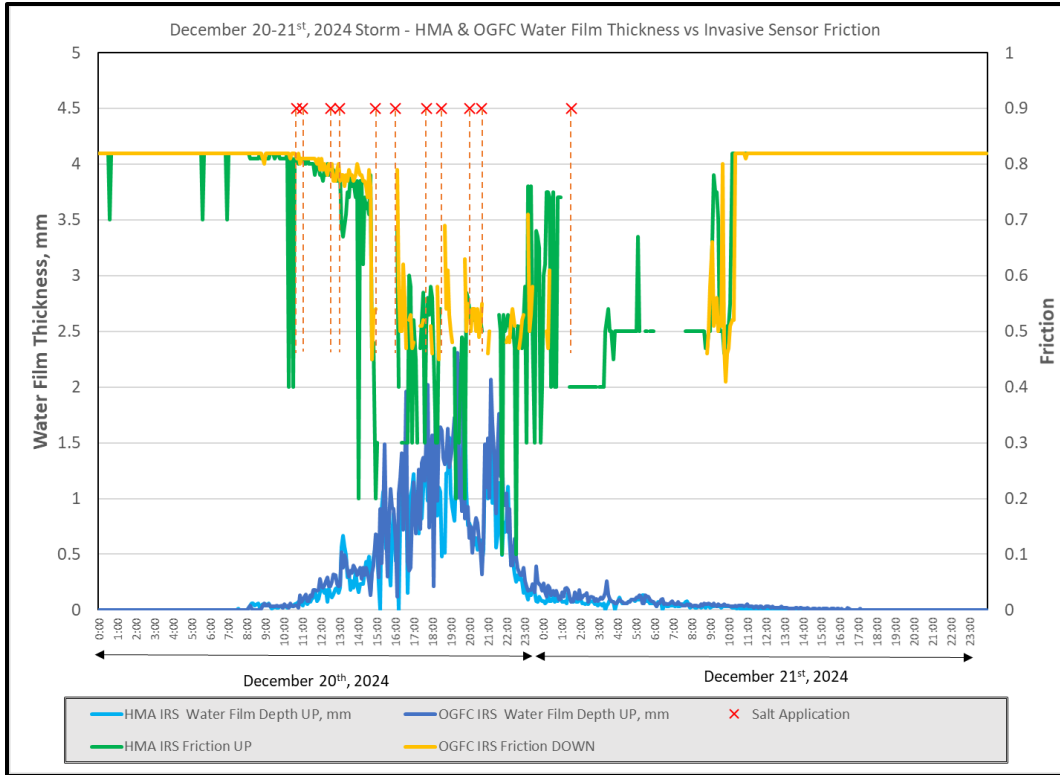
**Figure 4.5: Water film thickness versus invasive sensor friction (2025)**

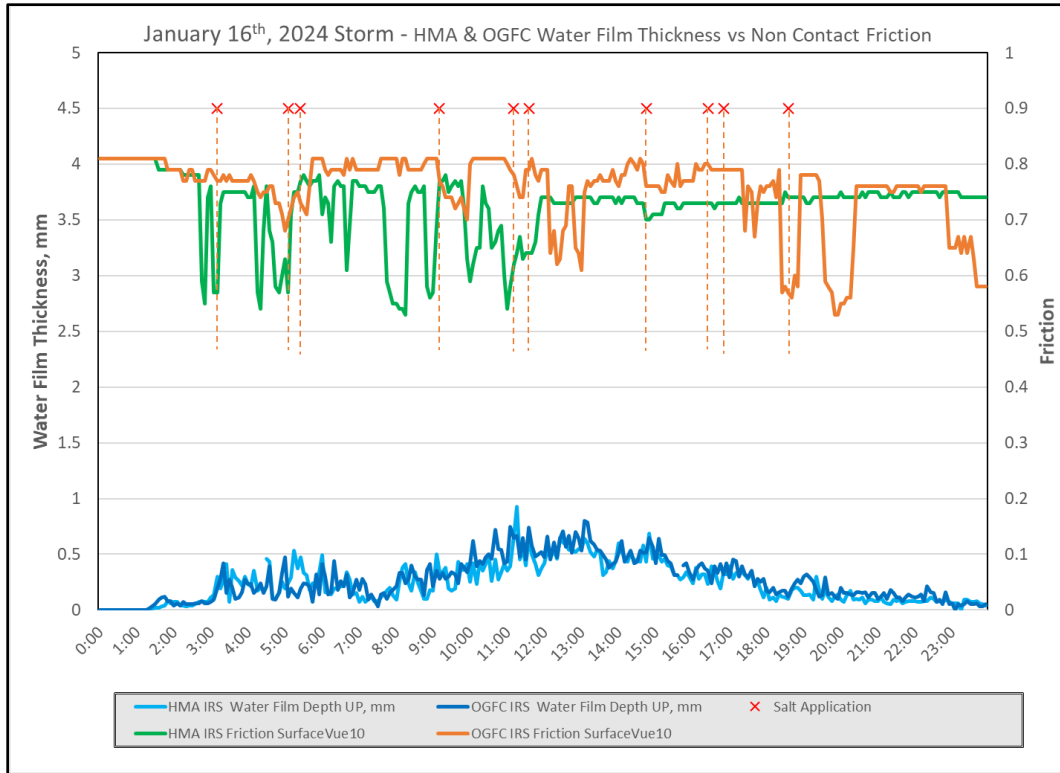
**Figure 4.6: Water film thickness versus non-contact sensor friction (2024)**

Because of the data gaps observed in the invasive sensor friction data, the friction value obtained by the non-contact SurfaceVue10 were plotted similarly versus water film thickness. As shown in Figures 4.6 and 4.7. The data showed agreement with the invasive sensor friction data. The friction characteristics of the DG and OGFC pavement types with respect to salt application were similar.

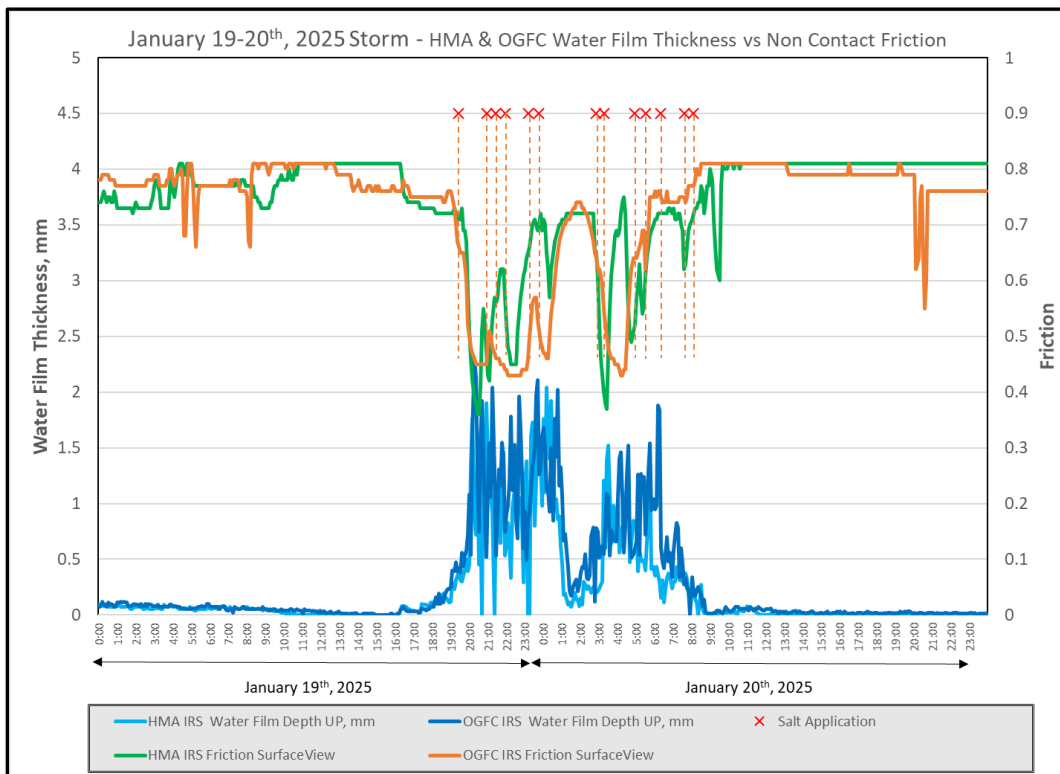
**Figure 4.7: Water film thickness versus non-contact sensor friction (2025)**

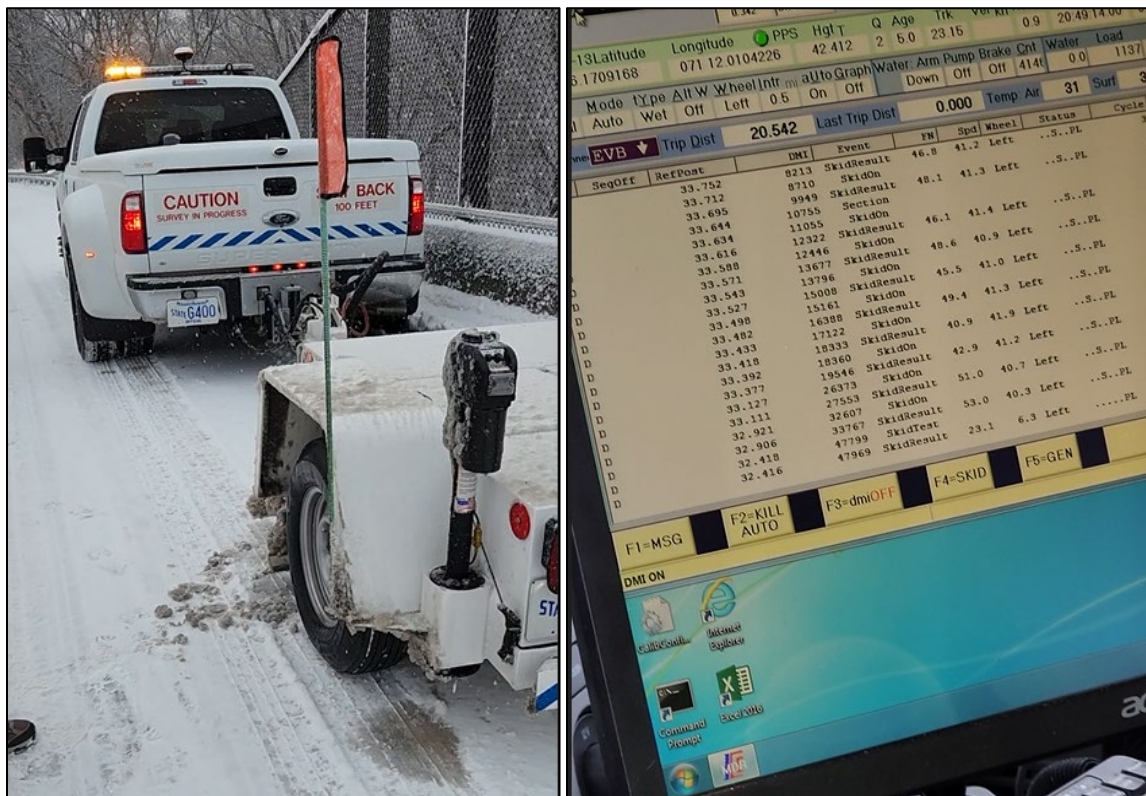
**Figure 4.8: MassDOT collection of surface friction data using the locked-wheel friction tester during a winter storm**

The locked wheel friction tester is a standardized device used to evaluate pavement surface friction under controlled conditions. It is widely employed by highway agencies to assess the surface friction of pavements such as dense-graded asphalt, open-graded friction courses, and other surface types for both safety monitoring and research purposes.

The device consists of a test vehicle equipped with a smooth or ribbed tire mounted on a fixed axle. During testing, the vehicle is driven at a constant speed of approximately 40 mph while a controlled water spray is applied ahead of the tire to create a uniform wet surface. At a
