Massachusetts Department of Environmental Protection

Report to the Senate and House of Representatives on water quality at beaches under the care and control of the Department of Conservation and Recreation

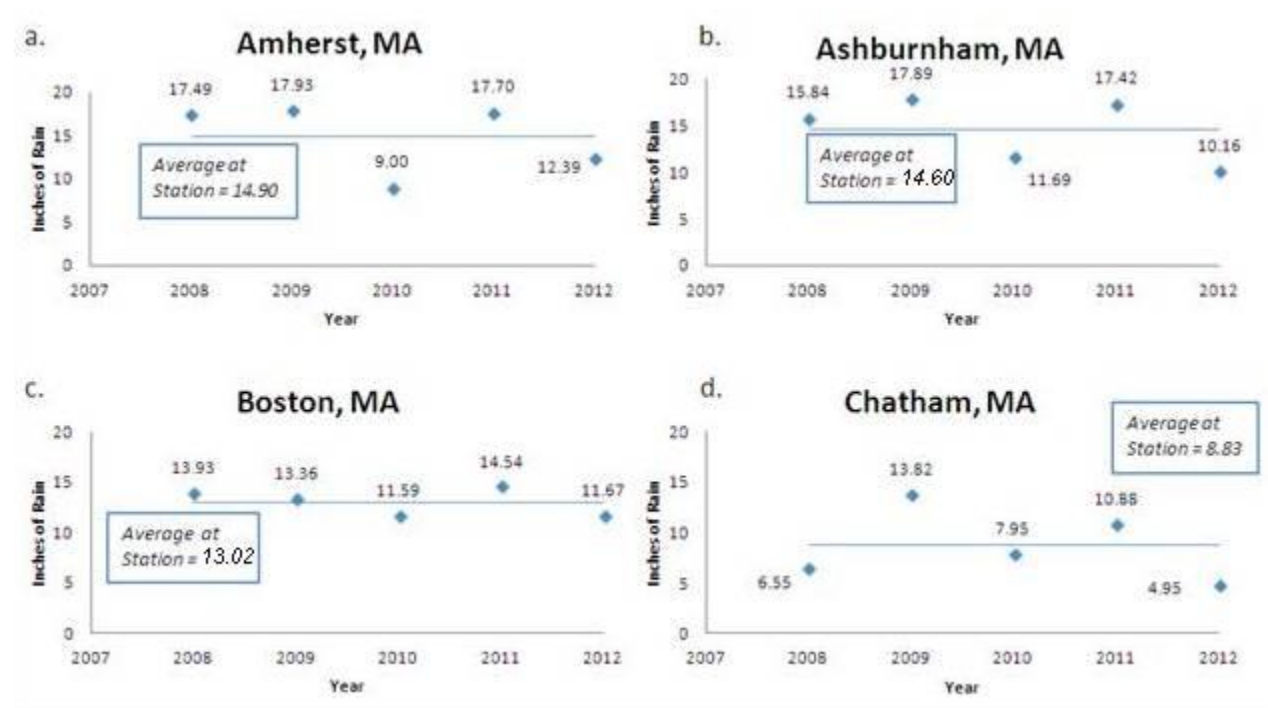
Figure 2. Yearly summaries of precipitation (in inches) at four Massachusetts weather stations a) Amherst, b) Ashburnham, c) Boston, and d) Chatham during the months of June, July, and August 2008 through 2012. The average at these stations is indicated by the horizontal line.

A brief summary of precipitation data collected at four weather stations in the state is provided below to illustrate the beach season conditions between 2008 and 2012. These data were summarized from records obtained from the National Oceanic and Atmospheric Administration (NOAA) for 2008 through 2012, <http://www.nws.noaa.gov/climate/index.php?wfo=box>, as cited in MA DPH (2013b). Although weather patterns fluctuate greatly during the summer months throughout Massachusetts, between 2008 and 2012, as shown in Figure 2, three of the five years were wetter than normal with the exception of the Cape Cod area.

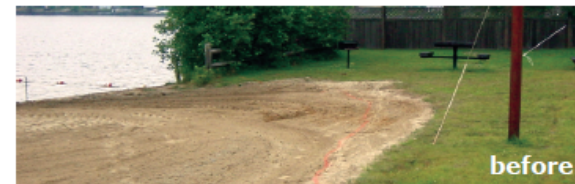
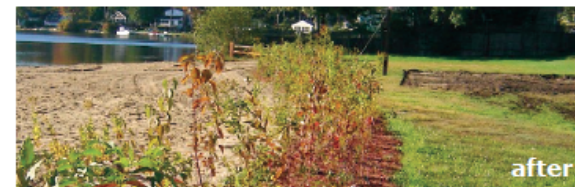
Vegetated Goose Buffers:

Geese prefer grazing in grassy areas that offer unobstructed access from the water. The "goose buffer" shown above was installed at Lake Wyola State Park in 2006. As the shrubs mature, they will provide a visual and physical barrier between the lake and the grassy areas of the state park beach.
