Summary of Green Infrastructure Site Recommendations

Green Infrastructure Assessment – Integrated Water Infrastructure Vulnerability and Climate Resiliency Plan – MVP Action Grant for the Towns of Charlton and Spencer

The **Town of Charlton** is vulnerable to flood-related damages, as evidenced by historical and recent flooding events. The Town of Charlton, in collaboration with the Town of Spencer and Fuss & O'Neill, developed a **water infrastructure climate resiliency plan to** help mitigate the effects of future flooding events that will become more frequent and intense as a result of climate change. The following is a **summary of key findings and recommendations** of the town's plan.

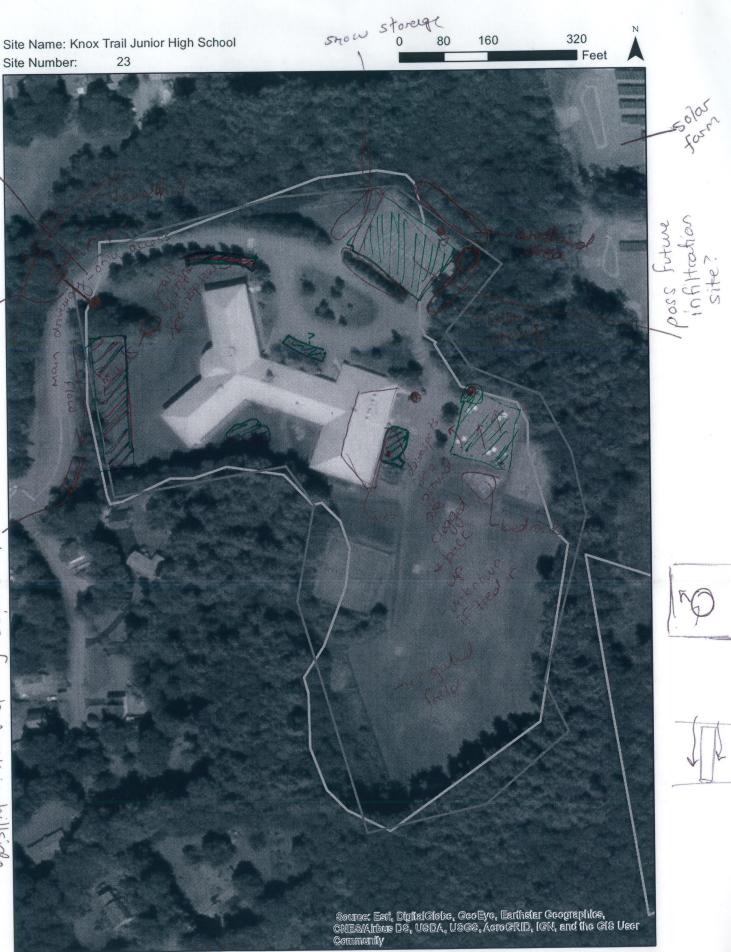
water seeping from beourack in Gerposed hillside

atony of road

PROPOSED RETROFIT Purpose of Retrofit: Channel Protection Flood Control Water Quality Recharge Demonstration / Education Repair Other: Replace culivert + improve inlet to reduce seepage from spring through road **Proposed Treatment Option:** Bein Barrels Created Wetland **Bioretention** Extended Detention Wet Pond Other: Forest buffer extension, cistern Infiltration Swale Filtering Practice Describe Elements of Proposed Retrofit, Including Surface Area, Maximum Depth of Treatment, and Conveyance: Bioretertion practices to help infiltrate water close to building (roof drainage) Be Infiltration when parking let(s) repaired to infiltrate water from fields + lots (focus on infilt in lower lot if gw not too high - better Rain barrels - elevated - to use for watering garden -use bioretention as arefrow extend forest buffer on north side of school SITE CONSTRAINTS **Adjacent Land Use:** Access: Residential Commercial Instit Institutional No Constraints Constrained due to Space Undeveloped D Other: Slope **Utilities Possible Conflicts Due to Adjacent Land Use?** Yes No Tree Impacts Structures Property Ownership If Yes, Describe: Other: Bedrock, wetlands **Conflicts with Existing Utilities: Potential Permitting Factors:** None None Dam Safety Permits Necessary Probable Not Probable Unknown Probable 🗌 Not Probable Impacts to Wetlands Probable Not Probable Yes Possible Impacts to a Stream Sewer **Floodplain Fill** Probable Not Probable Probable Not Probable Water Impacts to Forests Probable Not Probable Gas Impacts to Specimen Trees How many?_ Cable Approx. DBH Electric Electric to Streetlights **Overhead Wires Other factors:** \square Other: Marked A/B soils but wetlands Soils: Soil auger test holes: Yes No adjacent Yes No Evidence of poor infiltration (clays, fines): Evidence of shallow bedrock: Yes No wetlands Evidence of high water table (gleying, saturation):

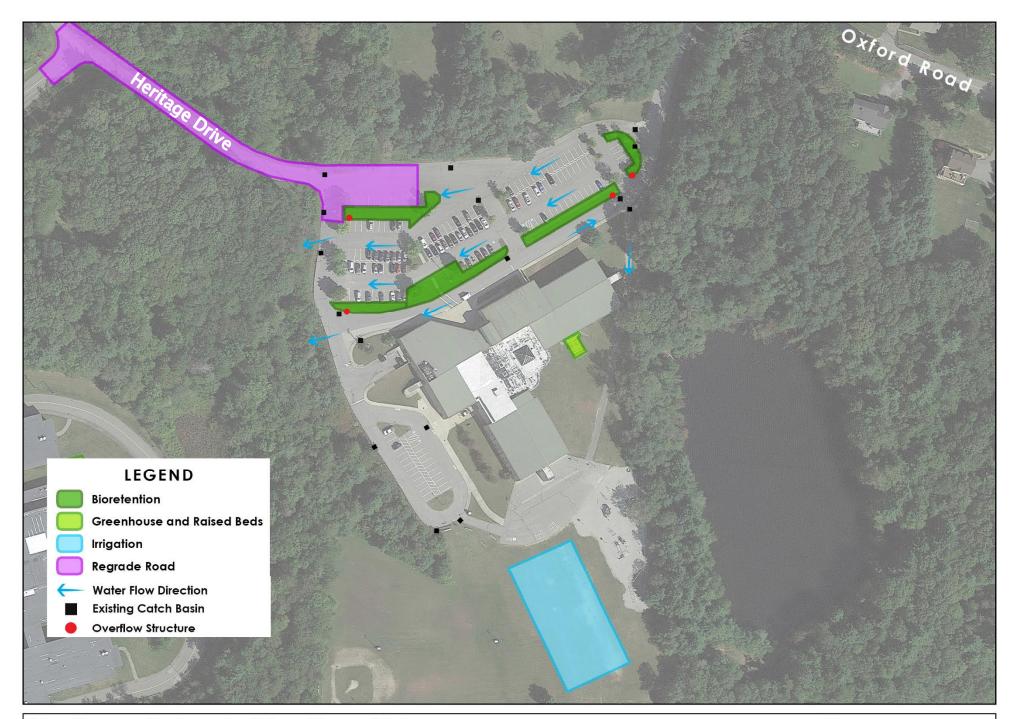
Heritage School, Charlton, MA Site Number: 1 May 2019

Proposed ConceptInstall bioretention basins in the existing landscape islands in the

- main parking lot to filter water before it enters the wetland complex.
 Regrade and consider elevating Heritage Drive between the Heritage School and the turn off to Charlton Middle School to reduce the risk of flooding.
- Capture runoff from the roof for irrigation of fields and the greenhouse and raised beds, to reduce use of treated town water for irrigation.
- Install educational signage to inform students and visitors about the function and benefits of green stormwater infrastructure and low impact development.
- Incorporate stormwater concepts into the school's curriculum, using the proposed retrofits as real-world examples and sites for hands-on learning.

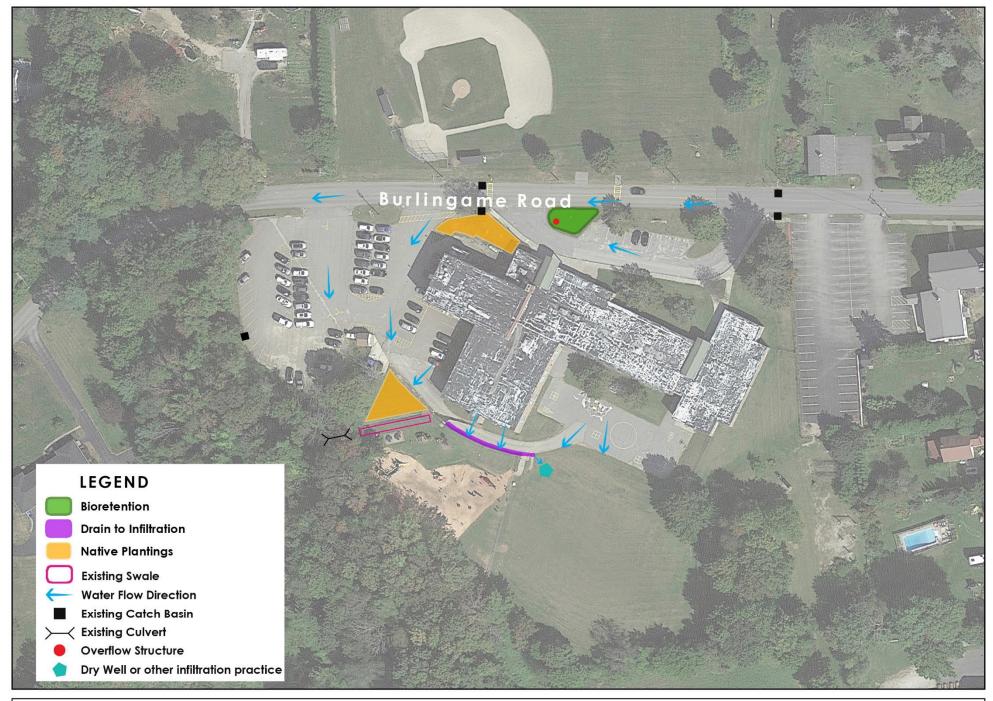
Charlton Elementary School, Charlton, MA Site Number: 3 May 2019

The proposed retrofit concept is located at the Charlton Elementary School on Burlingame Road. Much of the site's runoff is currently collected by catch basins and drained down the hill to the southwest. Runoff currently causes wet conditions in the playground at the rear of the school building and erosion along the stairs from the access road to an adjacent field. This field was once used as a septic system and is therefore expected to have high infiltration rates. Runoff at the front of the building currently drains into municipal storm sewers along Burlingame Road via catch basins.

- Install a drain along the south edge rear access road between the road and the playground fence to divert runoff away from the playground and stairs, where it is causing wet playground conditions. Install an underground infiltration system beneath the field to infiltrate the diverted water. Perform infiltration testing before committing funds to this practice, to confirm adequate infiltration rates.

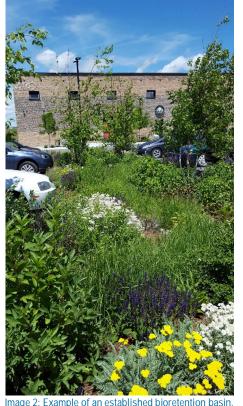
- Install a bioretention basin along the southwestern edge of the parking lot to capture stormwater before it flows down the steep slope toward Prindle Lake. Construct the southwestern embankment of the bioretention basin as a level spreader to evenly distribute rather than concentrate overflows.
- Include a sediment forebay or similar pretreatment structures like ٠ the one shown in Image 3 to improve treatment and extend the lifespan of the bioretention basin.
- Install educational signage to inform visitors about the function and benefits of green stormwater infrastructure and low impact development.

Bioretention Concept Summary Total Impervious Area: 0.4 acres Treated Water Quality Volume: 1,600 ft³

Estimated Cost Bioretention: \$28,000

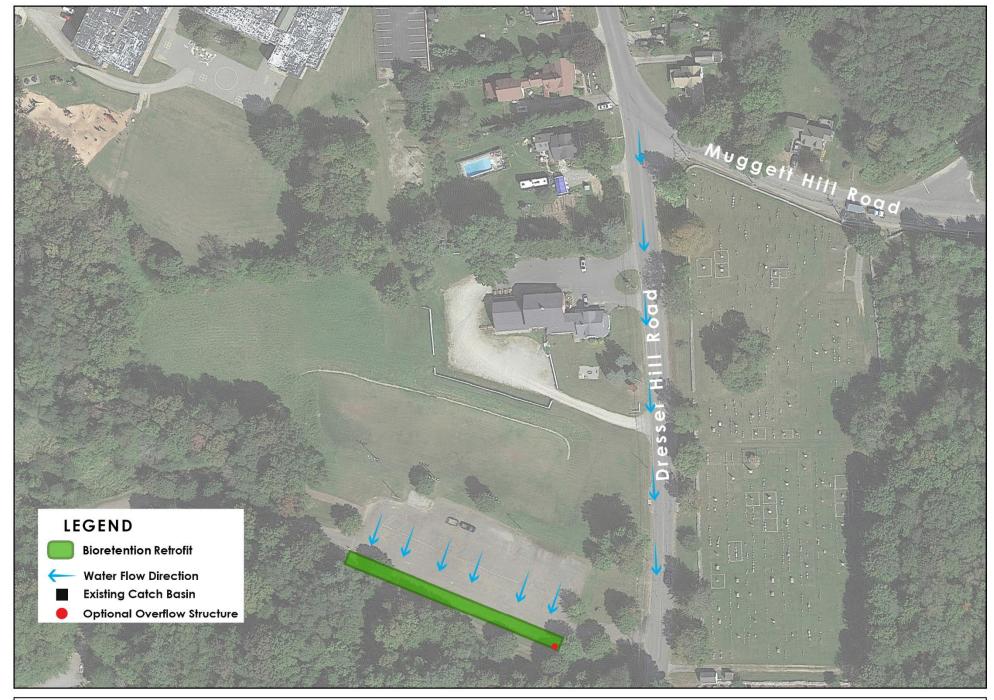
Maynard Farm Recreation Area, Charlton, MA Site Number: 5 May 2019

The proposed retrofit is located at the largest and most heavily used parking lot at the Maynard Farm Recreation Area. Three parking lots serve the facility. The largest parking lot (the first lot when entering the site from Dresser Hill Road) is paved but the asphalt is in poor condition and the parking lot requires repaving. Runoff from the lot drains to an existing armored swale along the southern edge of the lot. The runoff concentrates at several locations before entering the swale, which has led to rilling and erosion at the edge of the lot. The swale discharges to a wetland/pond south of and downslope from the swale via an eroded ravine that has been armored with stone. Existing storm sewers along Route 31 do not capture runoff from the parking lots.

- Adjust snowplowing practices to prevent plowing of snow into the bioretention basin during winter months. Plowing snow into the bioretention basin would cause it to fail. Snow should be plowed toward the north, west, or east sides of the lot.

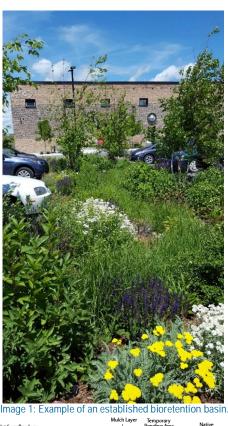
Image 2: Example of a parking lot with bioretention and diagram of a bioretention basin. Image source: MA Clean Water Toolkit.

Pending Area (Gase, Vestured or Store-Lived Suite) (Gase, Vestured or Store-Lived Suite) (Gase, Vestured or Store-Lived Suite (Gase Calific States Case) Pending Area (Gase Vestured or Store-Weir (Deerline) (Gase Case) Pending Area (Deerline) (Deerline)

- Design the parking lot with integrated bioretention basins to capture and filter parking lot runoff.
 Select vegetation to shade and cool the parking area while creating an aesthetically pleasing site.
- Install an underground infiltration system to allow treated rainwater to infiltrate beneath the parking lot.
- Incorporate permeable pavers into pedestrian walkways.
- Install educational signage to inform visitors about the function and benefits of green stormwater infrastructure and low impact development.

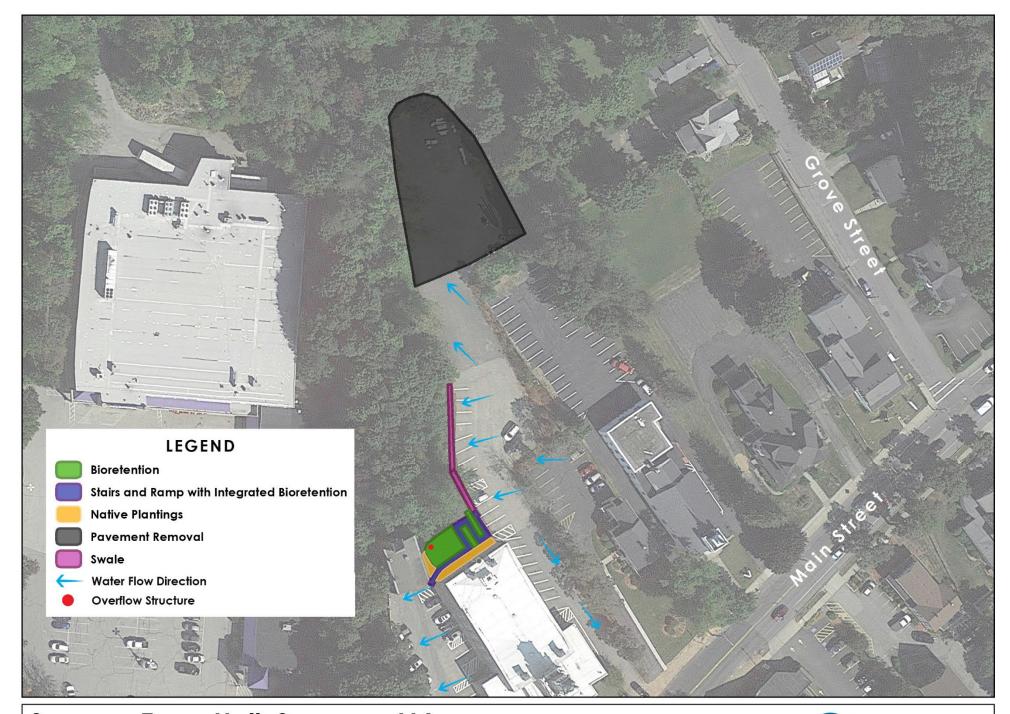
Spencer Town Hall, Spencer, MA Site Number: 8 May 2019

- Supplement the bioretention areas with native plantings in areas that cannot be used for bioretention (e.g., due to proximity to the foundation of the Town Hall).
