**Final Report for the MassDEP MS4 Municipal Assistance Grant Program**

**The Buzzards Bay Stormwater Collaborative  
Illicit Discharge Investigation and MS4 Support**

**MassDEP MS4 Municipal Assistance Grant Program 2020-2021**

**Illicit Discharge Investigation Trailer**

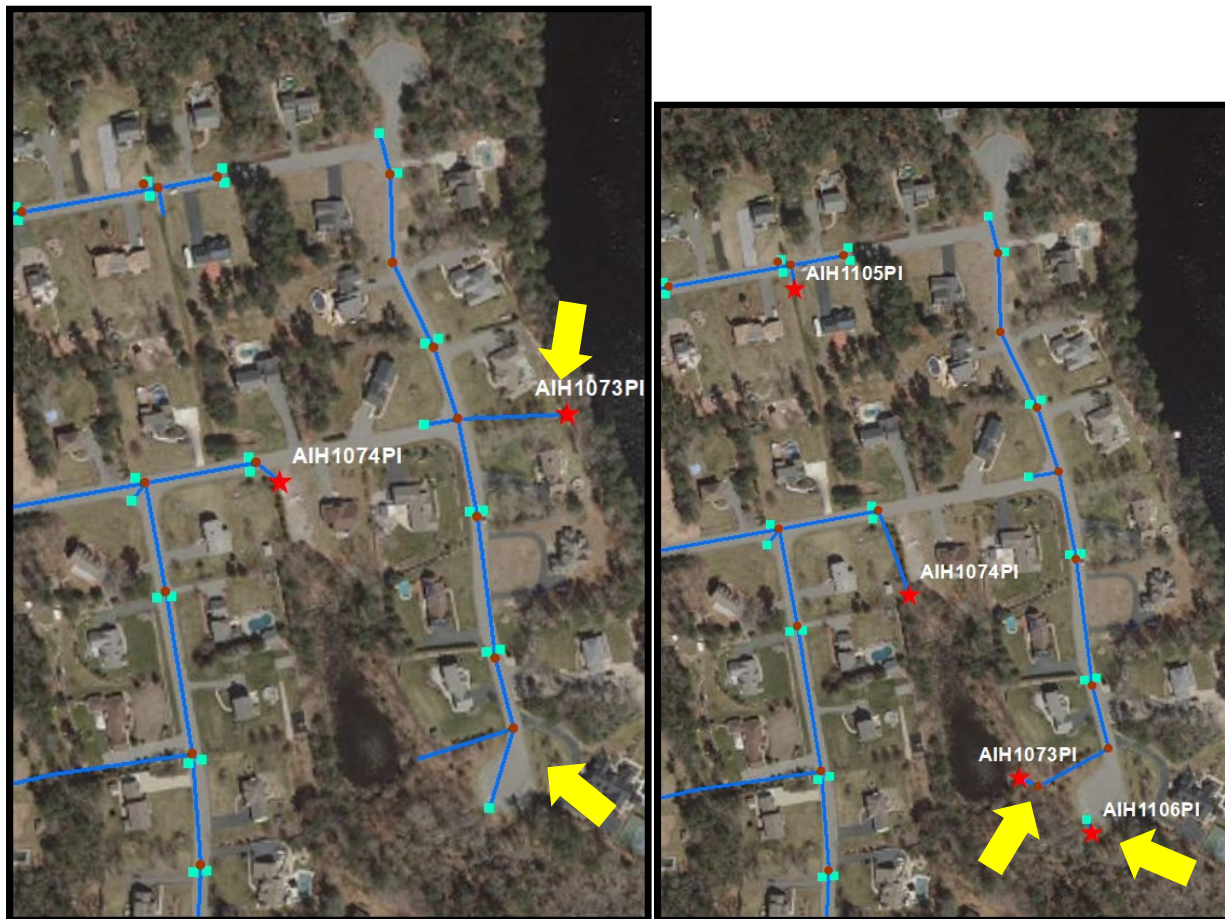
Example of before and after mapping:

Before

After

The data collected was used to update the Buzzards Bay National Estuary Program stormwater GIS. Despite the extensive and detailed mapping of some areas before the investigation, there were opportunities for some corrections and additions while going through the investigation process. Other areas with less mapping available before the inspection, now have a comprehensive map of the stormwater network. The comprehensive GIS mapping developed through IDDE inspections is a critical tool in refining catchment area definitions and ultimately prescribing stormwater solutions.
