**Final Report on a Project Designed to Reduce Damage to Sinking Groundlines by
Adjusting Lobster Gear Hauling Equipment**

**Submitted to NOAA Fisheries
by**

**Richard Allen
R. B. Allen Associates
145 High St. # A
Westerly, RI 02891**

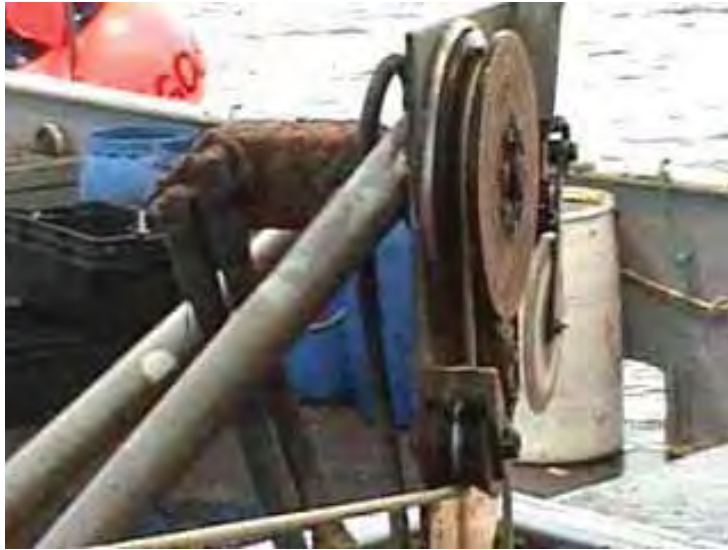
Figure 1. Trap hauler on offshore lobster boat showing rope leading into hauler through fairlead block. Disc at the bottom right of hauler exerts pressure on rope to prevent it from jumping out of hauler and is called a “pizza cutter.”

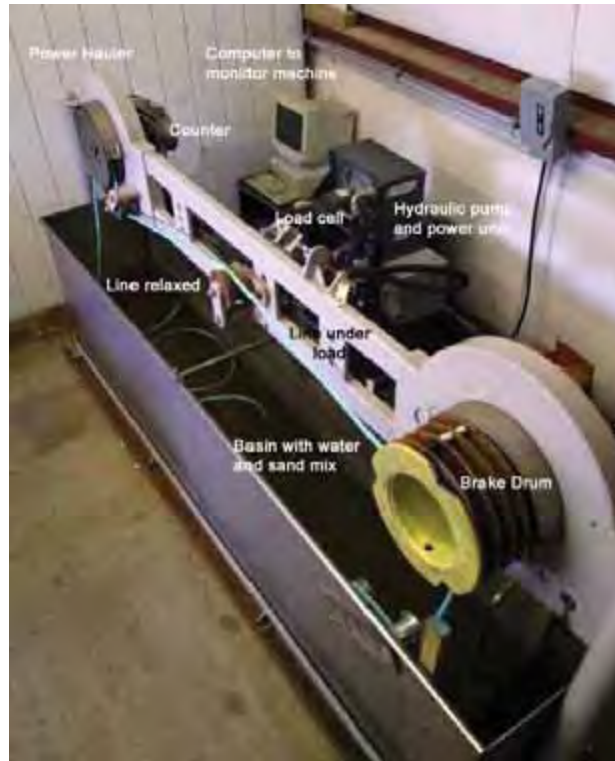
Figure 2. Trap hauling simulator.

In tests involving sediment, the simulator subjects non-buoyant test lines to a sand substrate representing a generalized offshore environment by allowing the line to lay in a relaxed (no load) state for a period of time within a 12-foot long basin of sand and water. The test line is then subject to a load typical of hauling offshore lobster gear from great depths by running the line between a 16" trap hauler and an 11" diameter drum working against each other. The cycle of simulated set and haul is repeated for a predetermined number of times and the line is then break-tested to provide a quantifiable comparison. The simulator/ tester is housed at a *Marine Fisheries'* facility in New Bedford, Massachusetts.

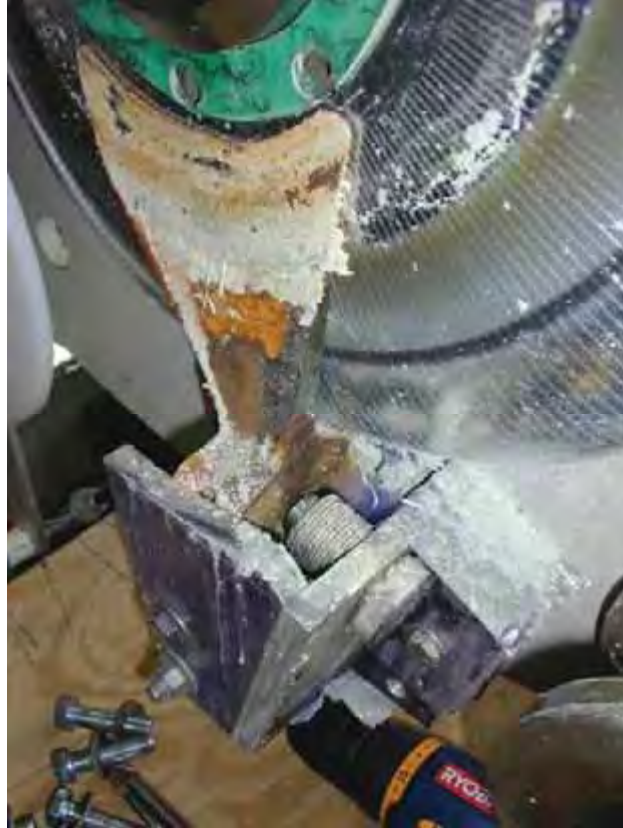
Figure 3 The force of the rope against the splitter was measured with a load cell mounted against the back of the splitter. The splitter was mounted with one bolt, which allowed it to pivot imperceptibly against the load cell. Any sideways movement of the splitter was constrained by the close-fitting bracket. The load cell was connected to a computer which recorded the splitter force at one second intervals.

For this project we fitted the simulator with a load cell that measured the force with which the rope pushed against the splitter. We assume that there is a higher likelihood of rope damage if the rope is pushing against the splitter with more force, which indicates that the rope is being forced out of the sheaves with more difficulty. The load cell was mounted in a bracket that was attached to the hauler frame. The splitter was mounted with one bolt, which allowed it to pivot against the load cell. The actual pivoting movement of the splitter was imperceptible. The load cell readings are intended to serve as an index that allows comparison between different hauler configurations, not necessarily to indicate the actual force exerted by the rope on the splitter. The fact that the load cell is directly opposite the point of contact of the rope, creating approximately equal torque arms for the load cell and the rope, should mean that the load cell reading approximates the actual force of the rope. The splitter was mounted in a close fitting bracket that allowed the pivoting movement but prevented sideways movement. We used an Omega Engineering, Inc. LC302-500 submini stainless steel load cell with a 500 pound capacity. This load cell had an accuracy of $\pm 0.5\%$, or ± 2.5 pounds. We experienced numerous failures of the load cell. We observed that the load cell experienced noticeable drift over time. We obtained useful information from the splitter load cell, but it was not consistent throughout our trials.

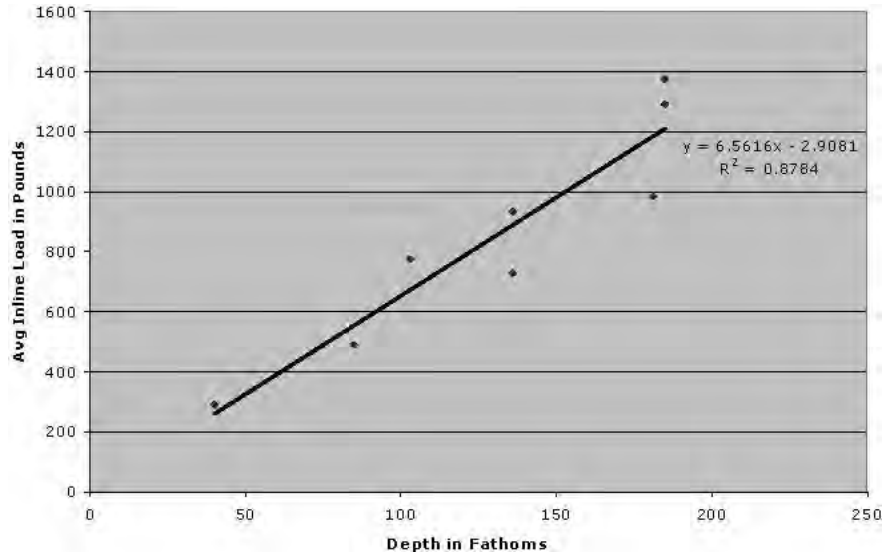
Figure 4. NOAA Fisheries Gear Technology Team data showing relationship between average hauling load and depth of set for offshore lobster gear.

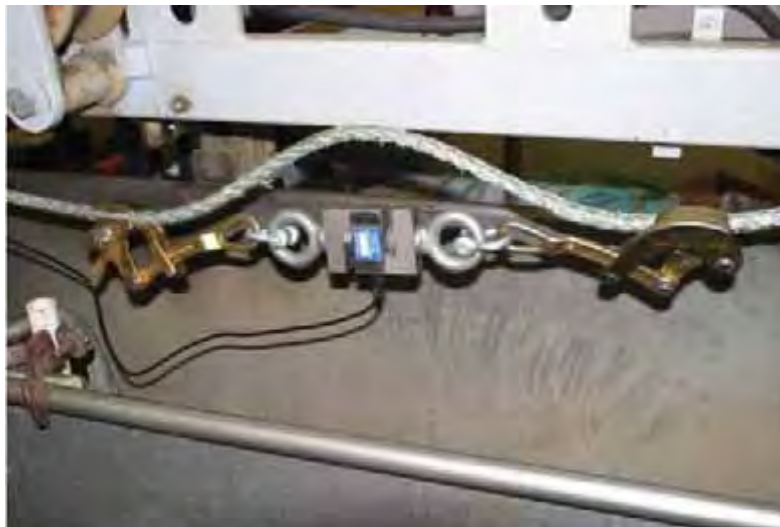
Figure 5. Computer connected electronic load cell attached to groundline on simulator to measure in-line tension in rope running on the simulator.

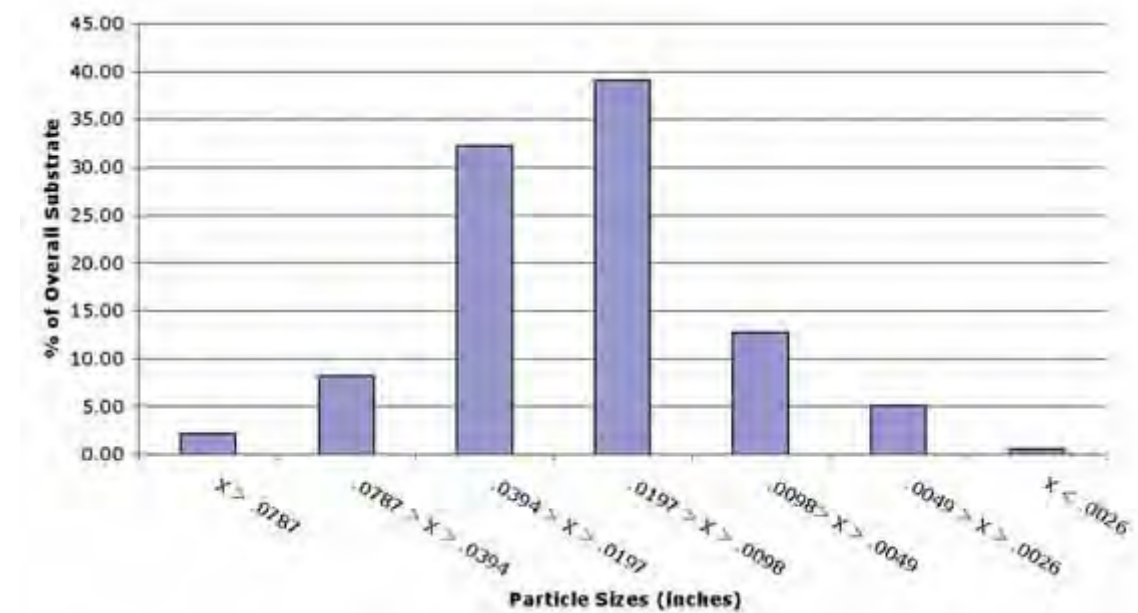
Figure 7. Substrate particle size distribution in the simulator tank.

The range of grain sizes for bottom sediments on typical offshore lobster fishing grounds on the Atlantic coast of the U.S. was obtained from United States Geological Survey data. A mix of sand particles made up of masonry sand and silt was used to approximate the average bottom-type of the offshore environment for the treatments that included the effect of sediment. Particle size was quantified by running a sample of the substrate through a set of sieves, drying the separated sub samples, and weighing them for comparison. For the most part (>95% by weight) sand particles ranged in size between .0049" and .0787" in size (see Figure 5). A cell of water between 4 – 8 inches deep was maintained over the sediment.

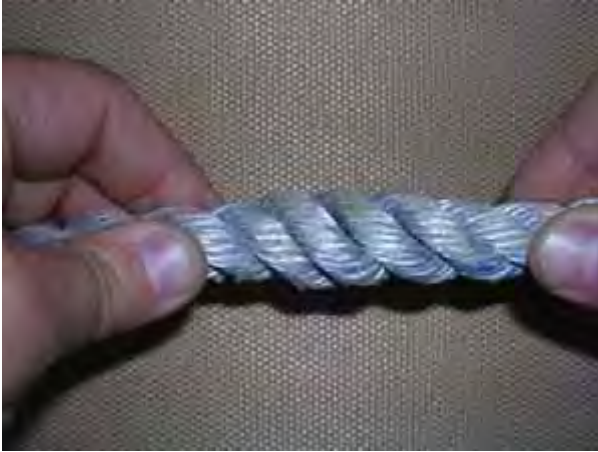
Figure 9. Our observations indicated that the standard splitter can cause rope “bunching” similar to that seen in this picture under certain conditions. Bunching of the rope makes it more likely that a strand of rope will jam between the splitter and the sheaves.

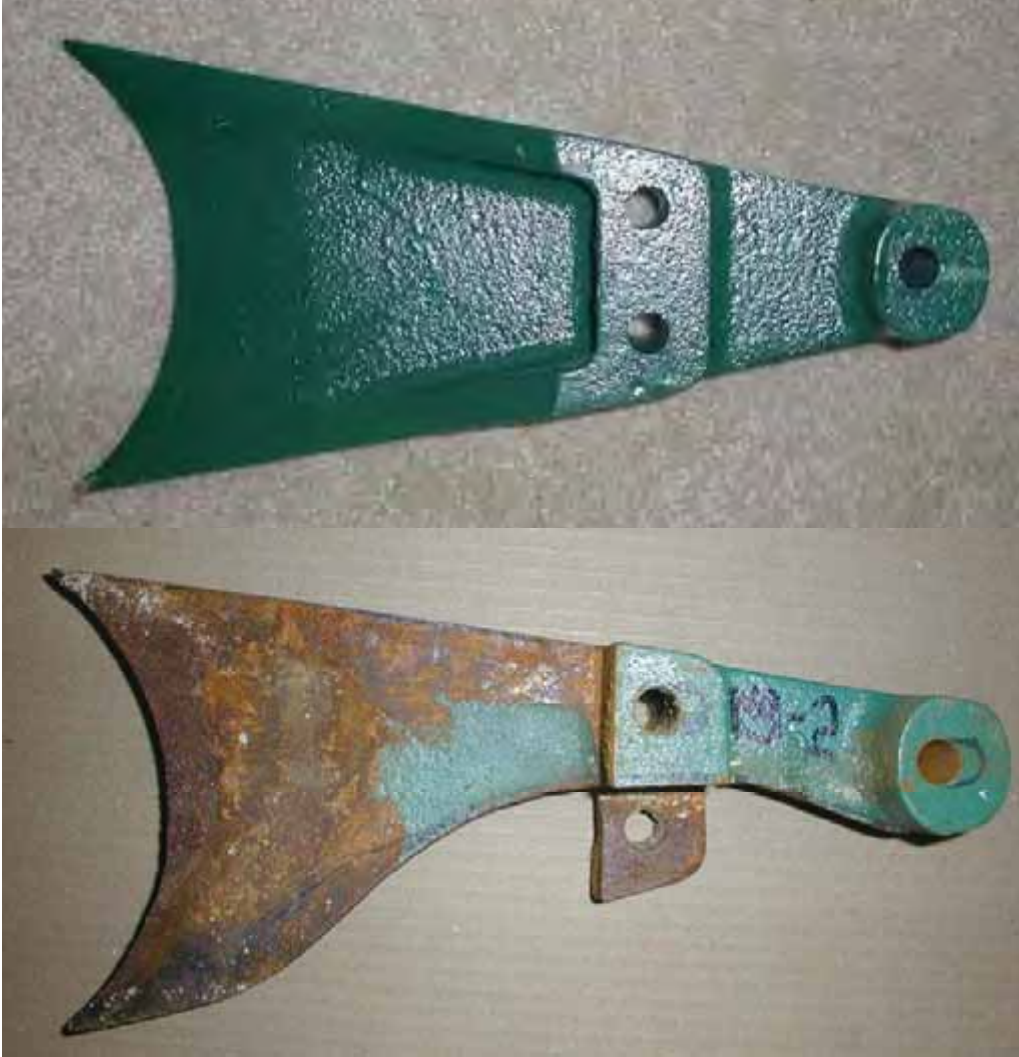
Figure 10. Comparison of standard cast steel Hydroslove rope splitter (top) with modified splitter that incorporates a reverse curve for the purpose of reducing the angle at which the rope impinges on the splitter.

3. Wear on sinking rope can be improved through the use of a splitter with a reverse curve on the edge that meets the rope. The reverse curve reduces the angle at which the rope impinges on the splitter, thus lifting the rope out of the V more easily.

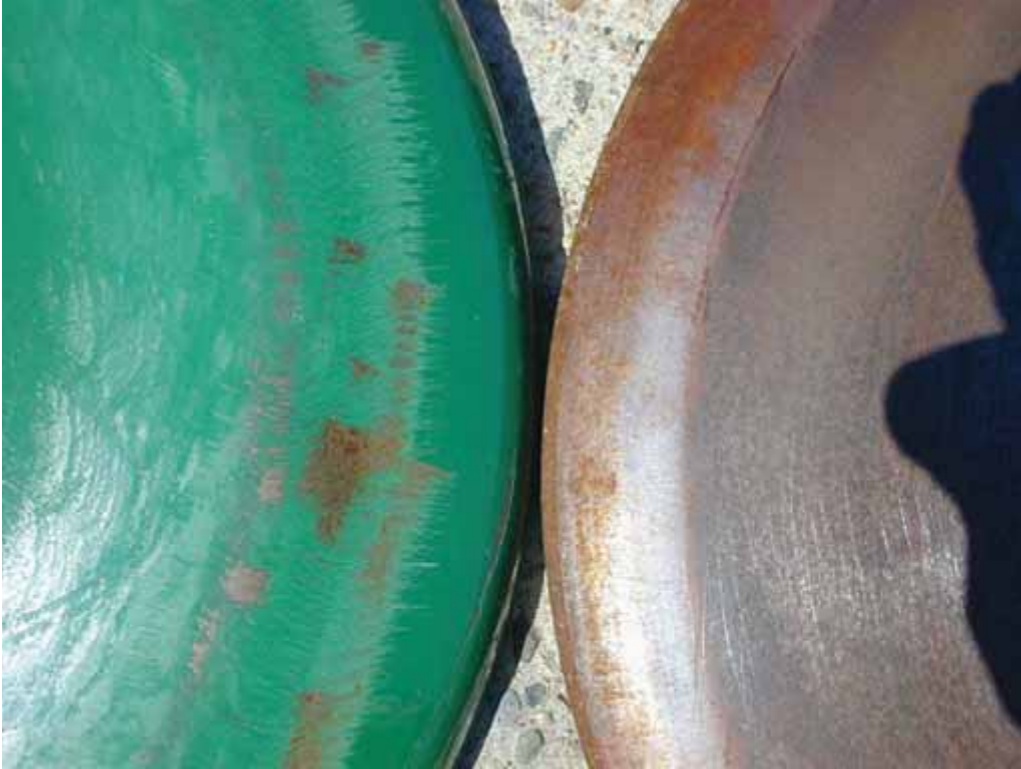
Figure 12. Slightly used Hydroslave 17" stamped steel sheaves next to machined steel sheaves. Hydroslave sheaves begin life with a smooth painted finish, which has been scuffed up in the picture above. Machined steel sheaves begin life with circumferential ridges left by the tooling. The depth and spacing of the machining ridges varies from machine shop to machine shop, and can be specified by the customer.

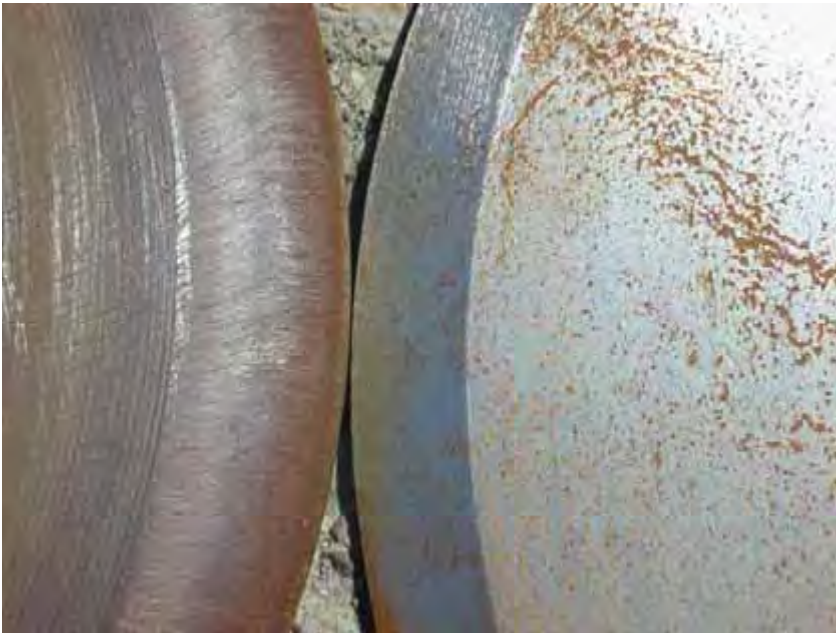
Figure 13. Two sets of machined steel sheaves showing differences in the circumferential ridges left by the lathe.

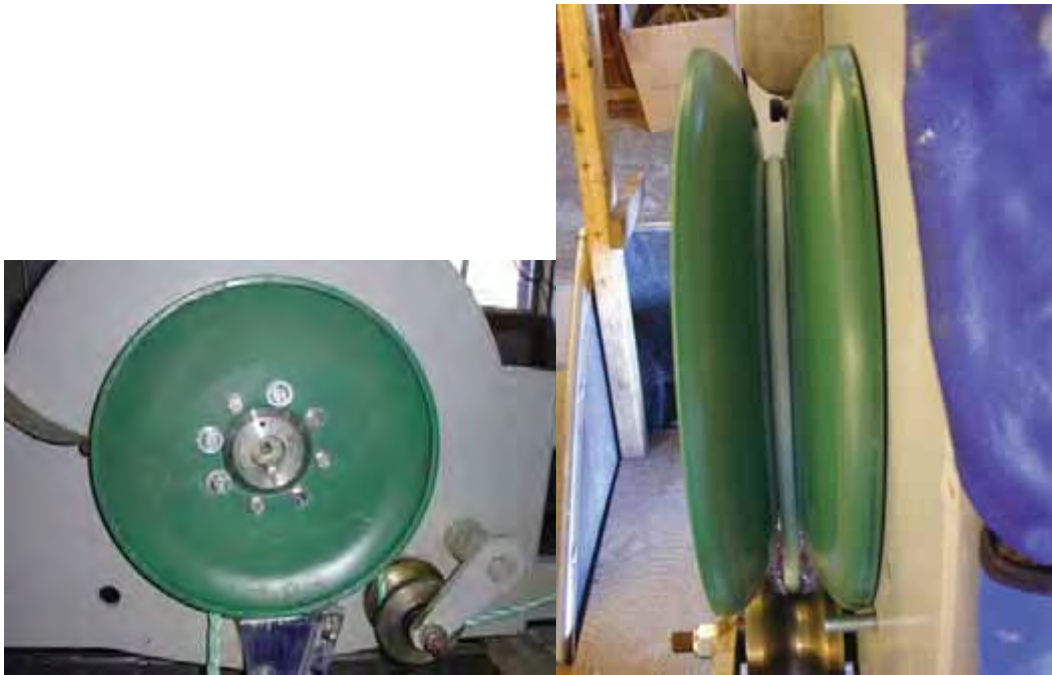
Figure 15. Front and side views of 17-inch Hydroslove stamped steel hauler sheaves that showed the least rope wear of any of our hauler treatments.

The most noteworthy potential for a reduction in rope wear through hauler modification was demonstrated by the increase in residual breaking strength of sinking groundlines tested with 17" Hydroslove hauler sheaves compared to the 16" machined steel sheaves that we considered our standard hauler setup. **The Hydroslove stamped steel sheaves gave the best results of all of our hauler tests, producing a 30% increase in residual breaking strength of sinking rope compared to standard hauler sheaves.** Additional details on the differences between our hauler configurations are provided in the body of the report. **Our research leads us to believe that the surface smoothness of hauler sheaves (related to the machining process) is a critical factor in determining rope wear.** Our observations also indicate that the angle between hauler sheaves and the depth at which the rope rides in the sheaves, determined by sheave spacing, is an important factor in rope wear for variable angle sheaves like the Hydroslove stamped steel sheaves. To our knowledge, the relationship between machining ridges on hauler sheaves and rope wear has not received any previous attention. The same holds true concerning the importance of sheave angles and spacing.

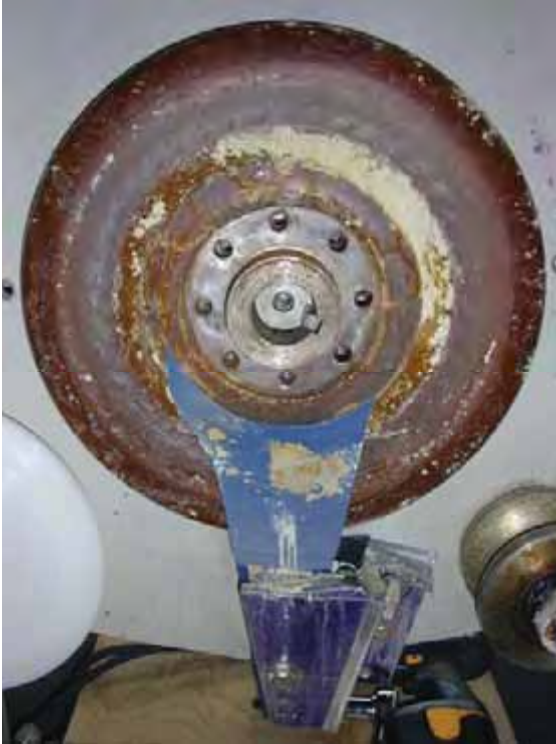
Figure 16. Treatment 11 utilized a low angle of incidence splitter machined from ultra-high molecular weight polyethylene.

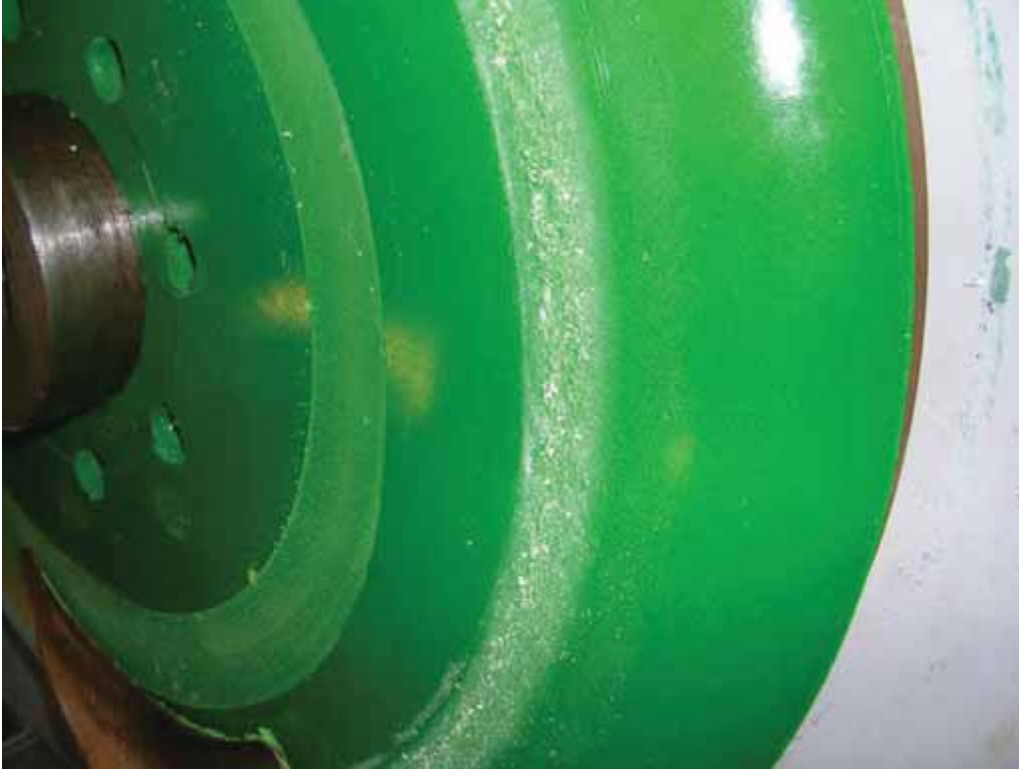
Figure 17. 47 Shore D polyurethane sheaves showed excessive wear after a short period of simulated hauling.

Treatment 12 utilized polyurethane sheaves with a hardness, or durometer, designated as 47 Shore D, which might be characterized as a medium hardness. The configuration included a standard steel splitter and zero spacing between the sheaves. The 47 Shore D sheaves showed a statistically significant improvement in rope wear compared to standard machined-steel sheaves, but the sheaves showed excessive wear that would not make them practical for commercial use.

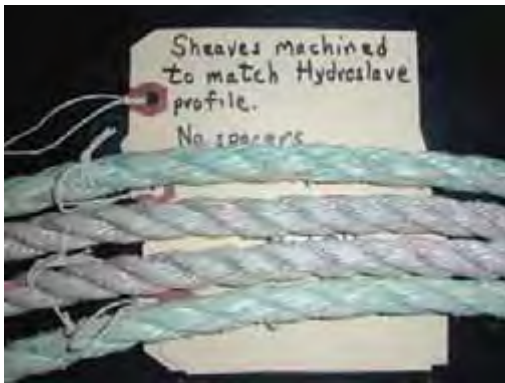
Figure 18. Rope samples from Treatment 19, sheaves machined to match Hydroslove variable surface angle stamped steel sheaves. The aqua colored rope is Polysteel © floating rope and the gray rope is a blended polyester and Polysteel © sinking rope.

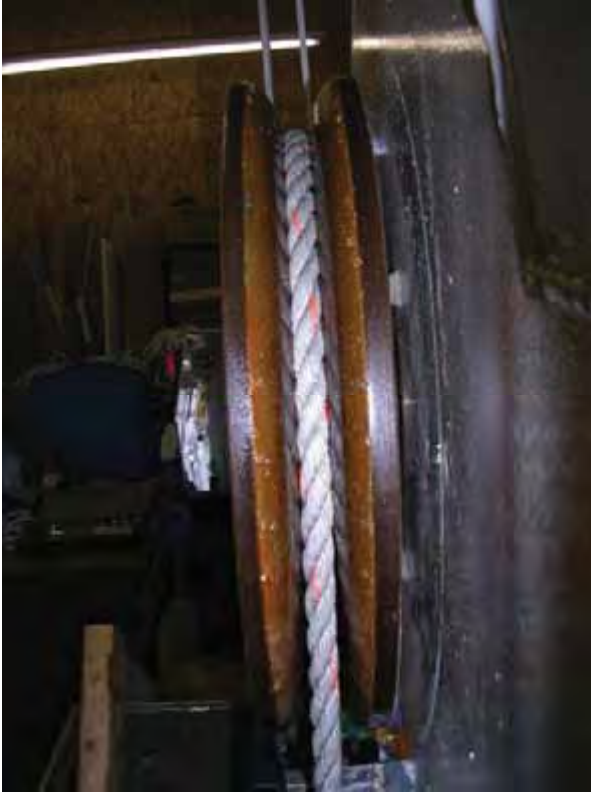
Figure 19. Variable surface angle machined steel sheaves that match the surface profile of Hydroslave stamped steel sheaves. With no spacer between the sheaves, the rope rides close to the outer rim where the angle between the sheaves is widening beyond the 4-degree angle of the standard offshore sheaves.

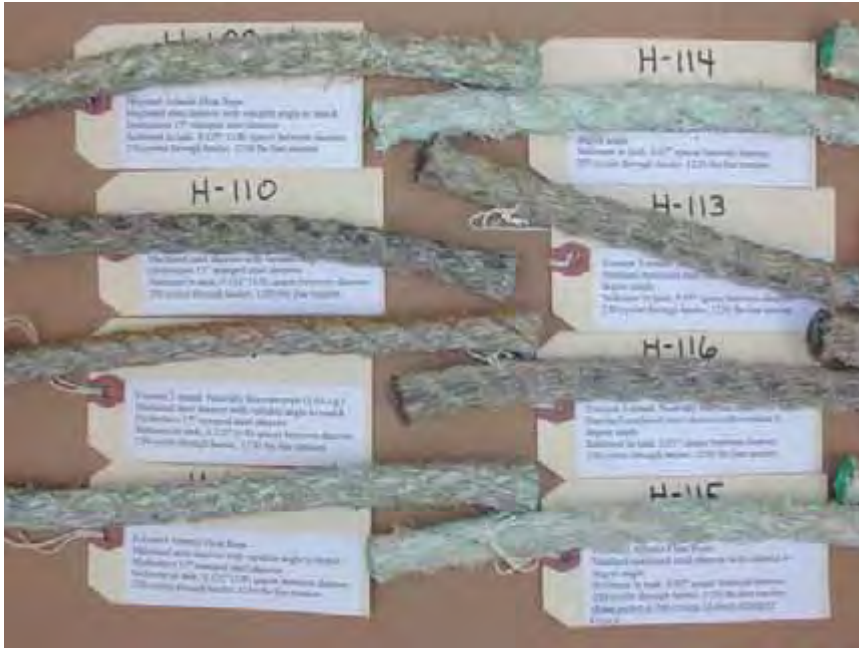
Figure 20. The four samples on the left are from Treatment 19, the variable angle machined sheaves. The samples on the right are from the standard, constant 4-degree angle machined sheaves. The samples on the left have a higher residual breaking strength that is statistically significant. Contrary to appearances, the breaking strength of the floating Polysteel © (light green) samples is higher than the residual breaking strength of the blended polyester/Polysteel © sinking rope.

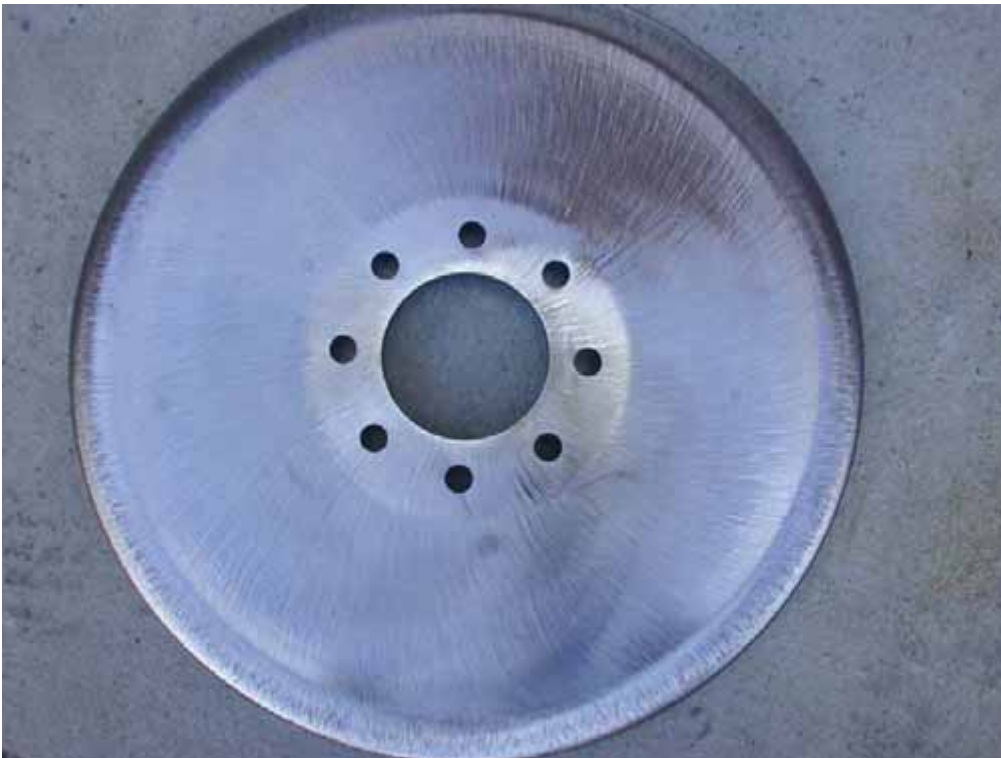
Figure 21. Newly machined sheaves that have been finished with a rotary grinder show the vestiges of circular machining ridges as well as the radial marks of the grinder. These surface irregularities contrast with the smooth surface of Hydroslove stamped steel sheaves that showed the best performance in terms of reduced rope wear.

Treatment 21 utilized a newly machined pair of standard sheaves with 0.03” spacing and a standard steel splitter. This test was intended to determine whether newly machined sheaves tend to produce more rope wear than sheaves that have been used. In the absence of a surface roughness gauge, we had no way to determine any quantitative difference in the smoothness of the sheave surfaces. Contrary to our expectations, there was no statistically significant difference in the residual breaking strengths observed with the newly machined sheaves compared to the standard sheaves that had been worn smooth through use.

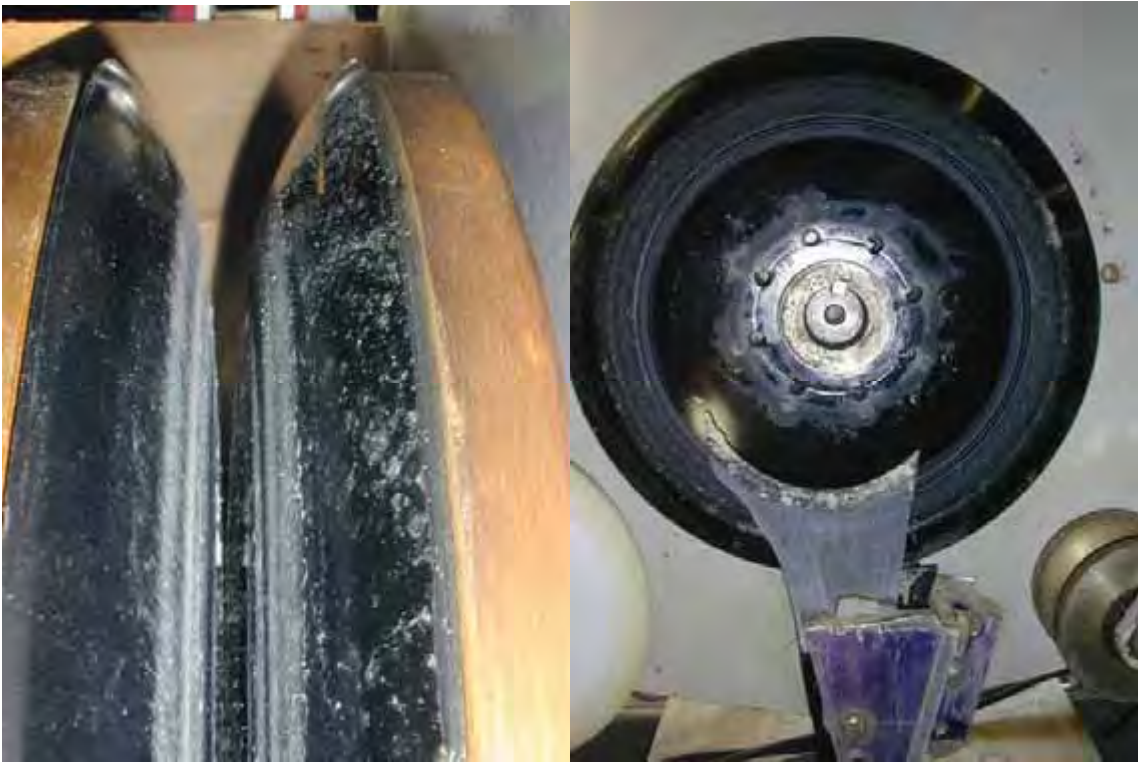
Figure 22. Images of harder durometer (65 Shore D) polyurethane sheaves after 14 hours of simulated hauling. Treatment 19 also utilized a splitter molded with 65 Shore D polyurethane.

Treatment 22 utilized polyurethane sheaves with a durometers of 65 Shore D, the hardest polyurethane material that we tested. These sheaves have a surface profile that matches the Hydroslove sheaves. The spacing between the sheaves was zero. The splitter was molded with 65 Shore D polyurethane. Treatment 19 utilized steel sheaves that were machined with a variable angle surface that matched the Hydroslove surface profile. There was no statistically significant difference in the residual breaking strengths observed with the 65 Shore D polyurethane sheaves compared to the machined-steel sheaves with a surface profile comparable to the Hydroslove stamped-steel sheaves.

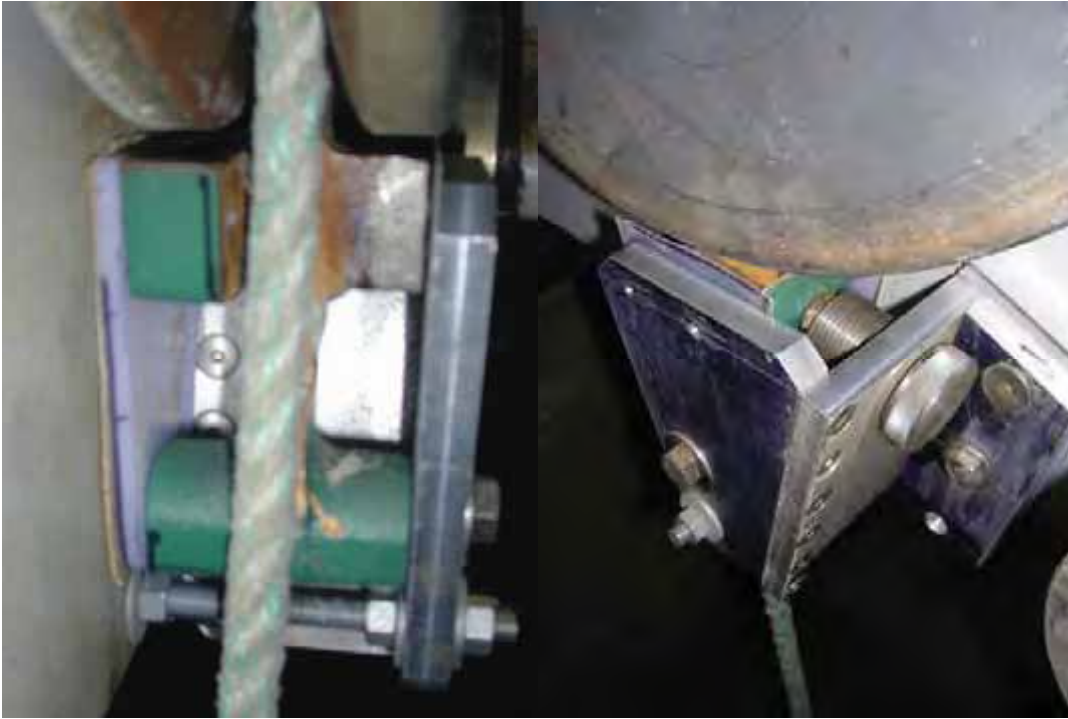
Figure 23. The picture on the left shows the rope being guided out of the hauler sheaves by the splitter. The picture on the right shows the load cell mounted behind the splitter on the hauling simulator. The knife was allowed to pivot on one bolt, exerting pressure against the load cell.

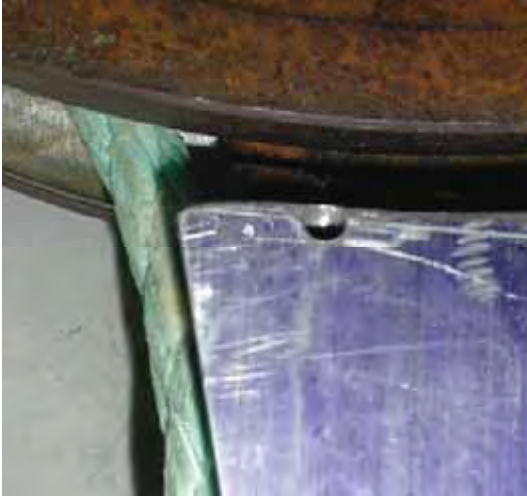
Figure 24. This picture shows clearly how the Polysteel © rope cleared the variable angle sheaves with no spacing without contacting the splitter within the radius of the sheaves.

One of the most notable and visible differences between the runs with the variable angle sheaves and other hauler configurations was the lack of pressure against the splitter. Our observations of the rope peeling out of the sheaves during trials with the variable angle sheaves with no spacing indicated minimal if any pressure on the splitter. The rope did not contact the splitter within the radius of the sheaves; rather, the stiffness of the rope caused it to curl out of the sheaves with contact against the splitter outside the radius of the sheaves (Figure 24).

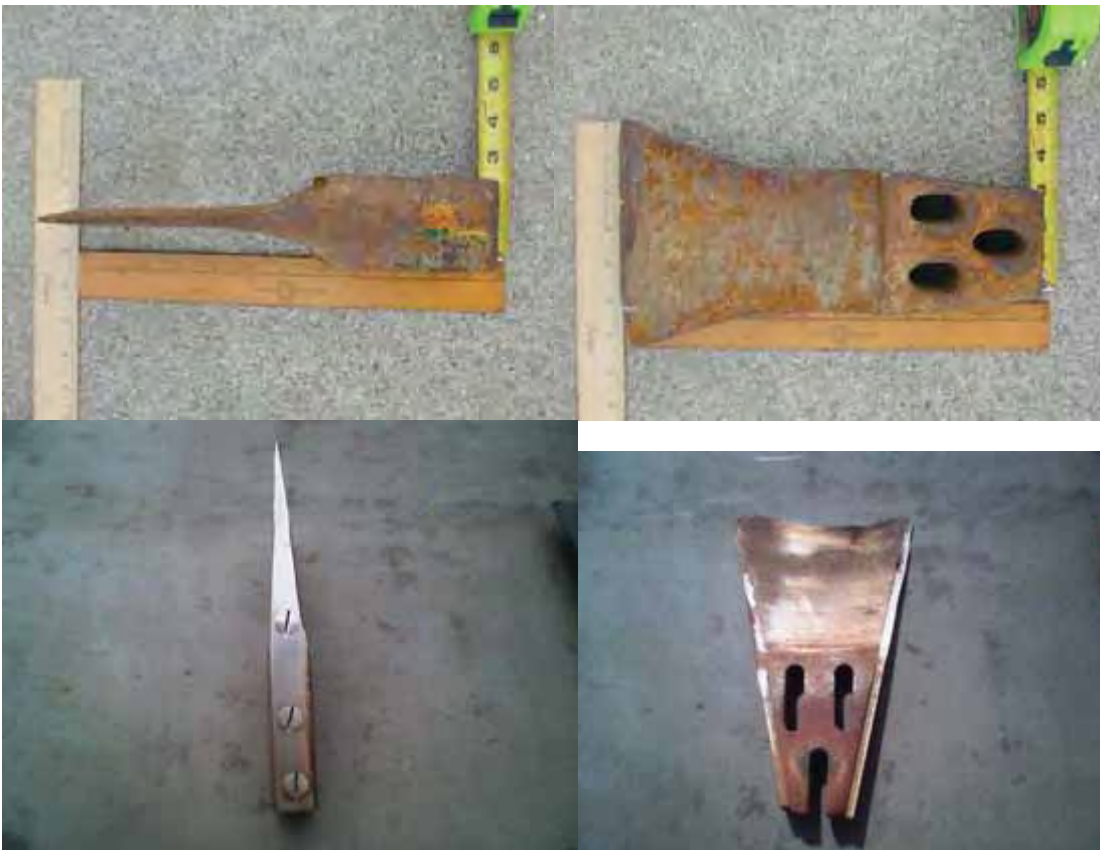
Figure 25. Steel wedges force ropes out of the v-groove between the hauler sheaves so that the rope won't simply wind around the hauler. These rope extractors (commonly referred to as splitters or knives) are made in a variety of shapes. Splitters tend to wear rapidly, forming a groove with sharp edges. The splitter in the bottom half of this picture has a replaceable stainless steel wear plate. The condition and fitting of the splitter are critical to rope longevity.

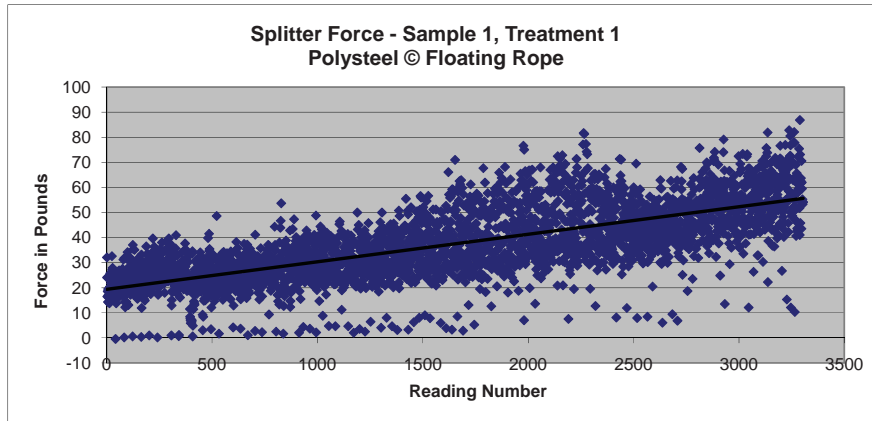
Figure 26. A graph of splitter force readings together with the trend line for the data points shows a continuous increase in the force required to push the rope out from between the sheaves over the duration of a test run of 125 hauling cycles. This data is from the runs 1, 2 and 5 (the load cell failed and the data from samples 3 and 4 were discarded). All of these runs used standard machined-steel sheaves with 0.1” spacing and a standard splitter. Note the lower starting point for run 1 compared to the others, and the steeper increase to a higher end point. Subsequent runs showed a higher mean force but with less of an increase from start to finish and a lower end point.

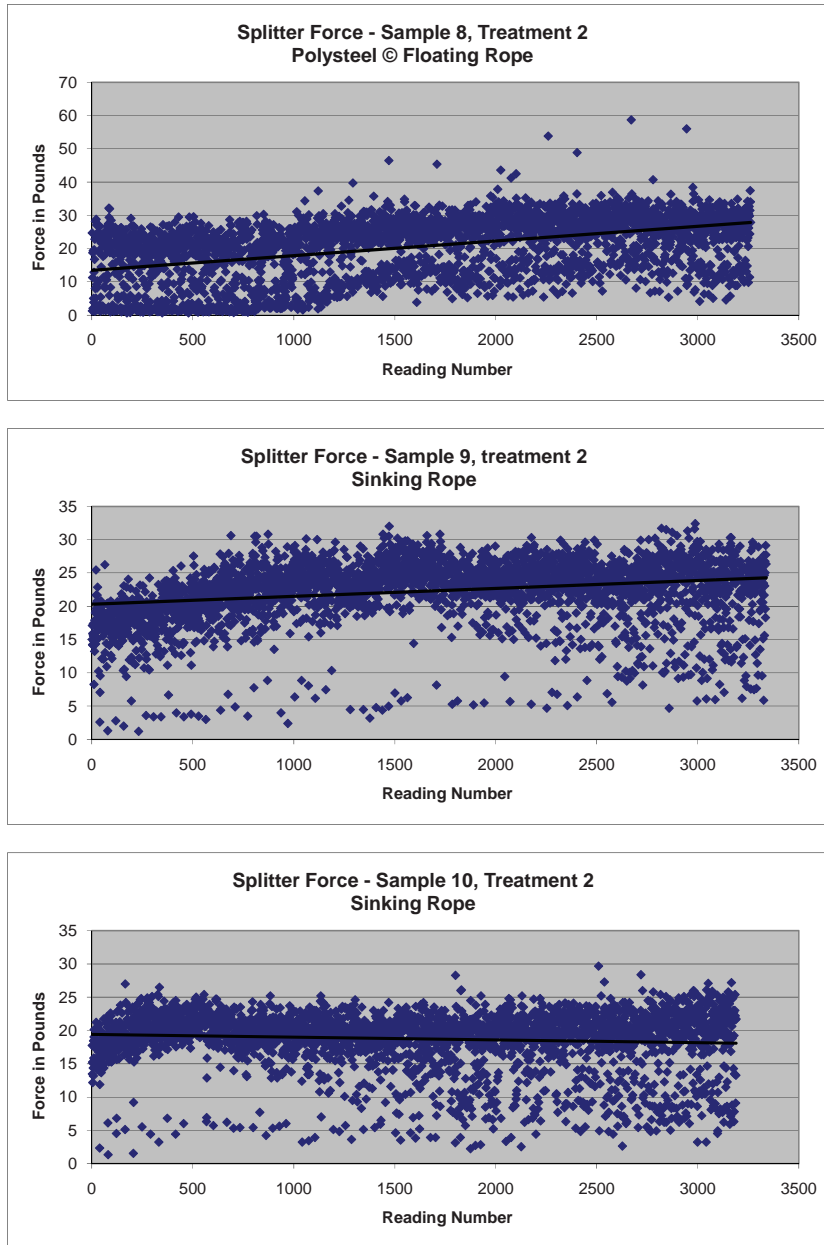
Figure 27. The mean force with which the rope pushes against the low-angle-of-incidence splitter is considerably less than that observed with the standard splitter and shows less of an inclination to increase from the beginning of a run to the end. These graphs represent data from the first three runs with the modified splitter (Treatment 2)

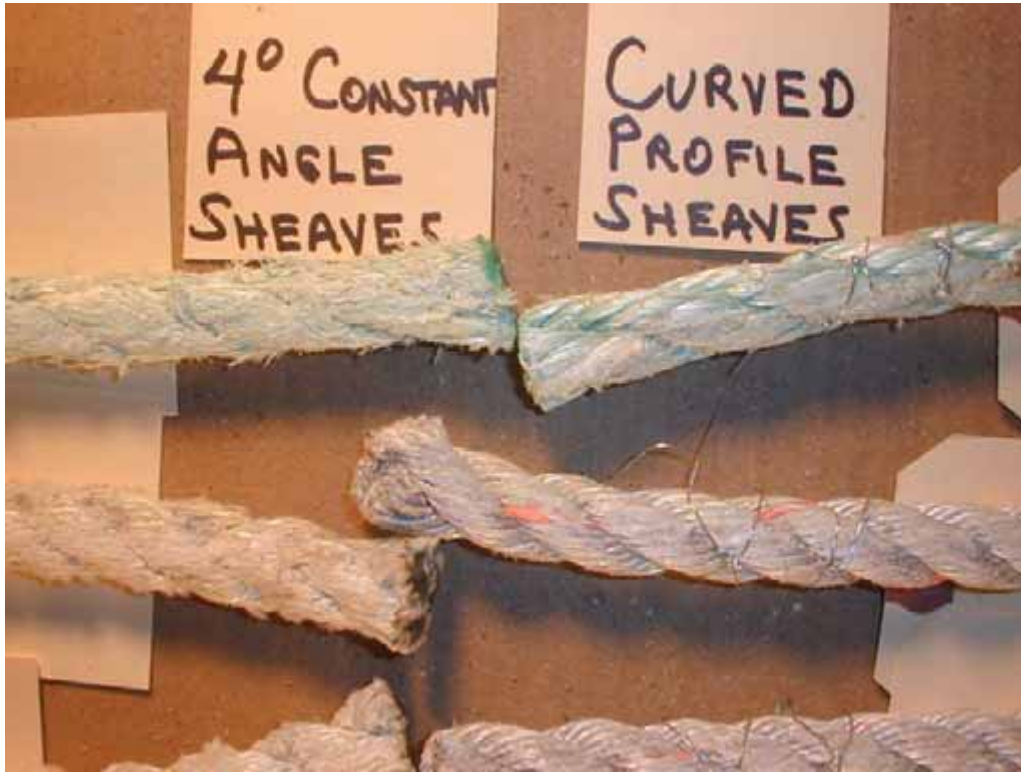
Figure 32. The standard 4-degree constant angle offshore sheaves cause more damage to the rope fibers than can be seen on ropes run on variable angle sheaves.
