**Report For:**  
Town of Palmer  
4417 Main Street  
Palmer, MA 01069

## **Forest Lake Assessment and Watershed Based Plan**

**Prepared by:**  
**Aquatic Restoration Consulting, LLC**  
18 Sunset Drive  
Ashburnham, MA 01430

*June 2023*

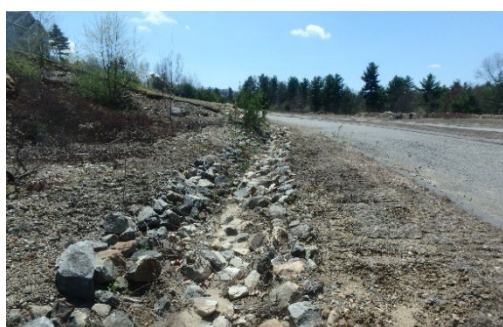
**Photo 1. Example of roadside ditch where vegetation would provide additional pollutant attenuation.**

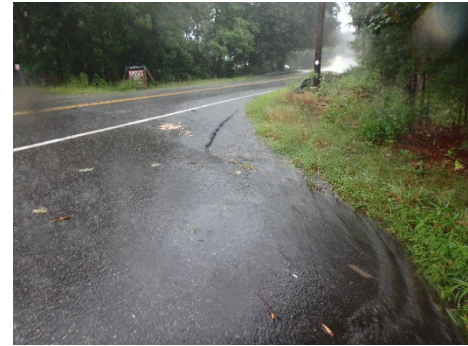
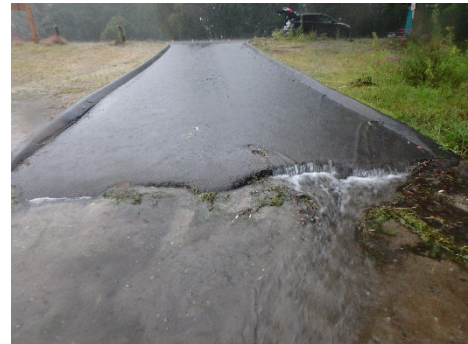
During rain events, significant sheet flow, with substantial velocity enters Forest Lake at the former boat launch location. This creates erosion, carrying excessive concentrations of TP, nitrogen, solids and bacteria. There is an opportunity to redirect this sheet flow and capture it in the newly constructed bioretention basin constructed by DFG. This basin was designed and constructed as part of the new state owned and operated public boat launch. The location of the former launch was adjacent to the swimming beach and the new launch isn't much further away, less than 250 feet. As mentioned in the Water Quality section, stormwater from this drainage area contained excessive TP (average 0.129 mg/L), high suspended solids (average 22 mg/L), turbidity (127 NTU) and excessive bacteria (total coliform >2420 mpn/100 mL and average E. coli 607 mpn/100 mL). Rerouting this runoff into the bioretention basin would essentially be significant reduction in pollutants by trapping and infiltrating the water. The capture of the high velocity water flowing down River Street would also reduce erosion at the beach.

**Photo 2. Sheet flow runoff from River Street along the former boat launch into Forest Lake**

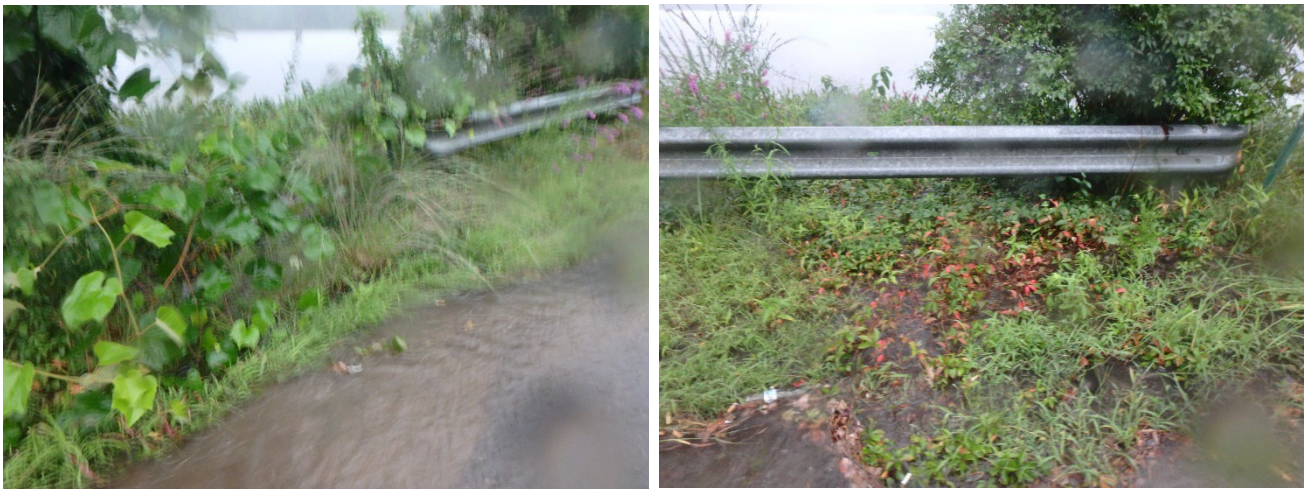
Another location of River Street runoff to Forest Lake that is a potential risk is about 340 feet to the west where road runoff cuts through a small depression draining the lake (Figure 12). While the volume of this runoff is likely less than that flowing down the slope to the east, this runoff is problematic given its proximity to the beach (exposure to swimmers) and the velocity which can erode the bank and potentially cause road stability issues at River Street. There is very little space to work with between River Street and the bank of the lake, so infiltration and treatment options are limited. A catch basin (or trench drain) may fit in this location and piped to the pond, a small cutoff portion of Forest Lake between River Street and Bennett Street to the northwest. The lake already drains into the pond prior to discharging to the Ware River to the west so there isn't an increased pollutant risk to receiving water. This measure will likely be expensive and therefore less of a priority, unless work to River Street is proposed in the future (repaving, grading, etc.).

**Photo 3. Sheet flow from River Street discharging to Forest Lake west of the beach**

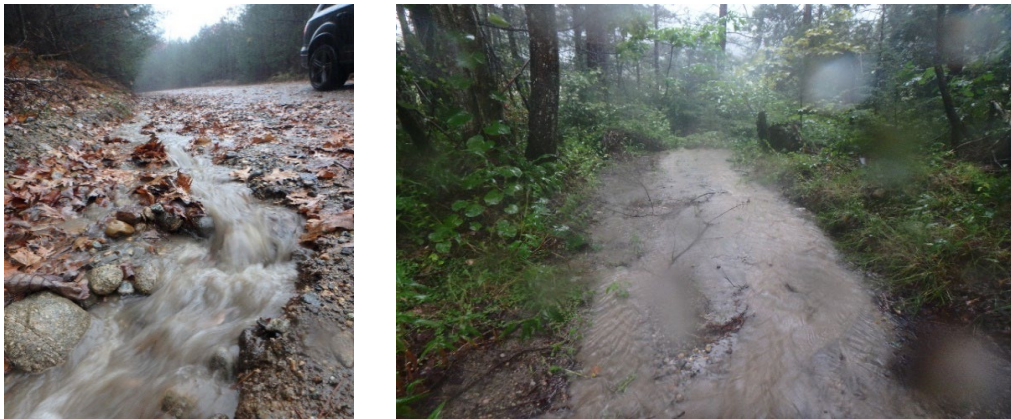
Forest Lake Road is a private dirt road allowing access to homes built along the southwestern portion of the lake. This road is steep in areas and there is no defined stormwater management. When the road is maintained or regraded, material is pushed to the side creating berms limiting water dissipation causing runnels within the roadway. The road could be redesigned to minimize runoff and maximize capture, infiltration and treatment. Runoff from the road contained high phosphorus (average 0.112 mg/L), excessive suspended solids and turbidity (average 143 mg/L and 1733 NTU, respectively) and extremely high bacteria (average total coliform >2420 MPN/mL and *E. coli* 8700 MPN/100 mL. Water runoff drains through a wooded area into the lake or directly to the unnamed tributary. There is very little infiltration and much of the water volume enters untreated.

**Photo 4. Sheet flow from Forest Lake Road**

**Left photo: along road no defined stormwater ditch. Right photo: untreated sheet flow through wooded area discharging directly into Forest Lake or unnamed tributary.**

- create grade beaks preventing water from flowing continuously uninterrupted gaining velocity and worsening erosion,
- create roadside ditches that are designed to infiltrate and disperse the flow rather than concentrating it. Vegetate ditches whenever possible. Ditches should not drain directly to the lake or tributary, rather an infiltration basin or trench should be constructed to hold the water and allow for infiltration.

- Broad based dips to carry water across the road to areas that can be designed to infiltrate water.
- Removing unnecessary berms or false shoulders. These exist in many areas along the road where road material is pushed aside during grading activities and general road use.
