Development of River Corridor Mapping Procedure with Initial Application in the North River Watershed, MA

Prepared for
Franklin Conservation District
Greenfield, MA

Prepared by
John Field
Field Geology Services
Portland, ME

April 2018

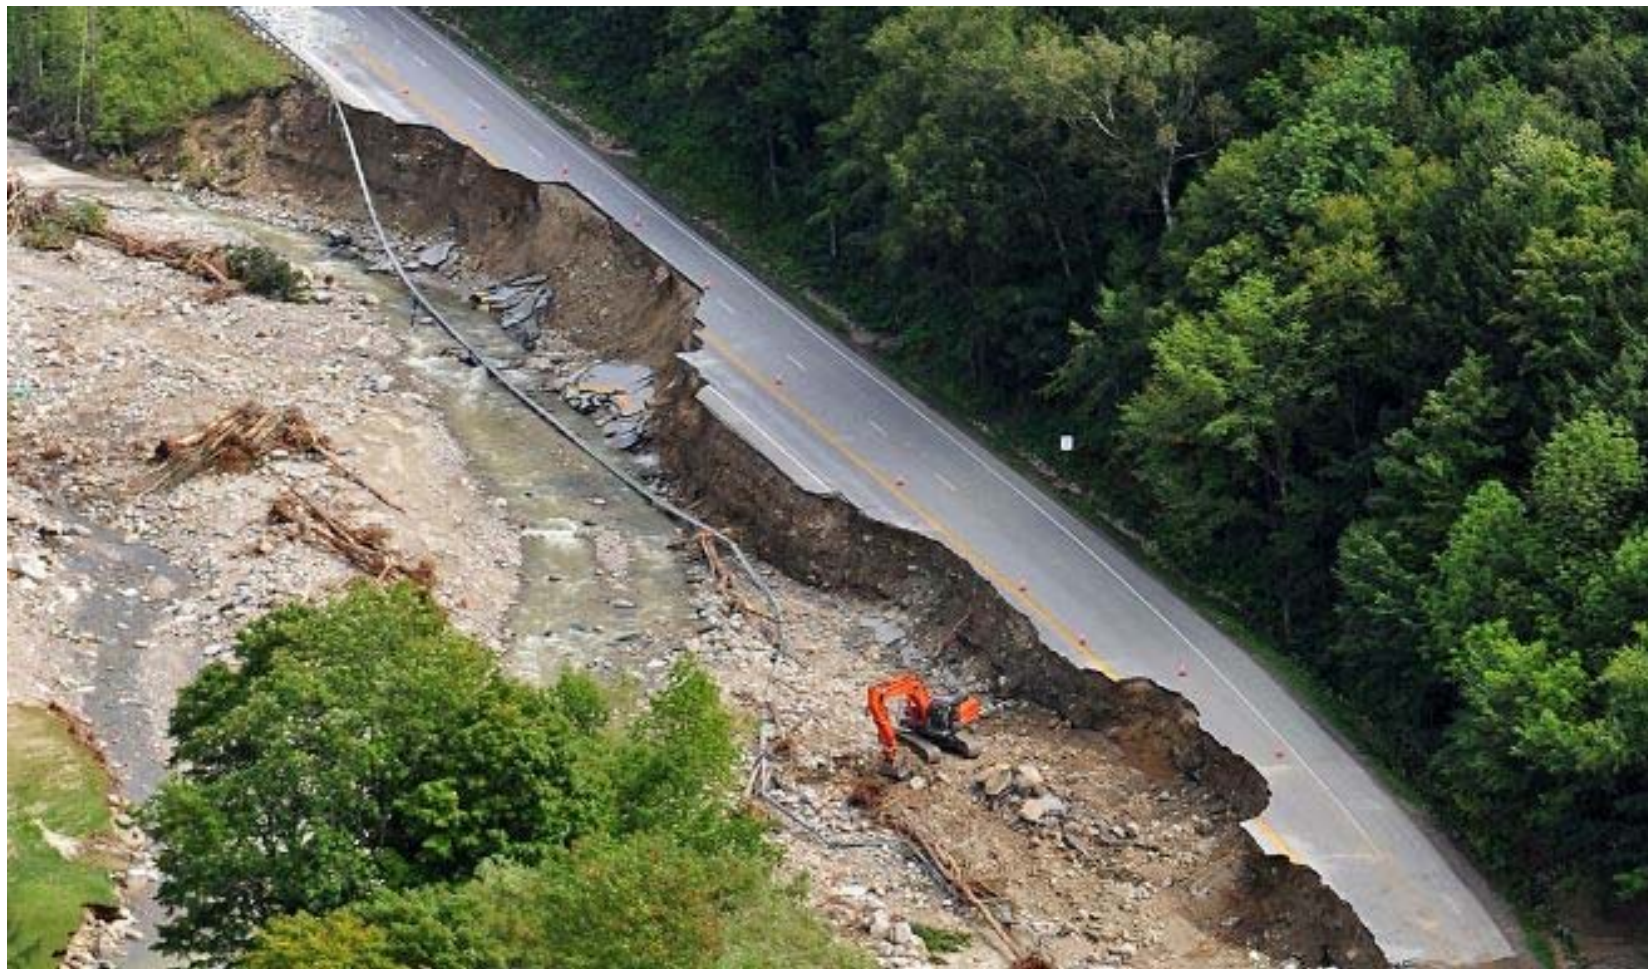
Figure 3. Significant recession of an elevated river terrace occurred in Mendon, VT during Tropical Storm Irene washing out portions of Route 4.

In many instances, a river channel's position is largely fixed on one or both banks by natural features (i.e., river or glaciogenic terraces, valley wall) where the development of an equilibrium condition is greatly inhibited by the natural constraints such that rapid changes may persist for millennia in the form of large mass failures (off of the high river banks) and high sediment loading downstream. The outer edges of the river corridor in these settings is fixed at these natural constraints such that the width of the river corridor, so defined, is not much wider than the river channel itself in narrow gorges (Figure 2). As described further below in Section 2.3, an optional 50-foot buffer can be created along the edge of the river corridor defined by high banks when the river channel is located at or near the river corridor boundary in recognition that mass failures or rapid bank erosion can cause the corridor boundary to recede tens of feet in a single flood (Figure 3).

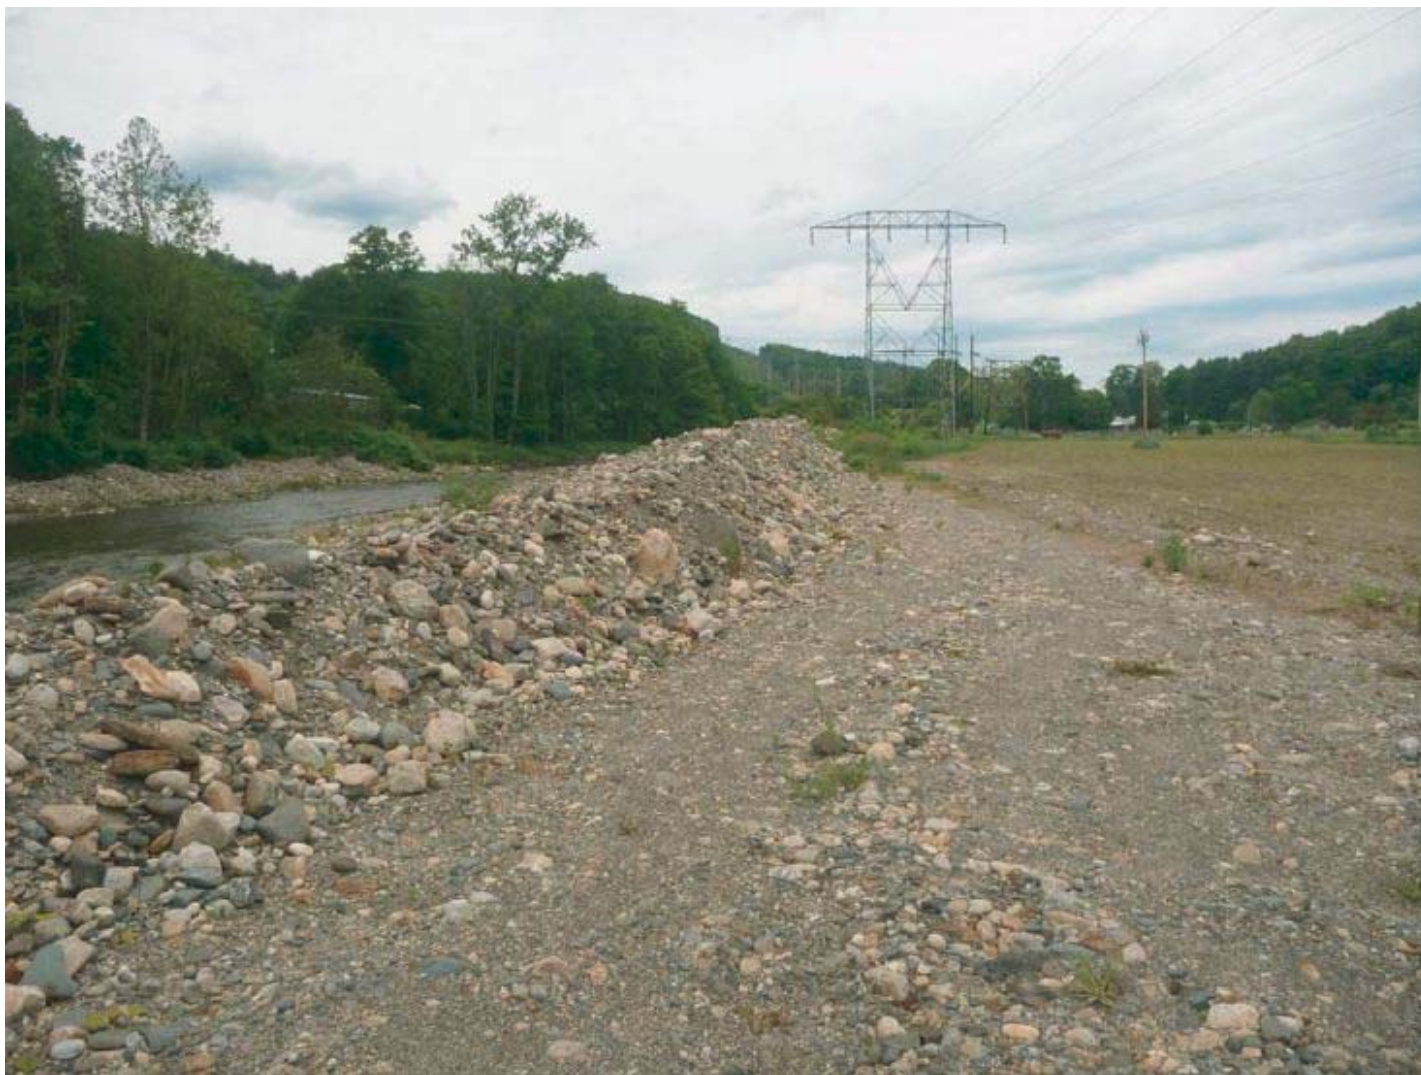
Figure 6. A berm built on the bank of the West Branch of North River as part of the post-Irene emergency work.

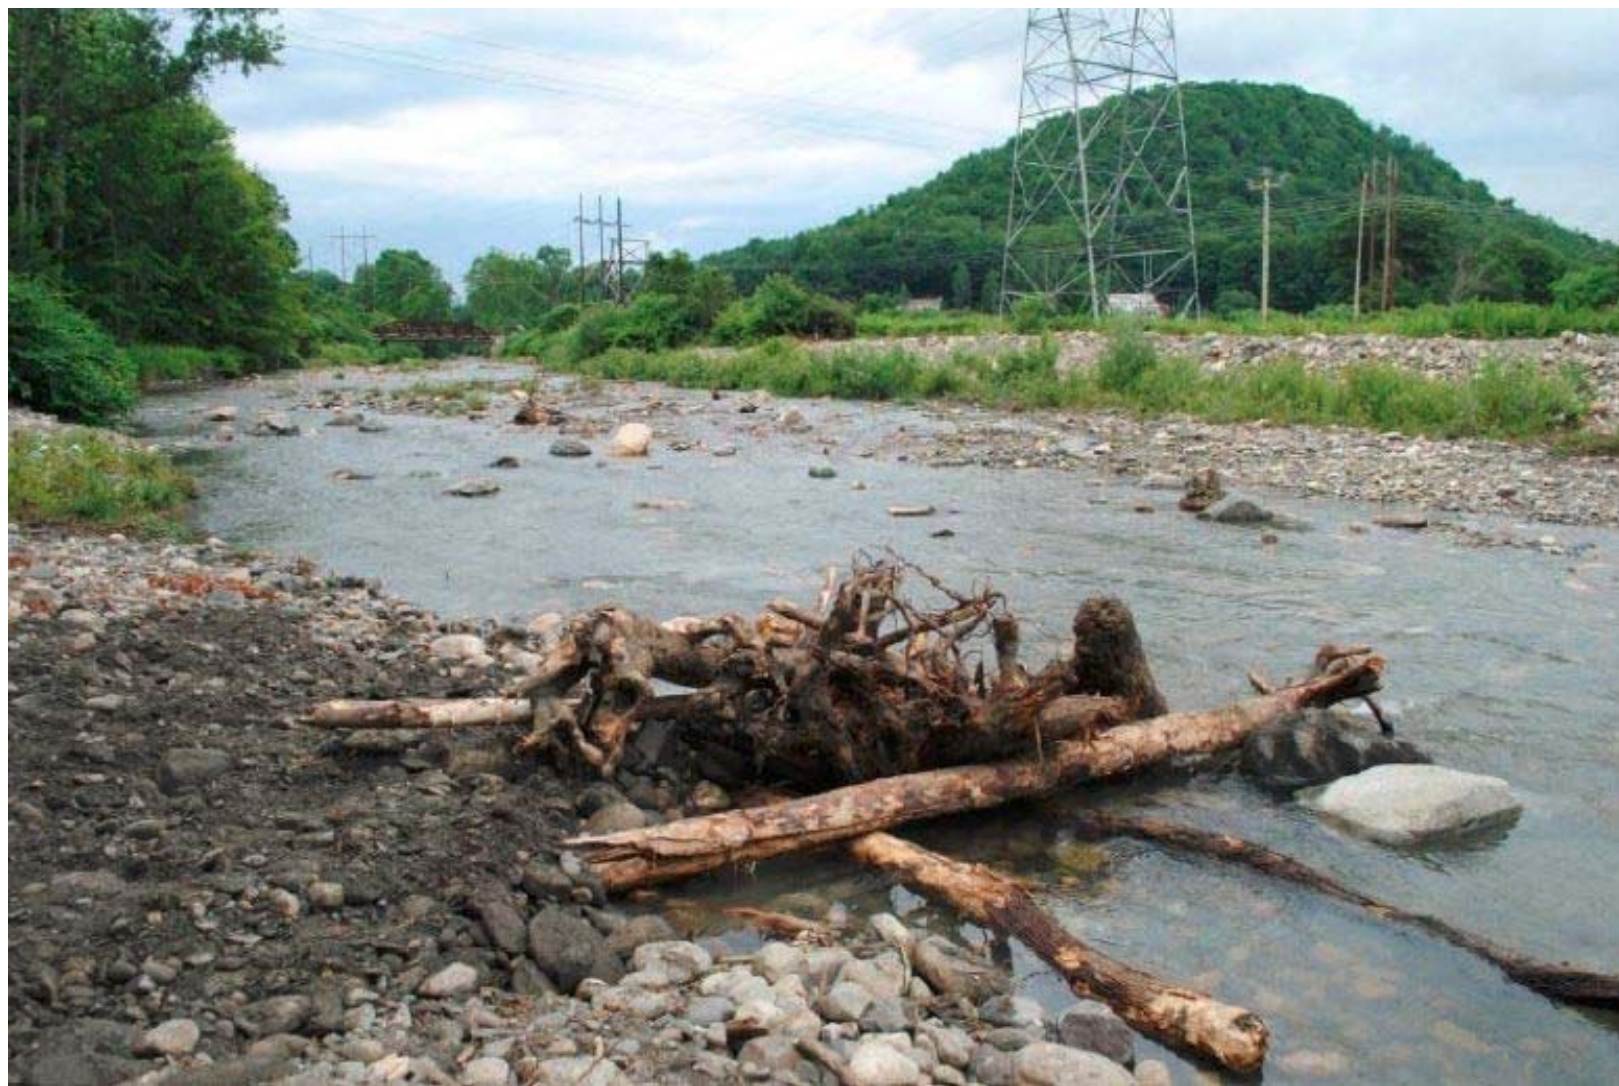
Figure 7. Wood and boulders added to the West Branch channel as part of restoration efforts following Tropical Storm Irene and post-flood emergency work.

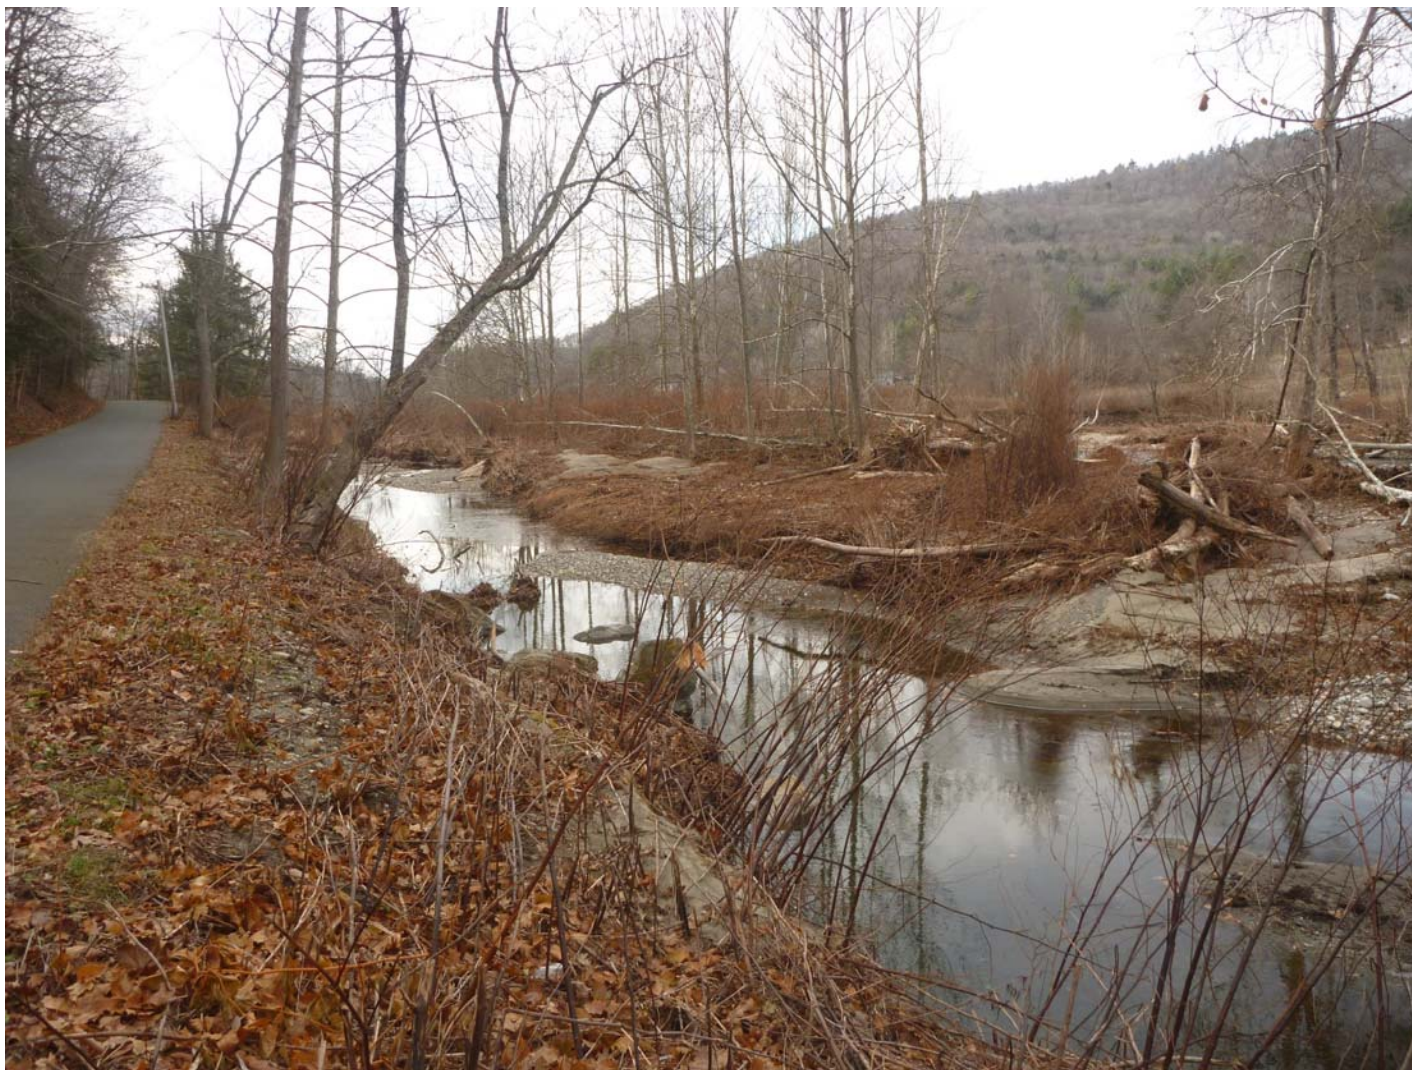
Figure 9. A side channel flows against the valley wall, marking the former position of the main channel of the North River mainstem.

The river corridor maps (Appendix 3) developed using the corridor mapping protocols (Appendix 1) cover the mainstem, East Branch, and most of the West Branch of the North River for a total of approximately 20 river miles. In addition to topographic maps and aerial photographs, LiDAR of the area also proved useful in identifying the location of terraces and former channel positions. Given the narrow valley, all of the corridor's boundaries are defined by river terraces, other elevated surfaces on the valley bottom, or the valley wall as evidence of past river positions extends across the entire floodplain even at its widest portions along the mainstem. Essentially the entire corridor is designated as moderate or high risk areas given the presence of confined areas, numerous valley constrictions and tributary confluences, and artificially straightened reaches constituting over 70 percent of the length of the mainstem and East Branch (Field, 2015). Straightened channels are prone to the rapid reformation of meanders across the floodplain during floods (Field, 2007) as was the case during Tropical Storm Irene (Figure 8). At valley constrictions floodwaters are impounded during large flow events, potentially causing rapid deposition and associated channel migration. Rapid input of sediment at tributary confluences during floods can cause bank erosion and channel migration downstream as the sediment is transported downstream. Field verification confirmed the position of the river corridor boundaries by noting evidence of former channels along the edges of terrace risers and the valley wall (Figure 9).

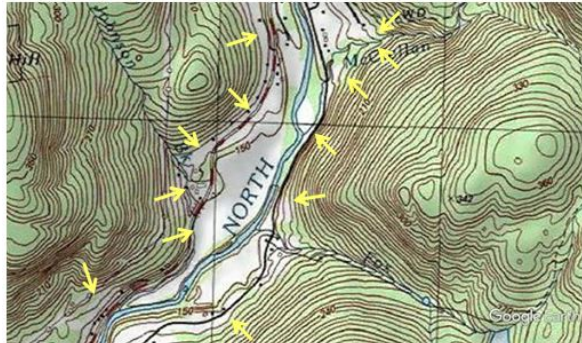
Arrows highlight change in slope at valley margin

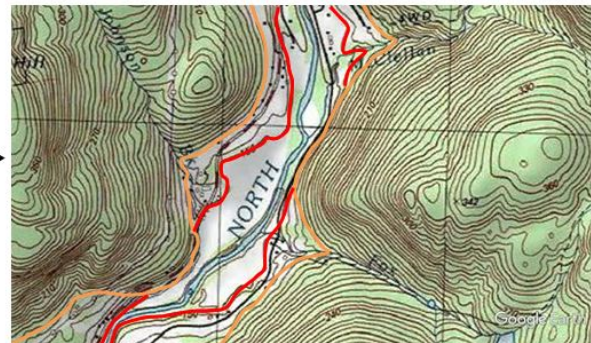
Terraces and older surfaces delineated

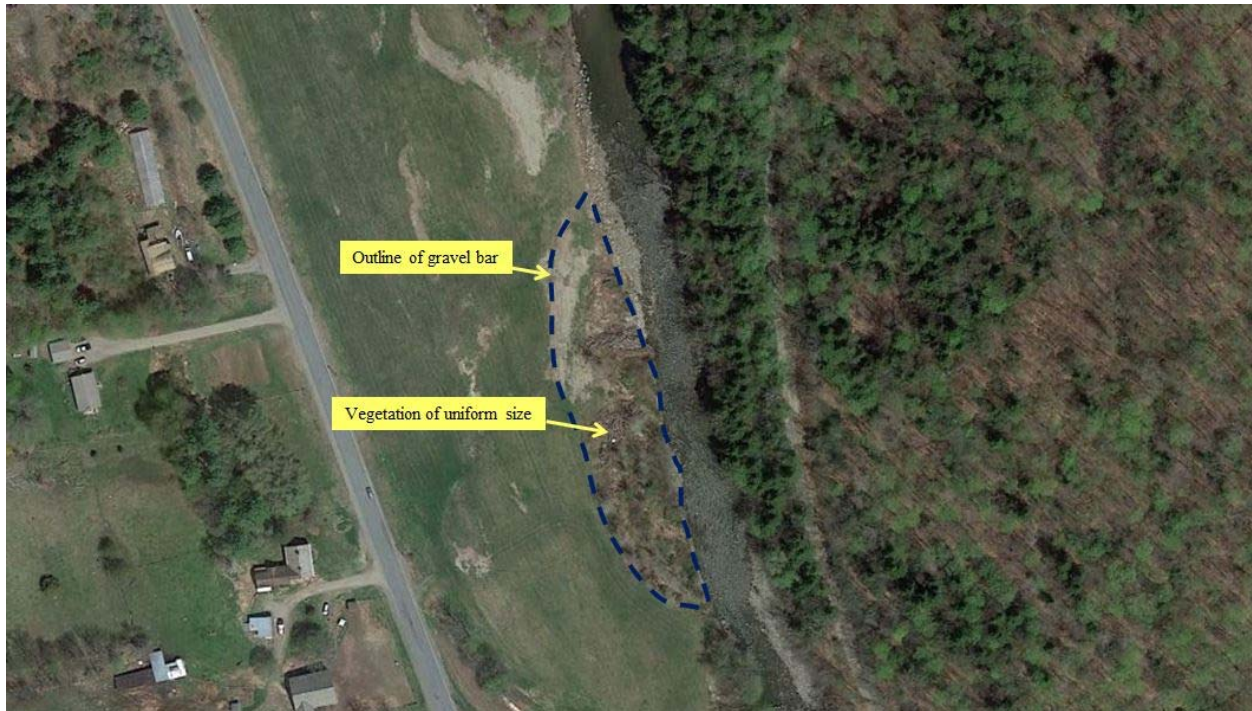
The aerial photograph of the North River below shows a wide gravel bar that is forested with trees largely of a uniform size (and age) suggesting relatively recent colonization of the bar. Such evidence suggests the channel has recently shifted (or been moved through human intervention) from this location, a supposition borne out by the topographic map (not shown here) that shows the channel occupying this area in the 1980s.

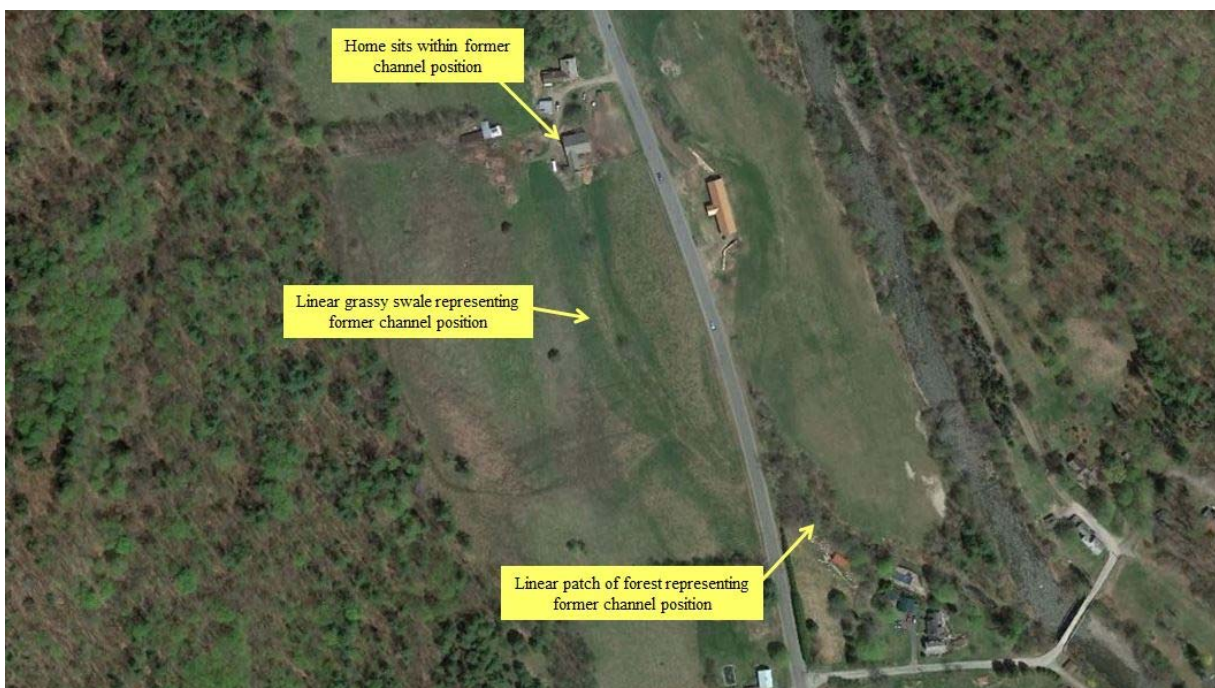
The aerial photo below of the North River shows a narrow linear patch of forest that represents a former channel position that is continuous with a narrow linear grassy swale on the other side of Route 112 that is part of the same former channel but is cutoff from overflow from the active channel by the highway. The home at the north end of the swale highlights how homes within the river corridor, even those on the other side of the highway from the active river channel, are potentially at risk during extreme flood events. The highway itself, that cuts across this former channel, is also at risk from channel migration during a large flood.

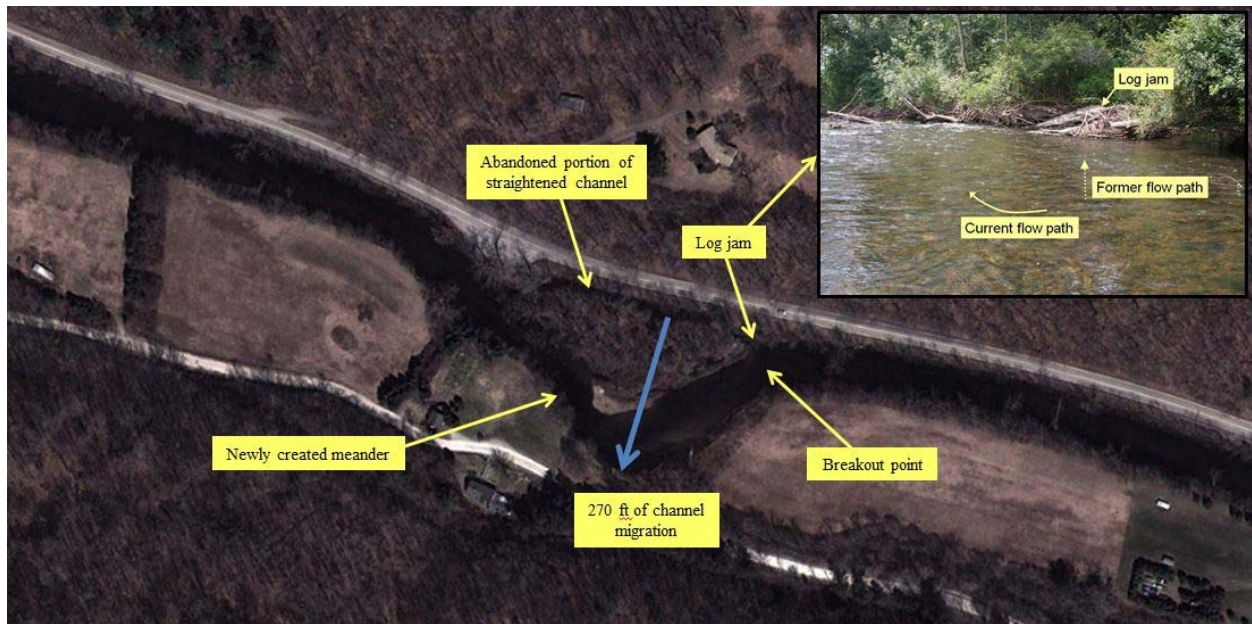
Artificially straightened channels are prone to the reformation of meanders when they become clogged with wood, sediment, or ice as highlighted in the figure below of the Batten Kill in Arlington, VT. A log jam clogged the straightened channel and flow broke out onto the floodplain with enough force to carve a new meander. Overnight the channel migrated across the full width of the corridor, leaving the front yard of one riverside landowner under attack by the river that literally hours before was over 250 ft away. Roads, bridges, homes, and other infrastructure are similarly at risk of channel migration where channels remain in a straightened configuration. Recognizing beforehand where such hazards are more likely to occur by identifying the location of straightened channels can improve emergency preparedness and land use planning.

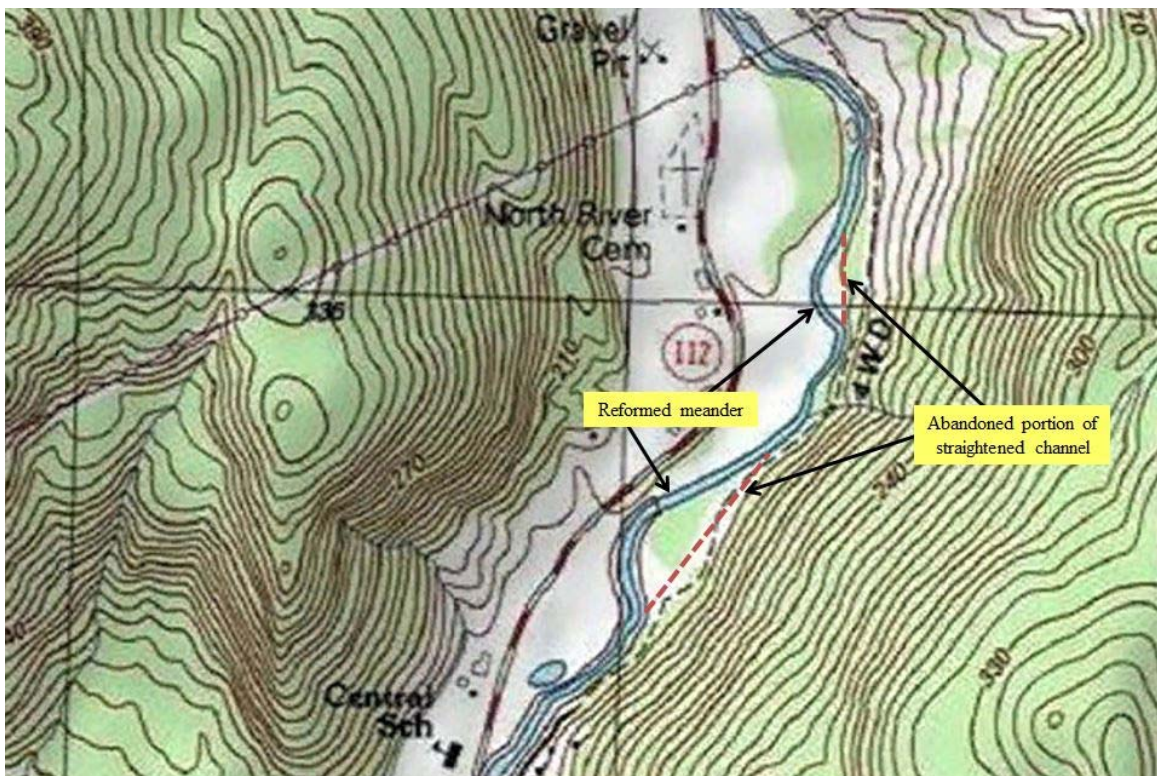
Elsewhere in New England, including on the North River as shown below, meanders have also reformed along straightened channels. These reformed meanders can be identified by their characteristic asymmetric shape (as in the Batten Kill example above) and represent priority areas for land conservation, because the quality of aquatic habitat is higher in meandering sections compared to straightened reaches. Furthermore, ensuring that the reformed meanders can continue to evolve slowly within a protected area reduces the chances of other meanders reforming rapidly in adjacent areas where the channel may remain in a straightened condition.

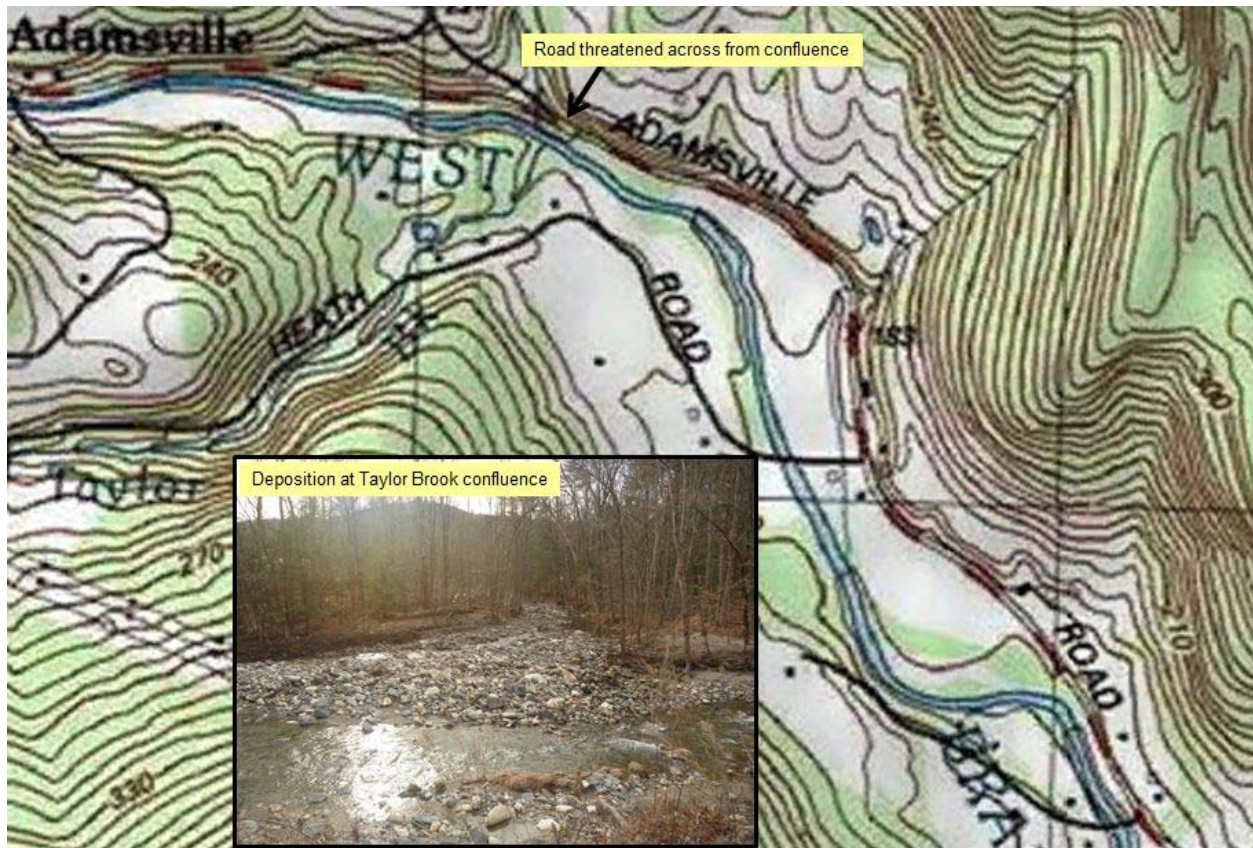
Noting the location of tributary confluences provides an indication of where significant deposition and channel migration might occur, a valuable tool in identifying at-risk infrastructure in the river corridor. Tributary confluences where significant sediment accumulation is occurring or could occur in the future represent priority areas for land conservation. In the North River watershed as shown below, the confluence of Taylor Brook and the West Branch is a site of significant sediment accumulation that could cause channel migration and threaten Adamsville Road across from the tributary mouth during a future large flood.

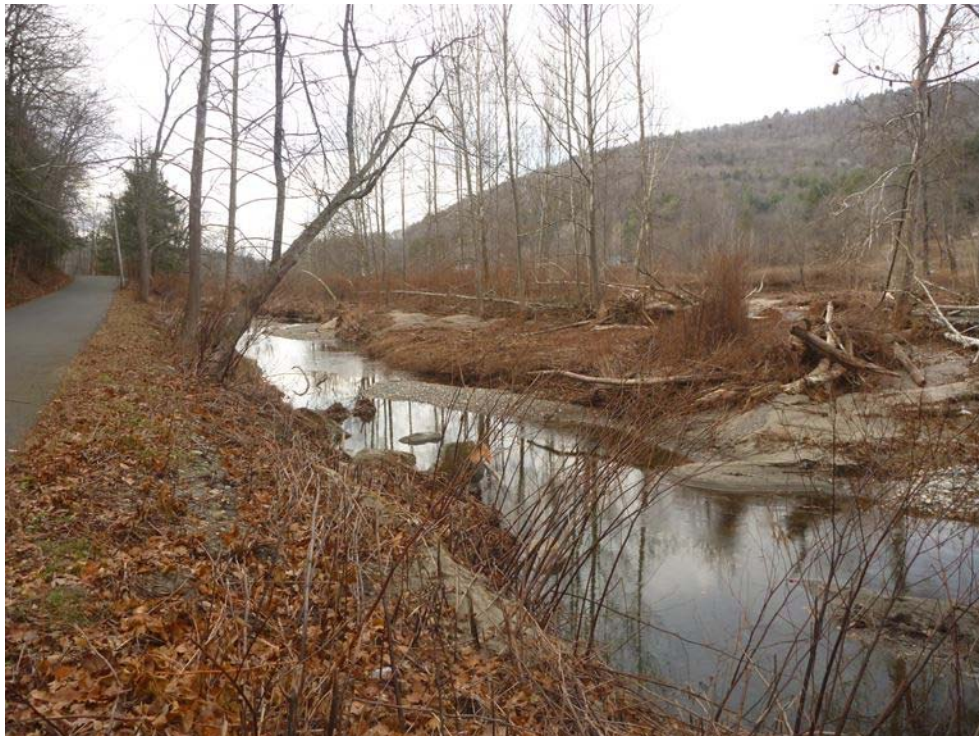
The position of former channels can be confirmed by noting the presence of larger depressions that once conveyed the river's full flow but now only receive minor flow from tributaries or as a side channel off of the new main flow path as exemplified below from the North River where reactivation of the former flow path (now side channel) could threaten Call Road during a large flood:

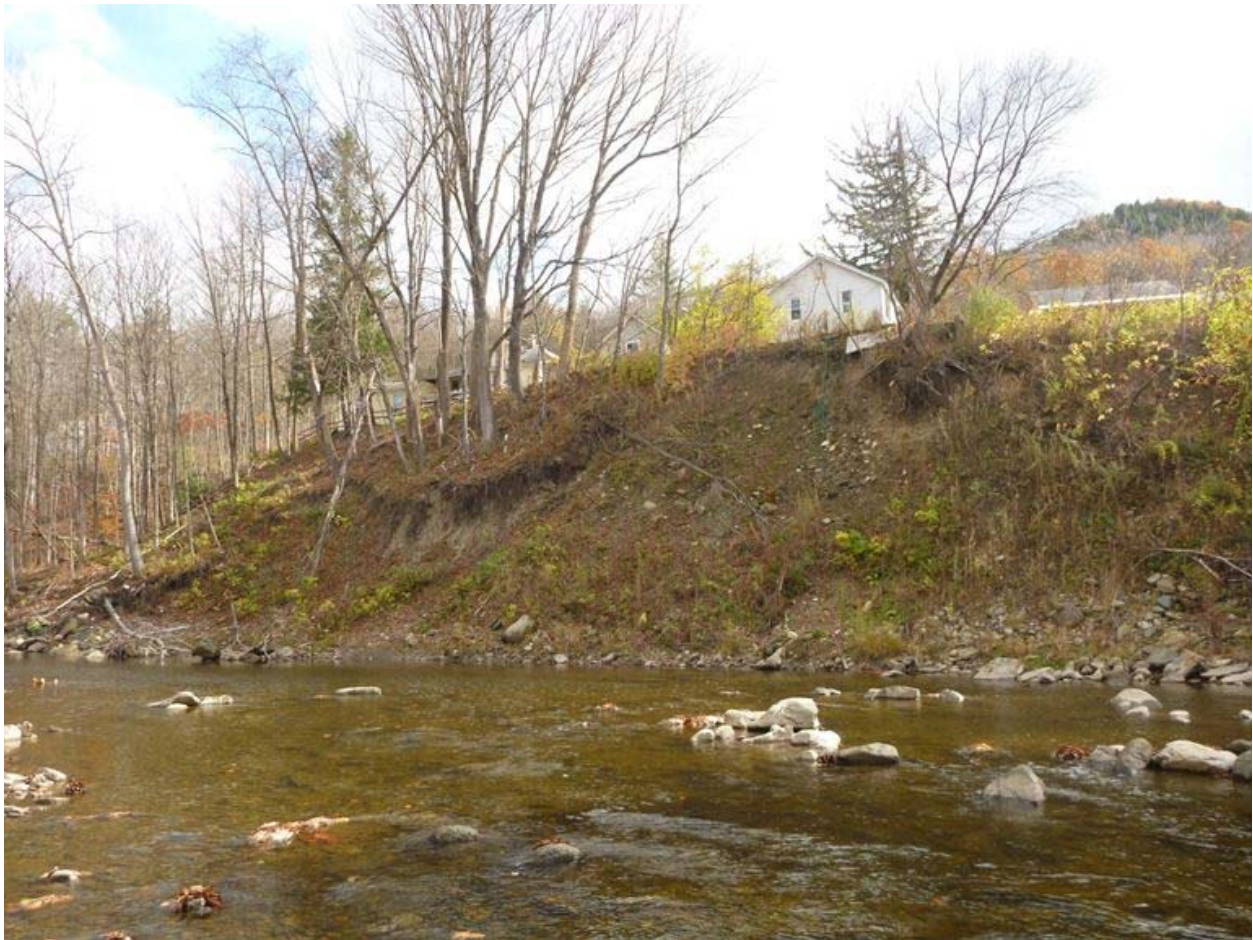
In addition to identifying at-risk infrastructure near straightened channels, valley/channel constrictions, and tributary confluences as illustrated in Step 5 above, field verification can also identify high eroding banks where the river is impinging on steep terrace risers that are generally located in narrow sections of the valley downstream of constrictions. Not only can infrastructure on top of the eroding bank be threatened but downstream areas can also experience significant sediment deposition and channel migration due to the large volumes of sediment generated from the high eroding bank as illustrated from the North River below:
