DIVERSION REPORT

2023 Green Line D Branch Surge

FTA-DPU-23-004, Action Item 3

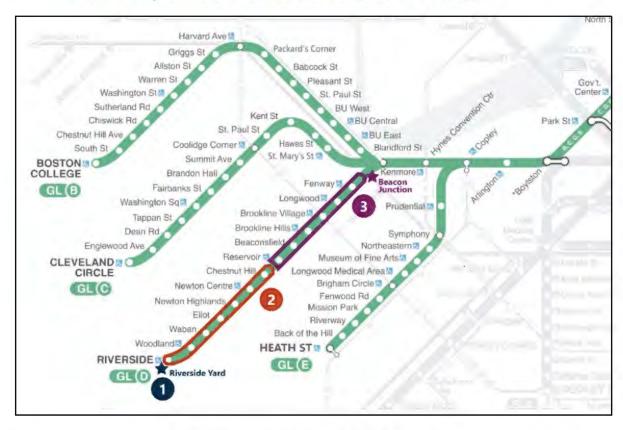
Figure 1. Green Line D Branch with work sections1

Between December 11 to December 20, 2023, the MBTA suspended Green Line service on the D Branch between Kenmore and Riverside Stations for 10 days of critical track work. The Surge comprises one main project focused on trackwork intended to remove 20 speed restrictions along three work sections.

Work Section 1 | Riverside Yard

Work Section 2 | Riverside to Reservoir

Work Section 3 | Reservoir to Beacon Junction (just past Fenway)
