DCR Division of Water Supply Protection: FY2021 Forest Harvest Proposals

Wachusett Harvest Proposal WA-21-272

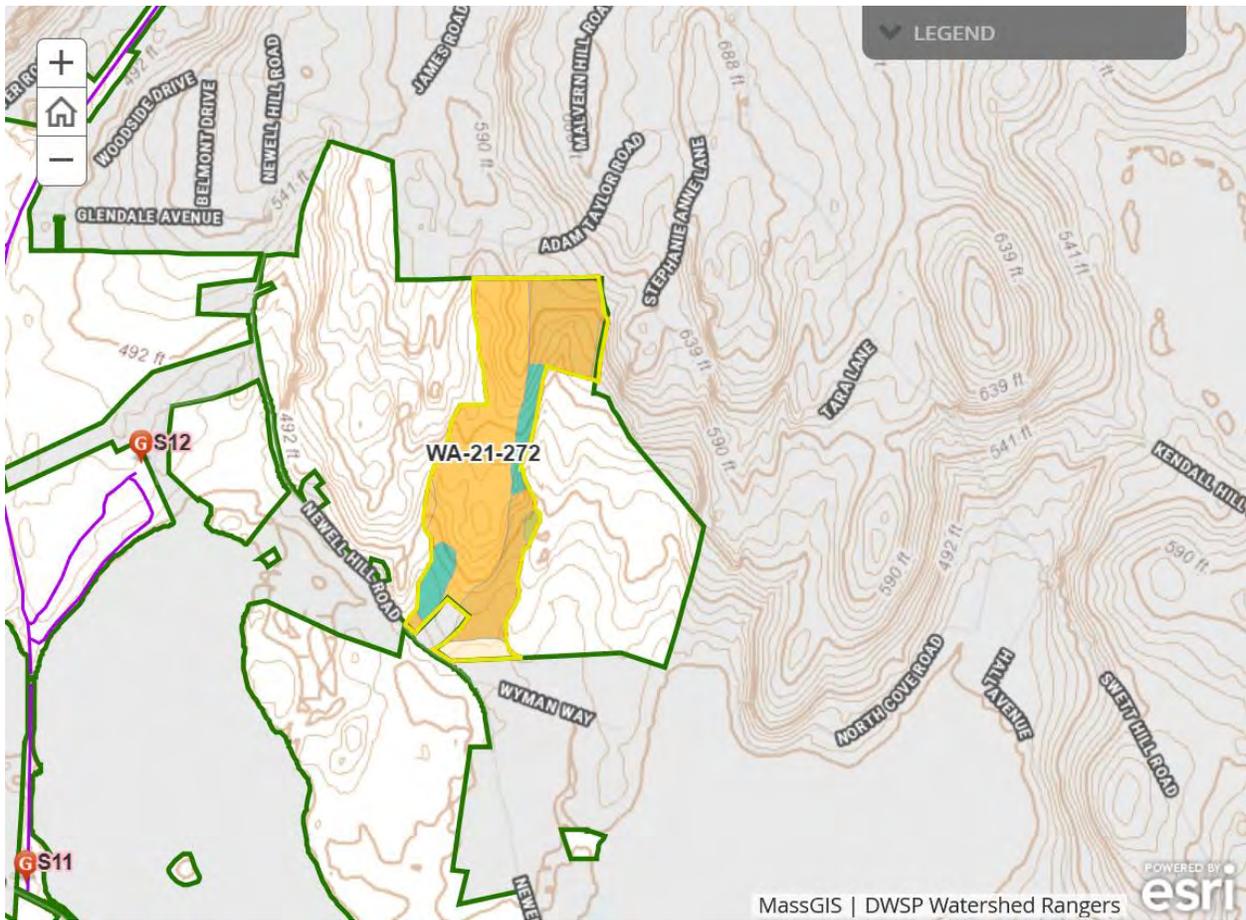
- Wetlands present? - **Yes**
- Streams present? - **Yes**
- Vernal pools present? - **Yes**
- Seeps present? - **None known**
- Are stream crossings required? - **No**
- Are wetland crossings required? - **No**
- Is logging in filter strips planned? - **Yes** ([Riparian Zone Mgt](#))
- Is logging in wetlands planned? - **No**

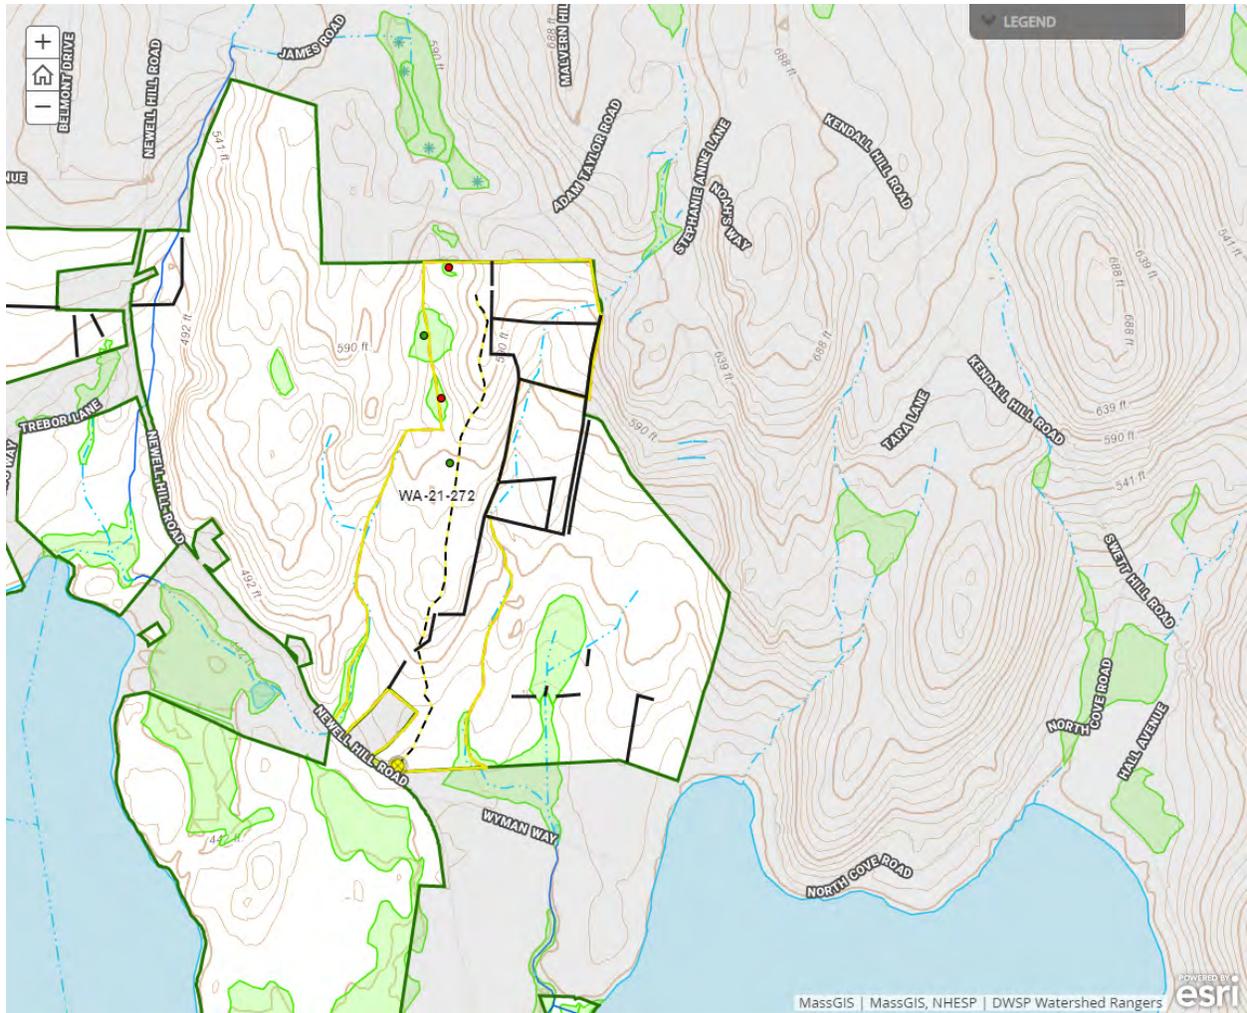
Cultural Resources

Although perhaps not culturally or archaeologically significant, there's an interesting very large pile of rocks in the north end of this area as shown on the map. It presumably is the result of the dumping of rocks that originated from agricultural activities on the property to the north. Stone walls are prevalent.

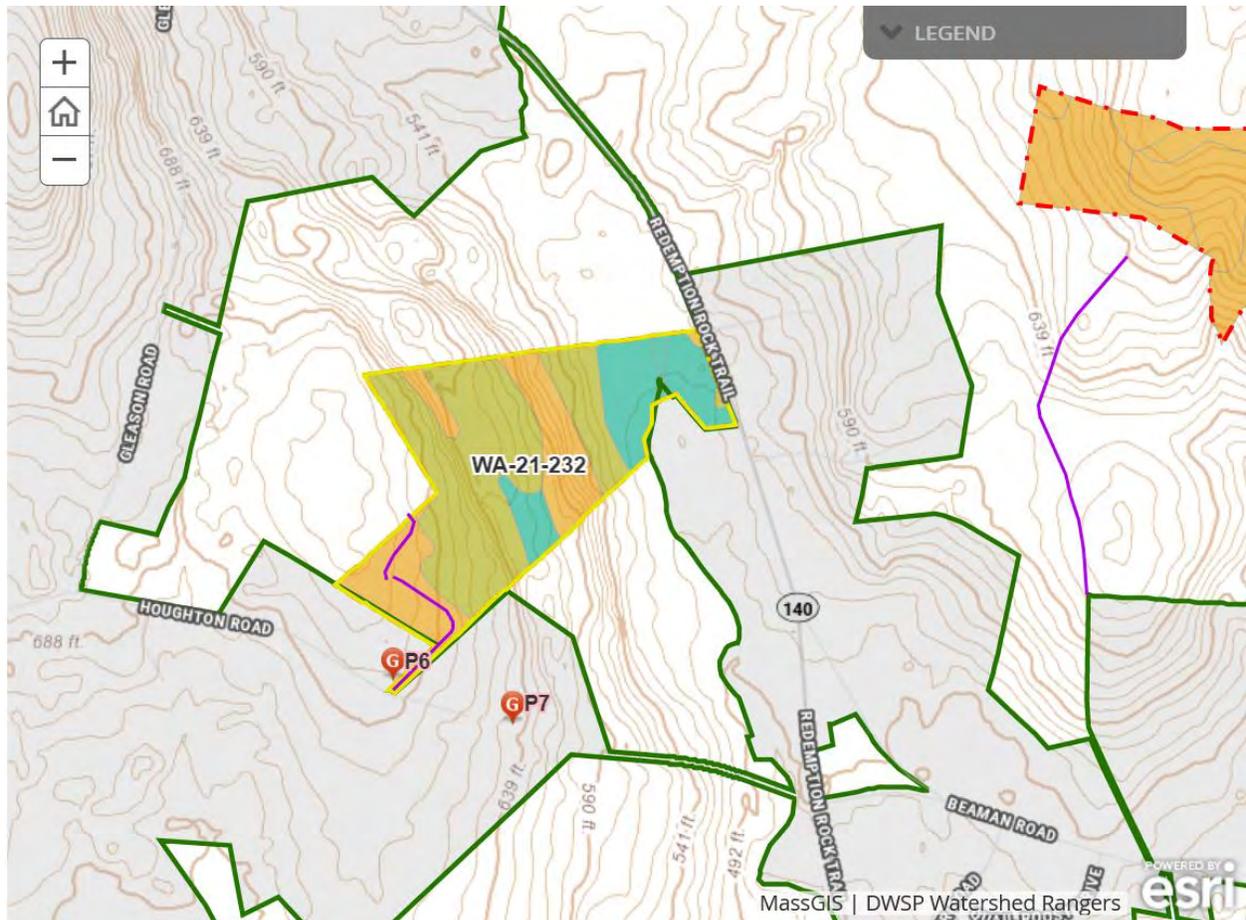
Wetlands

There is an existing underground cable line that crosses the wetland/stream and will most likely be used as the primary crossing location. An unmapped intermittent stream in the middle of the lot, connecting the upper and lower wetlands, will also need to be crossed. BMPs will be implemented as described in the LMP.

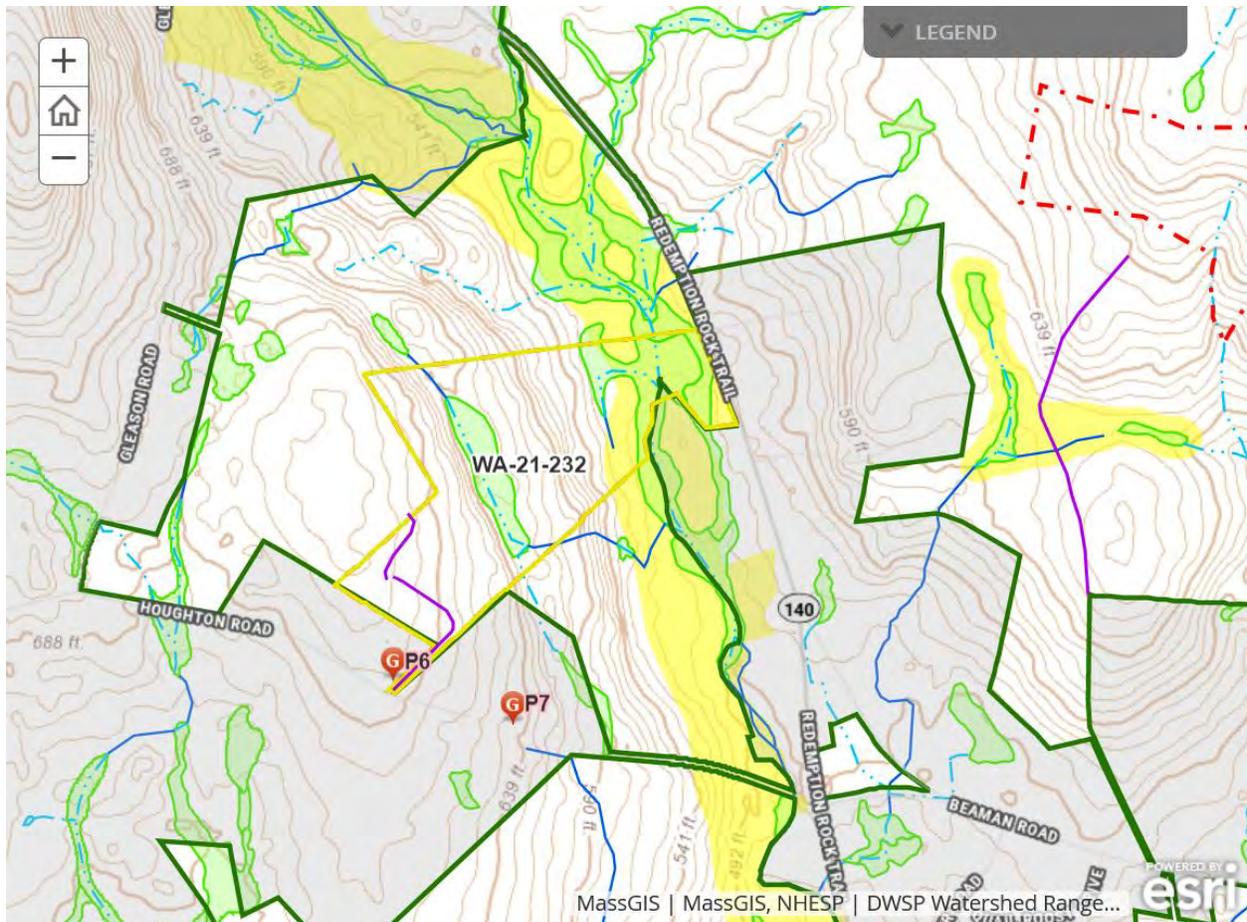
Environmental Quality Engineering

One stream crossing is proposed. The stream crossing was identified in the field with flagging and a water quality sample was collected at the proposed crossing. EQ staff will collect water quality samples at the stream crossings. Background samples will be collected downstream from the proposed stream crossing prior to logging in order to establish baseline conditions, while downstream and upstream samples will be collected to measure the effects of ongoing logging operations, and after, to determine whether there are any measurable impacts.

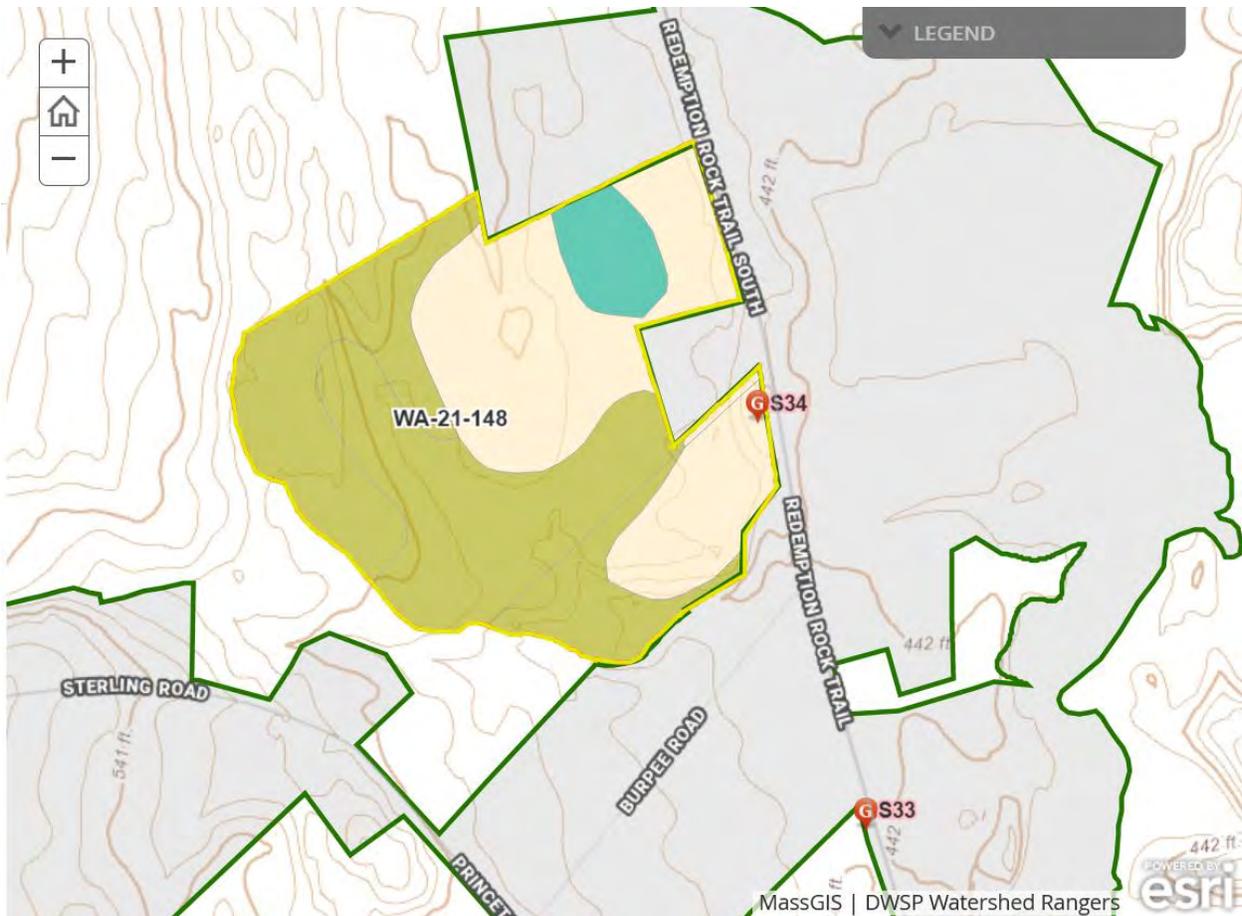
Wetlands

There are three verified vernal pools and one potential vernal pool within the proposal area. The stream crossing will be at a location previously used in 2006, and will be monitored by EQ.

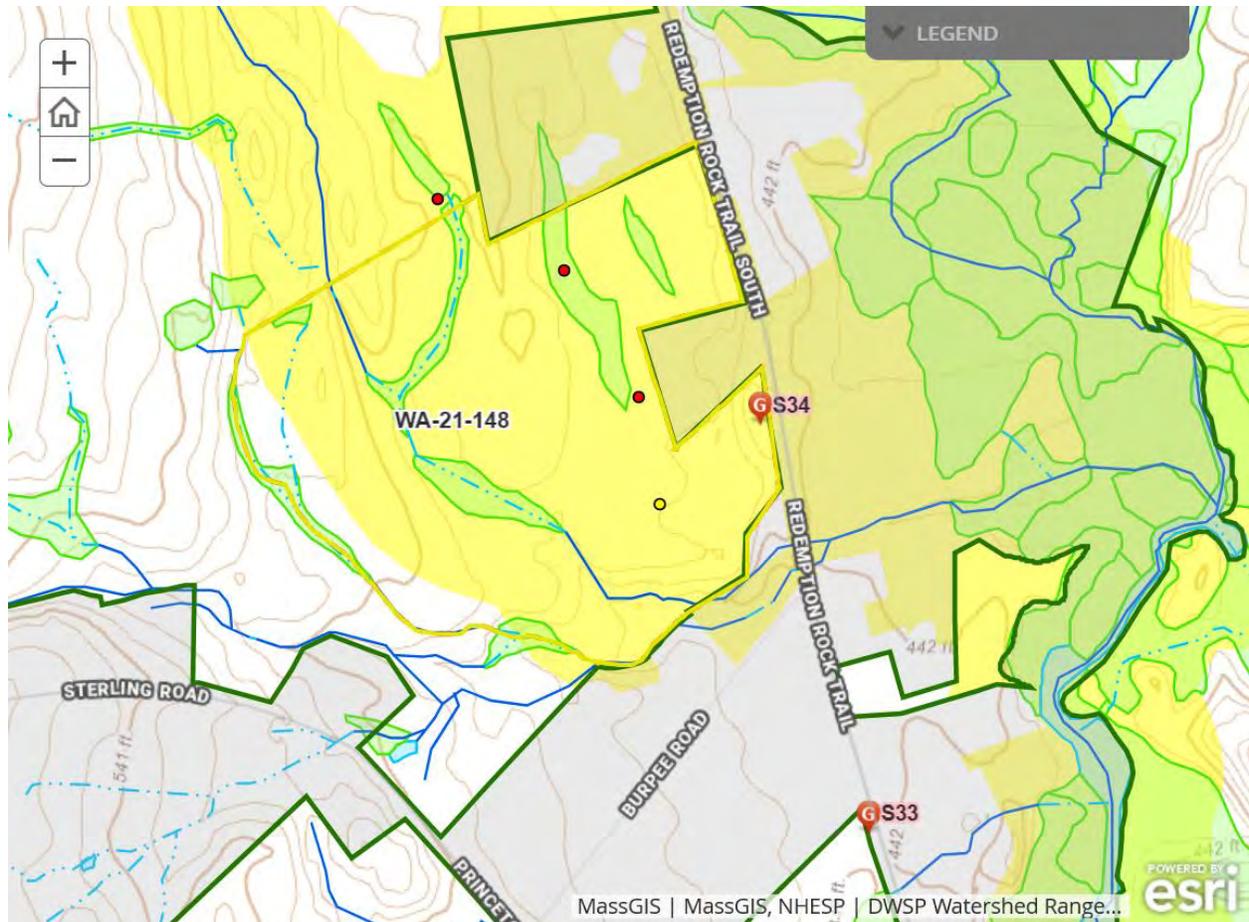
Environmental Quality Engineering

This crossing is proposed at the same location as was used in 2006. The site was walked on 04/07/20. The crossing was flagged in the field and a water quality sample was collected at the proposed crossing. EQ staff will collect water quality samples at the stream crossings. Background samples will be collected downstream from the proposed stream crossing prior to logging in order to establish baseline conditions, while downstream and upstream samples will be collected to measure the effects of ongoing logging operations, and after, to determine whether there are any measurable impacts.
