HAMPSHIRE COUNTY COURTHOUSE HVAC SYSTEM EVALUATION SUMMARY

HVAC SYSTEM EVALUATIONS COVID-19

Office of Court Management

January 25, 2021

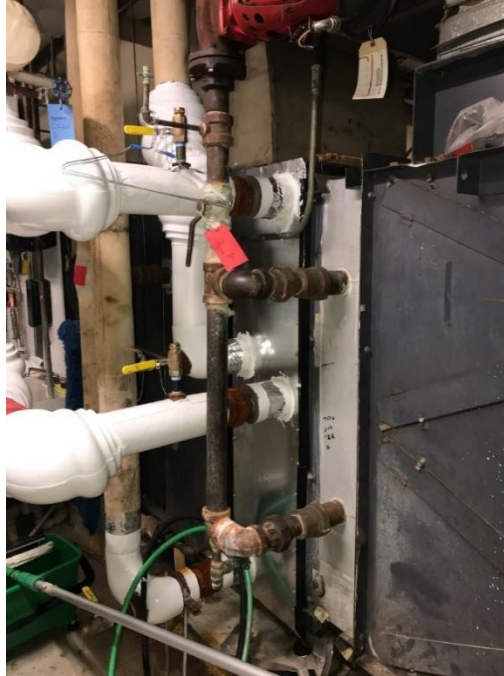
All AHUs have a hot water heating coil; a chilled water cooling coil; supply air fan; a mixing box with return air (RA) and outdoor air (OA) dampers, and a v-bank filter section. Air handlers HVAC-1 and HVAC-2 have return air fans. Two of the AHUs have a hot water preheat coil and were initially designed to handle a higher volume of outdoor air, and possibly had the capability for a dehumidification sequence. The 2" thick air filters were recently upgraded from MERV-8 to MERV-13, in all units except HVAC-7 which still had MERV-8 filters installed.

Photo 2 – AHU-1 components, right to left, v-bank filter section, HW preheat coil, CHW cooling coil, HW reheat coil.

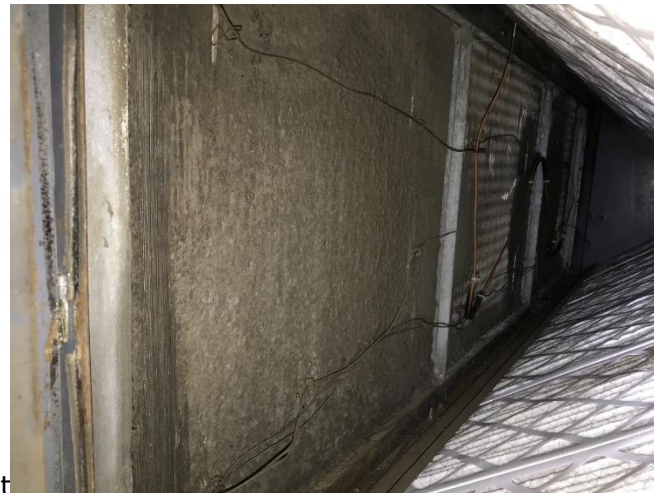
HVAC-6 serving the Judge's Lobby on the third floor in the Historic Courthouse is no longer used. There is no fan belt and the heating coil is disconnected.

Photo 4 – HVAC-6 cooling coil

Several coils were noted as being dirty (see Photos 1 and 4). These should be cleaned. All accessible pre-heating, cooling, and heating coils should be inspected and cleaned as necessary.

The non-operational air handler serving the Judges' Lobby should be repaired, refurbished, cleaned, and recommissioned or replaced in full so that ventilation air is provided to this space. The cooling coil and drain pan must be cleaned. The heating coil may need to be replaced. This unit will have to provide code-required ventilation air to the space it serves, even if other systems are presently providing temperature control.
