HISTORICAL SALT MARSH RESTORATION IN MASSACHUSETTS:

A COMPARATIVE STUDY OF PRE-RESTORATION AND POST-RESTORATION BIOLOGICAL MONITORING DATA

Massachusetts Office of Coastal Zone Management

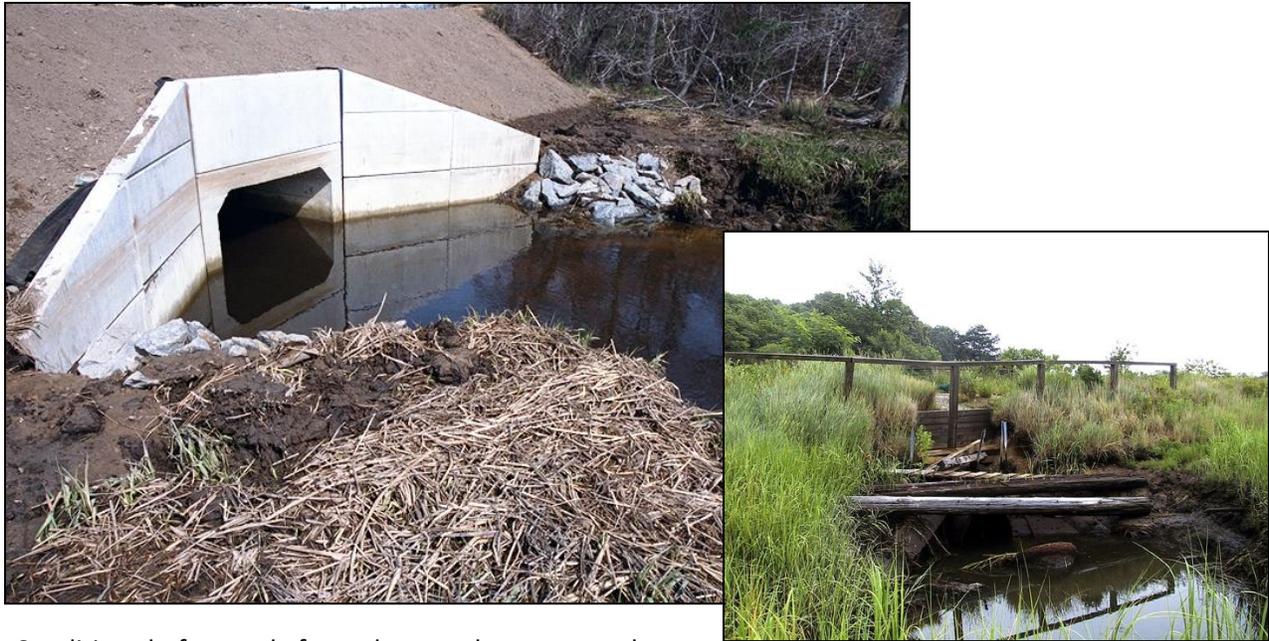
Conditions before and after culvert replacement at the Eastham Bike Path site. *Credit: CZM*

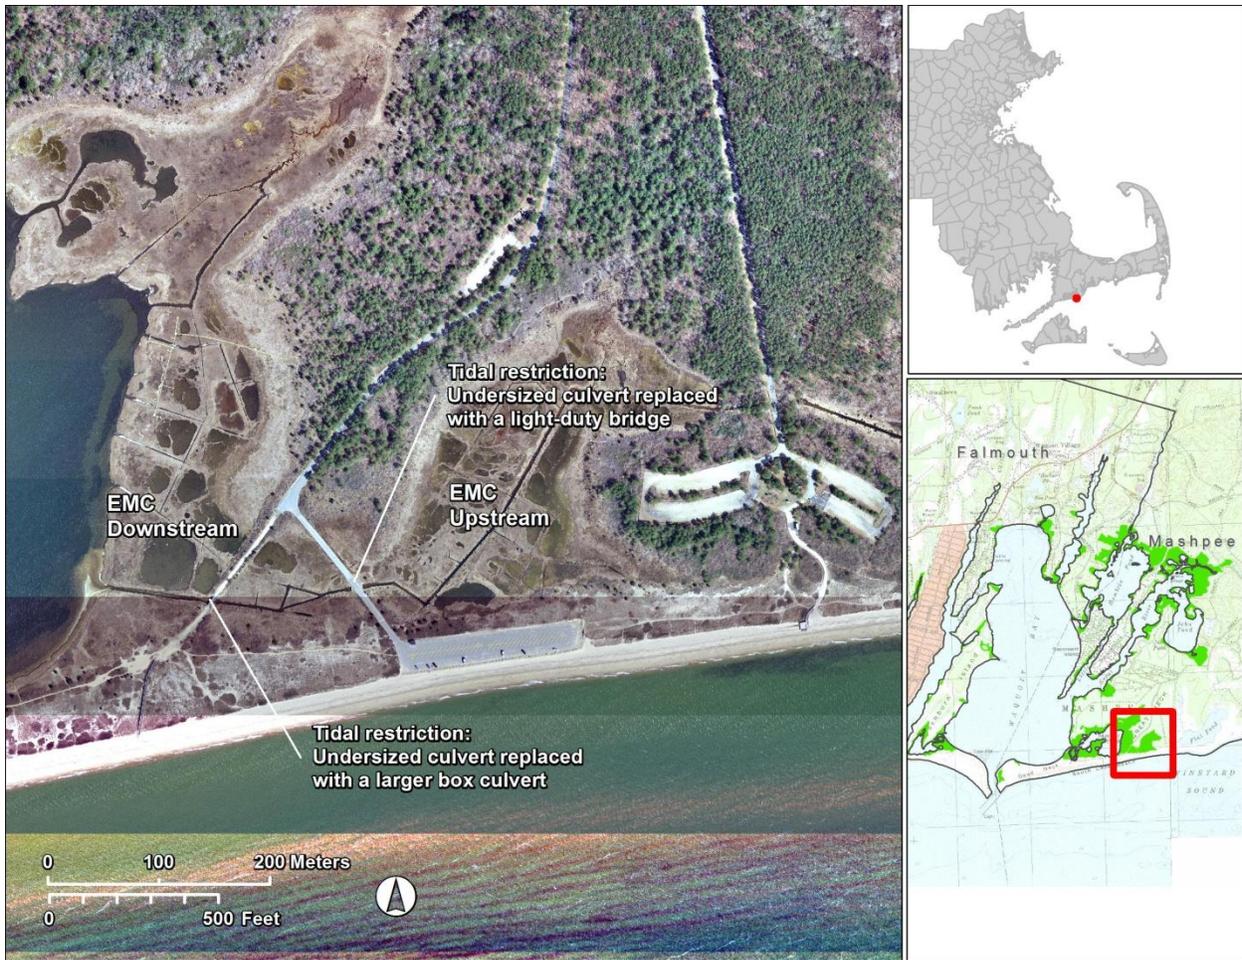
Figure 10. Overview map of the Sage Lot Pond salt marsh sampling area.

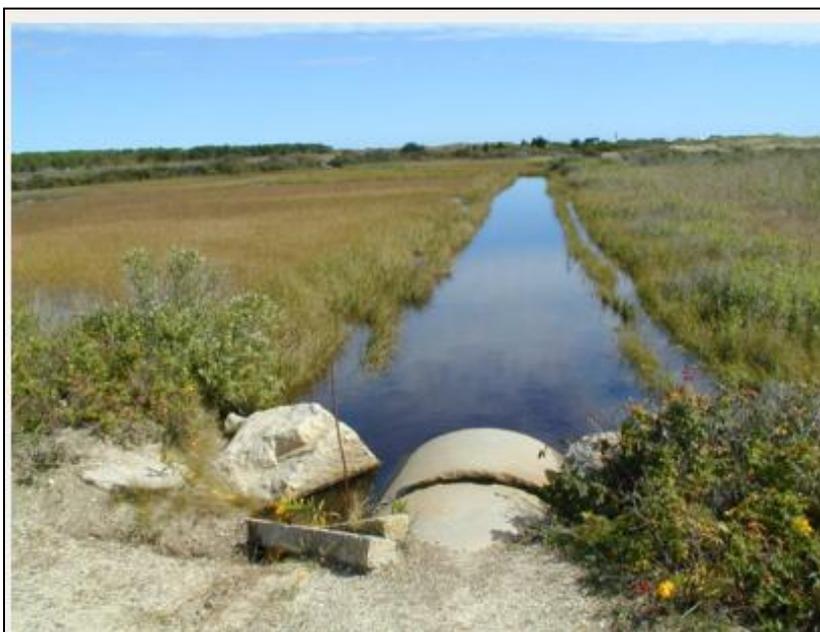
Culvert at Sage Lot Pond prior to replacement.

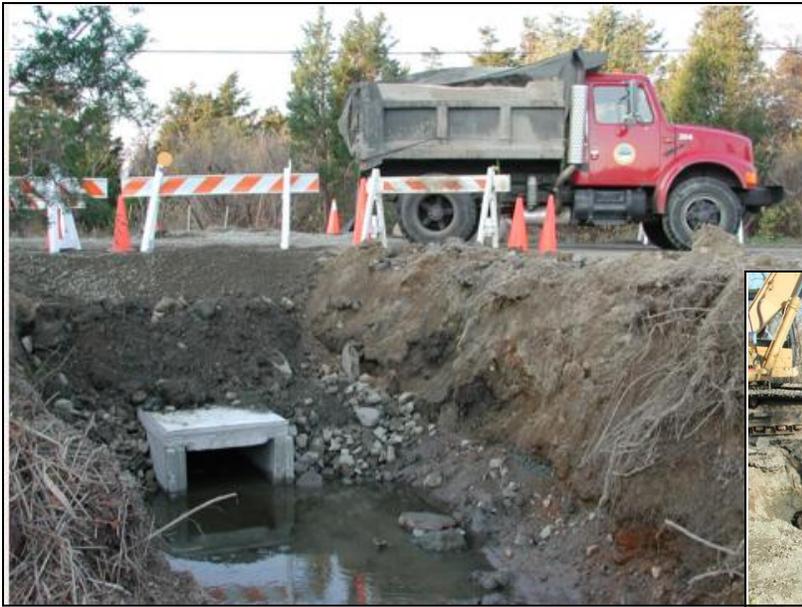
Installation of the new box culvert at Conomo Point.
Source: NOAA Restoration Atlas
