HISTORICAL SALT MARSH RESTORATION IN MASSACHUSETTS:

A COMPARATIVE STUDY OF PRE-RESTORATION AND POST-RESTORATION BIOLOGICAL MONITORING DATA

Massachusetts Office of Coastal Zone Management

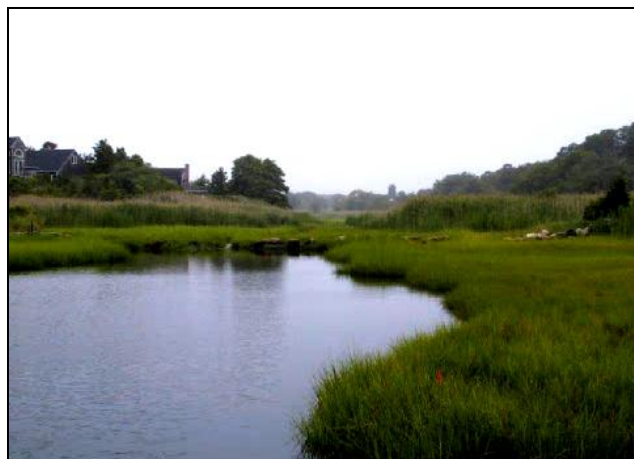
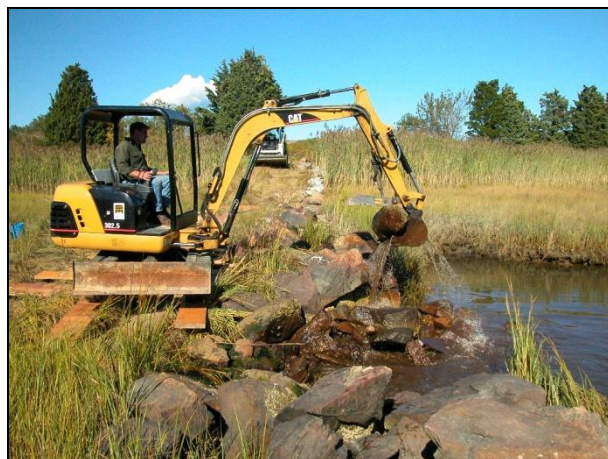
Mary Chase salt marsh pre-restoration and during removal of the stone dike. *Credit: CZM*

The Mary Chase salt marsh is located within the Nauset Marsh embayment system on the outer arm of Cape Cod in the town of Eastham (Figure 2). A historic stone and earthen dike bisected the marsh, restricting tidal flows from Abelino Creek until a portion was removed in October of 2003. This significantly increased tidal flows to the marsh, however as the dike is considered a historic structure, complete removal was not permitted. As a result, areas upstream of the dike do not drain completely during ebb tide. The two sample pairs are located upstream and downstream of the historic dike, with an evaluation area of 8,623 m² and 12,601 m² respectively. For this analysis macroinvertebrate and vegetation data collected just prior to the restoration in August 2003 were compared to contemporary data collected in August 2013.

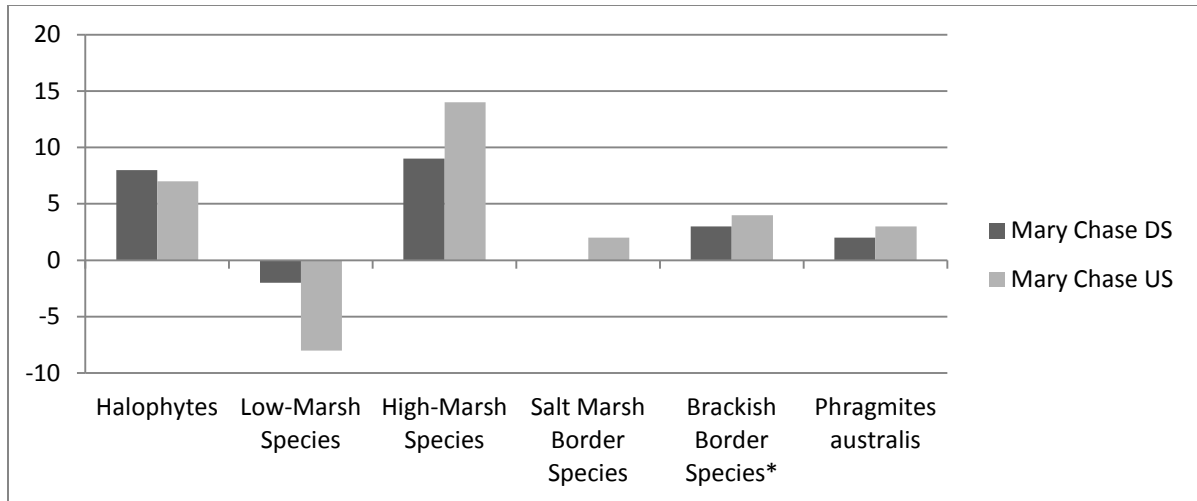
Figure 3. Change in vegetation metrics measured as relative (%) abundance from pre-restoration to post-restoration at the Mary Chase site for downstream (DS) and upstream (US) sample locations.

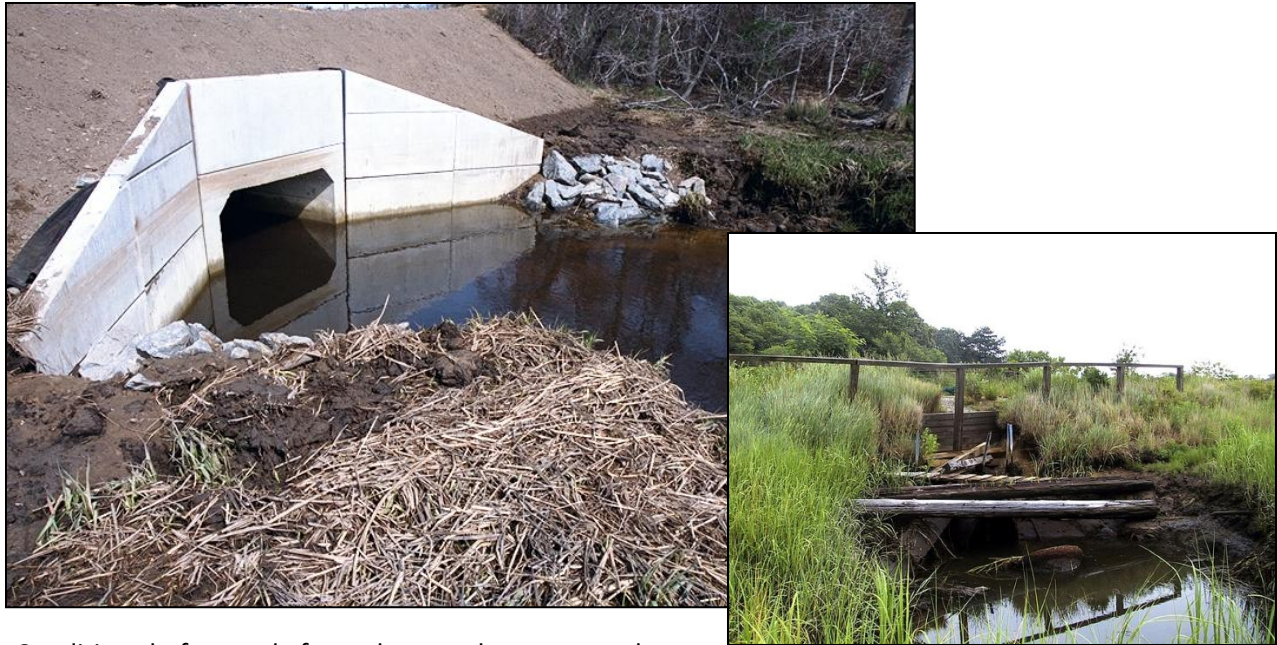
Conditions before and after culvert replacement at the Eastham Bike Path site. *Credit: CZM*

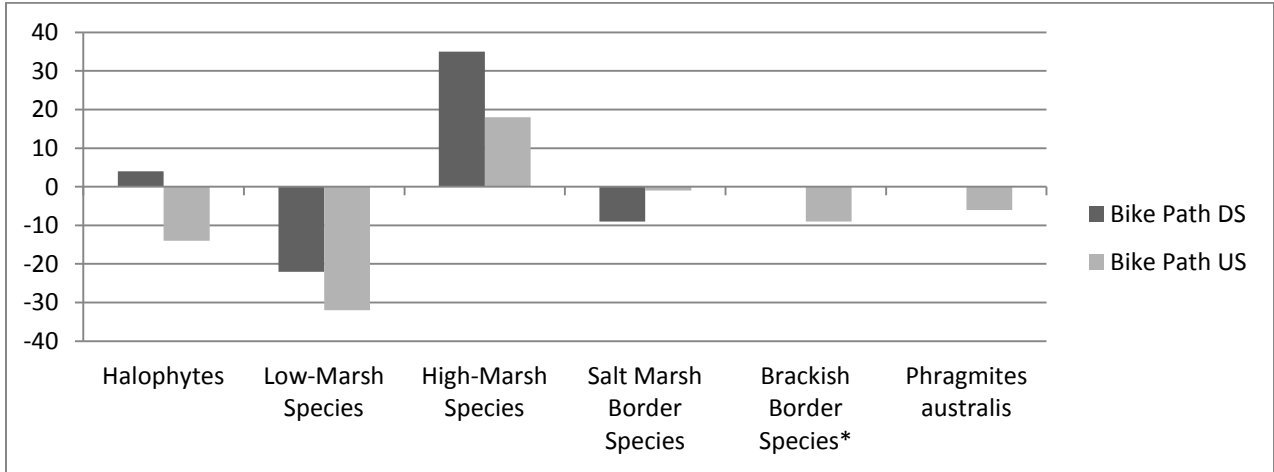
Figure 7. Change in vegetation metrics measured as relative (%) abundance from pre-restoration to post-restoration at the Bike Path Site for downstream (DS) and upstream (US) sample locations.

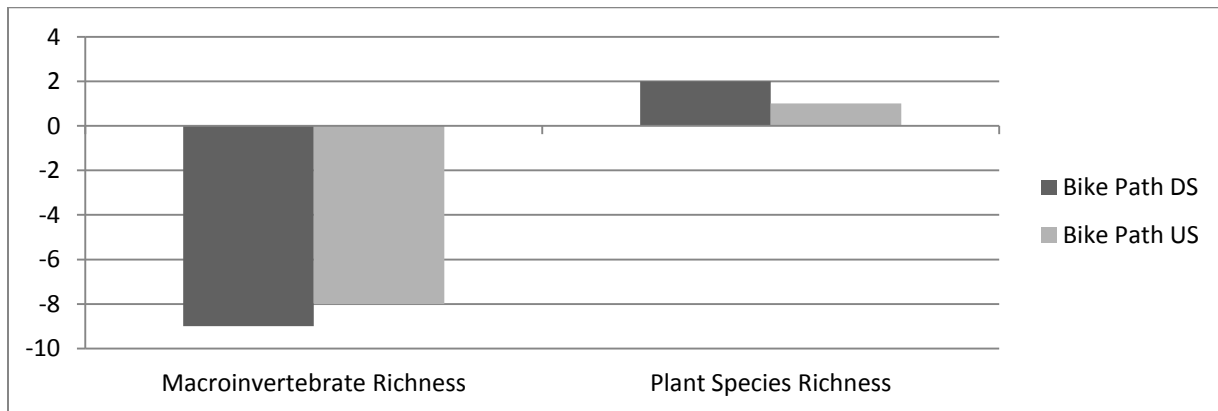
Figure 9. Change in richness measured by number of taxa (macroinvertebrates) or number of species (vegetation) from pre-restoration to post-restoration at the Bike Path site for downstream (DS) and upstream (US) sampling locations.

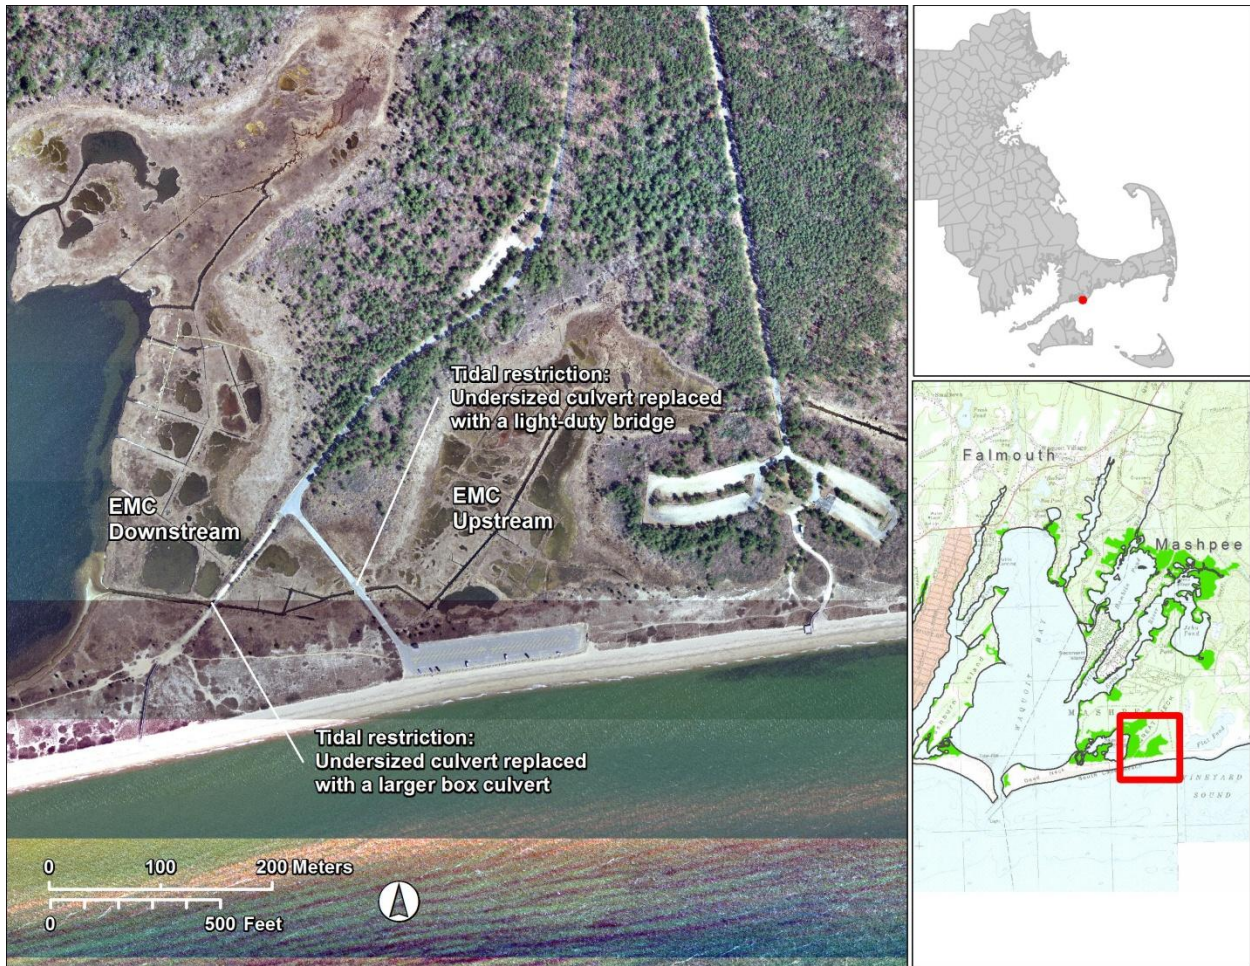
Figure 10. Overview map of the Sage Lot Pond salt marsh sampling area.

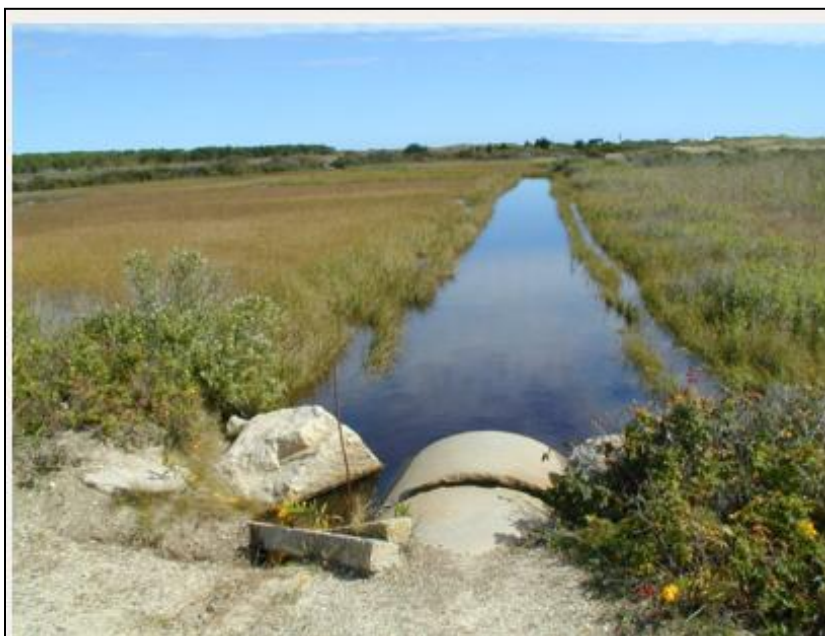
Culvert at Sage Lot Pond prior to replacement.

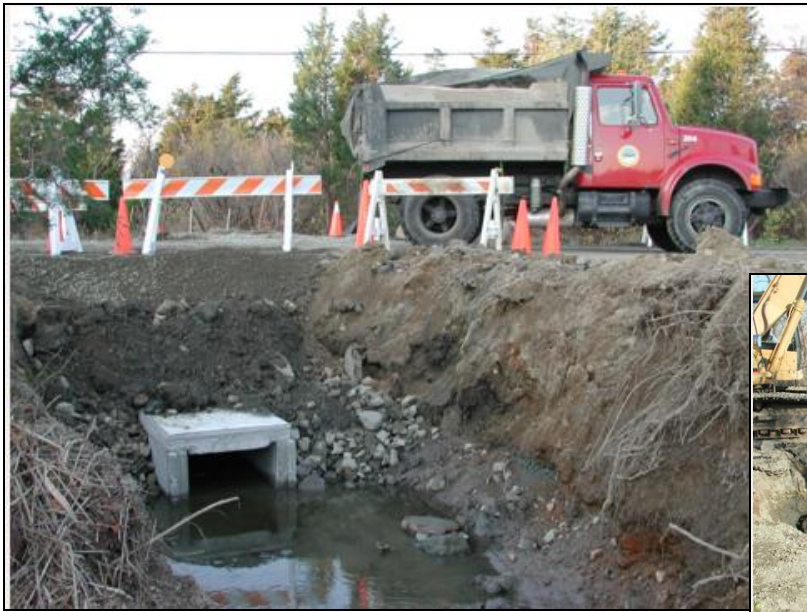
Installation of the new box culvert at Conomo Point.
Source: NOAA Restoration Atlas

The Conomo Point wetland is located on Conomo Point Road in Essex, MA. Prior to restoration a significant tidal restriction existed from a partially collapsed stone culvert under the two-lane paved road that bisects the marsh. The culvert was replaced in late 2000 with a 3 x 4 ft box culvert to increase tidal flow into the restricted 1.2 acre portion of the marsh. For this analysis, macroinvertebrate and vegetation collected in July 2000 prior to the restoration are compared to data collected in 2013.

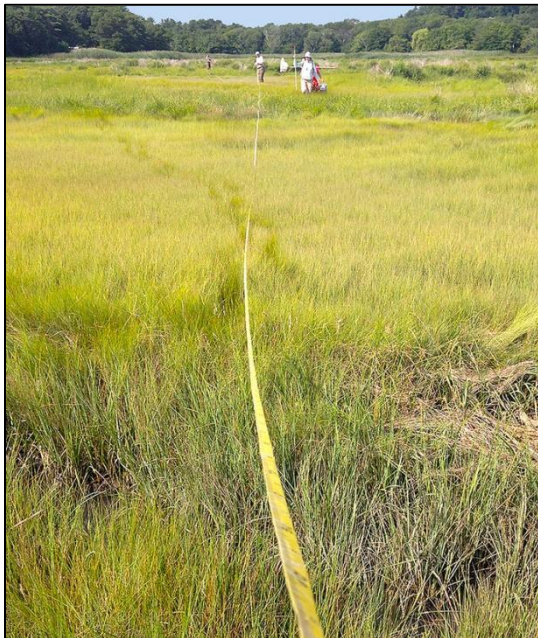
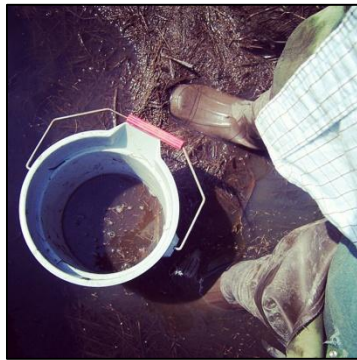
Vegetation and macroinvertebrate sampling in a salt marsh. *Credit: Chris Garby, CZM*

Vegetation was sampled along each transect within 1 x 1 m plots placed at 60 ft intervals, starting at the creek edge and progressing along the entire length of the transect up to the upland edge. The last plot was always located in the salt marsh border/fringe community, so if the regular plot interval occurred in the upland above this community, it was moved back on the transect until it was located in the border and that distance on the transect was noted on the data sheet. In each plot, every plant was identified to

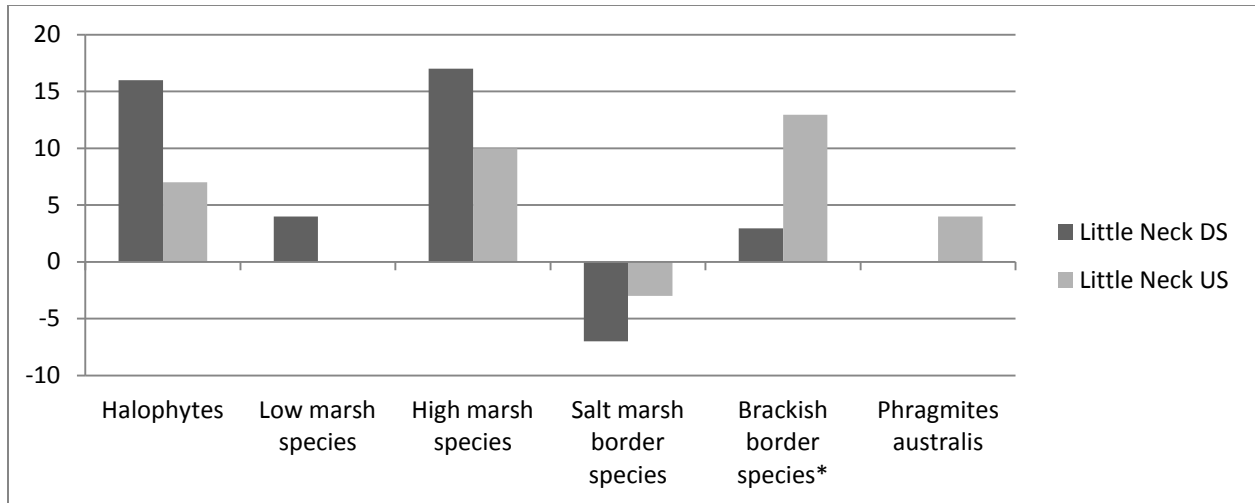
Figure 19. Change in vegetation metrics measured as relative (%) abundance from pre-restoration to post-restoration at the Little Neck Site for downstream (DS) and upstream (US) sample locations.

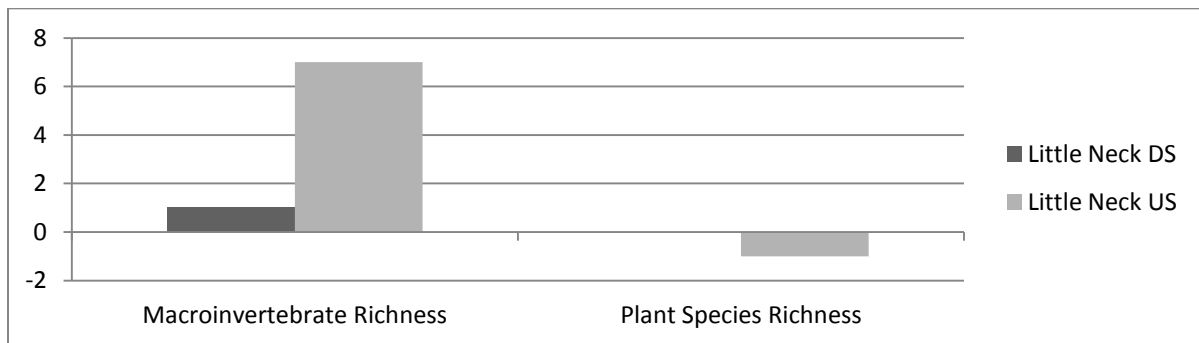
Figure 21. Change in richness measured by number of taxa (macroinvertebrates) or number of species (vegetation) from pre-restoration to post-restoration at the Little Neck site for downstream (DS) and upstream (US) sampling locations.

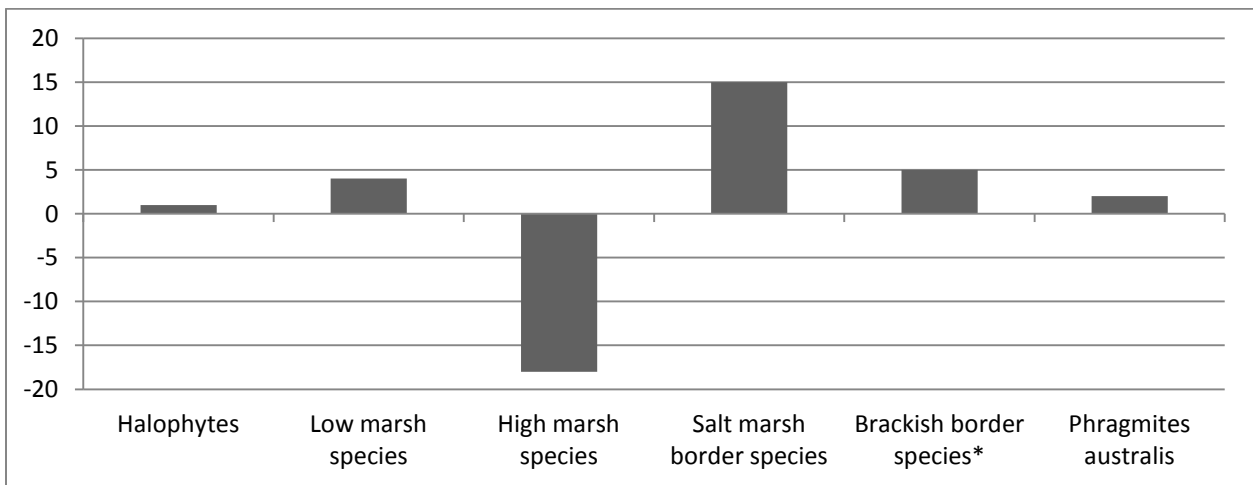
Figure 27. Change in vegetation metrics through time measured as relative (%) abundance at the Coast Guard Beach reference site.

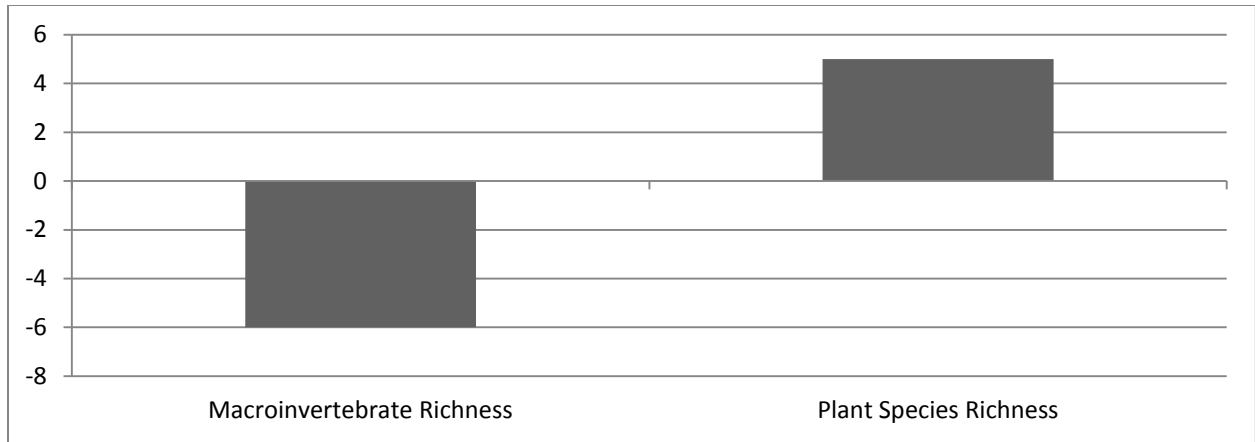
Figure 29. Change in richness measured by number of taxa (macroinvertebrates) or number of species (vegetation) through time at the Coast Guard Beach reference site.
