INDEPENDENT TECHNICAL REVIEW OF WINTHROP SHORES RESERVATION RESTORATION PROJECT

TECHNICAL REVIEW

Tetra Tech conducted a site visit of the Winthrop Beach shoreline on Thursday 5 May 2016. The timing of the 05 May inspection enabled coastal engineers to observe the condition of the shoreline over the range of tide, with the timing of arrival largely coincident with the high tide event at approximately 1045 hours. The weather at the time of the inspection was intermittent light to moderate rain showers, winds NE at 15-20 mph, temperature 45 degrees Fahrenheit. Two inspectors walked the entire ~5,000 ft Project shoreline commencing from a point roughly due east of Crystal Cove Avenue (approximately 200 ft south of the southern groin S-1), and ending roughly coincident with a point due east of the intersection of Beach Road and Winthrop Shore Drive (approximately 200 ft north of the terminal groin).

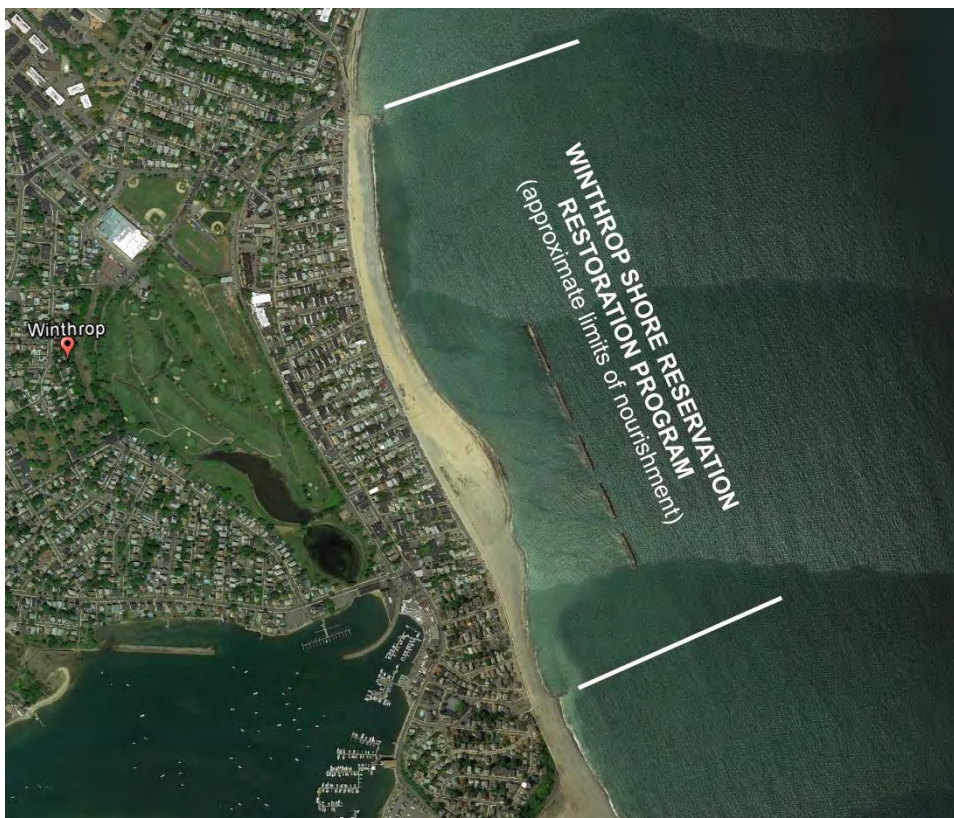
Figure 1. Winthrop Shores Reservation Restoration Program – Shore Protection Project Limits
(image courtesy of Google Earth)

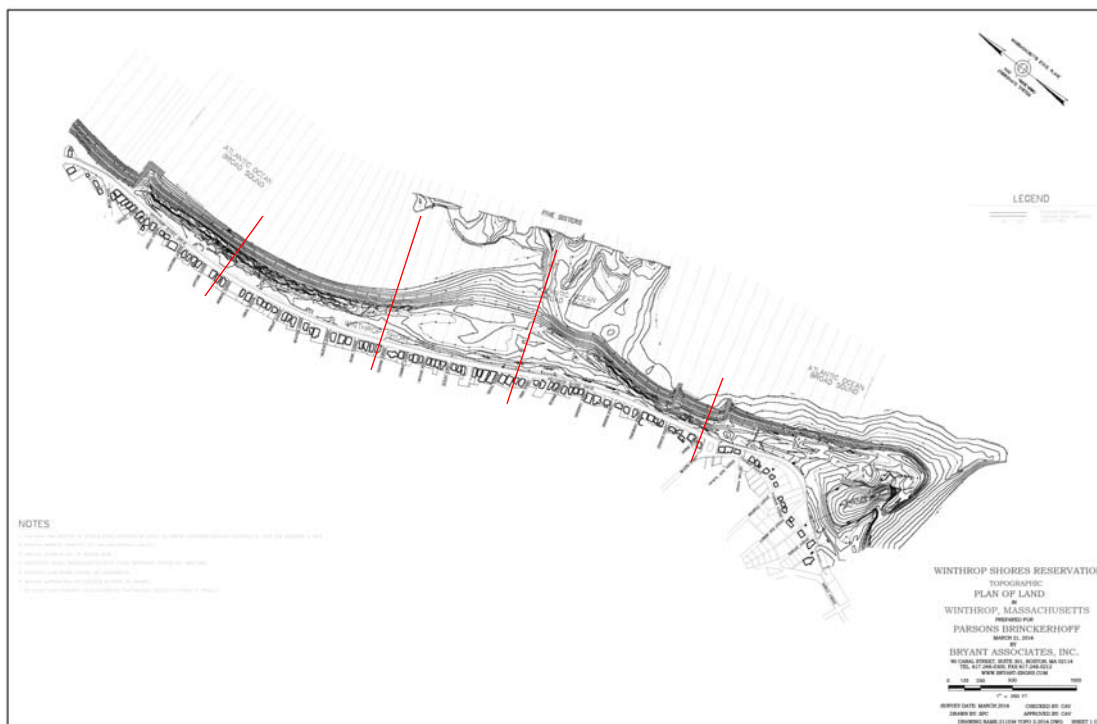
On 26 April 2016, DCR provided Tetra Tech with AutoCAD files of the first three quarterly monitoring surveys, conducted in August and November 2015, and March 2016. The files provided plan view contour plots of the Project shoreline and nearshore zones from the seawall (~+20 ft) to -10 (elevations referenced to Boston base). Representative cross sections comparing the three surveys at the locations are shown in Figure 2 (Plan view). At Coral Avenue

and Dolphin Avenue the approximate shoreline location midway between Ocean Avenue and Irwin Street, and midway between Charles and Moore Streets, are shown comparatively in Appendix C. The vertical scale is exaggerated at 5:1 to better show the relevant changes in the beach profile elevations and slopes.

Figure 2. Plan view of Project Shoreline Contour Plot with Locations of Selected Cross-Sections for Comparison (see Appendix C for representative cross sections comparing the three surveys).

Overall, the survey data shows adjustments that would be expected following a restoration or nourishment project to the upper beach berm position over the time period August 2015 to March 2016, and only modest shoreline position changes at elevation +5. This provides a partial indication of the overall stability of the placed materials.

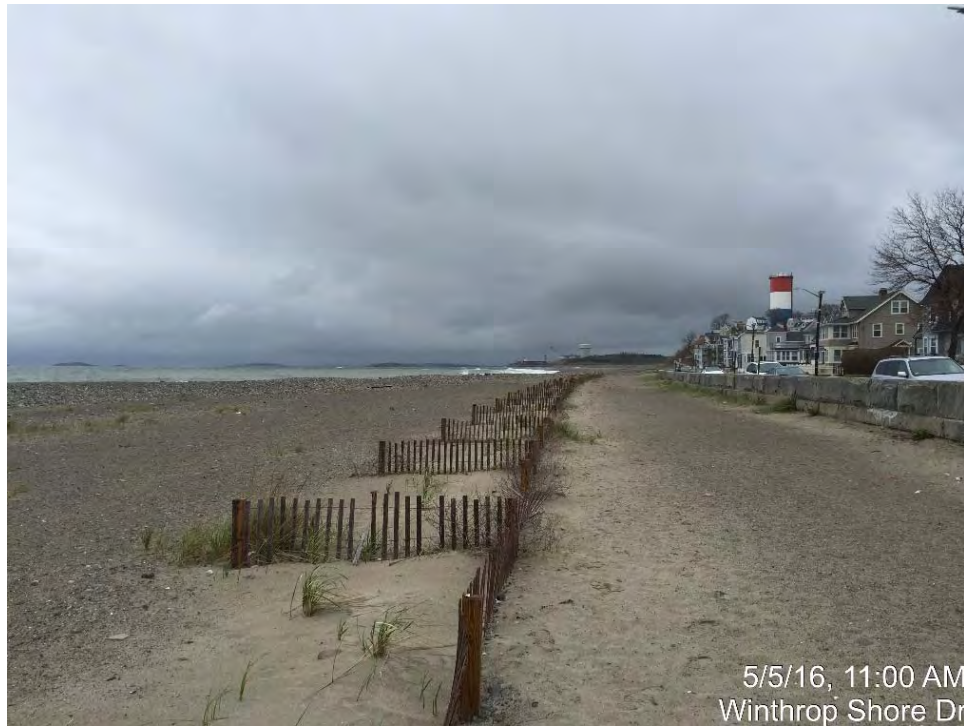
The back beach berm that ties into the seawall from approximately Tewksbury Street north to approximately Pearl Avenue could be generally characterized at the time of the site inspection, near or shortly following high tide, to contain a relatively broad and moderately-sloped (1:15) face, with the width noted as highly variable along this entire reach of shoreline. Representative views of this shoreline segment are provided as Photographs 1, 2 and 3. The remaining emergent shoreline noted during high tide in this reach transitions from a largely sand and medium gravel to cobble interspersed sediment matrix to one more dominated by cobble sized units. It is noted that this area is roughly coincident with the 'shadow' of the Five Sisters.

Photograph 1. Upper beach berm near Underhill Street looking South-southeast toward Groin #5/south terminus of Project.

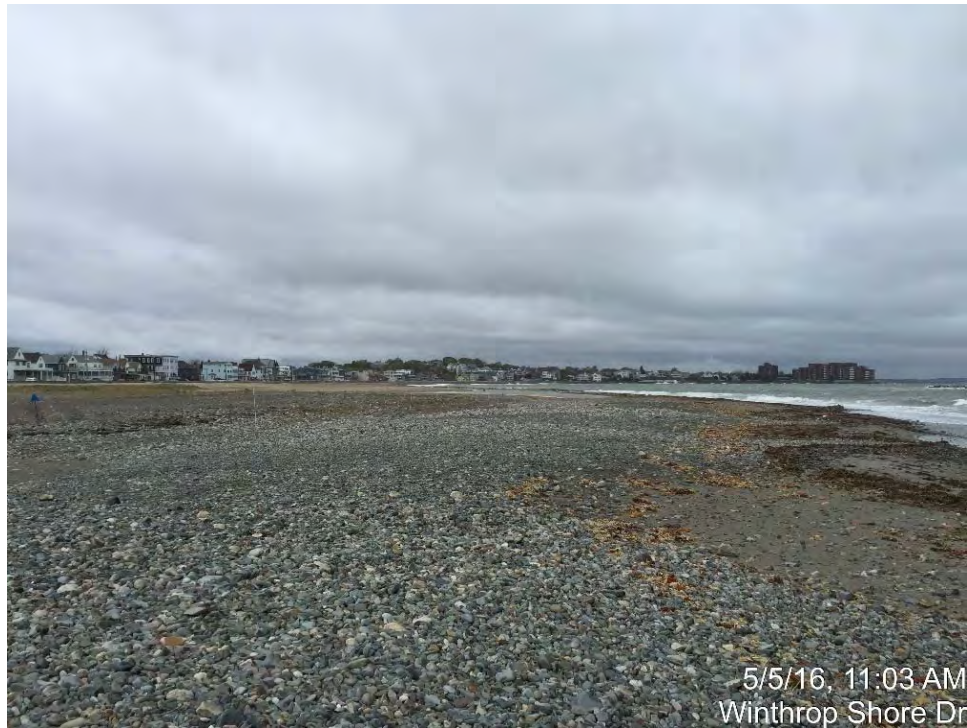
Photograph 2. Lower beach berm in the 'shadow' of the middle breakwater (Sister) looking north. Photo taken east of mid-point between Ocean Avenue and Cutler Street.

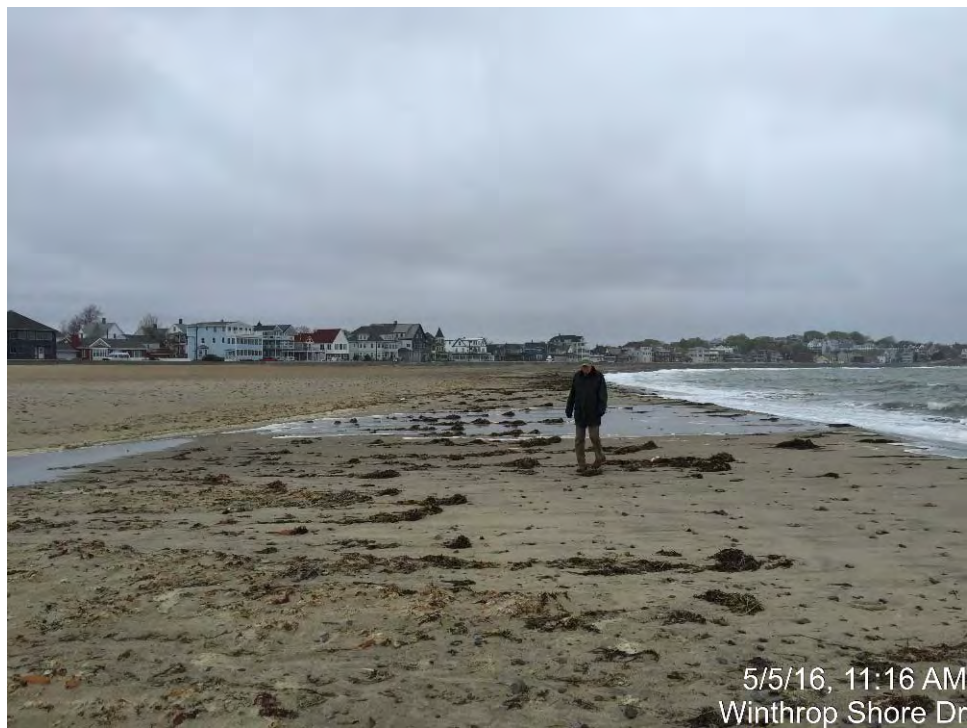
Photograph 3. Project shoreline in lee of northernmost breakwater ("Sister") looking north; photo taken east of Forrest Street.

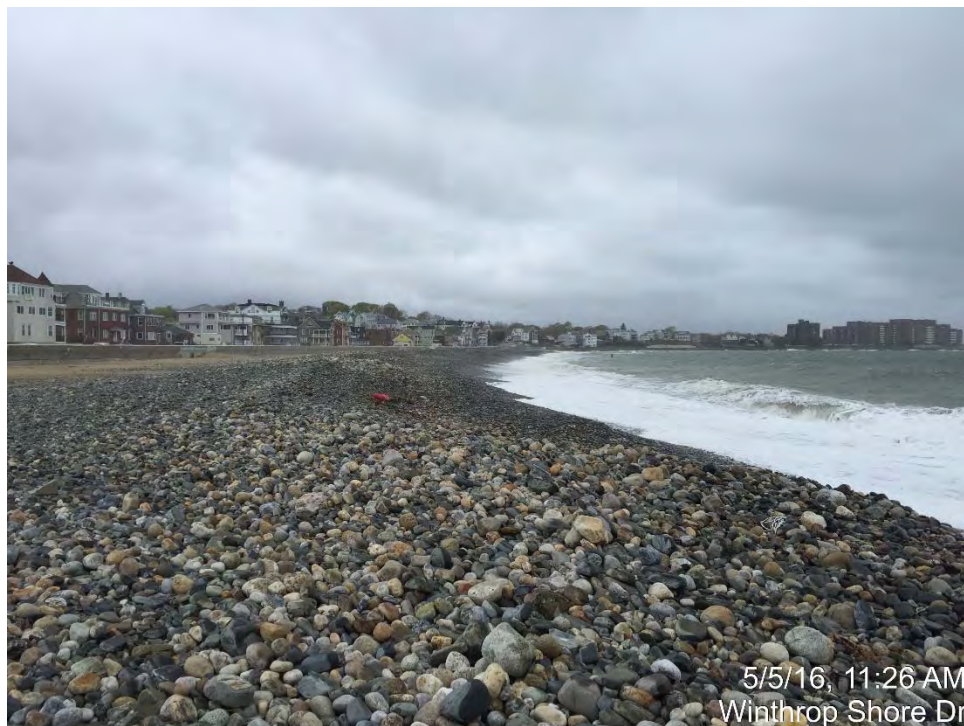
North of Pearl Avenue, and continuing north to the terminus of the Project, the shoreline configuration was noted to transition rapidly to not only a narrower beach width, but a much steeper (1:3) berm face comprised of gravel, cobble and small boulders. The back beach berm was noted to gradually diminish to approximately 30 ft in width from the face of the seawall to the exposed crest of the terminal groin (Photographs 4 and 5).

Photograph 4. Project shoreline in vicinity of Trident Avenue.

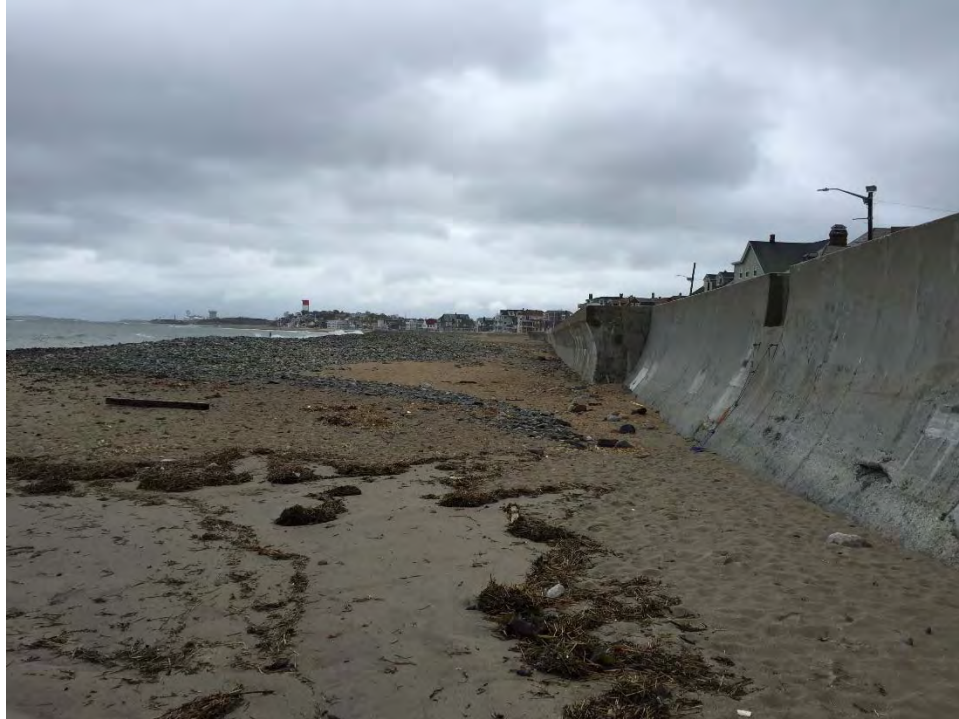
Photograph 5. Project shoreline in the vicinity of the terminal groin, located approximately 180 ft north of the Locust Street/Winthrop Shore Drive intersection.

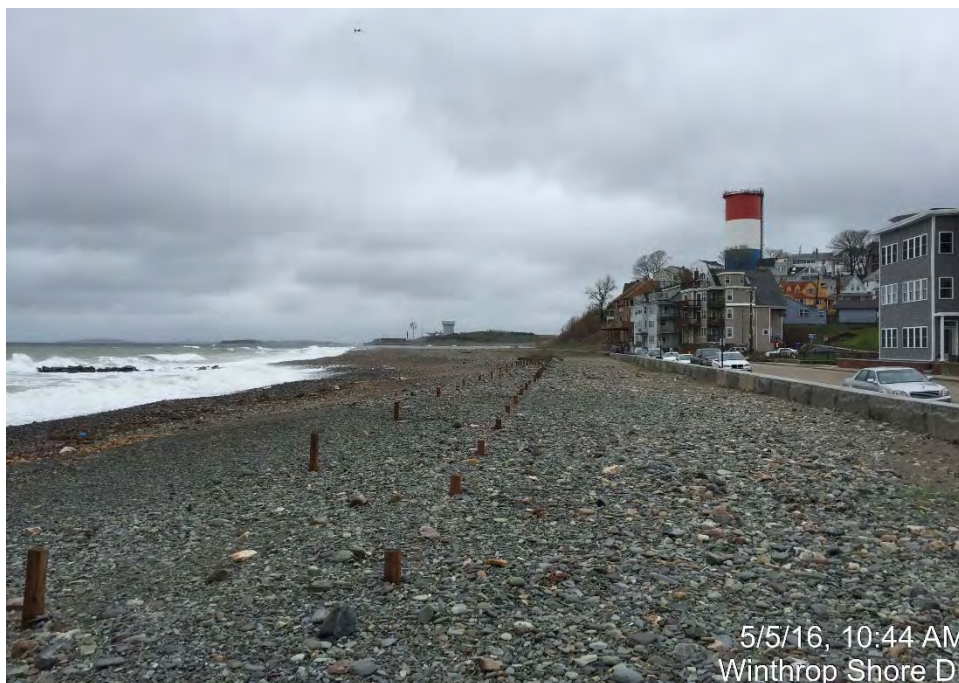
South of Tewksbury Street to the south Project limit, the shoreface was noted to be similarly comprised of gravel and cobble, but the berm slopes were not as steep nor as high in crest elevation as those noted between Seafoam and Myrtle Avenues in particular (Photograph 6).

Photograph 6. Project shoreline in the vicinity of Charles Street.

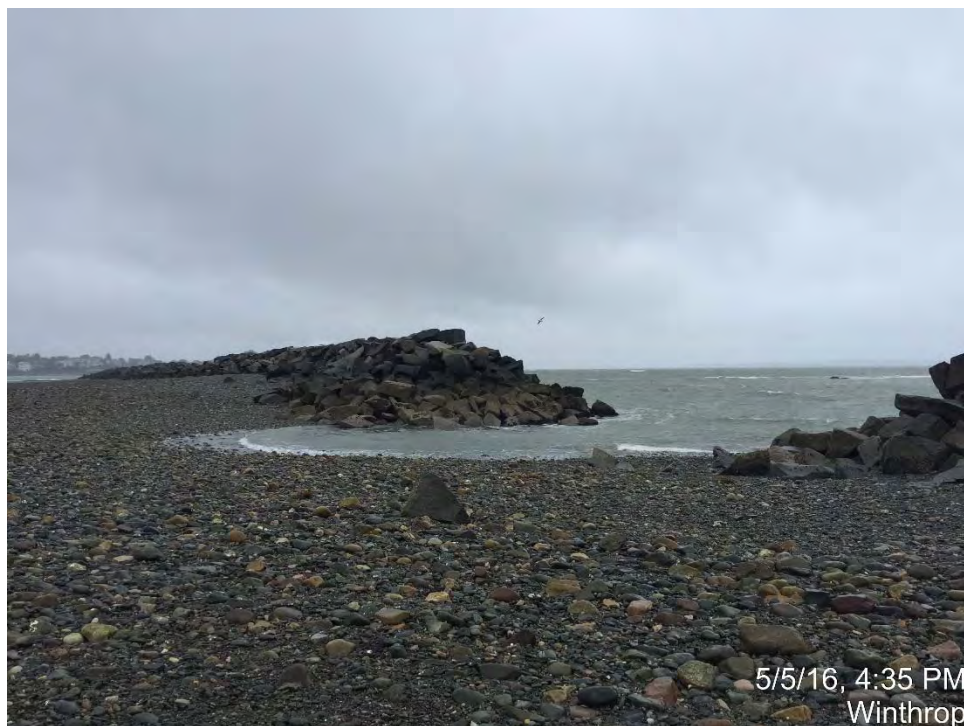
Returning to the beach at low tide (~1545 hours), winds were noted to be generally NE at 20 mph with occasional gusts estimated at 25 mph, moderate to heavy rain, temperature 42 degrees Fahrenheit. With water levels at approximately 1 ft below normal, much of the lower portion of the beach could be readily observed. Again commencing at the south end, Tetra Tech engineers traversed much of the southern shoreline from Groin #5, noting that the seaward terminus of the southernmost two groins were completely emergent. It was possible to walk to the landward edge of the southernmost three breakwaters at this time. A sand and gravel matrix was observed on a low, flat tombolo platform extending to each of these breakwater units. The crescentic gap between the middle and fourth breakwater was estimated to extend landward approximately 50 ft to the water's edge at the time the tombolos were traversed on foot (Photograph 7).

Photograph 7. Tombolo formation in the lee of the middle Sister and the adjacent breakwater to the south just beyond the time of low tide.

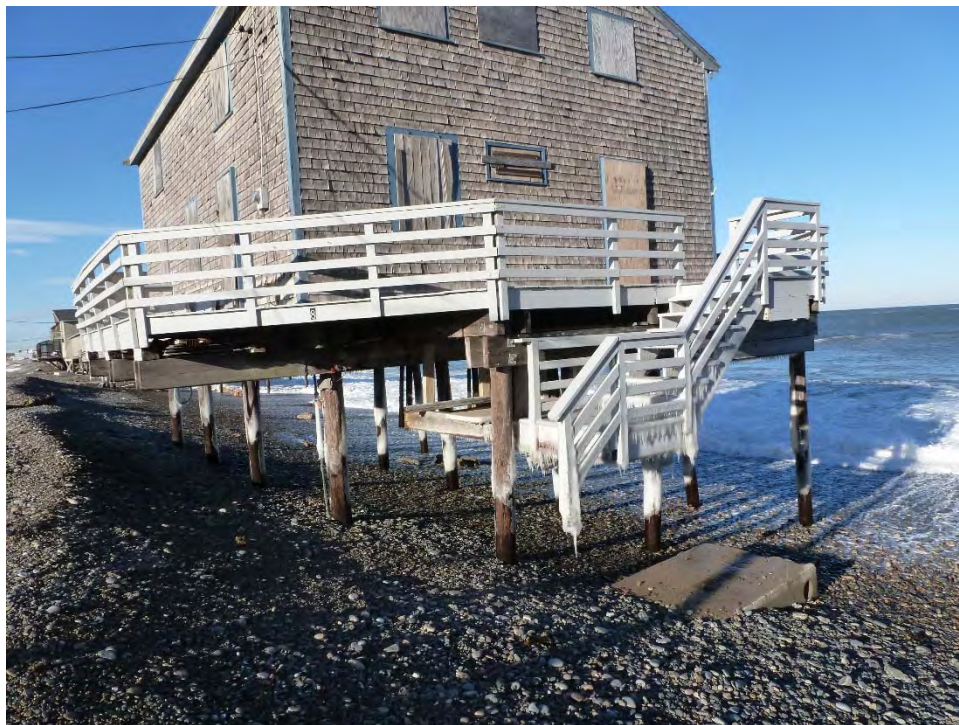
Rocky beaches including Winthrop Beach make up a significant portion of the world’s shorelines. They are variously called cobble, shingle, and rubble beaches. Significant portions of the east facing Massachusetts coast line consists of shingle beaches or coarse sandy gravel beaches in small coves between rocky headlands (“pocket” beaches). The NW-SE trending coastline on the South Shore between Nantasket, Hull and Brant Rock, Marshfield consists primarily of such beaches. In several cases, such as Mann Hill Beach and Humarock Beach in Scituate (see Photographs 8 and 9), homes are built directly on the shingle berm with steep cobble winter berms on the seaward face.

Photograph 8. Mann Hill Beach, Scituate, MA

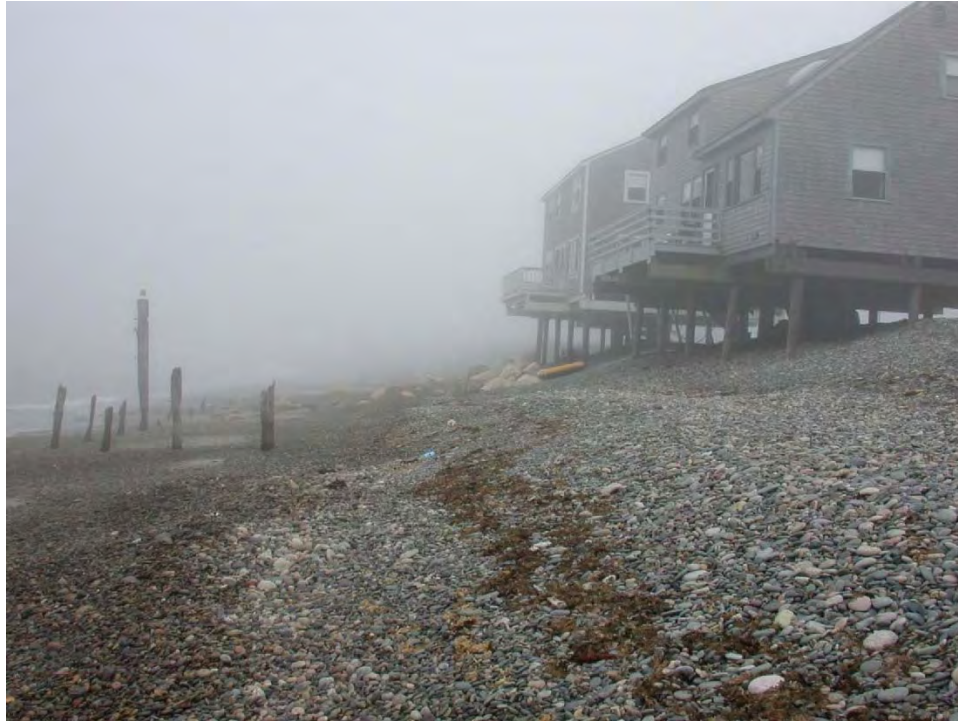
Photograph 9. Humarock Beach, Scituate, MA

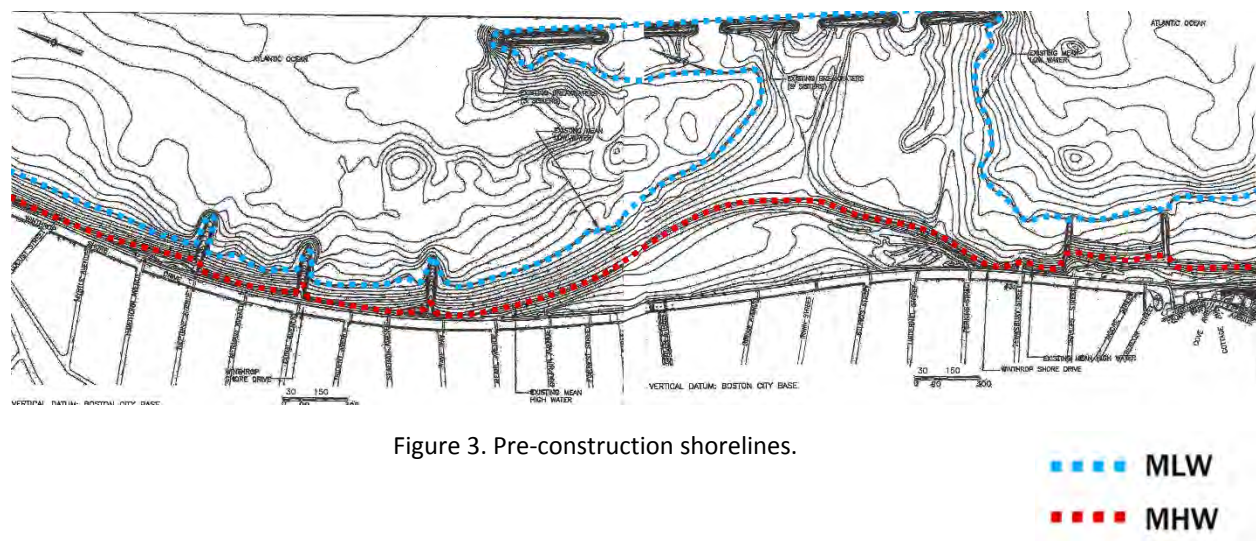
Figures 3, 4 and 5 show the high and low water marks before the Project, as the Project was designed and the Project in March, 2016. These figures are based upon actual field surveys and construction drawings. As is evident from an inspection of the beach today, the wave energy, primarily in the winter and spring of 2015 and 2016, has resorted and redistributed the fill materials which were placed by December, 2014.

Figure 3. Pre-construction shorelines.

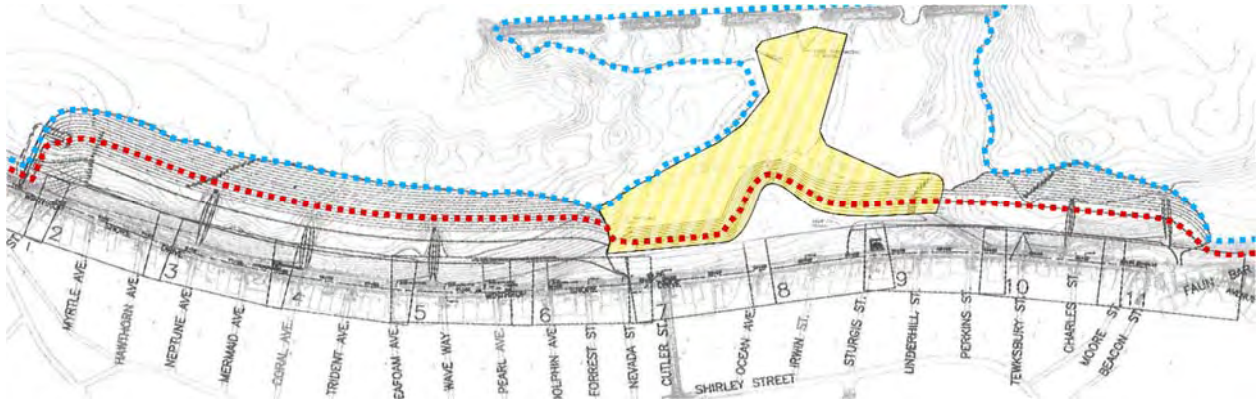
Figure 4. Design shorelines.

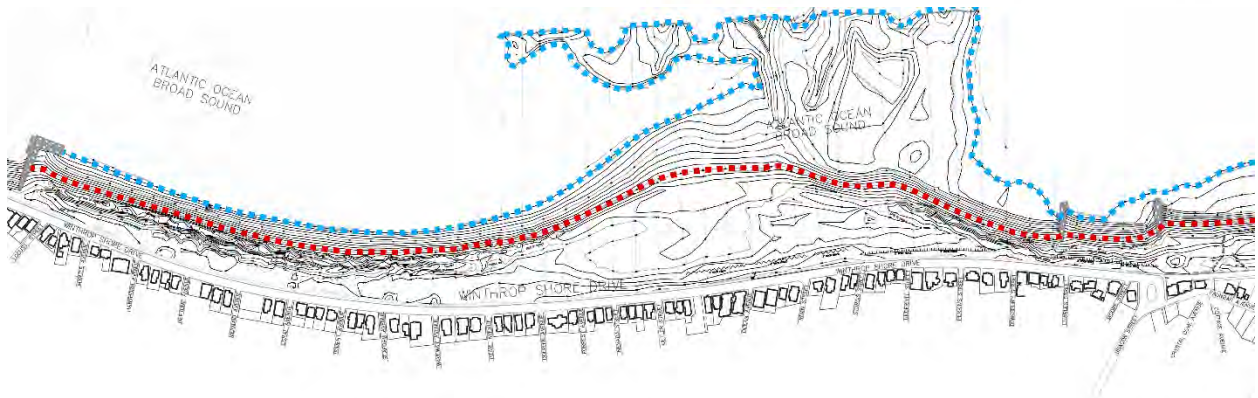
Figure 5. Post-construction shorelines.

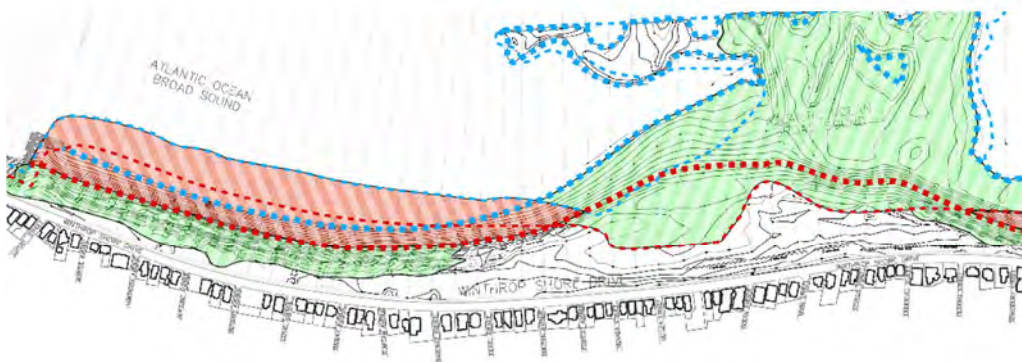
Figure 6. Erosion and deposition of the fill materials.
