**IPSWICH RIVER WATERSHED
2000 WATER QUALITY ASSESSMENT REPORT**

IPSWICH RIVER WATERSHED
2000 WATER QUALITY ASSESSMENT REPORT

92-AC-1

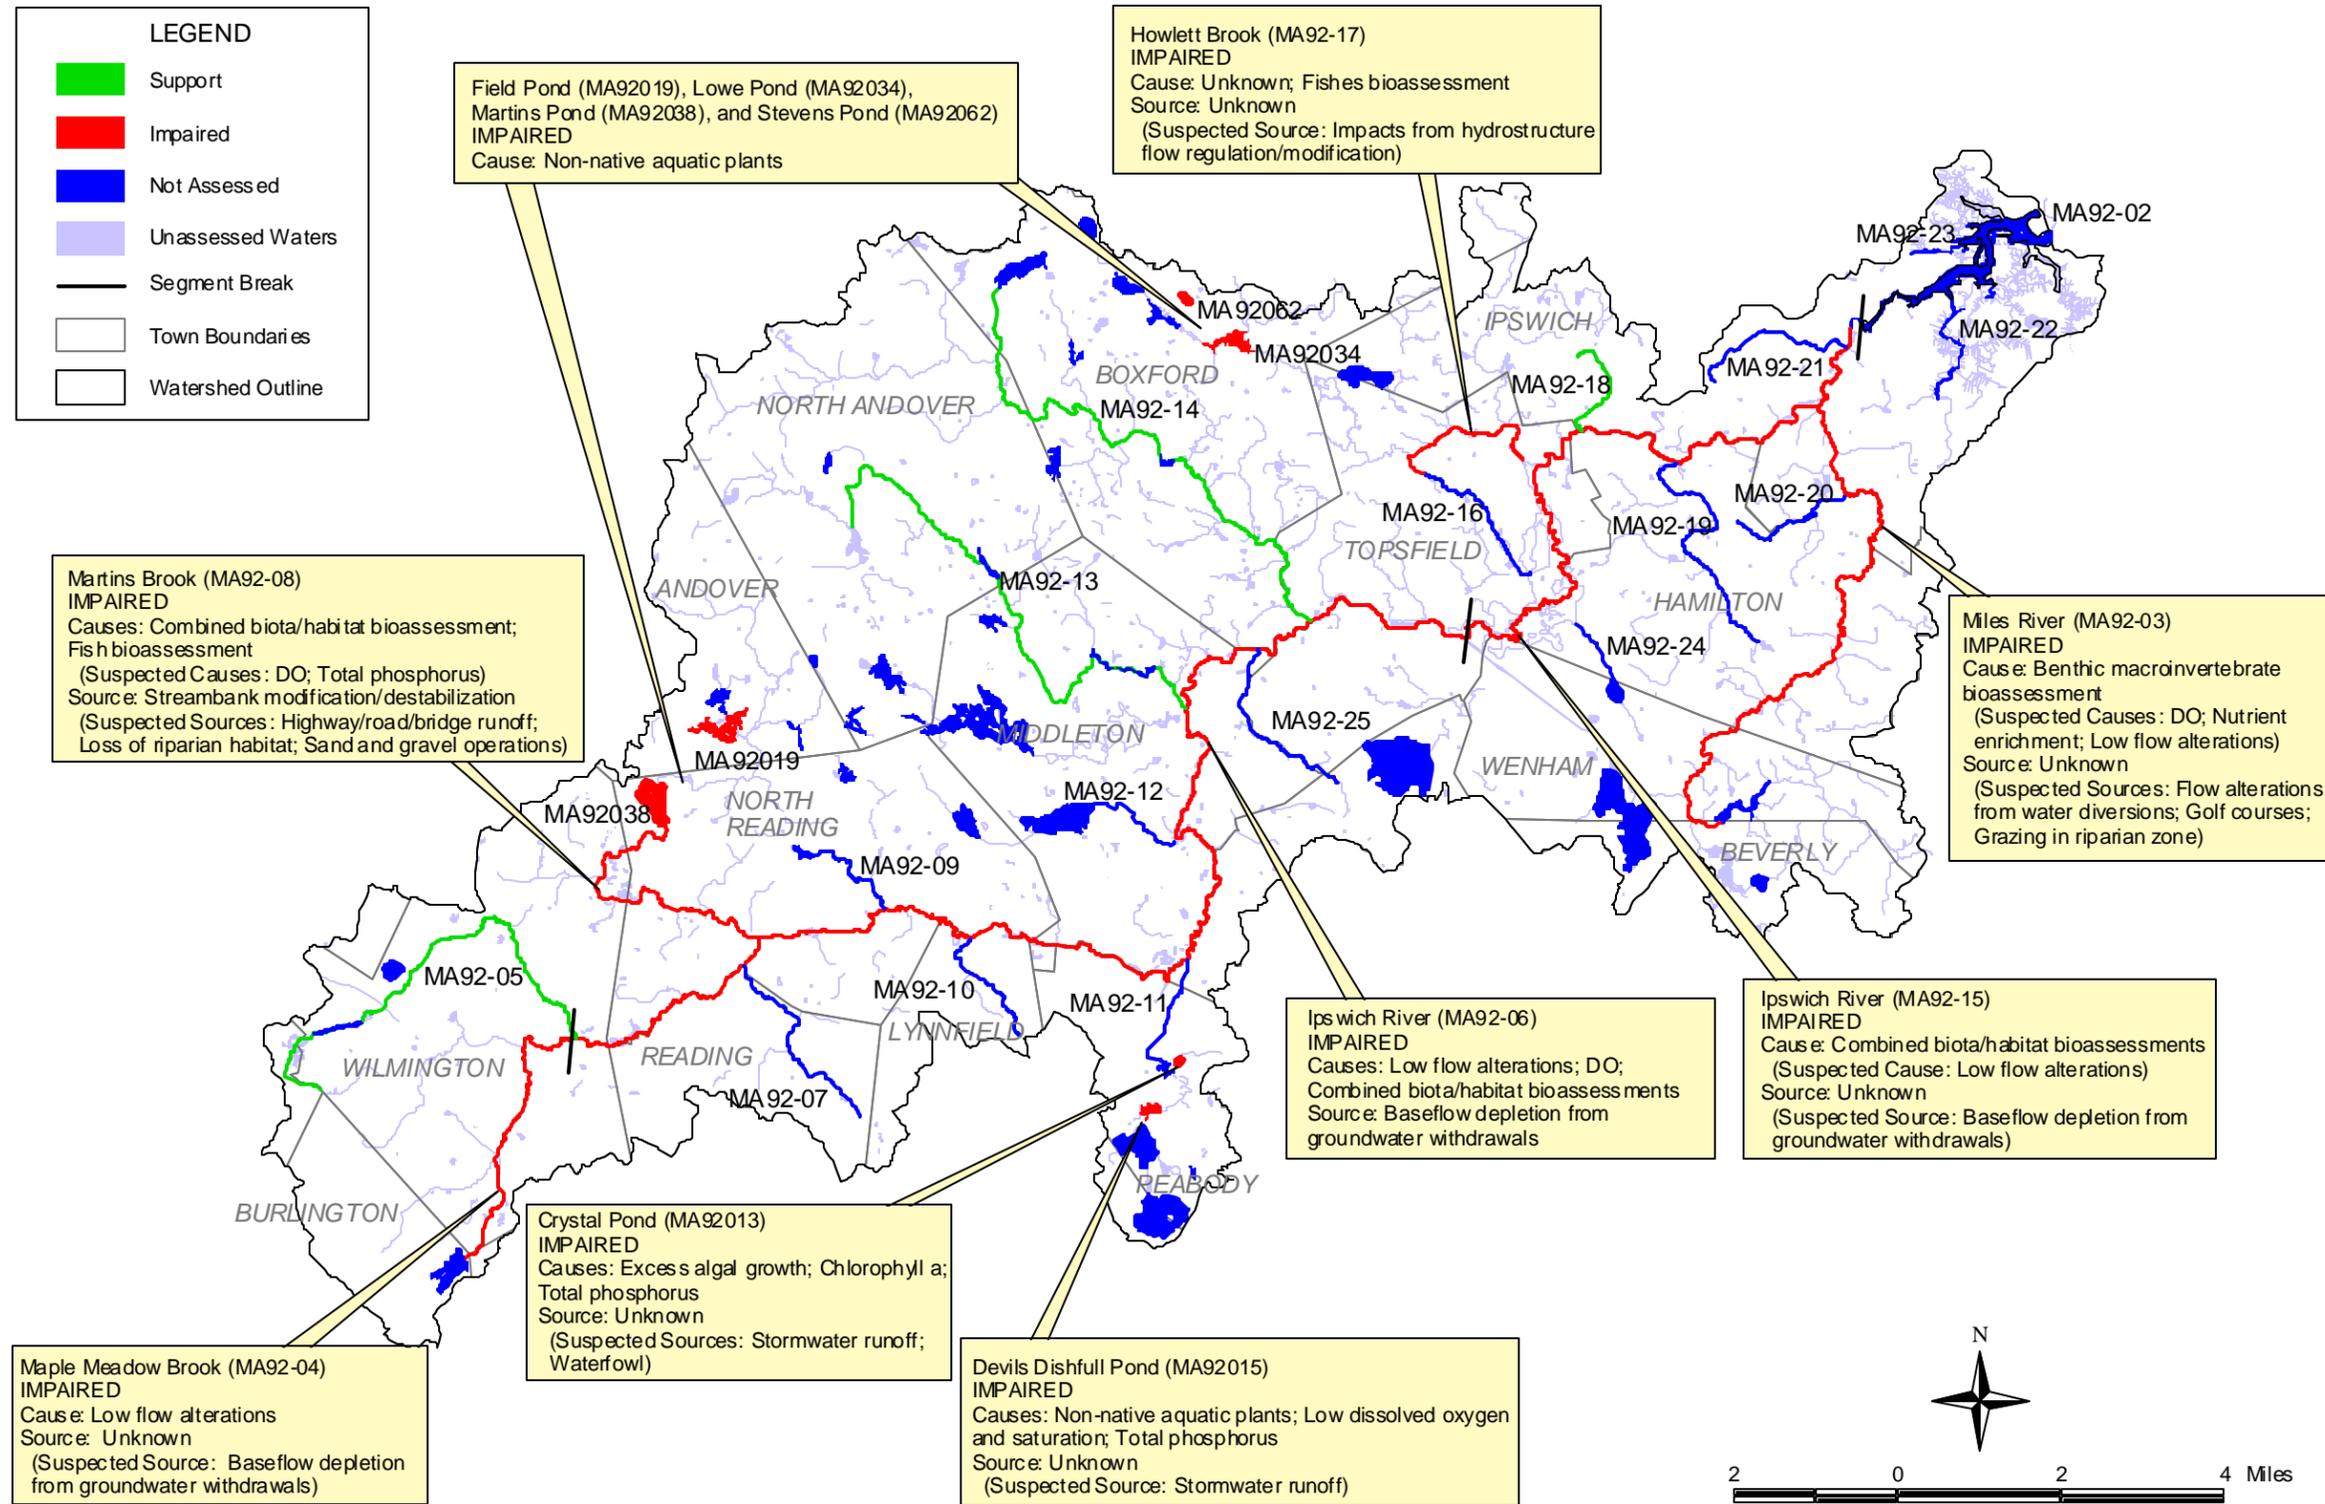
Figure 1: Ipswich River Watershed
 Aquatic Life Use Assessment Summary – Rivers, Estuarine Waters and Lakes

As illustrated in Figure 1, seventy-seven (77)% of the freshwater river segments in the Ipswich River Watershed included in this report is assessed as either support or impaired for the *Aquatic Life Use*. Four tributaries to the Ipswich River, totaling 23.5 river miles (Boston, Fish, Gravelly, and Lubbers brooks), are assessed as supporting the *Aquatic Life Use*. The *Aquatic Life Use* is impaired for the entire freshwater portion of the Ipswich River, as well as Howlett Brook, Maple Meadow Brook, Martins Brook, and the Miles River. When known, one of the primary causes of impairment is low-flow alterations, although impacts to the benthic macroinvertebrate and fisheries communities, other habitat quality degradation, and low dissolved oxygen, were also documented. Where known, sources of impairment include baseflow depletion from

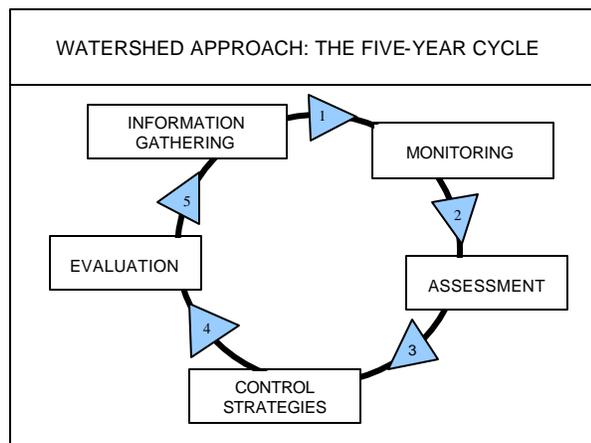
Figure 5. Five-year cycle of the watershed approach

The Massachusetts watershed approach is a collaborative effort between state and federal environmental agencies, municipal agencies, citizens, non-profit groups, businesses and industries in the watershed. The mission is to improve water quality conditions and to provide a framework under which the restoration and/or protection of the watershed's natural resources can be achieved. Figure 5 illustrates the management structure to carry out the mission. This report presents the current assessment of water quality conditions in the Ipswich River Watershed. The assessment is based on information that has been researched and developed by the Massachusetts Department of Environmental Protection (MA DEP) through the first three years (information gathering, monitoring, and assessment) of the five-year cycle in partial fulfillment of MA DEP's federal mandate to report on the status of the Commonwealth's waters under the Federal Water Pollution Control Act (commonly known as the Clean Water Act).

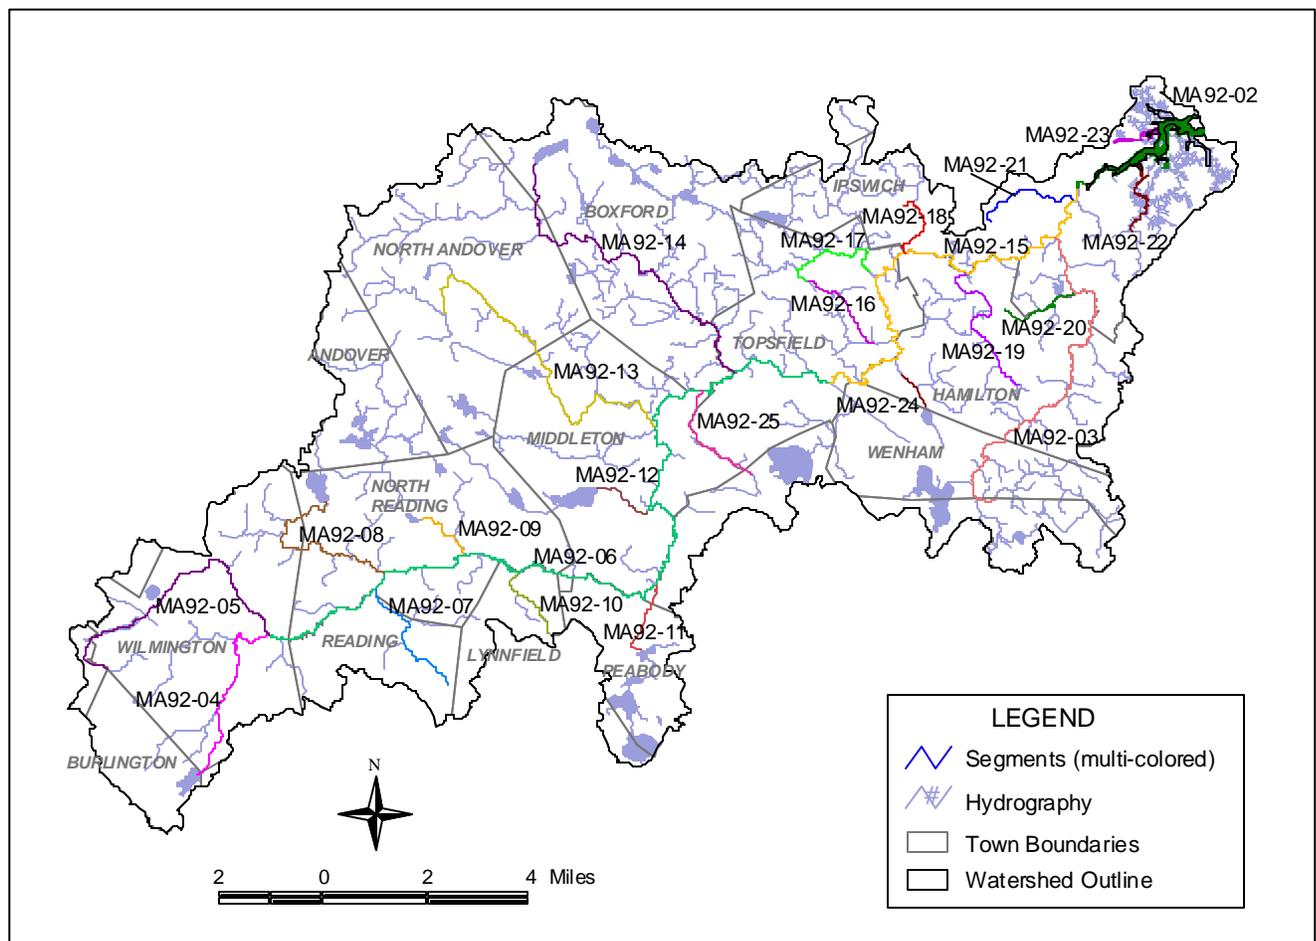
Figure 9. River and Coastal and Marine Segments in the Ipswich River Watershed

MA92-02	Ipswich River	MA92-10	Wills Brook	MA92-18	Gravelly Brook
MA92-03	Miles River	MA92-11	Norris Brook	MA92-19	Black Brook
MA92-04	Maple Meadow Brook	MA92-12	Unnamed Tributary	MA92-20	Long Causeway Brook
MA92-05	Lubbers Brook	MA92-13	Boston Brook	MA92-21	Kimball Brook
MA92-06	Ipswich River	MA92-14	Fish Brook	MA92-22	Labor in Vain Creek
MA92-07	Bear Meadow Brook	MA92-15	Ipswich River	MA92-23	Unnamed Tributary
MA92-08	Martins Brook	MA92-16	Mile Brook		
MA92-09	Unnamed Tributary	MA92-17	Howlett Brook
