# The State of the SNETT

*Southern New England Trunkline Trail  
Assessment & Recommendations*

SOUTHERN NEW ENGLAND TRUNKLINE TRAIL  
A NATIONAL RECREATION TRAIL  
FALL 2014

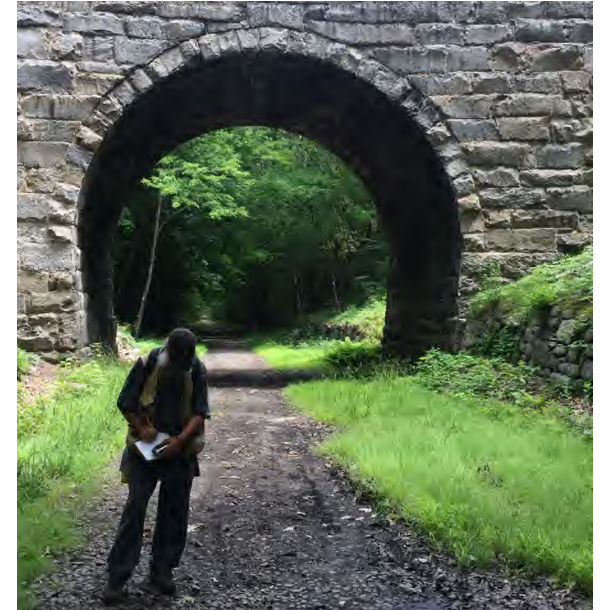
Looking east at the Wallum Lake Road bridge. Historical photos show two rails lines on this section.

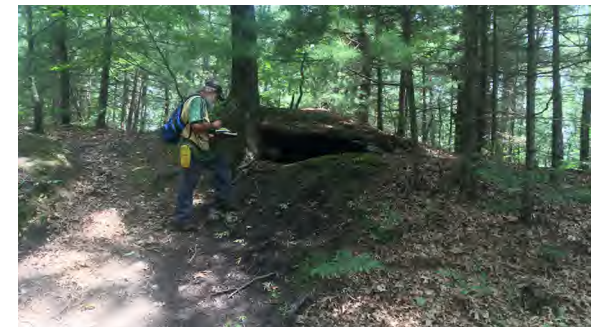
sections that are in relatively good shape headed east. Width is 10 feet until Lee Pond; after Lee Pond it widens to 15 feet. This section has light whaling, is dry and pleasant. It should be noted that the Grand Trunk parallels the SNETT (on average 75-100 feet away) on the south side after Lee Pond. One of the interesting features on this section is the dugout structure on the north side.

Dugout type structure north side of the SNETT.

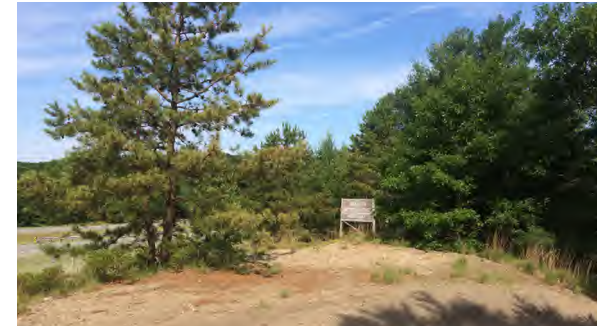
West end of the elevated section of the SNETT between Route 146 and Route 146A. View is looking northwest to Route 146. The motor lodge sign marks the approximate center line of the former railbed.

- Grading is needed but not urgent.
- Parking is needed for this section.
- Resolve access issue for the Route 146 perimeter fence, which is breached.
- The chain link perimeter fence for Route 146 should be mended.

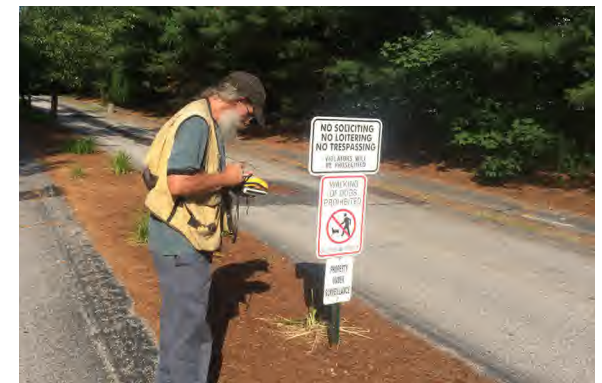
“Walking of Dogs Prohibited”, and “No Soliciting, Loitering, or Trespassing.” There is a sidewalk on the south side of Castle Hill Way. From Route 122, Castle Hill Way climbs gently to meet the original SNETT grade, and after reaching the original grade, the Grand Trunk line “crosses” in a NW-SE direction on two concrete abutments. A quarter mile from Route 122, Castle Hill Way curves to the south and the SNETT continues onto a grassy area until reaching a gate with telecommunications equipment to the south.

Looking east on the SNETT, now Castle Hill Way, from Route 122.

- Determine the status of public access on Castle Hill Way. If public access exists, revise the entrance sign of Castle Hill Way accordingly.
- Resolve the SNETT reconnection at Canal Street.
- Add gravel around manhole standpipes.

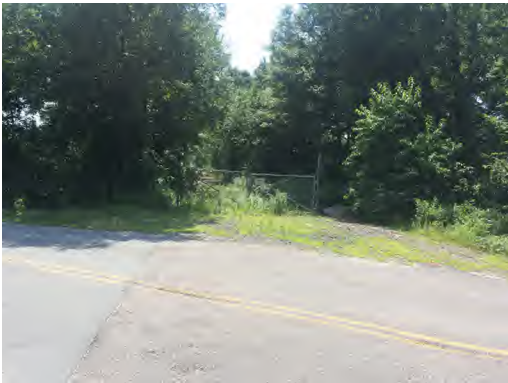
Looking west across Farm Street. Chain link fence with "Danger-Do Not Enter" sign.

- Similar to the previous section, negotiate a public access agreement with the Town of Blackstone for the sewer connector. Replace the chain link fence with a gate or bollards.

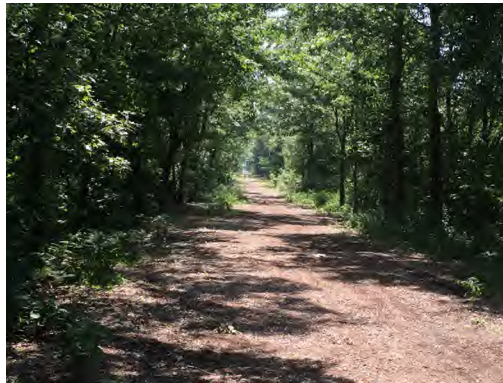
The SNETT looking west of the Farm Street chain link gate.

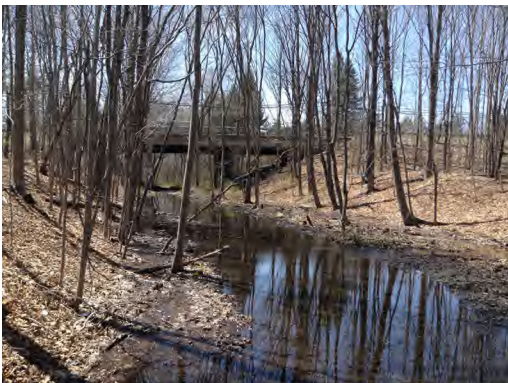
This is the most problematic section of the SNETT. The SNETT crosses under the Route 126 bridge-scheduled to be replaced by a concrete box culvert. Most of the drainage infrastructure under the bridge has failed and the SNETT is extremely wet in this area; it is so wet and overgrown here it is currently unusable. It appears that a culvert from a private property in this area may be diverting water onto the SNETT. The drainage problem continues for 0.34 miles east where the SNETT is entirely below grade. There is no parking or access at Route 126. One could theoretically park at the Bellingham School complex southeast of Route 126 and access the SNETT from a network of ATV/dirtbike trails behind the school.

Looking west at the Route 126 bridge. Standing water on the SNETT railbed.

- The wet section from Route 126 east will be challenging, but replacement of the bridge with a box culvert will be a good start. The water from this section will need a place to go and side ditching to help it get there. Trees and brush on the railbed need to be cut and this section will likely need grading and resurfacing.
- Much of Bellingham is whaled so badly from ATV/dirtbike damage that grading alone the trail will not solve the problem, in fact grading will result in a sunken treadway. Additional surfacing material will be needed in many places. Landscape fabric may help with drainage and provide a barrier to whaling.

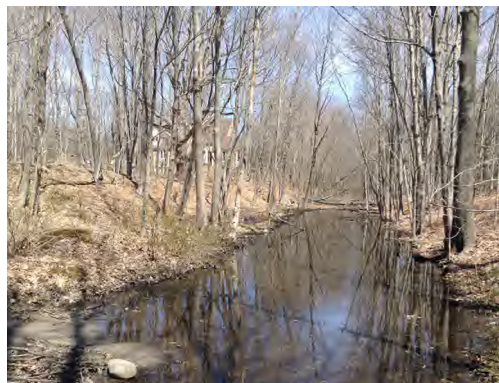
There is an established ATV/dirtbike trail along the south edge of the railbed, this reconnects to the SNETT once it emerges from the below grade swamp. This section is heavily damaged by ATV/dirtbikes with whales in places between 1.5 and 2 feet deep. The SNETT corridor is wooded on both sides until the 12 backyards of the adjacent Newland Avenue neighborhood. Much of the ballast here has been plowed to the side.

Looking east from the Route 126 bridge. The SNETT is under water.

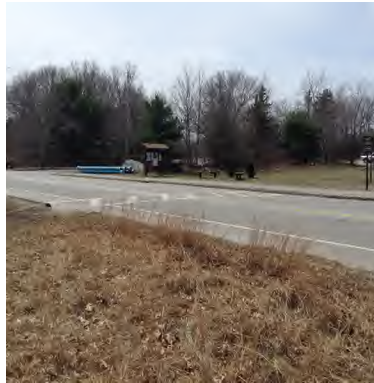
SNETT crossing of Center Street.  
Note crosswalk, trailhead kiosk, and parking sign.

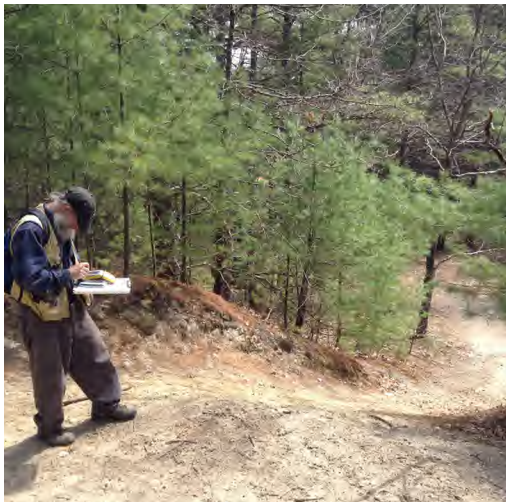
From Center Street east, the old rail line becomes more evident and the SNETT moves along with backyards to the south and woods to the north before reaching the old Railroad Street crossing. After this crossing the SNETT gains grade with farm fields to the south and woods to the north. Just before the farm fields end, a buried gas pipeline crosses the SNETT. The railbed is severely whaled from here to Lake Street. Starting at the pipeline there are numerous ATV/dirtbike trails that enter from both sides of the SNETT. In some places these trails climb the embankment to the railbed and are causing serious erosion to the SNETT's elevated berm.

Eroded illegal ATV/dirtbike access trails up the SNETT berm west of Lake Street.

- Major ATV/dirtbike damage. This entire section is very severely whaled and difficult for walkers. Vegetation on right of way slope and the edge is problematic for grading these whales without creating berms on either side of the right of way. In other words, the whales are so deep that the entire top of the right of way needs to be graded to fix them.
- The pass-through near the sportsman's club is a cultural resource that at one time allowed passage under the right of way. It may be possible to restore and use it as an interpretive opportunity.

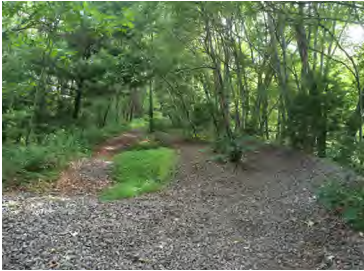
Braided and banked SNETT east of Lake Street.

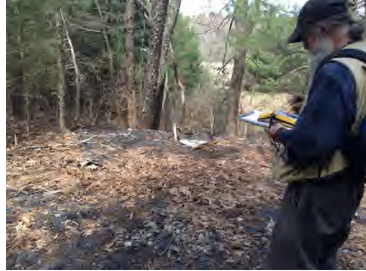
Asphalt shingle dump between Lake Street and Prospect Street.

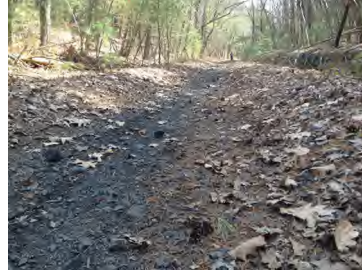
West of Prospect Street: ballast is cupped in the middle of the railbed.

- The wet, below grade section west of Prospect Street needs side ditching and grading. The windrowed ballast should be graded back into the cupped tread.
- The west half of this section is severely whaled by ATV/dirtbike use and is not pleasant to walk on, though we did see groups of walkers using it.
- The gate area at Lake Street is eroded is not preventing ATV/dirtbike access.
- Remove the asphalt shingle dump halfway through this section on the north side.
- The crib wall on the east side is impressive and worthy of interpretation.

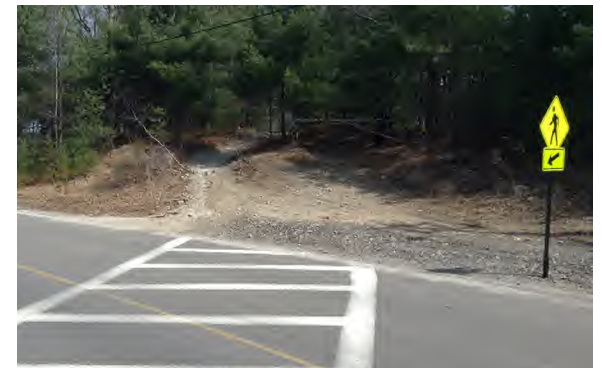
Looking east across Lake Street. Note eroded ATV/dirtbike pass through to left of gate.

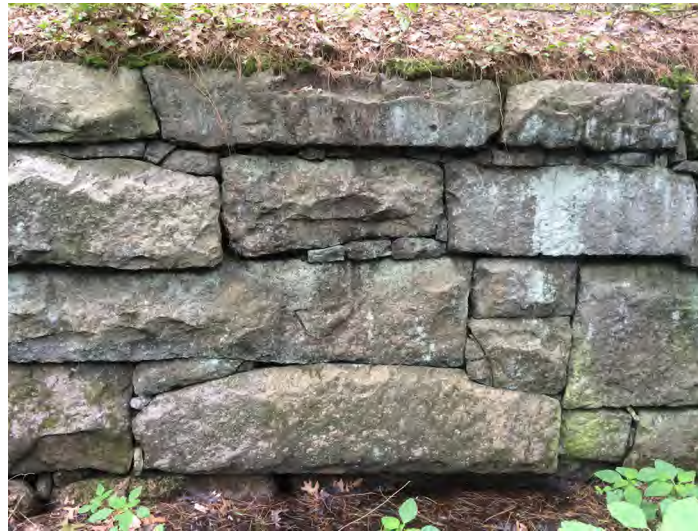
Detail of the 0.25 mile dry laid stone crib wall under and west of Prospect Street.

- Through access at Prospect Street; a tunnel is the preferred option.
- Historical research on the 0.25 mile crib wall at Prospect Street. This wall is one of the SNETT's impressive historical structures, along with the Wallum Lake Road bridge.
- Ditching and surfacing gravel for the 350 feet of wet areas east of Spring Street.
- Ditching and surfacing gravel for the 800 feet of wet section along the cut.
- Grading, particularly between Spring Street and Grove Street.

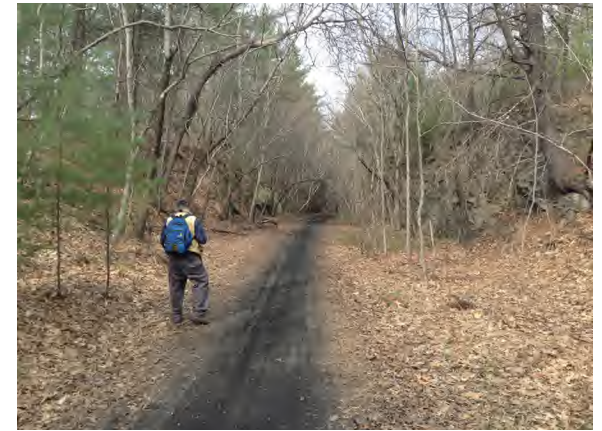
Looking west into the Franklin cut, west of Spring Street.

- The Spring Street gate is not effective at stopping motorized use.
- The cut area is wet for approximately 800 feet. Ditching on the north side of the right of way needs to be cleaned and new surfacing added.
- While there is some “backyard access” along this section, there does not appear to be any major encroachments.
- ATV/dirtbike damage is moderate with light whaling on the west side.
- Whatever approach is used for through access at Prospect Street, it would be preferable to highlight the historic resource of the south side crib wall.
- The right of way is largely clear of vegetation on this section though it closes in on the eastern at-grade section.

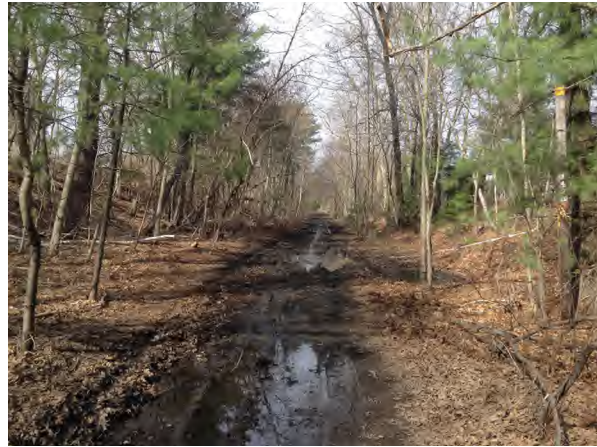
Wet area, looking west towards Spring Street in Franklin. west of Prospect Street.

- There is some “backyard access” on the east end of this section. Damage to the right of way has been caused by ATV/dirtbike access from private land.
- The 350 foot wet section east of Spring Street needs side ditching and surfacing material.
- The gate at Spring Street does prohibit vehicles, but not ATV/dirtbikes.

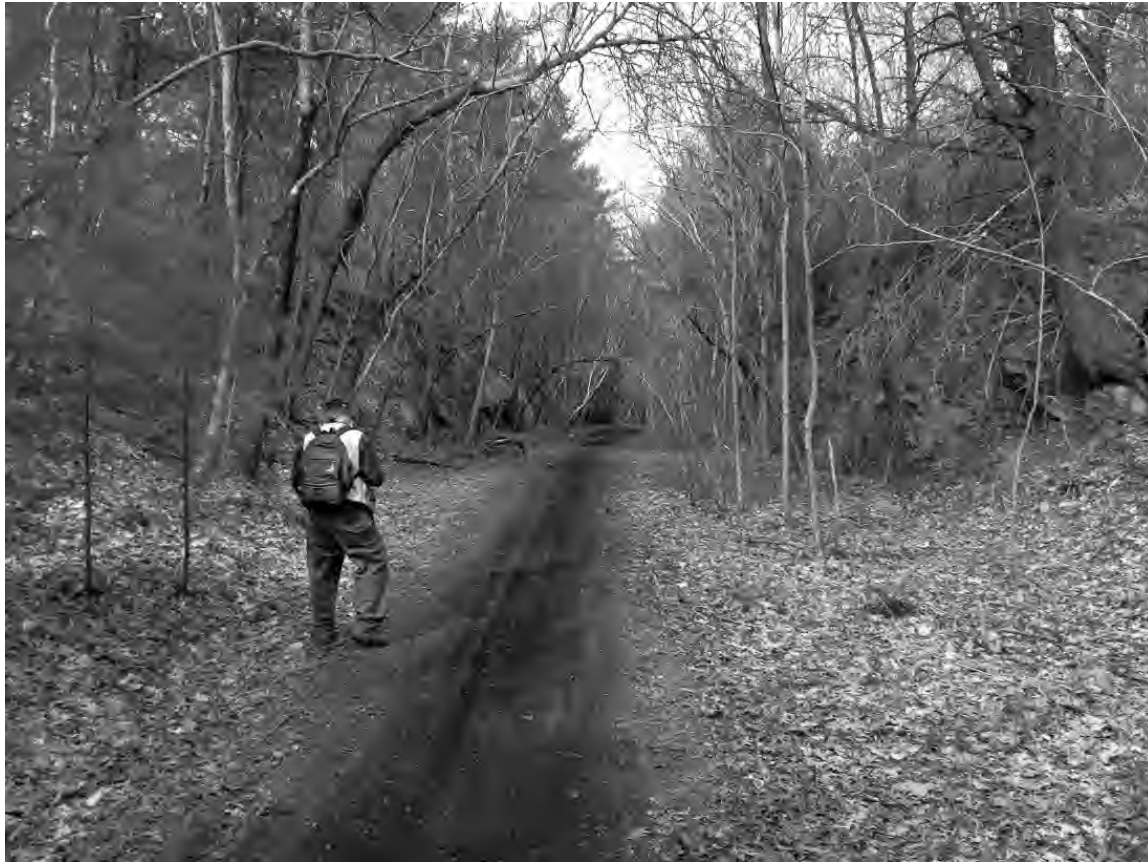
Looking west into the Franklin cut, west of Spring Street.
