WATERSHED-BASED PLAN

Keyup Brook
Within the Towns of Erving and
Northfield, MA

October 2024

Franklin Regional Council of Governments
12 Olive Street
Greenfield, MA

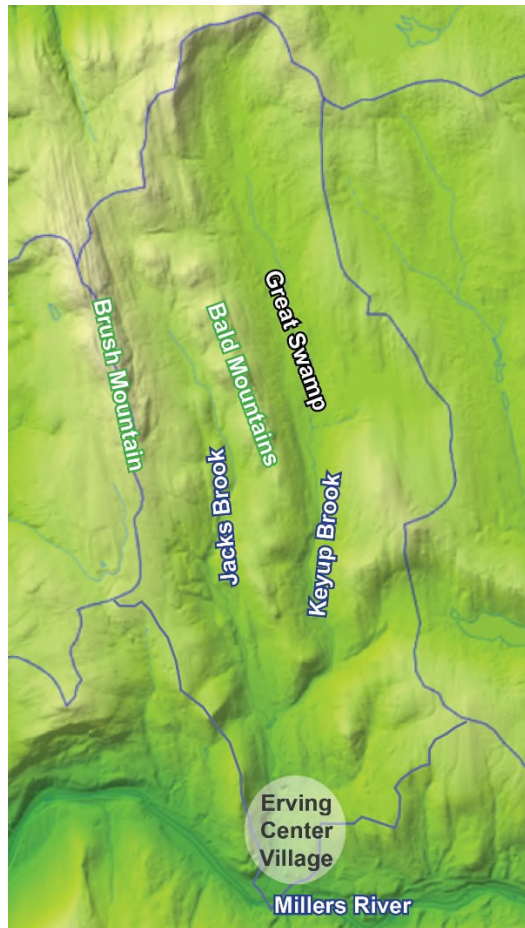
Figure 2: Major topographical features in the Keyup Brook Watershed

Figure 2 shows how Keyup and Jacks Brooks flow through relatively narrow valleys surrounded by high-elevation hills. Jacks Brook flows south between the Bald Hills and Brush Mountain, where there is a nearly 600-foot elevation difference between the brook and the Brush Mountain ridge. The wider valley that characterizes the upper watershed of Keyup Brook in the Northfield State Forest narrows between the Bald Hills and other hills in the northeast corner of Erving, flowing through a highly constricted valley along Swamp Road before it meets Jacks Brook.

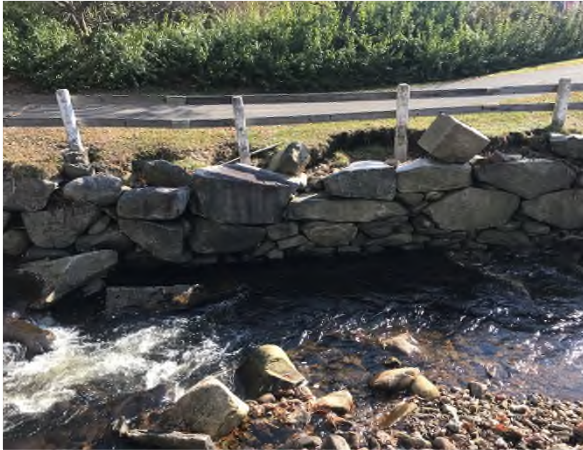
Figure 4a: Bank and wall erosion adjacent to Hanson Court, facing east

Flooding and fluvial geomorphic instabilities can increase sediment loading and transport rates in waterways, which contributes to turbidity, suspended solids, and physical substrate habitat degradation. Figures 4a through 4f of bank instability and active erosion along Keyup Brook demonstrate ongoing fluvial geomorphic instabilities, which represent serious risk to public infrastructure and private property and threats to water quality.

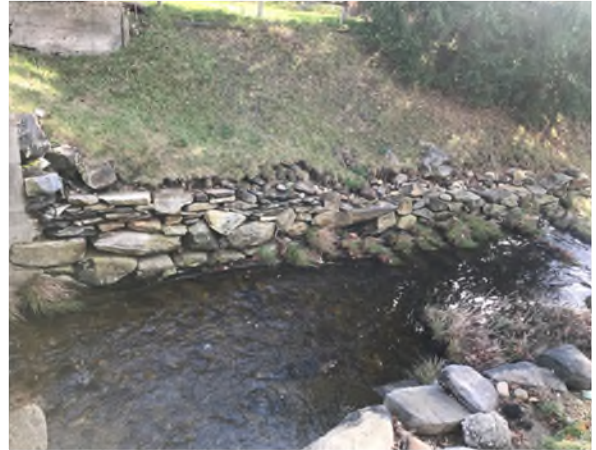
Figure 4b: Bank erosion downstream side of Route 2 bridge, east bank

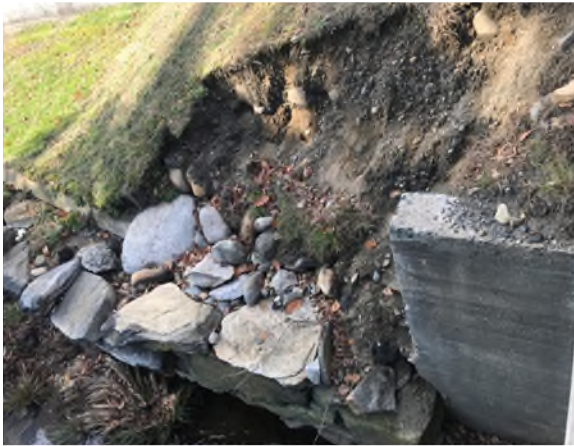
Figure 4c: Bank and wall erosion downstream side of Route 2 bridge, W bank

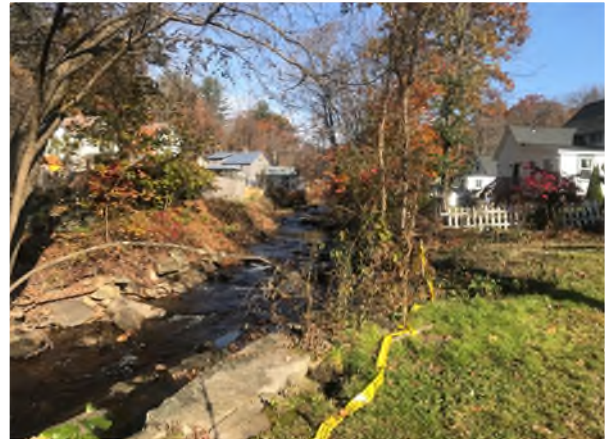
Figure 4d: Bank erosion in lower left corner at Church Street residence, facing north; note the hole in the lawn behind the retaining wall

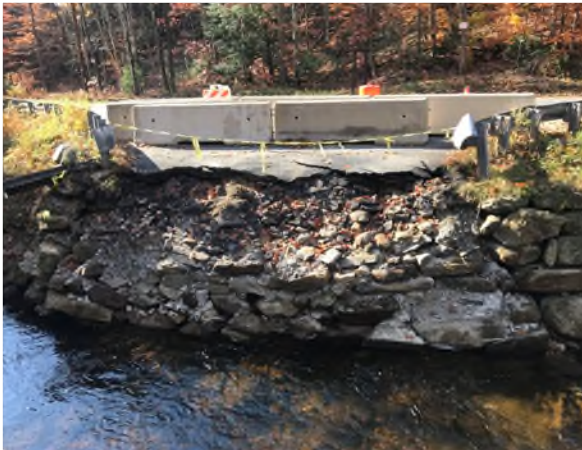
Figure 4e: Swamp Road bridge removed after structural damage, west bank

Paved roads are the dominant road type in the watershed; only Orange Road and the decommissioned Great Swamp Road, both in the upper watershed, are unpaved. No evidence of roadside erosion was found in fieldwork aside from the erosion along North Street in the vicinity of the Swamp Road bridge (see Description of Problem and Figures 4e and 4f).

The Swamp Road bridge destroyed by the 2021 July rains and the stretch of highly eroded bank along North Street are located in the middle watershed, just downstream of the convergence of Jacks and Keyup Brooks and the Pete's Pond Dam. There may be value in focusing on reducing stream power and capturing sediment upstream of this vulnerable section to reduce the intensity of future damage. The Town consulted with the Massachusetts Department of Ecological Restoration about the feasibility of restoring some of the floodplain at the 90-degree turn in Keyup Brook at North Street, but it is thought that this area has only nominal flood storage capacity.²⁸ A fluvial geomorphic study could identify other opportunities for floodplain restoration between the Swamp Road bridge and the Church Street bridge (see Nonstructural BMPs).

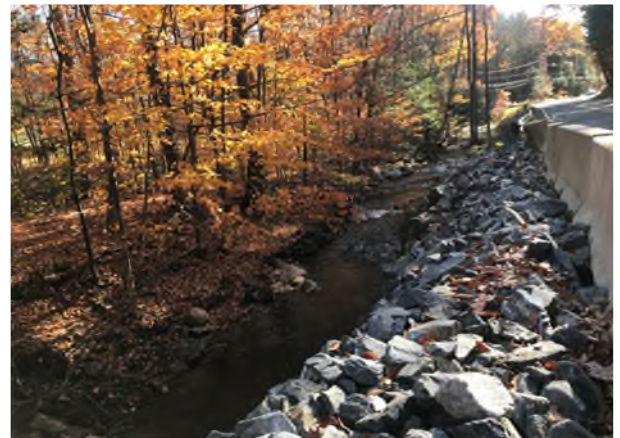
Figure 4f: Riprap placed along North Street after extensive damage to road shoulder, in which bank erosion came within three feet of a sewer main; the former Swamp Road bridge abutments are in the photo background
