Final Restoration Design/Restoration Action Plan for Kirvin Memorial Park, Pittsfield MA

Williams Street, Pittsfield Massachusetts

July 2025

Prepared for General Electric Company
Pittsfield, Massachusetts

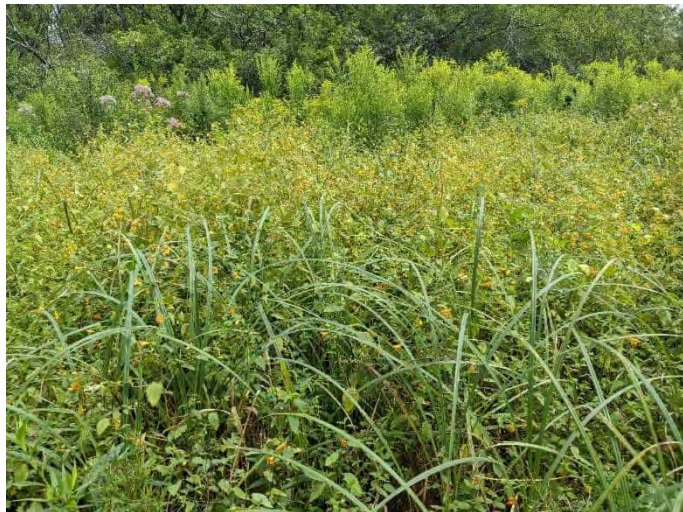
Client Name: General Electric Company		Site Location: Floodplain and Wetland Restoration Plan - Kirvin Park, Pittsfield, MA		Project No. 60605466	
Photo No. 1		Date: 8/9/2022		Photo No. 2	
Description: View North – Vegetation Monitoring Plot, MP-1		Description: View North – Vegetation Monitoring Plot, MP-2

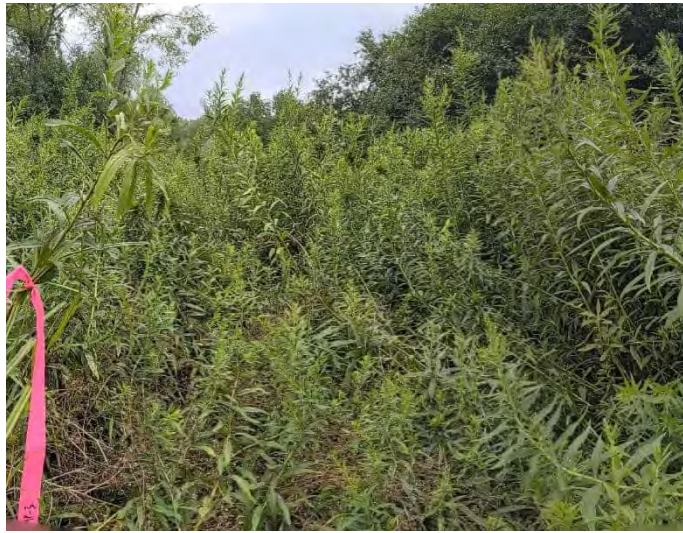
Photo No. 3		Date: 8/9/2022		Photo No. 4	
Description: View North – Vegetation Monitoring Plot, MP-3		Description: View North – Vegetation Monitoring Plot, MP-4

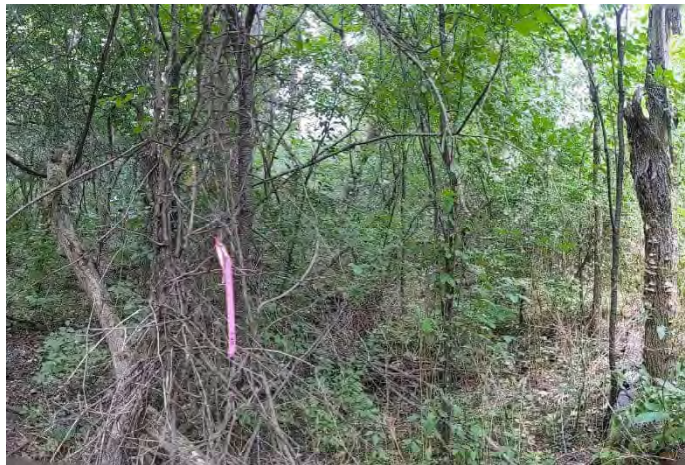
Photo No. 7		Date: 8/9/2022		Photo No. 8	
Description: View Northeast – Vegetation Monitoring Plot, MP-7		Description: View North – Vegetation Monitoring Plot, MP-8

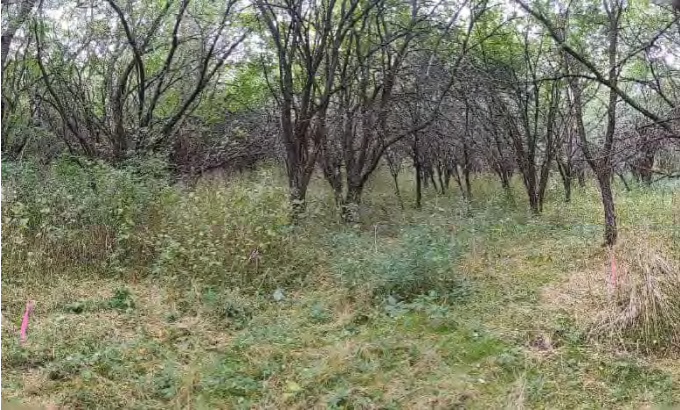
Client Name: General Electric Company		Site Location: Floodplain and Wetland Restoration Plan - Kirvin Park, Pittsfield, MA		Project No. 60605466	
Photo No. 9		Date: 8/9/2022		Photo No. 10	
Description: View West – Vegetation Monitoring Plot, MP-9		Description: View Southwest – Vegetation Monitoring Plot, MP-10

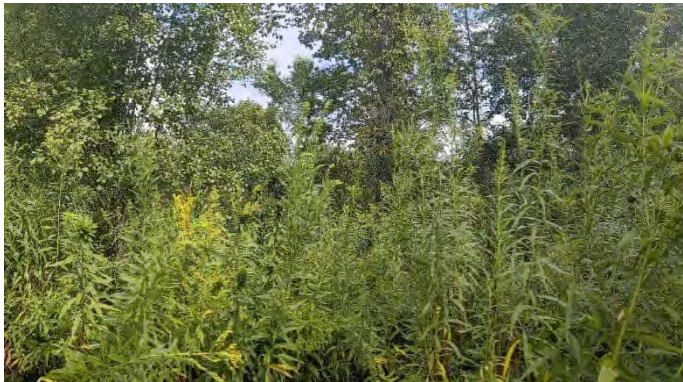
Client Name: General Electric Company		Site Location: Floodplain and Wetland Restoration Plan - Kirvin Park, Pittsfield, MA		Project No. 60605466	
Photo No. 17		Date: 8/23/2022		Photo No. 18	
Description: View North – Vegetation Monitoring Plot, MP-17		Description: View North – Vegetation Monitoring Plot, MP-18

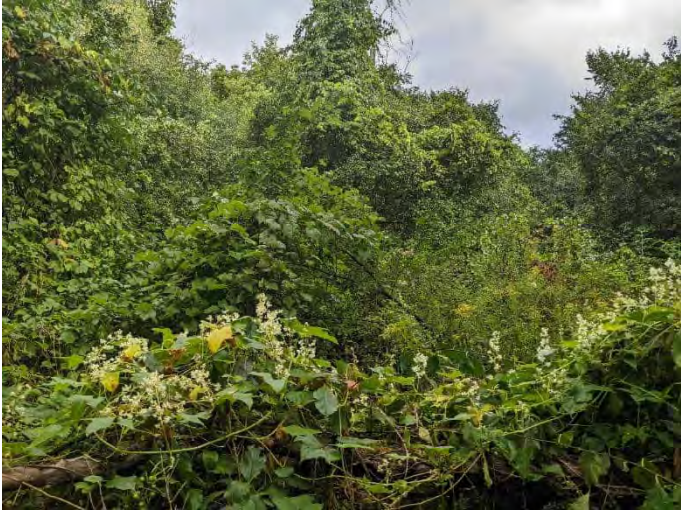
Client Name: General Electric Company		Site Location: Floodplain and Wetland Restoration Plan - Kirvin Park, Pittsfield, MA		Project No. 60605466	
Photo No. 25		Date: 8/23/2022		Photo No. 26	
Description: View North – Opening in buckthorn canopy		Description: View South – Opening in buckthorn canopy with dead tree snag in background.

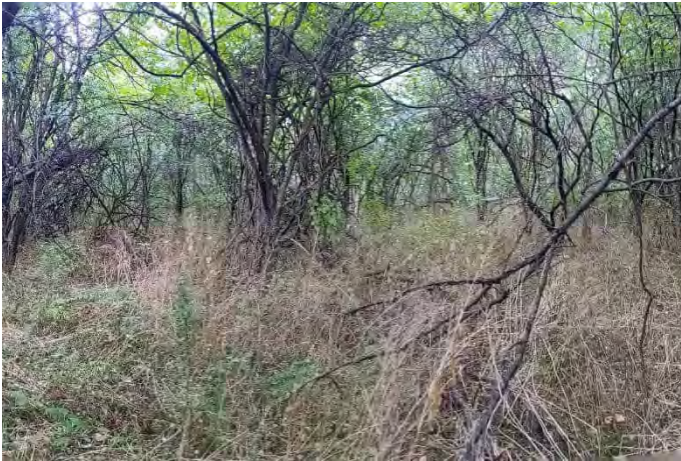
Photo No. 27		Date: 8/23/2022		Photo No. 28	
Description: View East – Area dominated by buckthorn with understory of garlic mustard		Description: View East – Approximately 0.07-acre dominated by young American elm trees

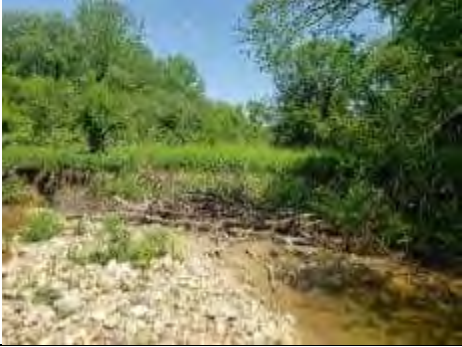
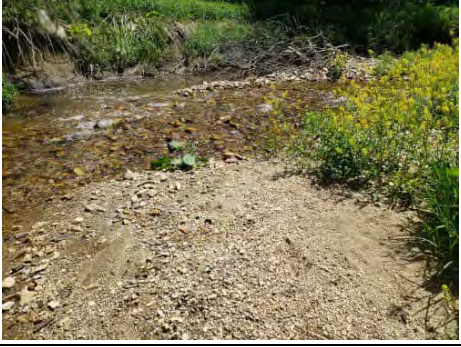
Ashley Brook near confluence with Sackett	Ashley Brook 100 ft upstream of confluence with Sackett

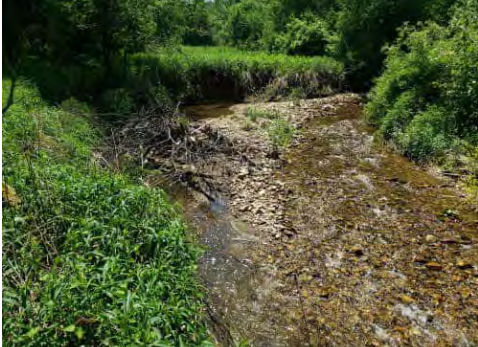
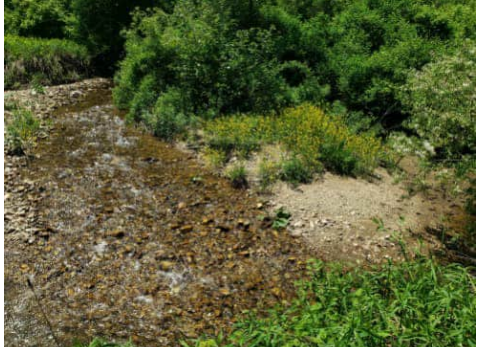
Ashley Brook 100 ft upstream of confluence with Sackett	Ashley Brook 100 ft upstream of confluence with Sackett

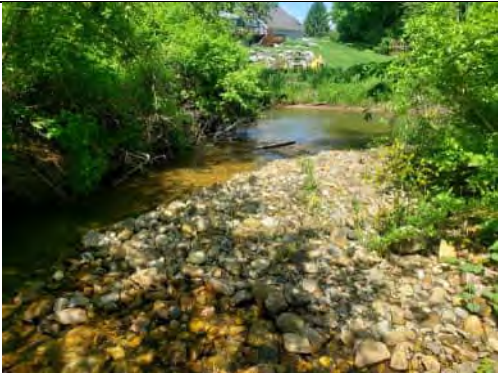
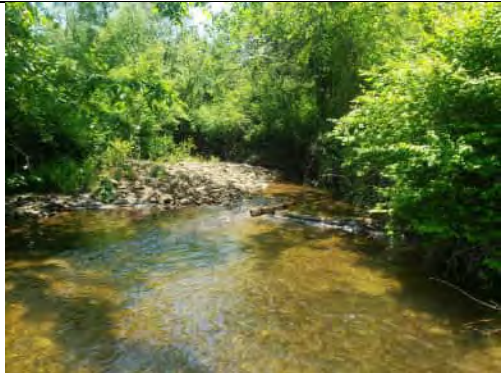
Ashley Brook (left) at confluence with Sackett (in distance)	Sackett Brook looking south at Ashley Brook confluence

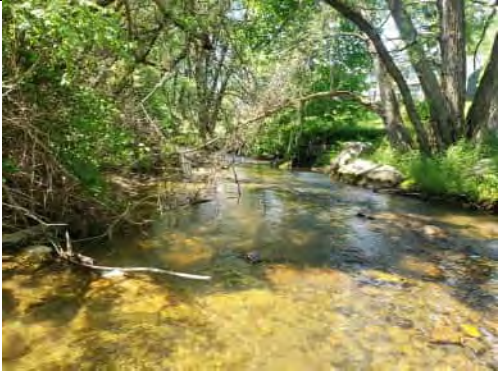
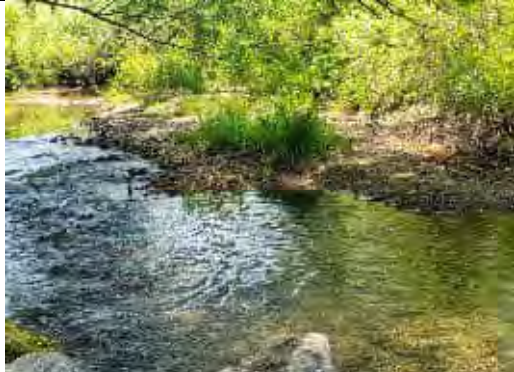
Sackett Brook just downstream of Restoration Area	Sackett Brook at upstream end of Restoration Area

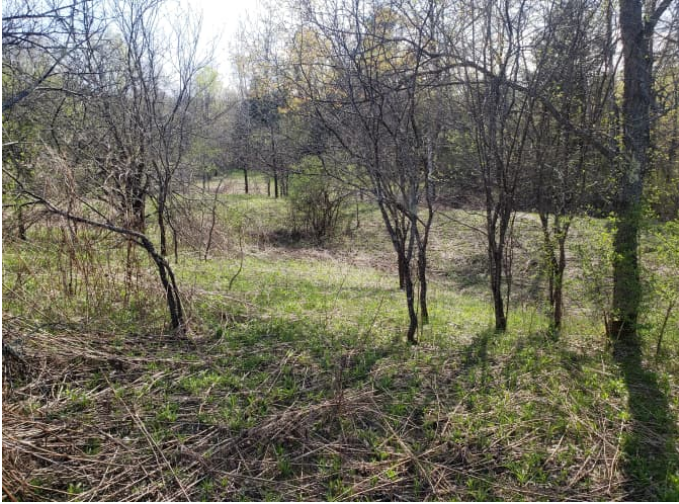
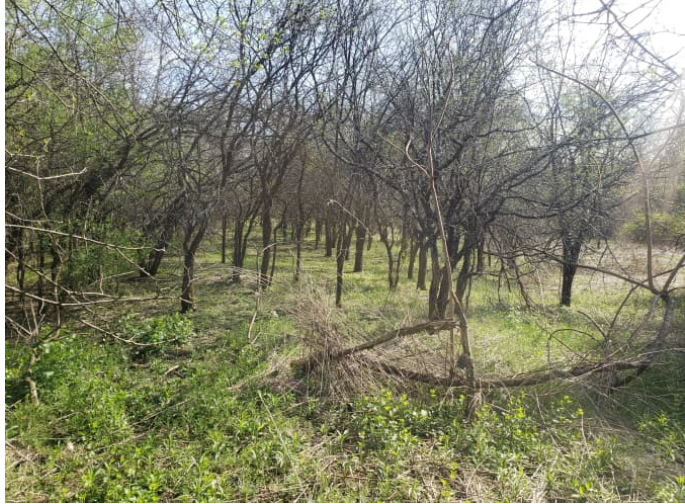
Client Name: GE		Site Location: Kirvin Park south staging area		Project No.	
Photo No. 1		Date: 5/1/25		Photo No. 2	
Description: View of buckthorn and Morrow's honeysuckle growth in south staging area.		Description: Buckthorn and garlic mustard growth in south staging area.

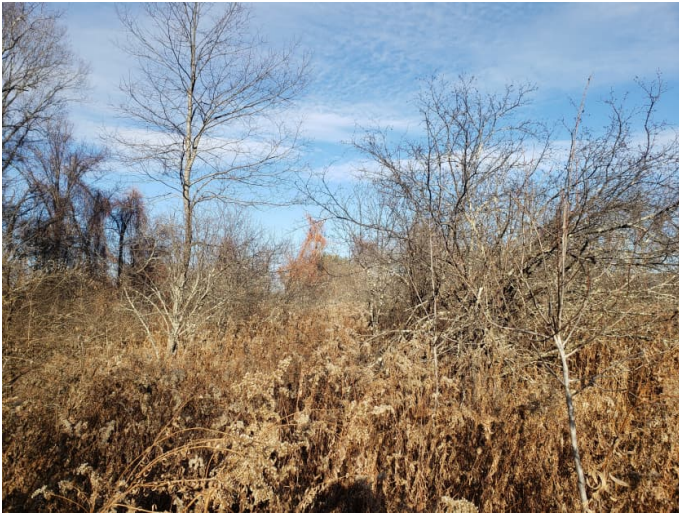
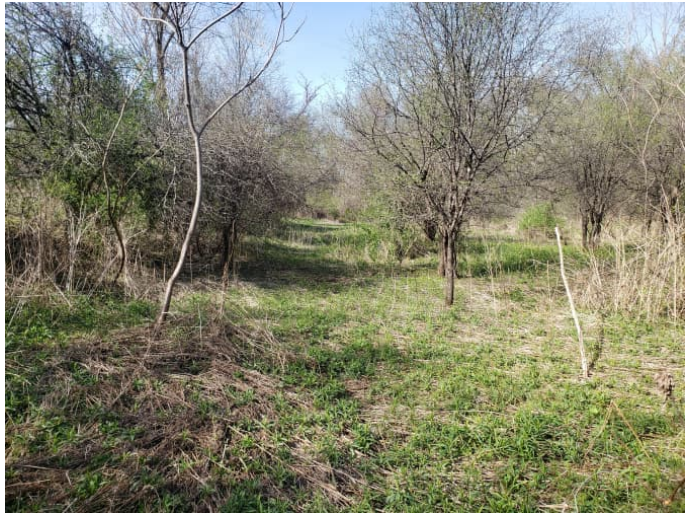
Photo No. 3		Date: 11/20/24		Photo No. 4	
Description: View of south staging area habitat in the fall of 2024. Buckthorn and multiflora rose thicket on the right.		Description: Low-lying swale in east side of south staging area. Scattered buckthorn growth.
