**REPORT#:** 18MA031

**REPORT DATE:** February 25, 2019

## Laborer Dies While Clearing Snow After a Blizzard— Massachusetts

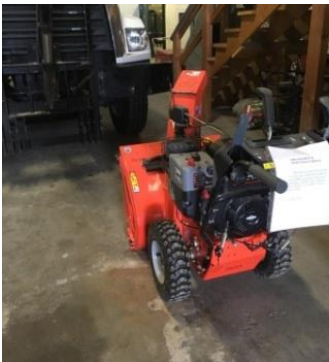
Figure 1 - Snow blower used at the time of the incident

The equipment being used by the victim at the time of the incident was a snow blower (Figure 1). The snow blower was manufactured in 2015. The snow blower operator's area was equipped with multiple controls. Starting at the left side of the operator's area was a heated handle with an integrated traction drive clutch lever, a chute control, electric start, deflector control, speed selector, and the heated right handle with an integrated clutch lever. The snow blower has a 16 inch diameter steel auger, a 28 inch clearing width, four cycle gas engine, and 16 inch wheels. The overall dimensions were 61.5 inches long by 30.5 inches wide by 45 inches high and it weighed 318 pounds.

When possible, scheduling snow removal activities outside of early morning hours could help reduce the risk of cardiac events from occurring. If early morning work in cold environments cannot be eliminated, risk can be tempered by reducing the physical demand required for the task. When employers are assigning snow clearing as a task, the employers should, as they did in this case, provide easily maneuverable self-propelled snow blowers and regularly provide preventive maintenance to ensure equipment is functioning properly. Employers should also ensure that work breaks are scheduled and that the property where the task will be performed is in good repair. For example, the uneven sidewalks or pathways would require additional strenuous maneuvering of a snow blower that can result in increased heart strain and risk of acute cardiac events.

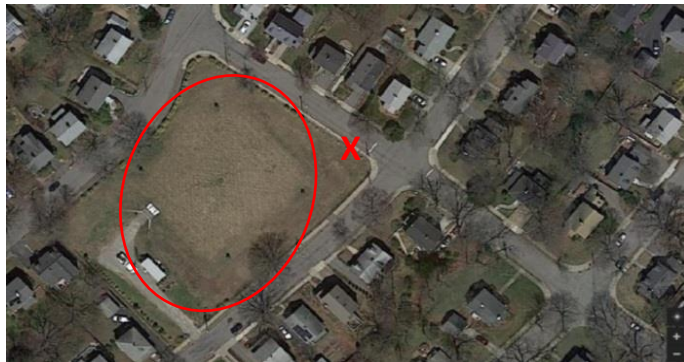
Figure 2 - Aerial view of the underground water tank location (red circle) and location where the victim was found (red X)

The incident occurred at an underground water storage tank located in a residential neighborhood (Figure 2). The area of the underground tank is owned and maintained by the authority. The tank capacity was two million gallons and the storage tank is higher than the ground level, but it is covered with grass. The property is enclosed by a chain-link fence and there is a small building on site that houses pump and electronic equipment. There is a gated driveway that leads to this building. Three sides of the property are boarded by streets with sidewalks. The fourth side of the property abuts a residential building. The sidewalks are about two feet wide and in many locations the sidewalks are buckled due to tree roots (Figure 3). The incident occurred on a section of the sidewalk.

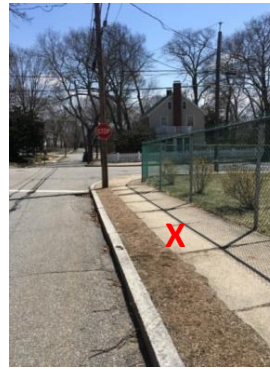
Figure 4 - Location where the victim was found (red X)

The workers then loaded the snow blowers onto the pickup truck and traveled to the next authority owned location, the incident location. The victim started at the far end of the property and started to clear the snow on the sidewalk while the co-worker remained in the driveway area. The victim had cleared a little more than half of the section of sidewalk when at approximately 3:45 a.m. he suffered a myocardial infarction and fell to the ground (Figure 4). A person who lived across the street from where the victim collapsed found the victim and immediately placed a call for emergency medical services (EMS). Within minutes of the placed call, the police and EMS arrived. The victim was transported to a local hospital where he was pronounced dead.

In this case, the victim was paired with a co-worker who was also at the worksite. At the time of the incident, the co-worker was located on the other side of the property, which made the victim outside of the co-workers view. Consequently, the victim's cardiac event and subsequent collapse was unwitnessed and CPR efforts were delayed.
