WATERSHED-BASED PLAN

Lake Cochituate

June 29, 2018

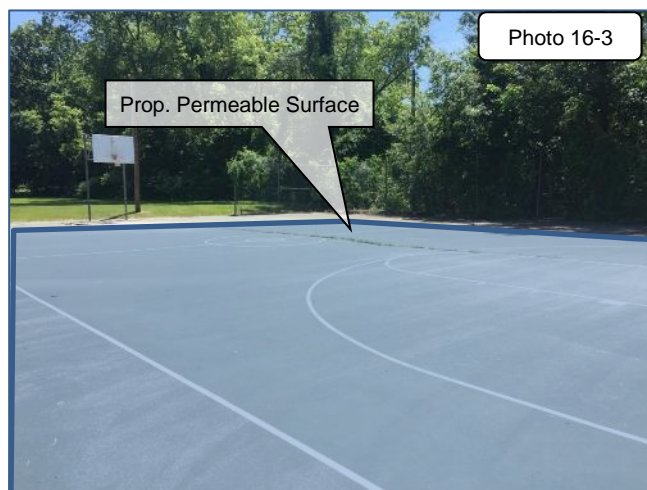
Parcel Ownership: Town Owned (Recreational Park)

Sizing Characteristics	
BMP Drainage Area (acres)	2.1
BMP Size (storm depth; inches)	0.5
Impervious Area (%)	33
Estimated Pollutant Load Reduction	
TP (lbs./yr.)	0.88
TN (lbs./yr.)	7.0
TSS (lbs./yr.)	327.2
Estimated Cost	
Planning-level Capital Cost	\$39,100

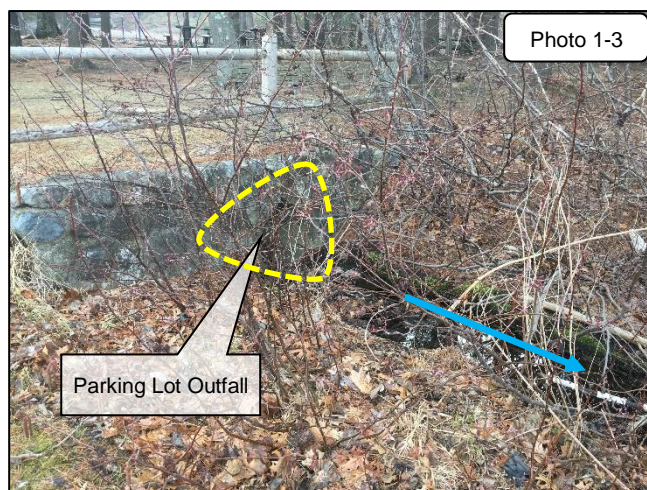
Parcel Ownership: Town Owned Parcel

Sizing Characteristics	
BMP Drainage Area (acres)	3.0
BMP Size (storm depth; inches)	0.5
Impervious Area (%)	73
Estimated Pollutant Load Reduction	
TP (lbs./yr.)	2.5
TN (lbs./yr.)	19.6
TSS (lbs./yr.)	933
Estimated Cost	
Planning-level Capital Cost	\$96,000

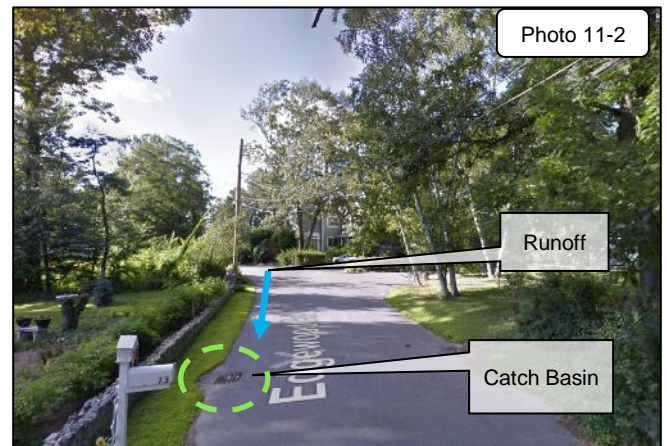
Wetland Permitting: As a replacement/ upgrade of existing stormwater infrastructure, no WPA permitting is anticipated.

Parcel Ownership: Town Owned (Right-Of-Way)

Sizing Characteristics	
BMP Drainage Area (acres)	1.7
BMP Size (storm depth; inches)	0.5
Impervious Area (%)	23
Estimated Pollutant Load Reduction	
TP (lbs./yr.)	-
TN (lbs./yr.)	-
TSS (lbs./yr.)	54.1
Estimated Cost	
Planning-level Capital Cost	\$20,100

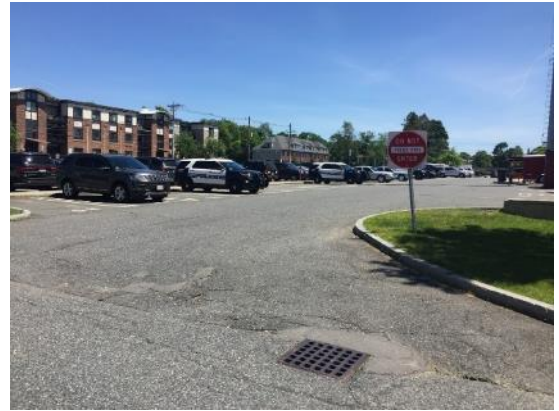
BMP Type: Bioretention Cells (parking lot islands)

BMP Location: 10 Clarendon Street

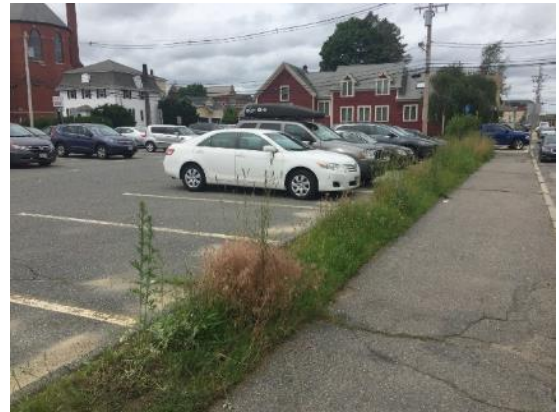
Alternative Site Natick 23: South Ave Parking Lot

BMP Type: Bioretention Cell

BMP Location: 73 South Avenue

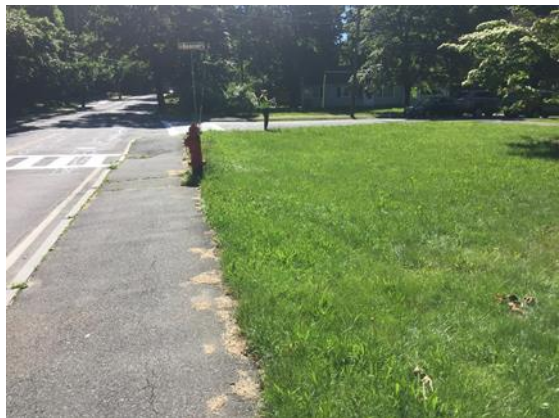
Alternative Site Natick 24: Bacon Street

BMP Type: Raingarden

BMP Location: North Main Street and Kansas Street

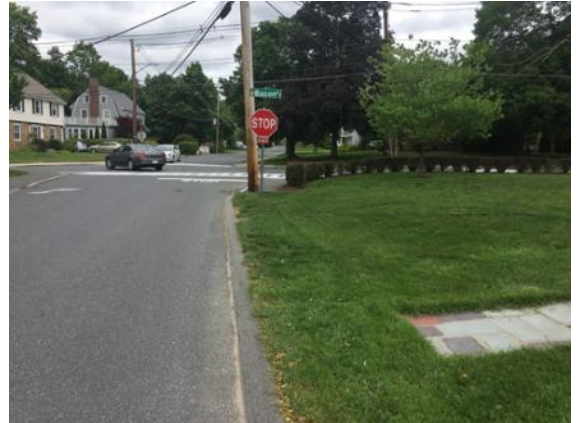
Alternative Site Natick 24: Bacon Street and Park Ave (A)

BMP Type: Bioretention Cell

BMP Location: Intersection of Park Avenue and Bacon Street

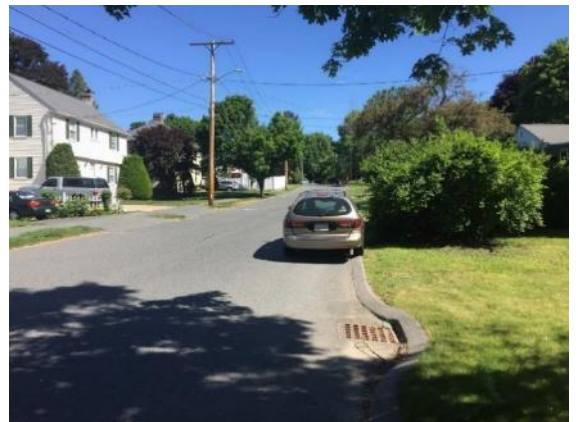
Alternative Site Natick 25: Park Avenue

BMP Type: Raingarden

BMP Location: Intersection of Park Street and Grove Street

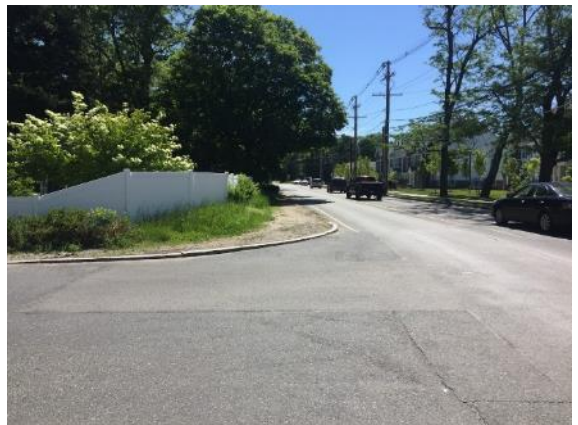
Alternative Site Natick 26: Park Avenue and Main Street

BMP Type: Bioretention Cell

BMP Location: Intersection of North Main Street and Park Avenue

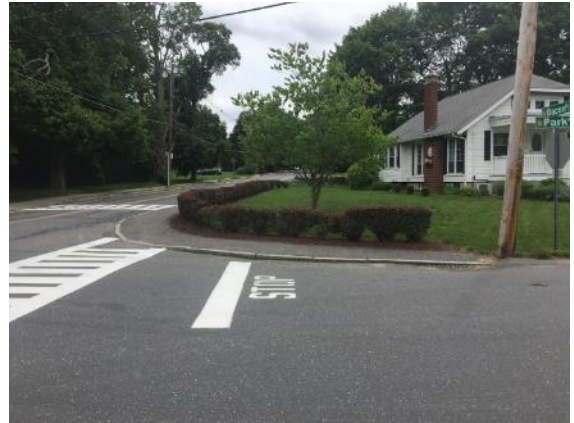
Alternative Site Natick 27: Bacon Street and Park Ave (B)

BMP Type: Water Quality Swale

BMP Location: Intersection of Park Avenue and Bacon Street

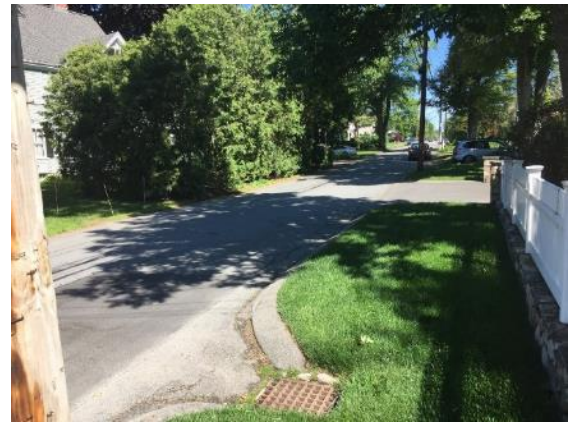
Alternative Site Natick 28: Charles Street

BMP Type: Raingarden

BMP Location: Intersection of Charles Street and Grove Street

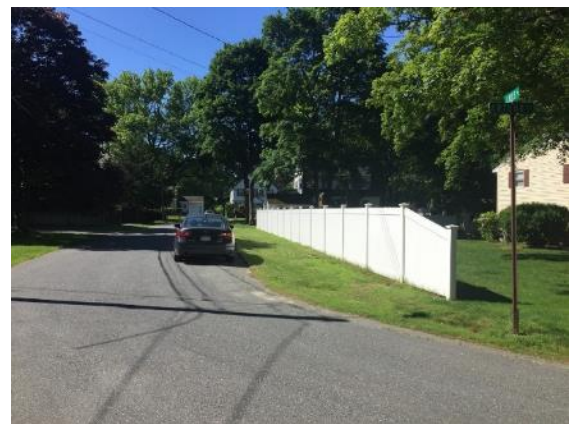
Alternative Site Natick 29: Lois Street

BMP Type: Water Quality Swale

BMP Location: Intersection of Lois Street and Arthur Street

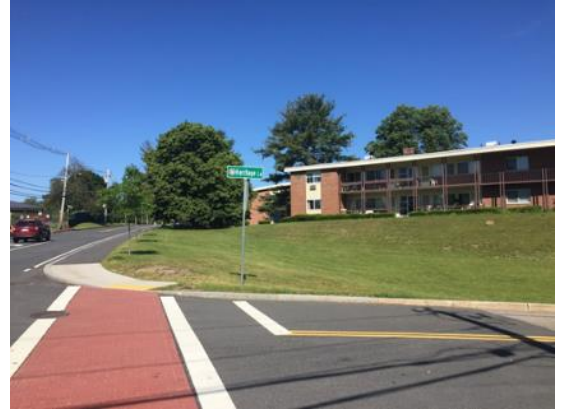
Alternative Site Natick 30: Heritage Lane

BMP Type: Bioretention Cell

BMP Location: Intersection of Kansas Street and Heritage Lane

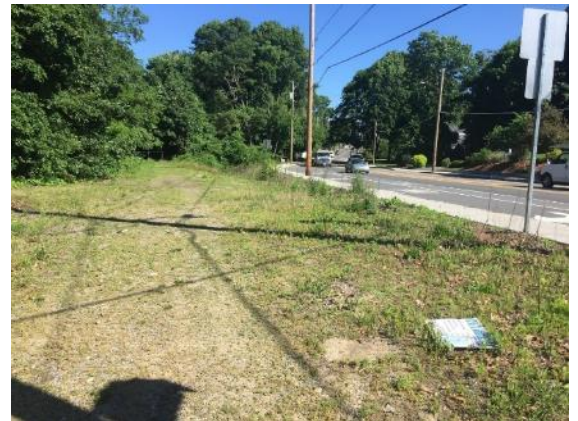
Alternative Site Natick 31: North Main Street

BMP Type: Water Quality Swale

BMP Location: North Main Street and Kansas Street

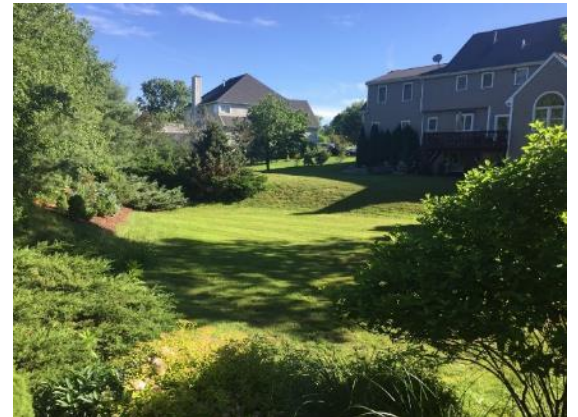
Alternative Site Natick 32: Blossom Circle

BMP Type: Extended Detention Basin

BMP Location: 6 Blossom Circle

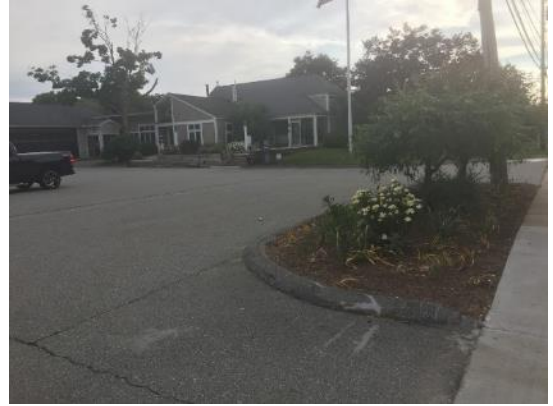
Alternative Site Natick 33: Natick Animal Clinic

BMP Type: Bioretention Cell

BMP Location: 121 West Central Street

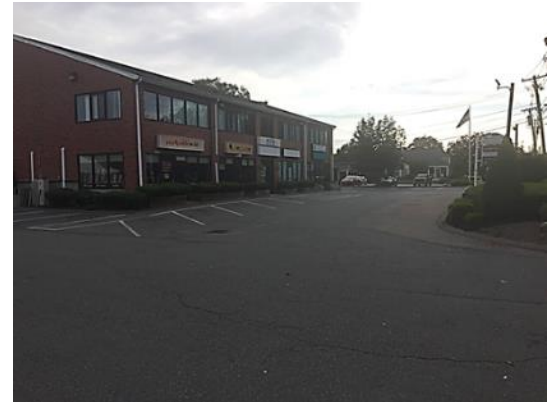
Alternative Site Natick 34: Pizza Shop

BMP Type: Hydrodynamic Separators

BMP Location: 127 West Central Street

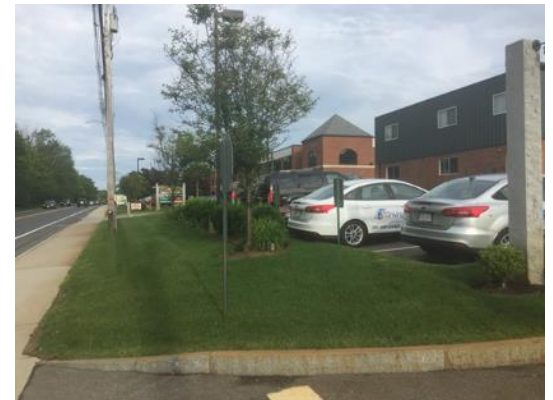
Alternative Site Natick 35: De Luca Landscaping

BMP Type: Bioretention Cell

BMP Location: 115 West Central Street

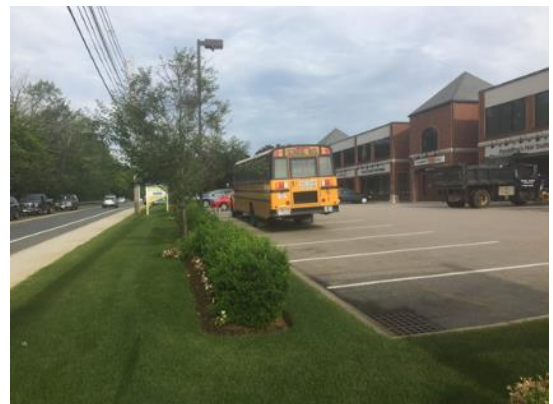
Alternative Site Natick 36: Lakeview Crossing

BMP Type: Bioretention Cell

BMP Location: 119 West Central Street

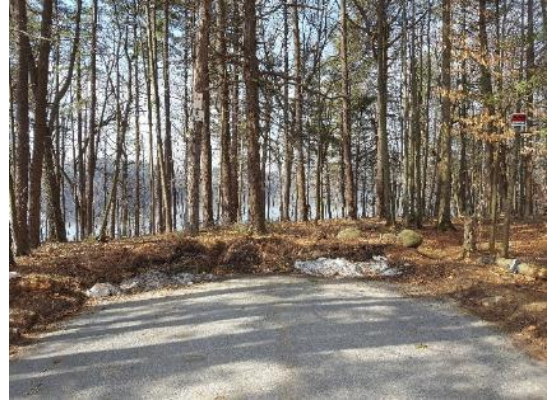
Alternative Site Wayland 13: Fuller Road

BMP Type: Hydrodynamic Separator

BMP Location: 59 Fuller Road

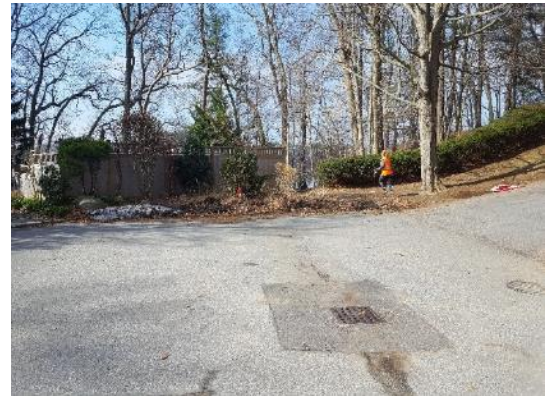
Alternative Site Wayland 14: Maguire Road

BMP Type: Vegetative Barrier

BMP Location: North Main Street and Kansas Street

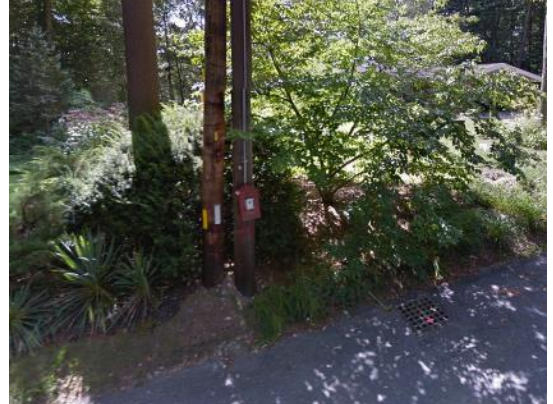
Alternative Site Wayland 15: Lake Road Terrace

BMP Type: Hydrodynamic Separator

BMP Location: Intersection of Lake Road and Lake Road Terrace

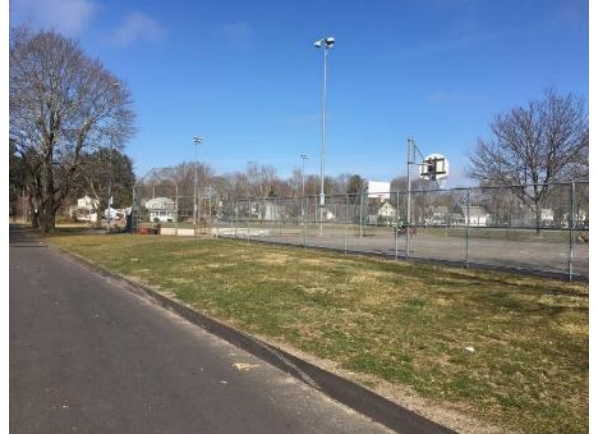
**Alternative Site Wayland 16: Cochituate
Baseball Field C**

BMP Type: Raingarden

BMP Location: West Plain Street

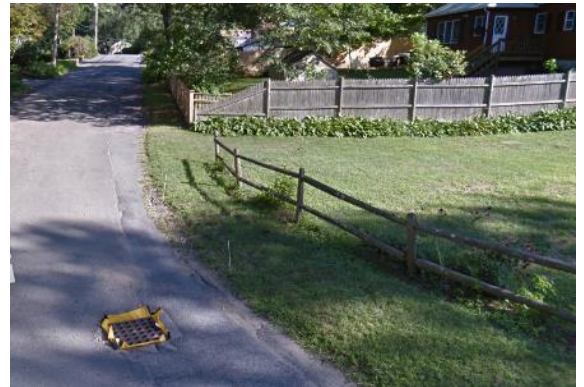
Alternative Site Wayland 17: Lakeview Road

BMP Type: Hydrodynamic Separator

BMP Location: 24 Lakeview Road

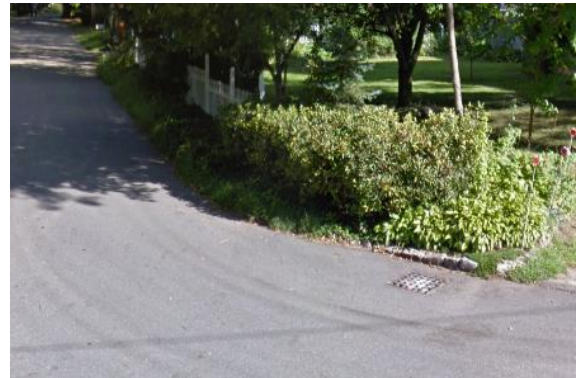
Alternative Site Wayland 18: Parkridge Road

BMP Type: Hydrodynamic Separator

*BMP Location: Intersection of Parkridge Road and
Edgewood Road*
