WATERSHED-BASED PLAN

Lake Wyola (MA34103)

October 2024

Franklin Regional Council of Governments
12 Olive Street
Greenfield, MA

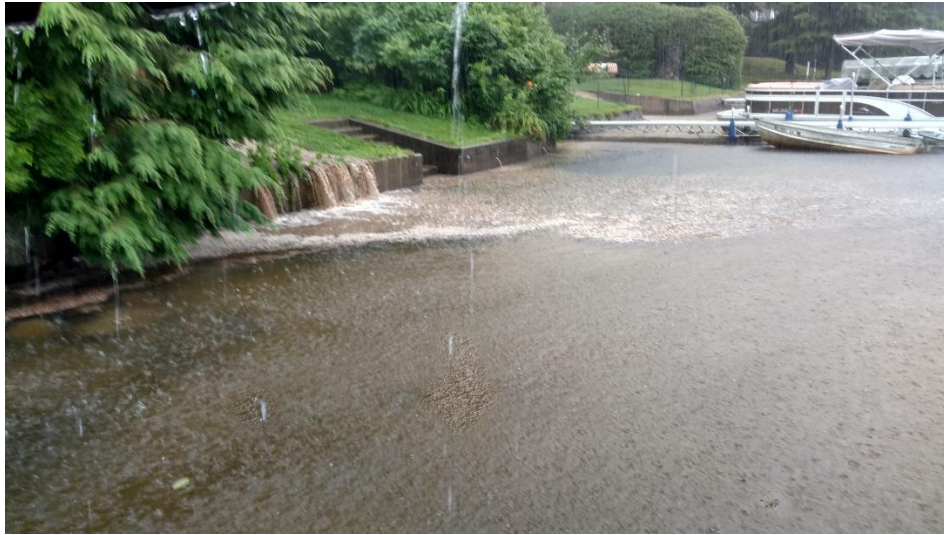
Figure A-4: Untreated stormwater entering Lake Wyola during heavy rainfall via piped and surface flow through a residential property at low point in the road

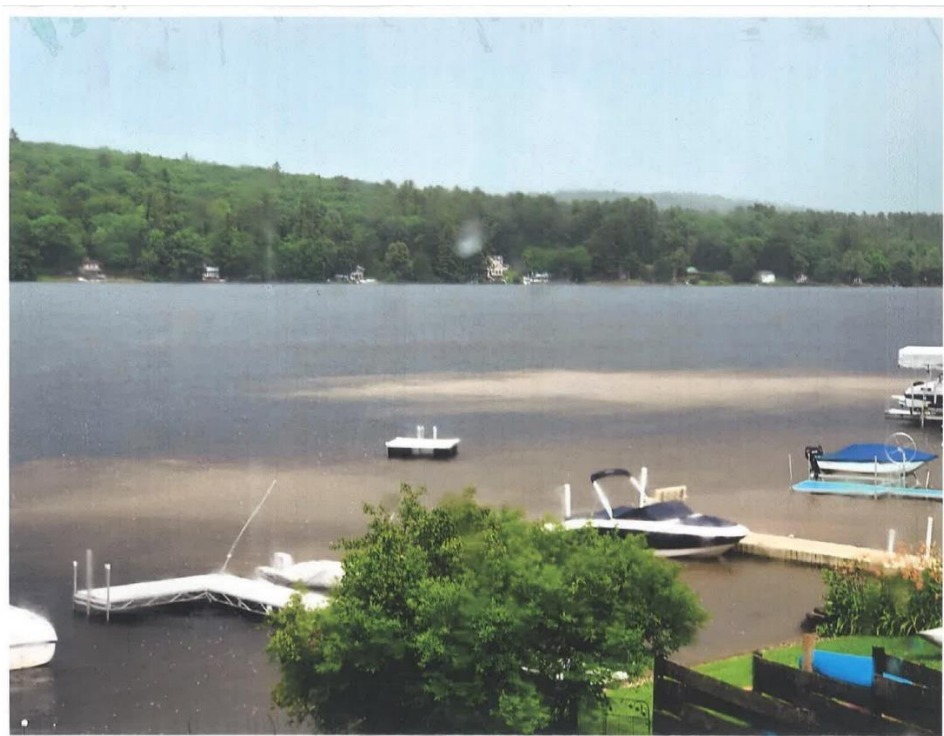
Figure A-5: Sediment plumes from two drainage pipes on west side of Lake Wyola after heavy rainfall, July 14, 2021

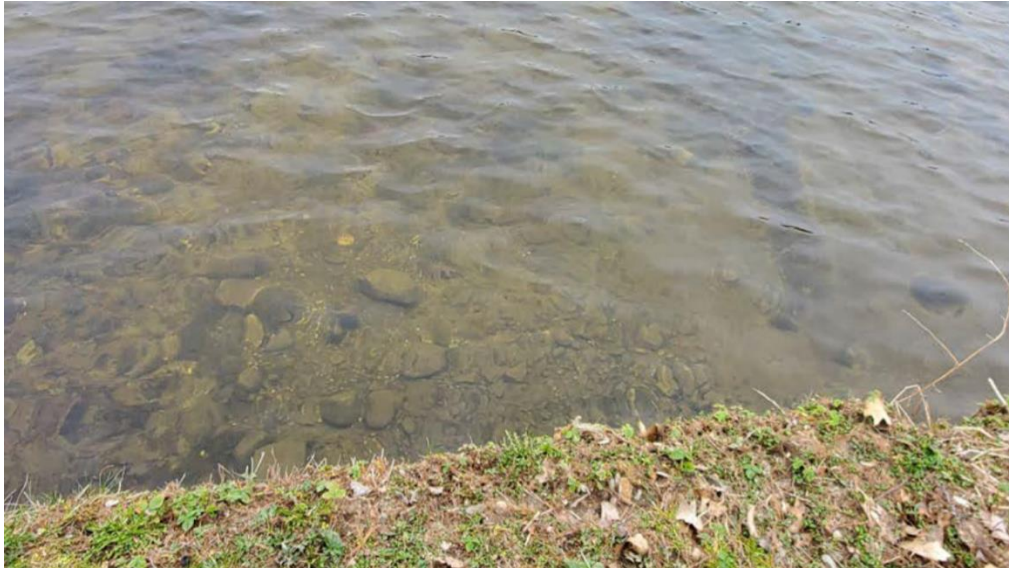
Figure A-6: Road material deposition in lake

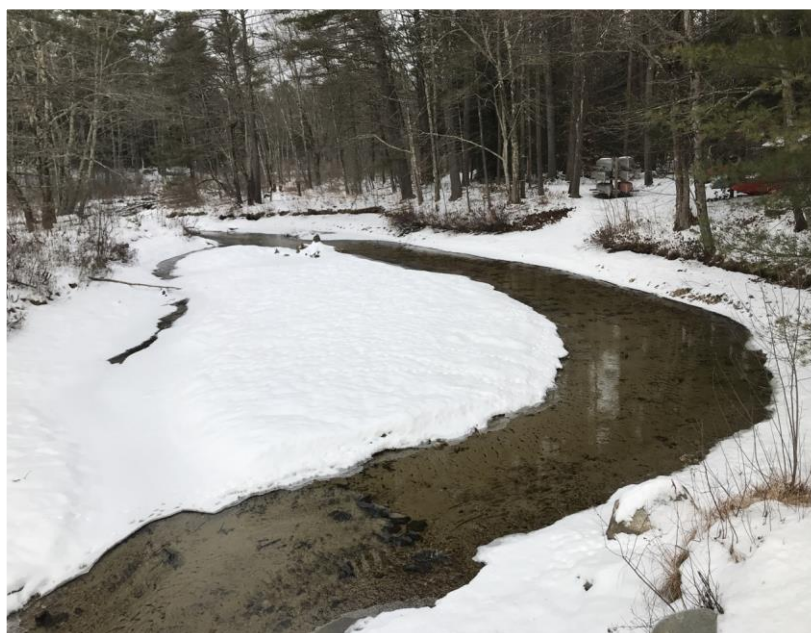
Figure A-9: Channel of Fiske Brook flowing through area North Cove north of Lakeview Drive, as seen from Lakeview Drive

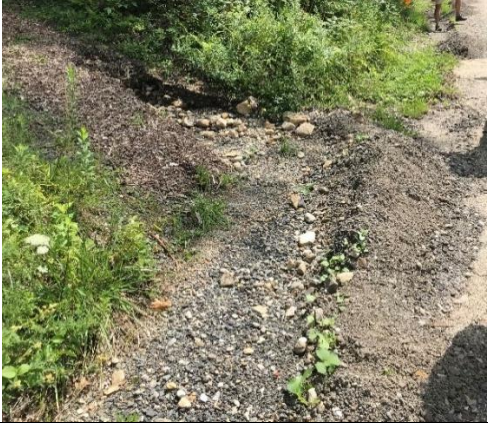
Shore Road		
<ul style="list-style-type: none">• Runoff from Dawson Straights, across a residential property and along Shore Drive is causing erosion and depositing sediment.

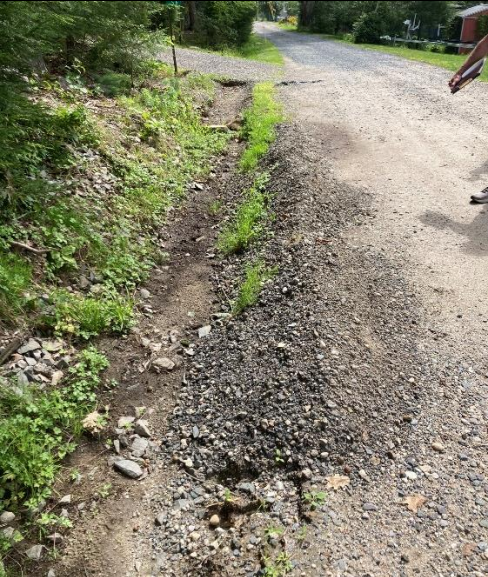
<ul style="list-style-type: none">• Shore Road shoulder was been eroded away by July rain storms, and residents have been repairing with material from gravel piles.

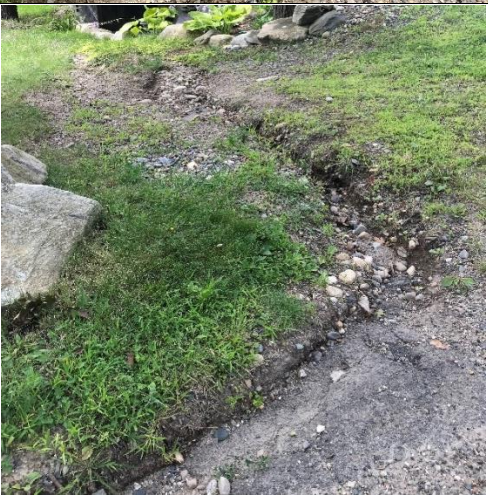
<ul style="list-style-type: none">• Drainage from Shore Drive, down to Hans Bietsch beach (LWA east side beach) is eroding a channel.

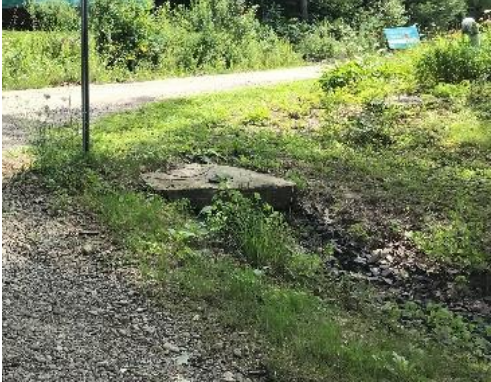
Pine Drive	
<ul style="list-style-type: none"> Driveway pipe, swale, and catchment area have been working this summer. Two loads of sediment had developed at that point in the summer that required removal from the catchment pool.

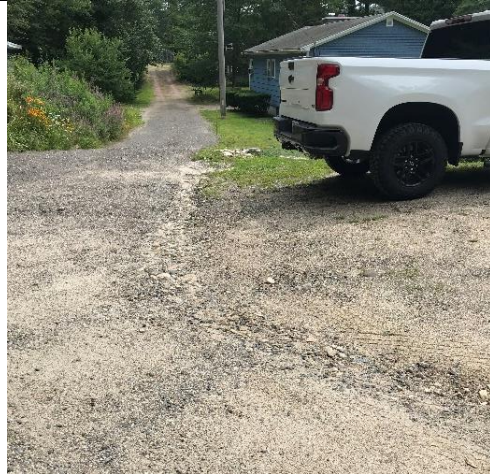
- “Oily” road sheen coming from hillside when it rains. One resident mentioned the hillside was filled with buried wood chips, and the sheen may be coming from rotting wood chips. (FRCOG informed participants how to distinguish an oil bacteria sheen from a petroleum oil sheen– more info <https://www.pca.state.mn.us/sites/default/files/c-er4-07.pdf>).

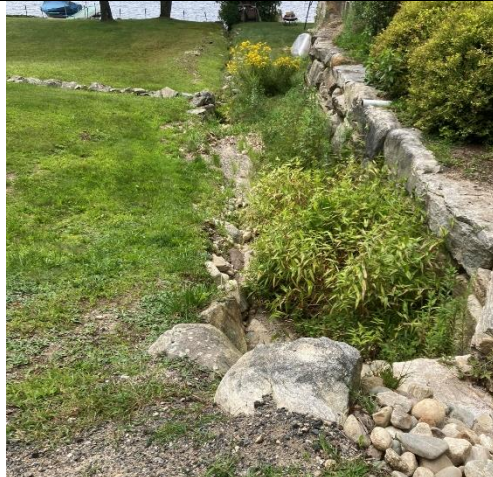
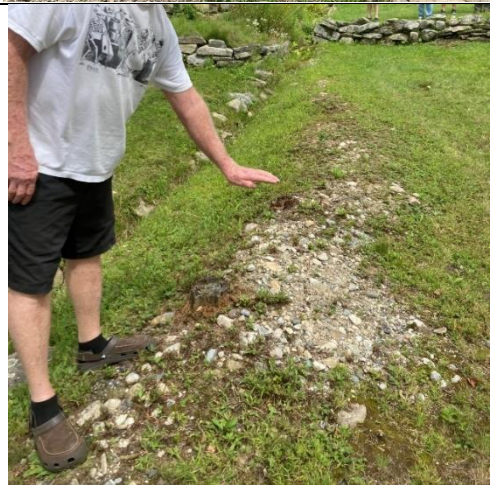
- Corner of North Laurel Drive & North Laurel Extension is ditched from the north side of North Laurel Drive, piped under road, and water is conveyed down a yard drain on North Laurel Drive that sediment has to be shoveled out of “all the time”. Sometimes the sediment piles up next to the yard drain at the level indicated by the resident in the below image.

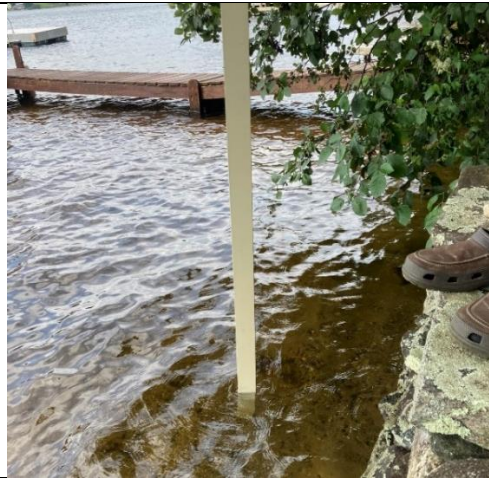
- End of dock on North Laurel Drive used to be “diveable” but now only 2 – 3’ deep; depth to bottom from the retaining wall at 5 inches during field walk.

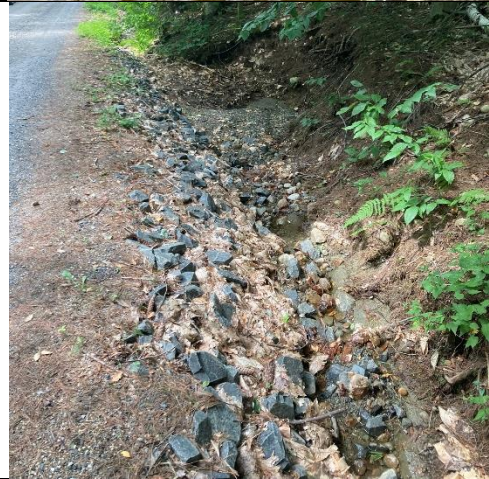
- Circa 2021, North Laurel Road ditches were enhanced, armored with riprap, and level catchment areas were installed in the ditch. Sediment is visible in these catchment areas.

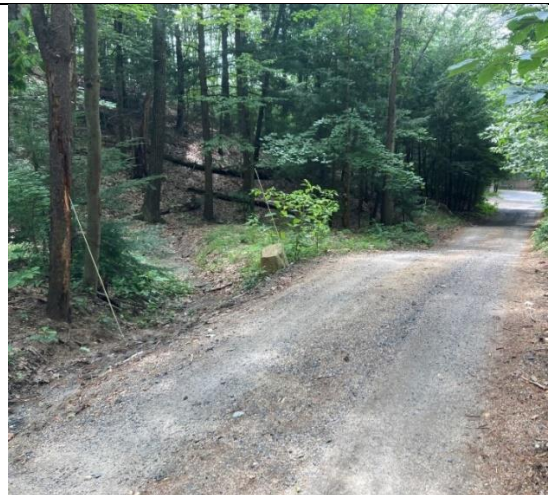
- LWA installed three broad-based dips with turnouts in 2022.

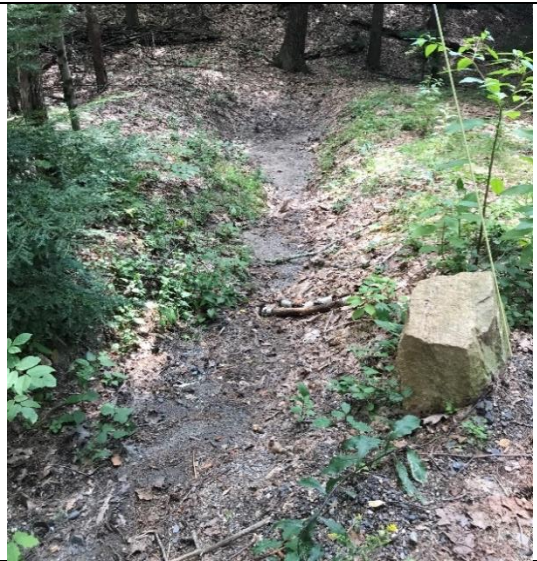
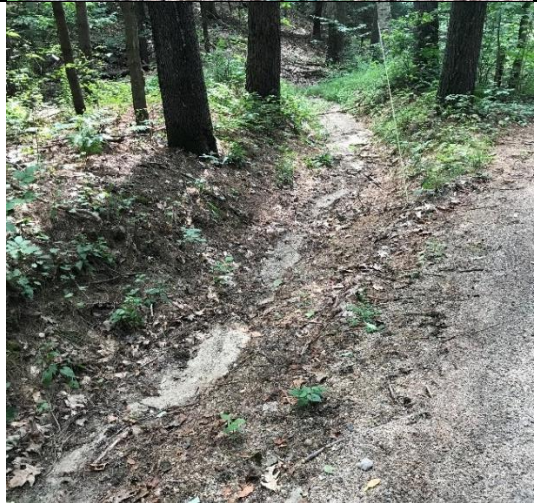
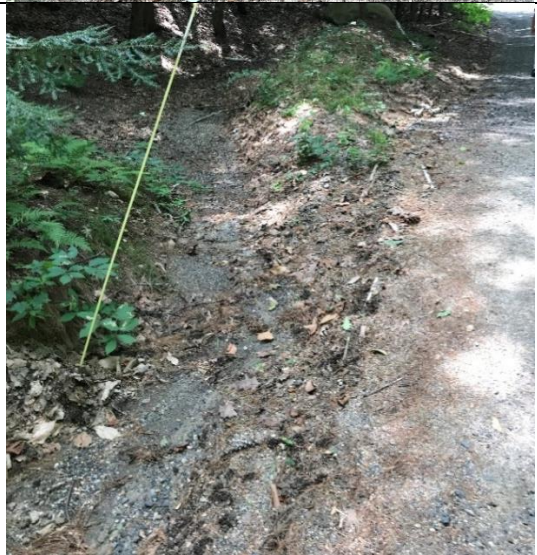
- Sediment observed in all three turnouts, indicating they are working as planned.

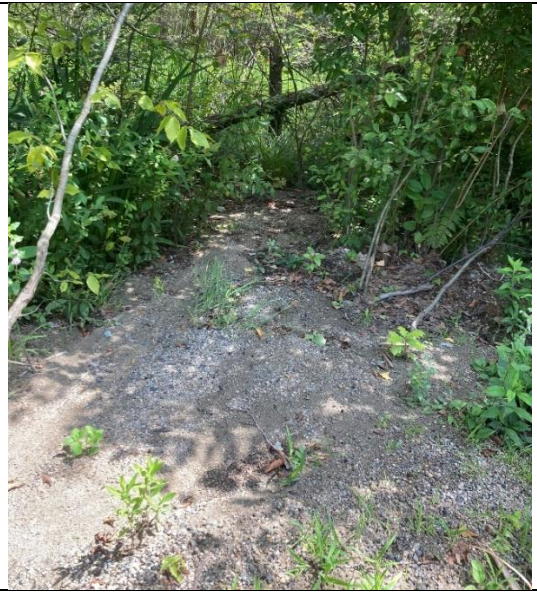
- At very south end of South Laurel Drive, sediment is reaching a vegetated area bordering Ames Brook.

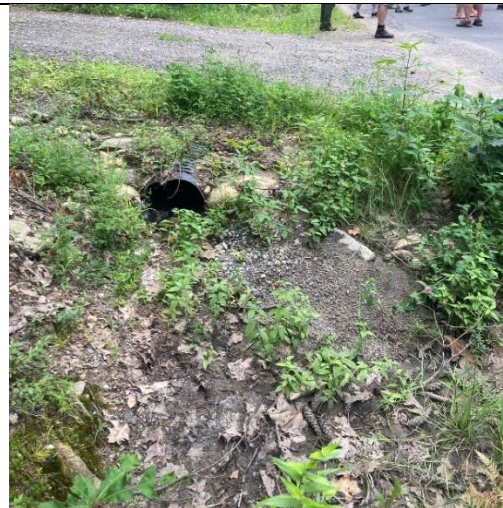
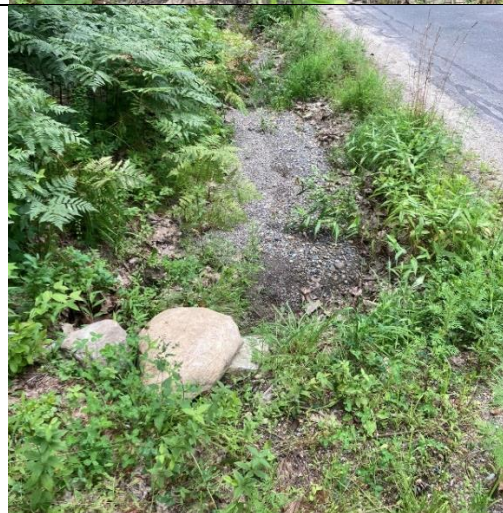
- Locks Pond Road upslope side driveway culverts are still working, but ditch has good amount of sediment in it.

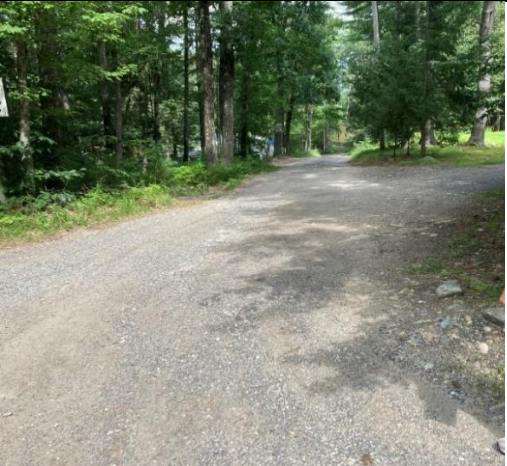
<ul style="list-style-type: none"> Intersection of Locks Pond Road and Great Pines Drive in decent condition.

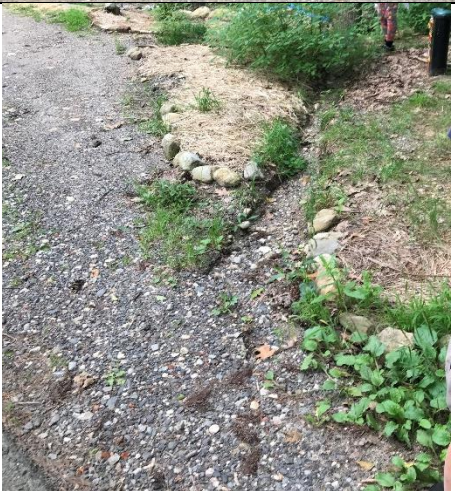
<ul style="list-style-type: none"> Stormwater sheets off Locks Pond Road and into a private driveway off Locks Pond Road. The driveway traps a lot of sand coming from Locks Pond Road; owner has had to deal with this influx of sand.

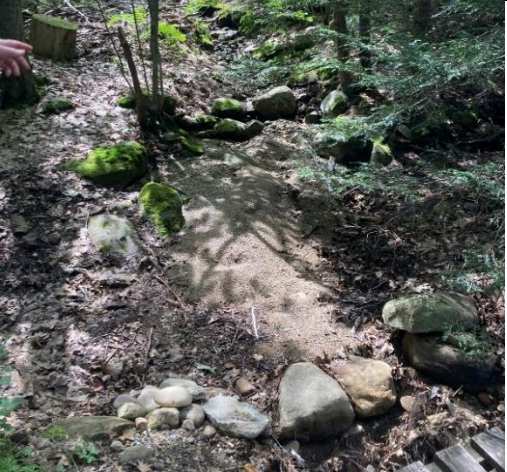
<ul style="list-style-type: none"> Residents report there is still a lot of water coming from Locks Pond Road. 	
<ul style="list-style-type: none"> Residents noted idea of the town managing stormwater upstream of Locks Pond Road so that residents downstream would not have to manage the volume that they do. 	
<ul style="list-style-type: none"> Winter sand coming from Locks Pond Road down drainage accumulating in or near unmaintained section of King Road.

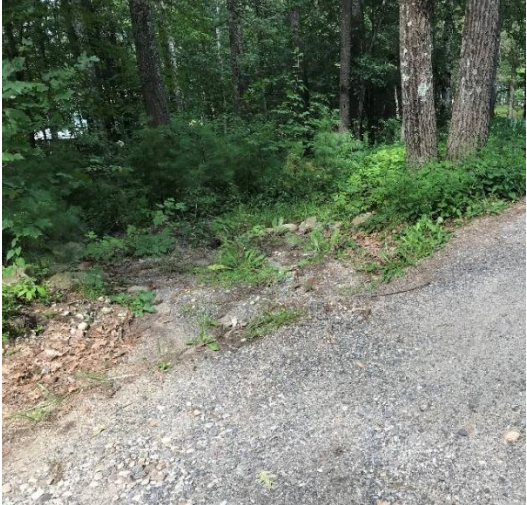
Great Pines Drive and side streets	
<ul style="list-style-type: none"> • Turnout on Great Pines Drive is capturing sediment.

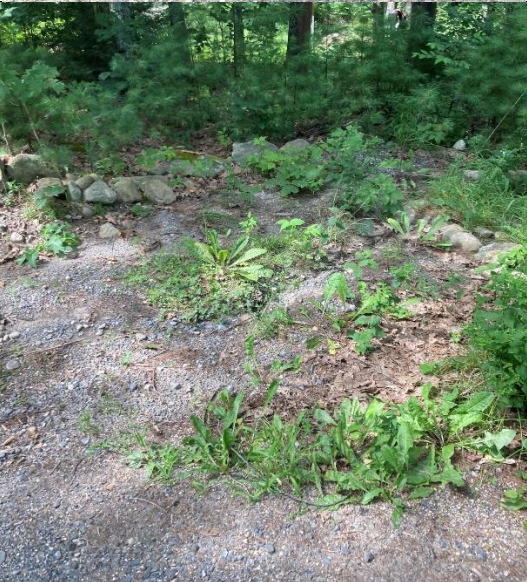
<ul style="list-style-type: none"> • Turnout at corner of Great Pines Drive and King Road is capturing sediment.

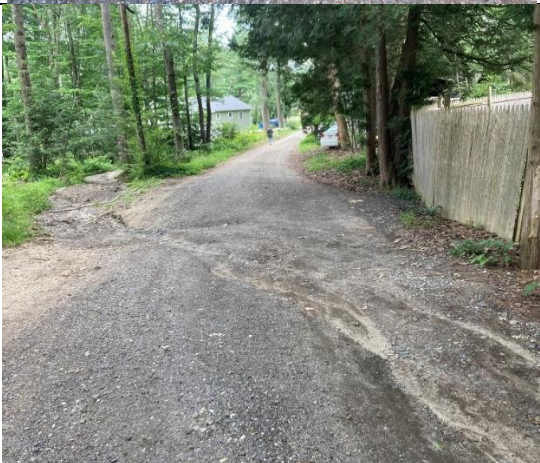
<ul style="list-style-type: none"> • Water crossing Great Pines Drive is directed into a turnout and a series of large basins just below Birch Drive. Basins were full of sediment.

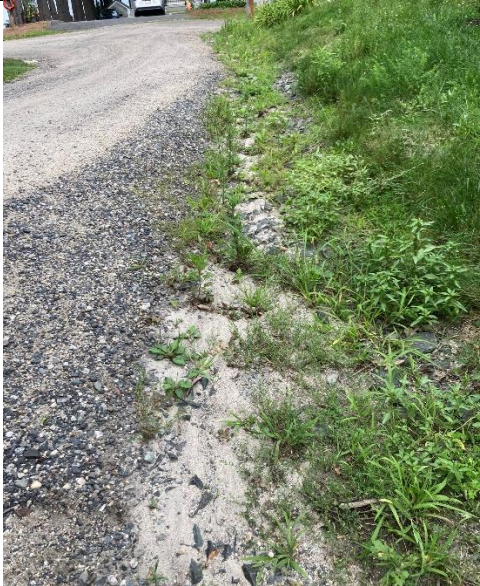
<ul style="list-style-type: none"> Shoulders /ditches of Great Pines Drive lower section show signs of erosion and sedimentation; ditch on south side was filled with gravel/rip rap, now mostly covered with sediment.

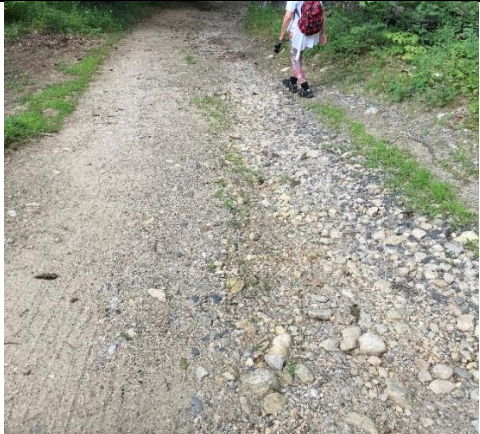
Stebbins Road	
<ul style="list-style-type: none"> Erosion observed on Stebbins Road.

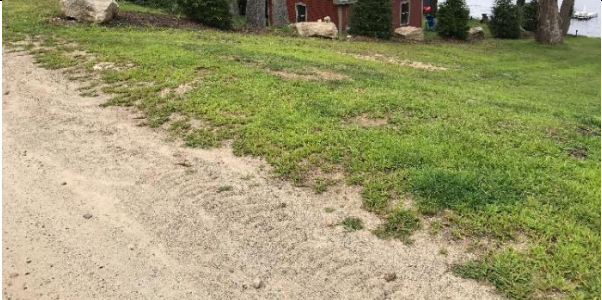
Lake Drive	
<ul style="list-style-type: none"> Berms were noted along Lake Drive roadside and driveway curb cuts. Berms direct water down the road rather than off the road. The road has also become entrenched as the road elevation is lower than the surrounding land and road material is eroded away by stormwater that is forced to travel down the road.

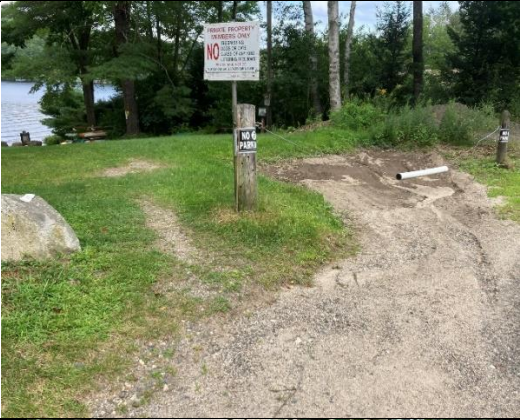
<ul style="list-style-type: none"> BMP on Association Beach, which takes water coming off of Great Pines Drive, is reported to be working and was filled with sediment at the time of visit.

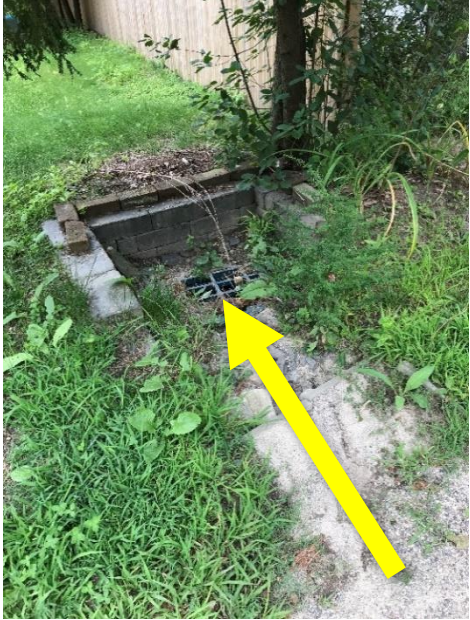
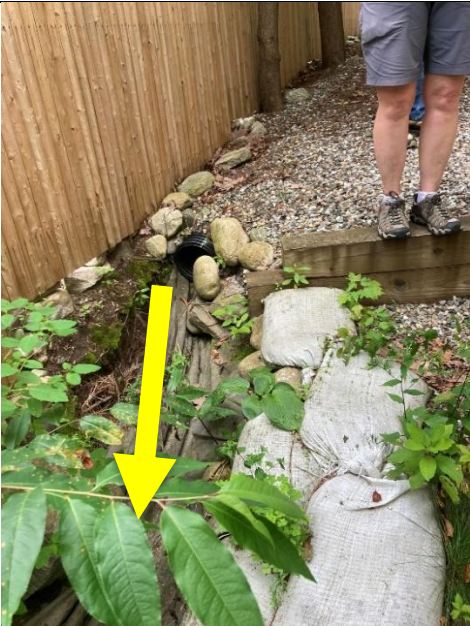
<ul style="list-style-type: none"> Residence on Lake Drive lies at a low point in the road and berming on neighboring properties has resulted in increased runoff being directed into property. 	<div data-bbox="922 571 1388 1186">

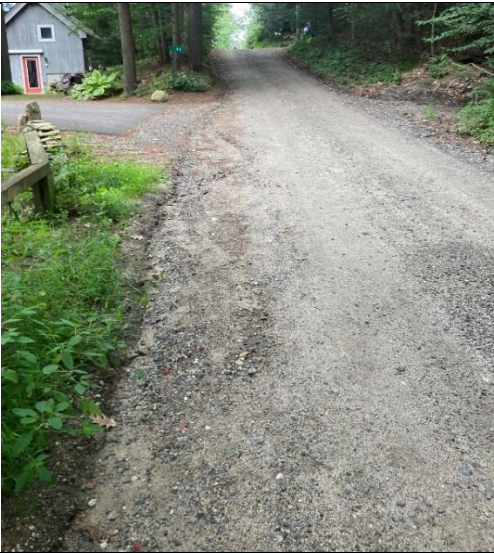
<ul style="list-style-type: none"> Erosion noted on Lake Drive where runoff flows a distance to the low point.

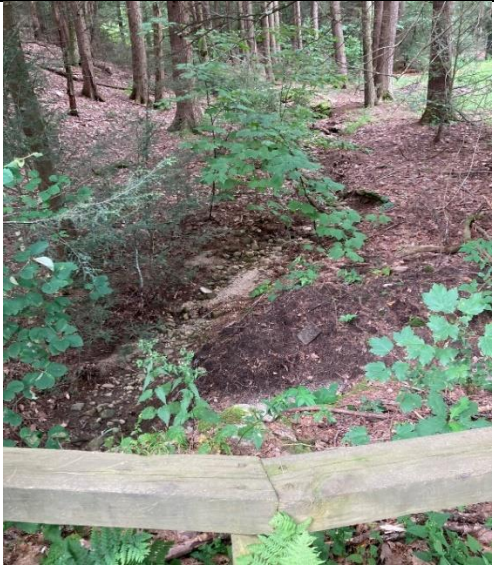
<ul style="list-style-type: none"> A major drainage route coming from the direction of Locks Pond Road crosses Lake Drive through a double culvert. This culvert generally works well but can clog during extreme storm events.

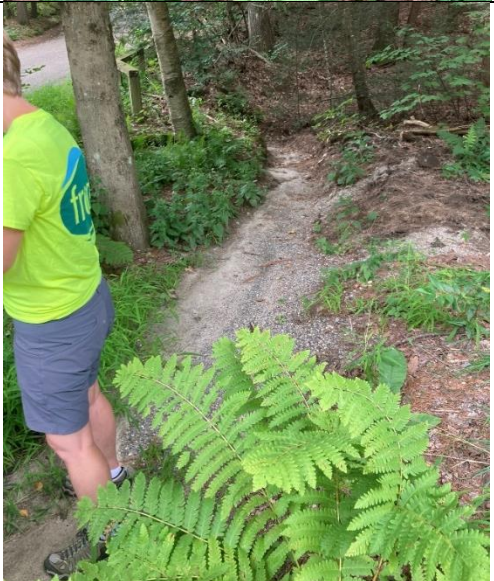
<ul style="list-style-type: none"> Sediment present in turnout that is diverting water from both a neighboring driveway and Lake Drive. This turnout is directly connected to the drainage pictured above.

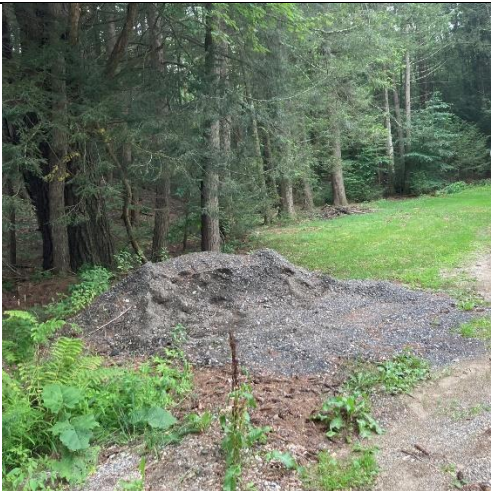
<ul style="list-style-type: none"> • Pile of gravel provided by the LWA for residents to take to fill potholes. This is located adjacent to the turnout pictured above.
