REPORT#: 18MA022

Land clearing and forest product company owner overcome by carbon monoxide in hopper of wood chip burning boiler—Massachusetts

MASSACHUSETTS

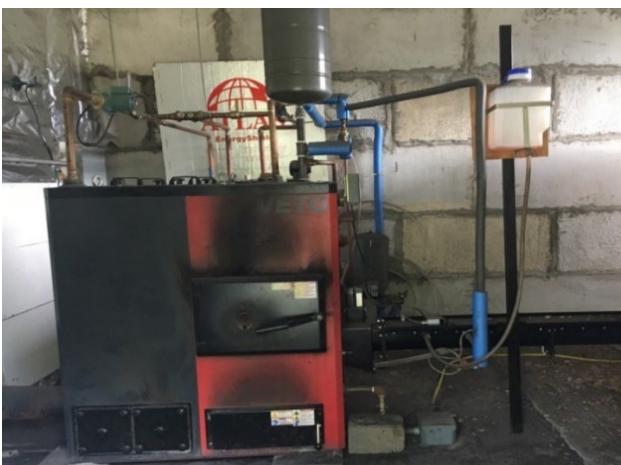
The equipment involved in the incident was an electrically controlled solid fuel boiler system (Figures 1 and 2). The unit was purchased from a Finland manufacturer through a distributor in Massachusetts and was installed by the victim himself, 18 months prior to the incident, despite cautions about the need for professional installation. It had been used through almost two winter heating seasons. Prior to installing this unit, the company had used an outdoor furnace that could burn large pieces of waste wood such as stumps, roots, and trunks. Because that unit had trouble burning wet wood and needed to be refueled daily, the owner had worked with the equipment distributor to find a better system.

The unit consisted of a solid fuel fired boiler and a computer-controlled fuel delivery system that monitored the burner status and moved fuel from a five cubic yard fuel hopper using an auger/conveyor (Figure 2). The unit was designed to burn manufactured wood pellets, briquettes, or wood chips of limited dimensions of 10-30 mm (<1.2 inches branchless wood). The employer made wood chips on site by processing trees, which were then used for fuel in the system. The fuel hopper was sized to allow for two days of continuous operation. Reportedly the unit routinely was not able to run unattended for two days, did not provide enough heat to adequately warm the workspace it was installed to heat, and had trouble burning chips that were large, irregularly shaped, or dirty.

Figure 1 - The boiler/furnace and the auger/conveyor

The wood burning system selected for this company was limited in its capacity, and was installed by the owner, instead by an "authorized professional installer," as directed in the manual. In practice, the system required emptying ash twice a day, rather than once a week, and entry into the fuel hopper to remove oversized wood pieces, every two to three

days, rather than thorough cleaning every six months. The system was too small for the heating desired and was running “harder” than expected. The flue was loose when inspected and the numerous occasions soot was found on the floor may have indicated it was installed incorrectly. The manual advises the connection between the boiler and chimney must be airtight, the combustion chamber must be under-pressured, and chimney sweeping may be necessary. It is possible the flue exhaust was not maintained well, nor operating correctly, and not inspected to ensure it remained open and operational.

According to the installation specifications, the shed building housing the unit was supposed to have a “compensation air hole” sized 1.5 times the chimney size, which would have allowed outside air into the building and apparently was not included in the design of the building.

At the time of the incident, the shed containing the boiler and wood chip hopper did not have a ventilation system or CO monitoring system. A CO monitoring system or detector might have provided warnings about the high concentration of CO and led to an inspection of the sources. Routine testing and maintenance schedules should have been developed and implemented for CO monitoring systems and/or detectors. In this case, a CO monitoring system would have had CO sensors inside the boiler room, a monitor and alarm in an area outside of the boiler room, and a ventilation system that could be activated automatically or by a worker outside of the shed, allowing for safe entry after sufficient fresh air had been introduced.

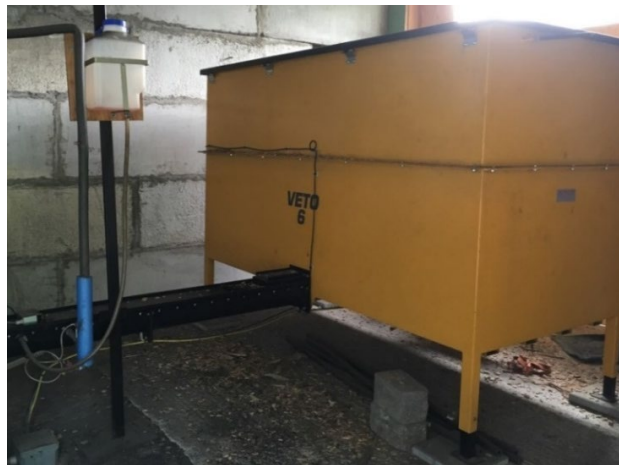
According to the manufacturers' manual the fuel hopper was 7'9" tall and the auger axis was located at the bottom of the hopper. Temperature sensors along the auger and an automated fire suppression system helped to ensure fire did not spread out of the burner and back to the fuel source. The fuel hopper was also sealed tight to help ensure the wood within the bin would not combust.

Figure 2 - The hopper and wood chip auger/conveyor

Discussion: A decal on the fuel hopper specifically warned about carbon monoxide hazard and cautioned that work should be done in pairs, but did not specifically label the hopper a confined space. Operation routinely required entry into the hopper to clear jams caused by large wood pieces every two to three days. The manual advised cleaning every

six months, removing the agitators/stirrer disks, at the bottom, to remove debris that collects under the gears. A ladder was needed to gain access to the fuel bin which indicated restricted entry and exit.

The fuel hopper was not explicitly labeled as a confined space by the manufacturer or the employer. This may be due to the device being designed and manufactured in Europe. But the warning decals and operator's manual described hazards and procedures consistent with confined spaces. The user manual for the boiler unit and hopper indicates that two workers should always be present when the hopper is entered for service. The label cautions that there is a risk of carbon monoxide poisoning and that work should be performed in pairs. In this situation, the victim had entered alone, using a ladder to access the interior of the fuel hopper because it had a wall height nearly eight feet off the floor, demonstrating restricted entry and exit. Also, the fuel hopper posed a risk of engulfment from the loose wood chips and a risk of a hazardous atmosphere (carbon monoxide), meeting the definition of a permit-required confined space. The employer should have recognized these hazards as meaning the hopper was a confined space, and thus developed a written permit confined space program, informed employees, and provided training. In addition, the employer should have posted a permit-required confined space sign on the hopper. Untrained rescuers are also at risk of being overcome by a hazardous atmosphere while trying to aide or rescue an affected person. The presence of permit-required confined space should include notification of all employees regarding the risks of unprepared rescue.

In this case, the manufacturer was aware of the hazard of carbon monoxide accumulation in the hopper and included multiple warnings about the hazard in the user manual and on the hazard decals on both the boiler and fuel hopper. Further implementation of PtD concepts by the manufacturer may have built in local exhaust ventilation and/or air quality monitoring within the hopper that could provide protection to the users of the equipment. An operating carbon monoxide detector on the unit may have prevented this death. The additional safeguard of a detector that could activate a local ventilation system would be even more effective.

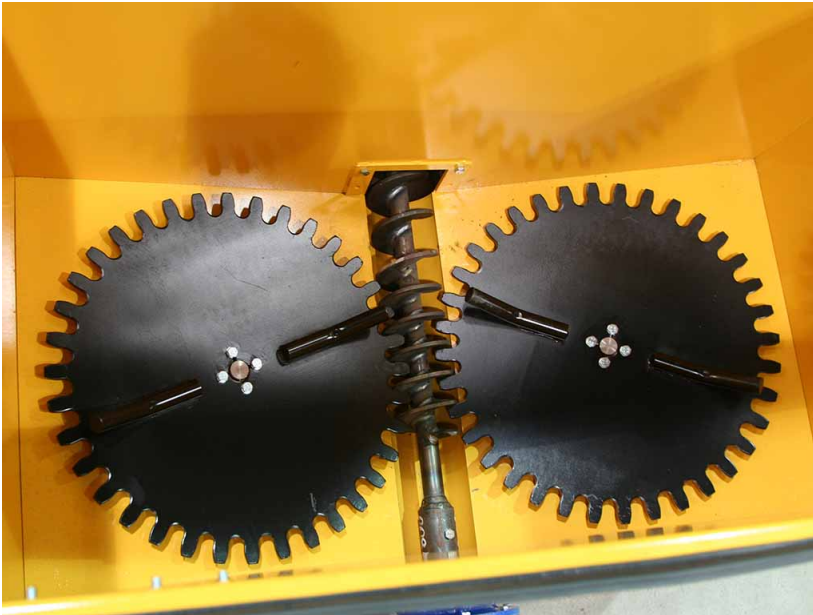
The auger that advanced the wood chips ran from the bottom of the hopper to the burner. Two metal agitators or stirrer disks were mounted on the floor of the hopper and would help the wood chips flow into the trough and be pushed by the auger (Figure 3). The manufacturer's instruction manual indicates that the fuel hopper should be cleared of possible obstacles weekly and also that these two disks should be removed every six months so debris that accumulates under the disks can be cleared.

Figure 3 – Agitators on the bottom of the hopper (picture from manufacturer)

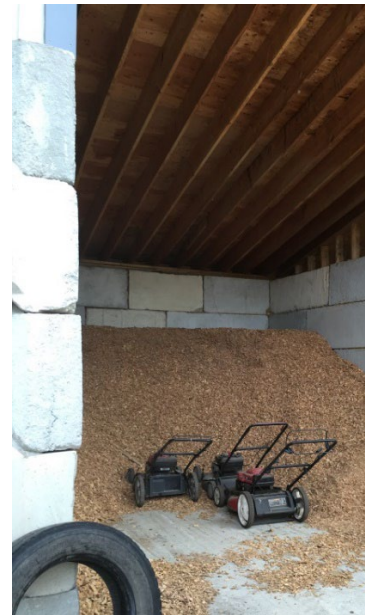
Figure 4 - Exterior storage area for the wood chips
