# **INDOOR AIR QUALITY ASSESSMENT**

**Lowell High School  
1922 Building  
14 French Street  
Lowell, MA**

Prepared by:  
Massachusetts Department of Public Health  
Bureau of Environmental Health  
Indoor Air Quality Program  
December 2017

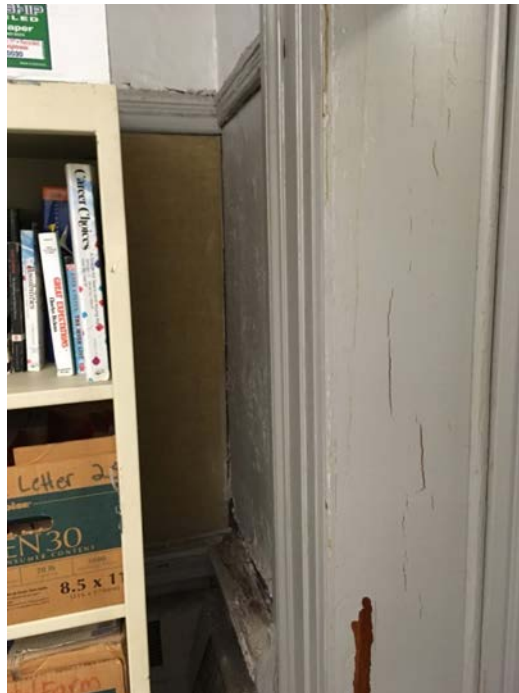
**Picture 2**

**Water-damaged plaster in room 105A behind freestanding shelf**

9. Repair water leaks in Room 105A. Repair plaster once water leak once repaired.
10. Replace any water-damaged/mold-colonized porous building materials (e.g., ceiling tiles, gypsum wallboard) in classrooms, hallways and stairwell areas. Ensure water-damaged materials are cleaned, replaced, and/or repaired in a manner consistent with the U.S. Environmental Protection Agency’s guidelines (US EPA, 2008).

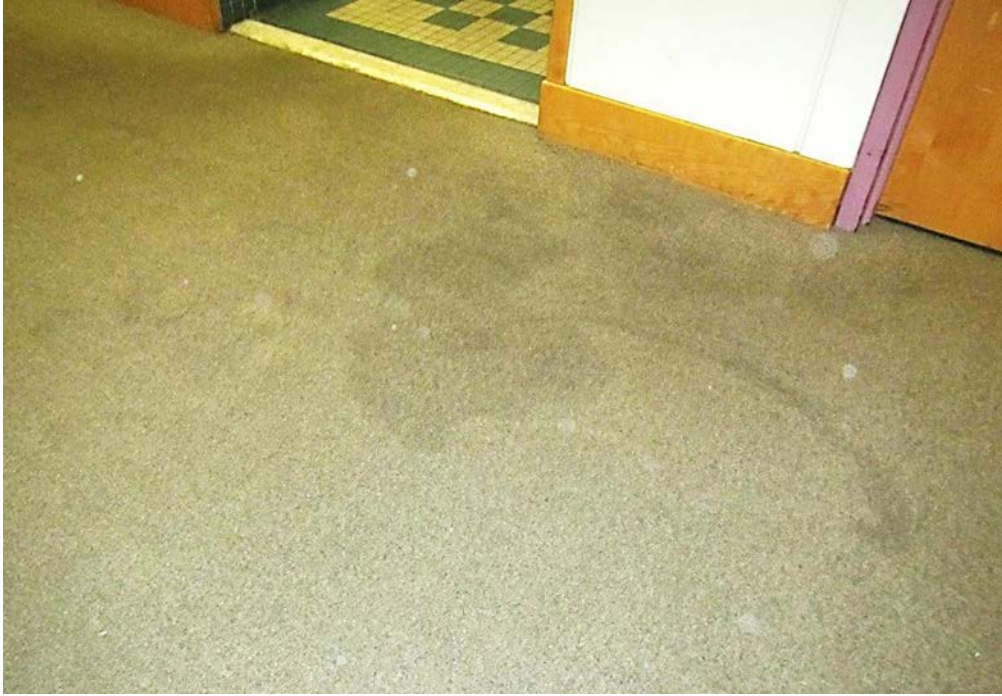
**Picture 3**

microbial colonization of carpeting, as well as a buildup of dirt and debris in older carpeting that could no longer be adequately cleaned. Some carpeting was visibly stained, wrinkled, or threadbare (Tables 1 and 2; Picture 3), indicating it was past its service life. The service life of carpeting in schools is approximately 10-11 years (IICRC, 2002). Aging carpet can produce fibers that can be irritating to the respiratory system. In addition, tears or lifting carpet can create tripping hazards. Carpeting should be cleaned annually or semi-annually in soiled high traffic areas as per the recommendations of the Institute of Inspection, Cleaning, and Restoration Certification (IICRC, 2012).

**Worn, stained carpeting**

1. For information regarding the roof and recommendations, please refer to the August 2017 IAQ assessment.
2. Remove any water-damaged, musty, or worn carpeting and replace with non-porous flooring in classrooms and below-grade areas.
3. Use openable windows to supplement fresh air during temperate weather. Ensure all windows are tightly closed at the end of the day. Inform occupants that windows should not be opened while the HVAC system is in cooling mode to avoid condensation.

23. Clean any remaining carpeting and area rugs annually or more often in high-traffic locations in accordance with IICRC recommendations (IICRC, 2012) and discard those that are worn out or too soiled to be cleaned.
