INDOOR AIR QUALITY ASSESSMENT

**Lowell High School
Freshman Academy
40 Paige Street
Lowell, MA**

Prepared by:
Massachusetts Department of Public Health
Bureau of Environmental Health
Indoor Air Quality Program
December 2017

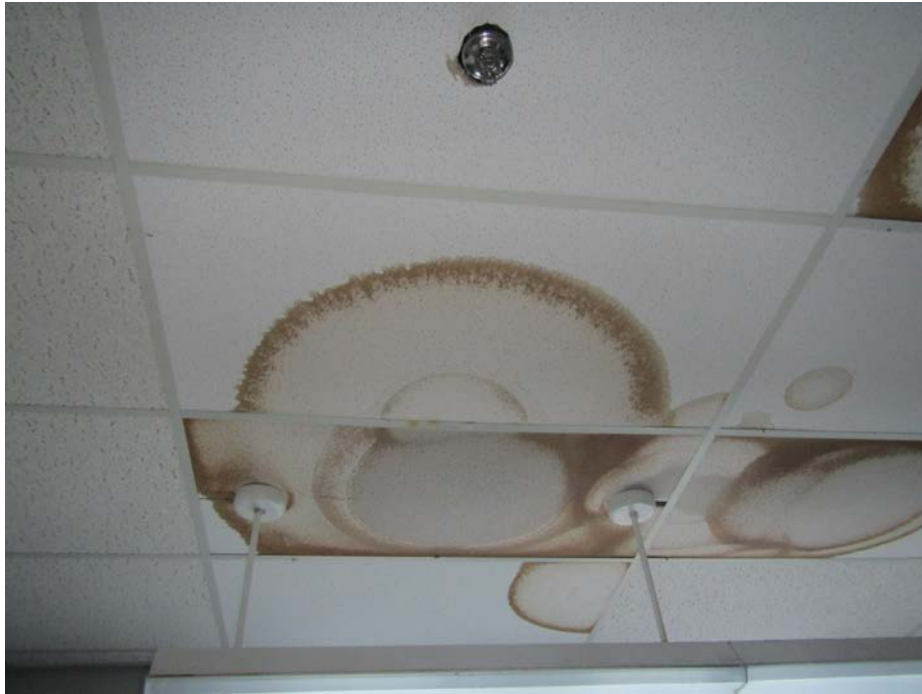
Picture 1

As mentioned in the preliminary report, water-damaged ceiling tiles and ceiling plaster were observed in some classrooms, offices, and hallways (Picture 1). Water-damaged ceiling tiles should be replaced after the leak is found and repaired.

Water-damaged ceiling tiles in classroom

6. Ensure roof and plumbing leaks are repaired and replace water-damaged ceiling tiles.
7. Repair other water-damaged building materials (e.g., wall/ceiling plaster).

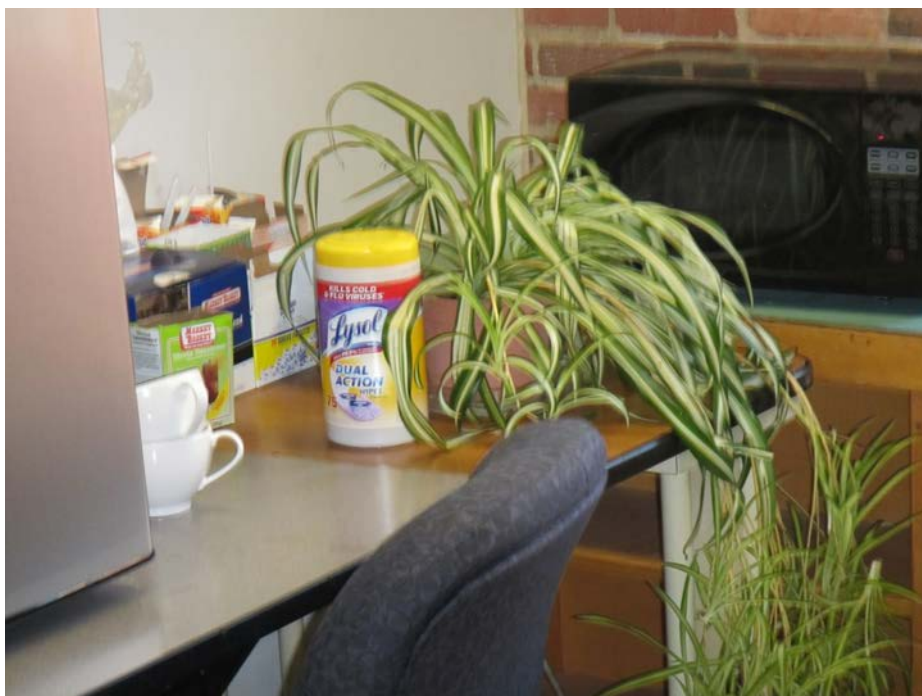
Picture 2

Indoor plants were observed in some areas (Picture 2). Plants can be a source of pollen and mold, which can be respiratory irritants to some individuals. Plants should be properly maintained and equipped with drip pans and should be located away from air diffusers to prevent the aerosolization of dirt, pollen and mold.

In addition to the conditions noted in the preliminary report, IAQ staff noted many areas with air fresheners/candles, scented cleaning products, and hand sanitizers (Pictures 2 and 3). These products contain volatile organic compounds (VOCs) and other fragrances which may cause irritation of the eyes, nose, and respiratory system.

Plant and scented cleaning product in the Freshman Academy

8. Reduce or eliminate the use of products containing VOCs (e.g., air fresheners, scented cleaning products, and hand sanitizer).
9. Properly maintain plants, including drip pans, to prevent water damage to porous materials. Plants should also be located away from air diffusers to prevent the aerosolization of dirt, pollen, and mold.

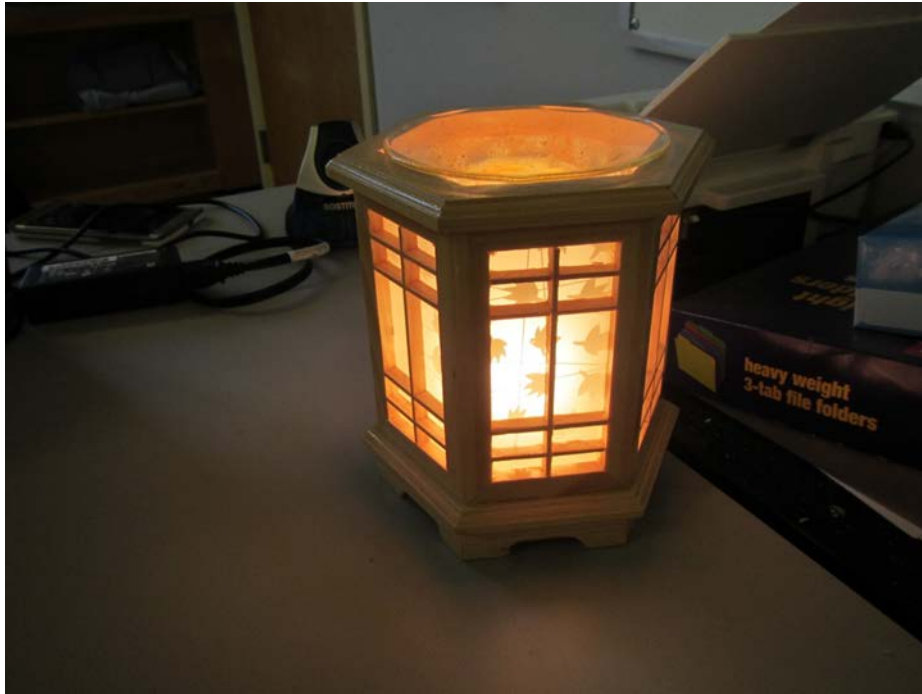
Picture 3

Scented candle in office area
