INDOOR AIR QUALITY ASSESSMENT

**Lowell High School
Freshman Academy
40 Paige Street
Lowell, MA**

Prepared by:
Massachusetts Department of Public Health
Bureau of Environmental Health
Indoor Air Quality Program
August 2017

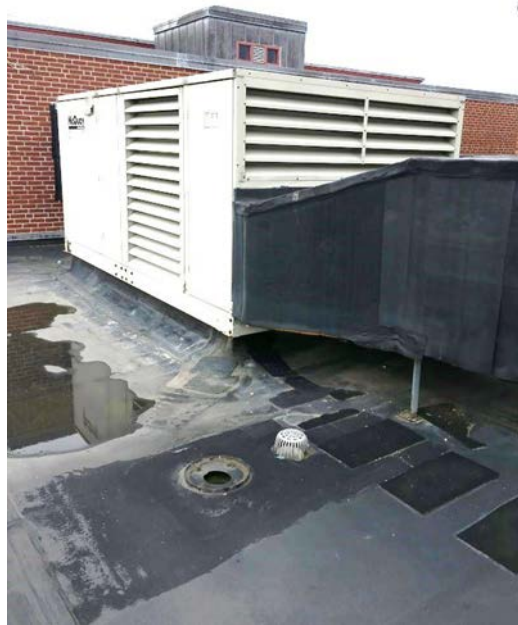
Picture 1

Ventilation for the Freshman Academy is provided by a single air-handling unit (AHU) located on the roof (Picture 1). Fresh air is distributed via ductwork connected to ceiling or wall-

Rooftop air handling unit (AHU)

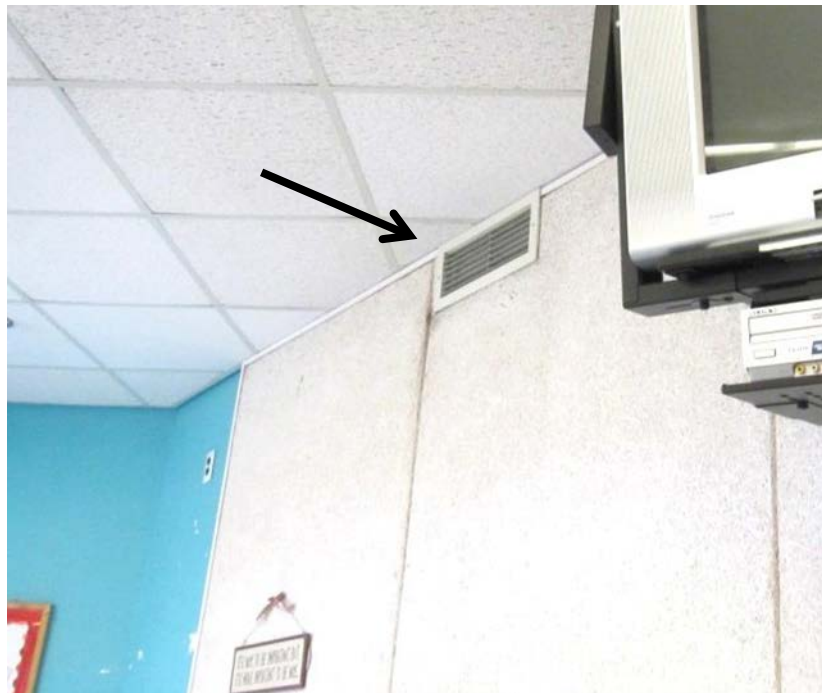
Picture 2

mounted diffusers in classrooms (Pictures 2 and 3). The amount of fresh air drawn into the units is controlled by moveable louvers connected to an activator motor to alter fresh air intake to help maintain temperature. Exhaust ventilation is provided by ceiling or wall-mounted grates that return air back to the AHU via ductwork.

Wall-mounted supply diffuser (arrow)

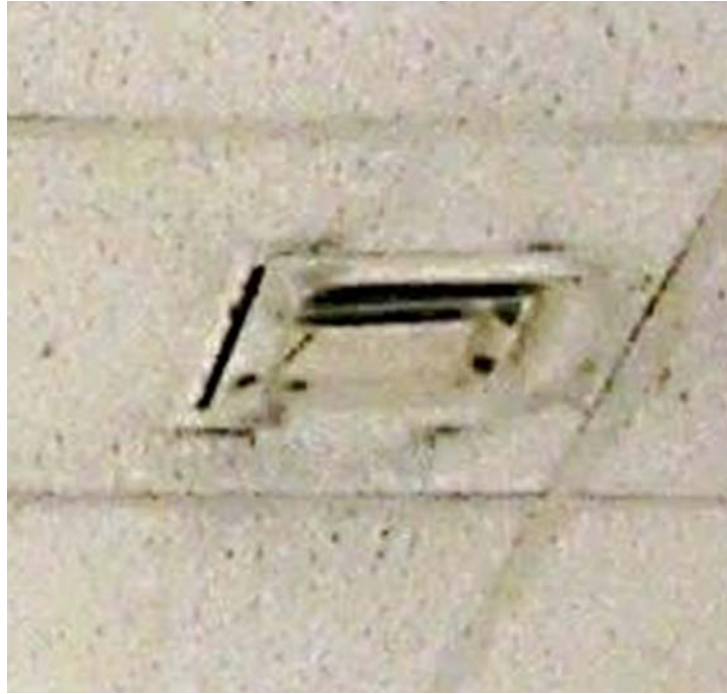
Picture 3

Many classrooms had personal fans. Some of these had dusty blades (Table 3). Many supply and exhaust vents were also observed to be dusty (Picture 3, Table 3).

Ceiling-mounted supply diffuser, note accumulated dust/debris on louvers/ceiling tiles

13. Regularly clean/vacuum supply, exhaust/return vents and fans to avoid aerosolizing accumulated particulate matter. If soiled ceiling tiles around vents cannot be cleaned, replace.

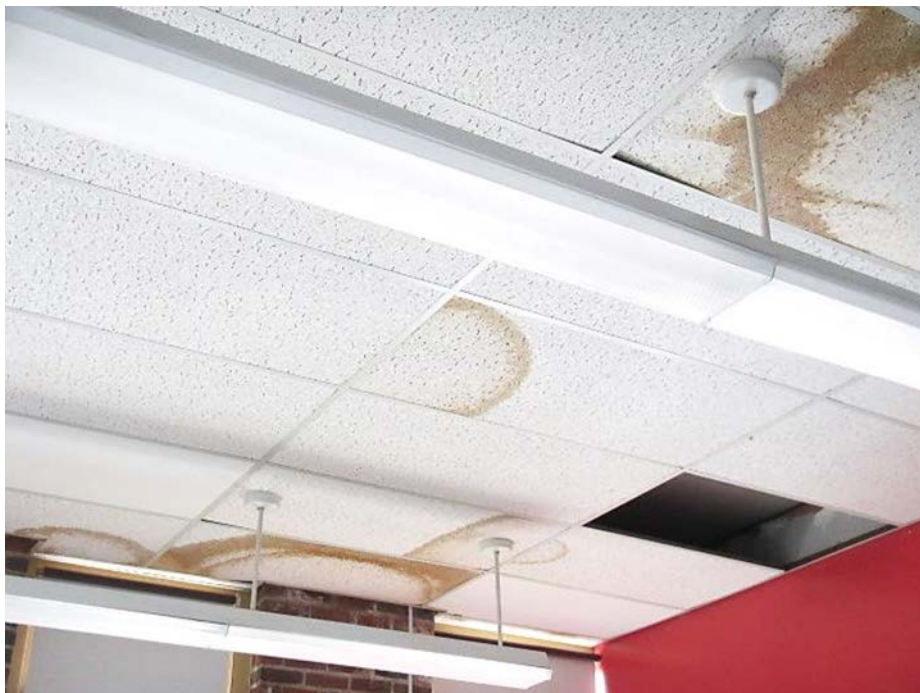
Picture 4

Water-damaged ceiling tiles and ceiling plaster were observed in some classrooms, offices, and hallways (Pictures 4 through 6; Table 3). Such damage indicates leaks from the building envelope or plumbing system. Water-damaged ceiling tiles should be replaced after the leak is found. In general, ceiling tiles have an open space above them (the ceiling plenum) and tend to dry out quickly, reducing the chance for mold colonization. Ceiling plaster does not contain organic material; therefore, it will not support microbial growth even when frequently moistened. In some cases, dust or paint on the surface of plaster can become mold colonized. If this occurs, plaster can often be cleaned to remove the mold.

Water-damaged and missing ceiling tiles

6. Consider working with a roofing contractor to examine methods of pitching roof towards drains to prevent water pooling.
7. Ensure roof and plumbing leaks are repaired and replace water-damaged ceiling tiles.

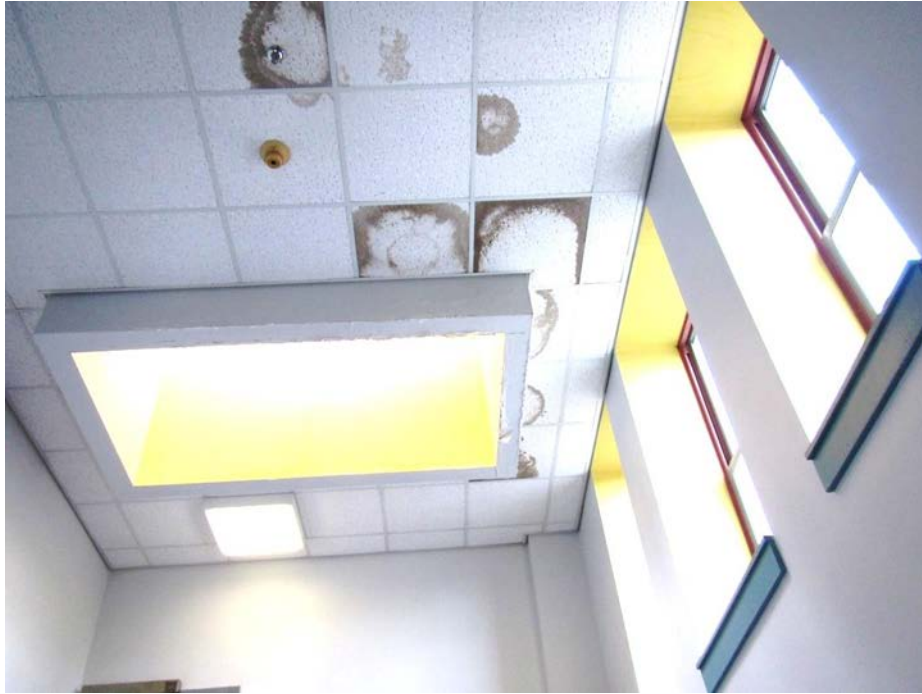
Picture 5

Water-damaged ceiling tiles next to skylight

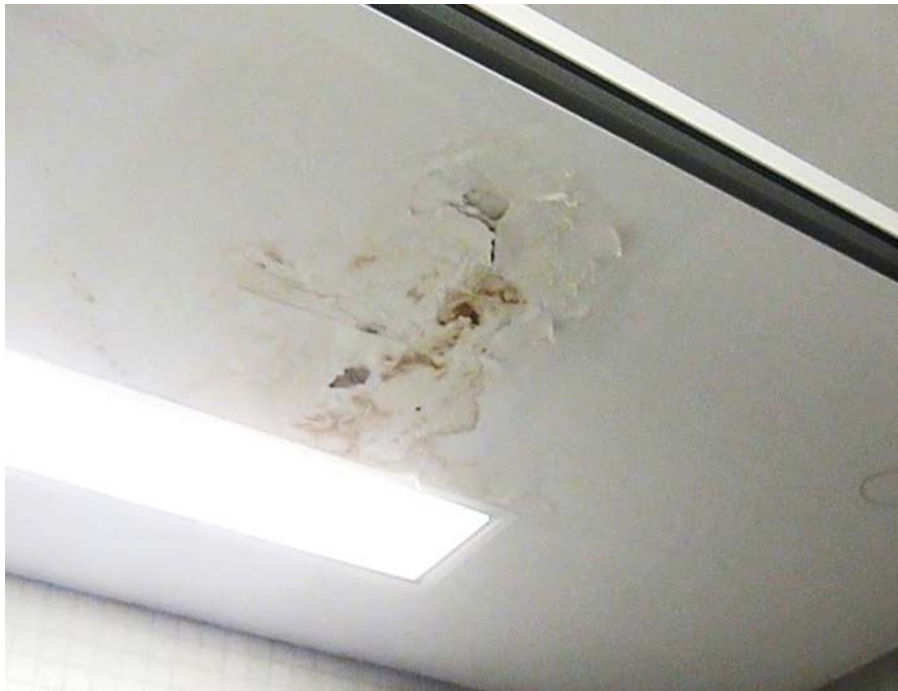
Picture 6

Water-damaged ceiling plaster

8. Repair other water-damaged building materials (e.g., wall/ceiling plaster).
9. Repair sink backsplashes to prevent water damage. Refrain from storing porous items or large amounts of items under sinks.

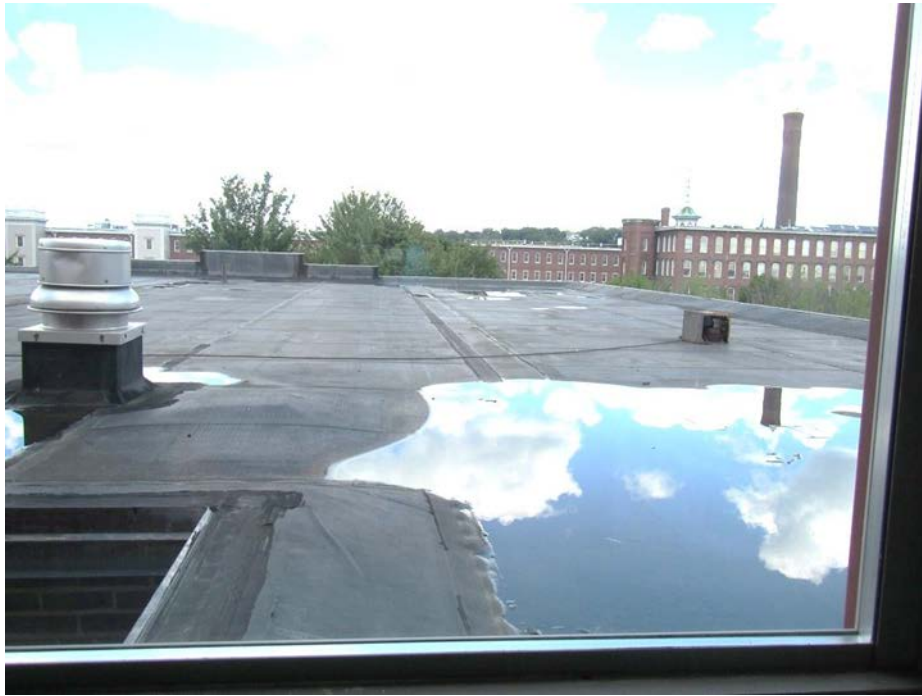
Picture 7

Water was observed pooling on sections of the roof (Pictures 7 and 8). This indicates that the roof is not draining properly. Pooling water can damage the roof membrane because freezing and thawing action during winter months can lead to leakage. In several areas, the roof membrane was found damaged/detached (Pictures 9 and 10).

Water pooling on roof

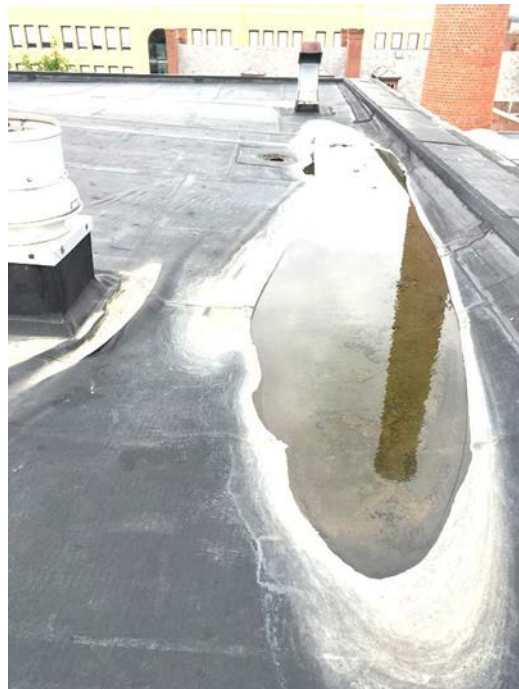
Picture 8

Water pooling on roof

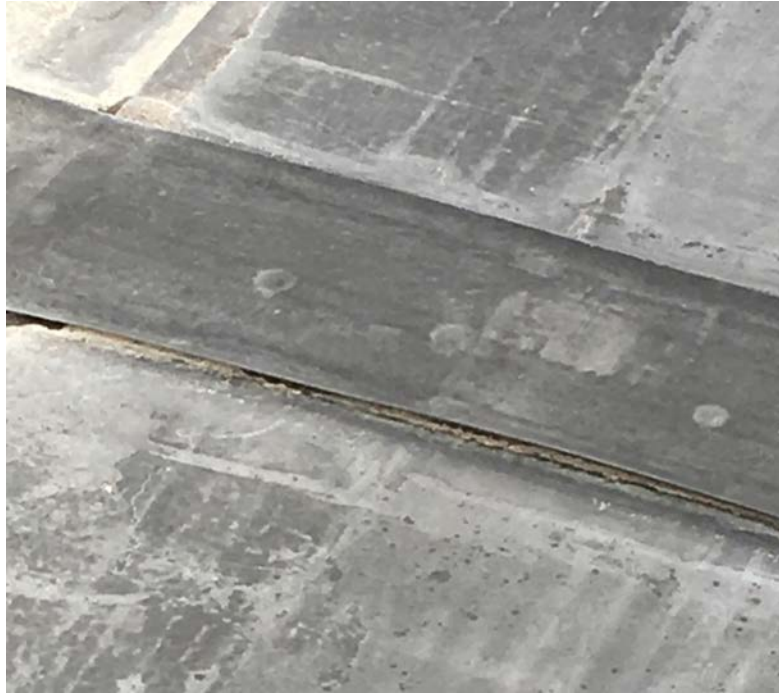
Picture 9

Detached roof membrane

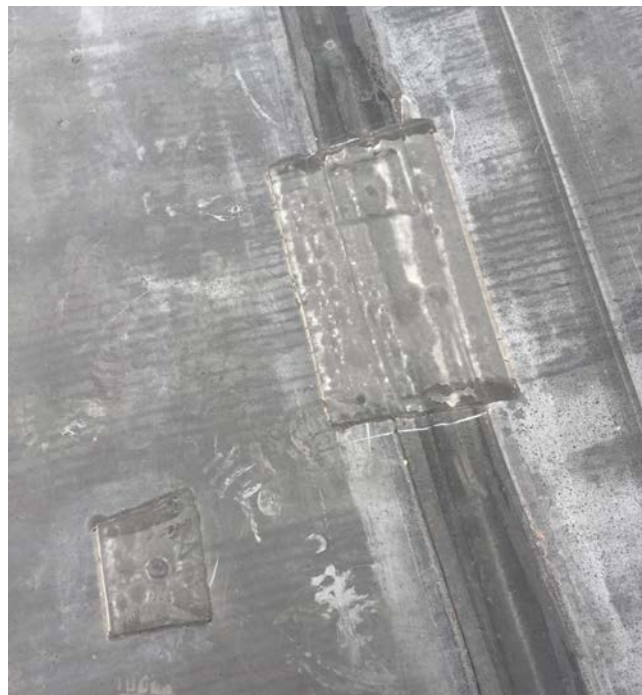
Picture 10

Detached roof patches

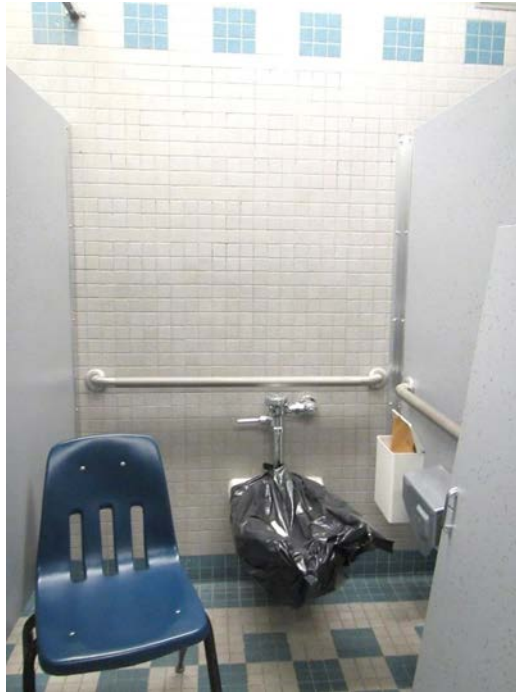
Picture 11

Sinks were observed in a number of classrooms. In a few areas, the backsplashes were unsealed (Table 3) which can lead to water damage to building materials. Some bathroom sinks were dripping and could not be shut off. Other fixtures, including toilets, urinals, and water fountains were found covered or labeled out of order (Picture 11). Leaking plumbing can be a source of moisture to classroom materials and the indoor environment, particularly when outdoor humidity is high. Some sinks examined also had porous items such as books and paper (Picture 12) stored inside the sink cabinet, which is a moist environment that can cause damage to items.

Broken toilet

10. Repair broken plumbing fixtures, or ensure water is turned off to prevent leaks.
11. Ensure that condensation from air conditioning equipment is draining properly. Check collector pans, piping and any associated pumps for clogs and leaks and clean periodically to prevent stagnant water build-up and remove debris that may provide a medium for microbial growth.

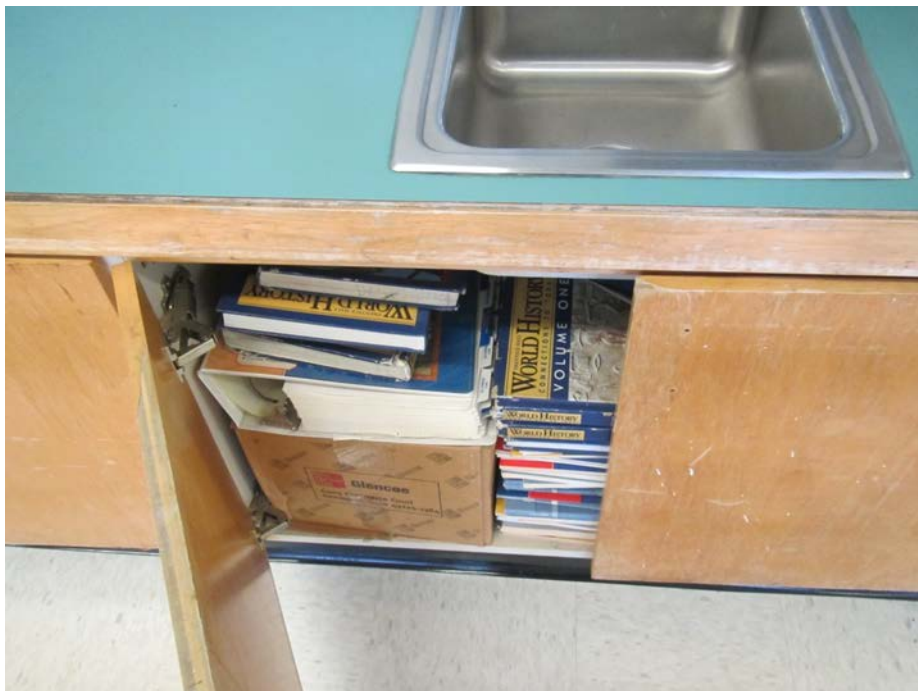
Picture 12

Books stored under sink

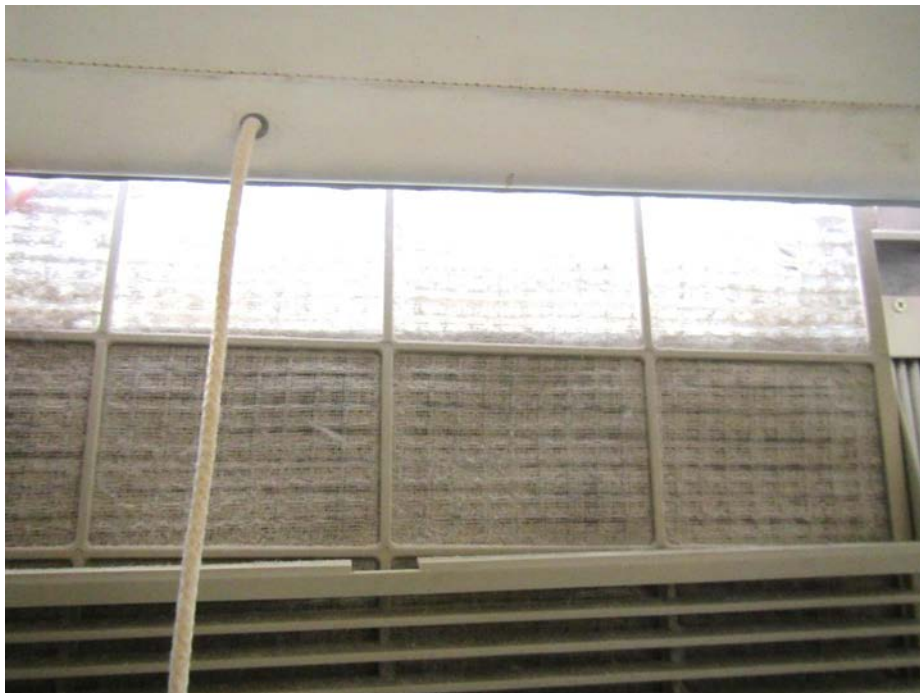
Picture 14

Equipment such as window and portable air conditioners and personal air filters are equipped with filters that need to be cleaned or changed. One window air conditioner filter was examined and found to be caked with dust (Picture 14). Dust can be a source of irritants and allergens in the indoor environment.

Very dusty window air conditioner filter

14. Clean window air conditioner filters prior to and periodically during the cooling season.
15. Clean carpeting and area rugs regularly and discard those that are worn out or too soiled to be cleaned.

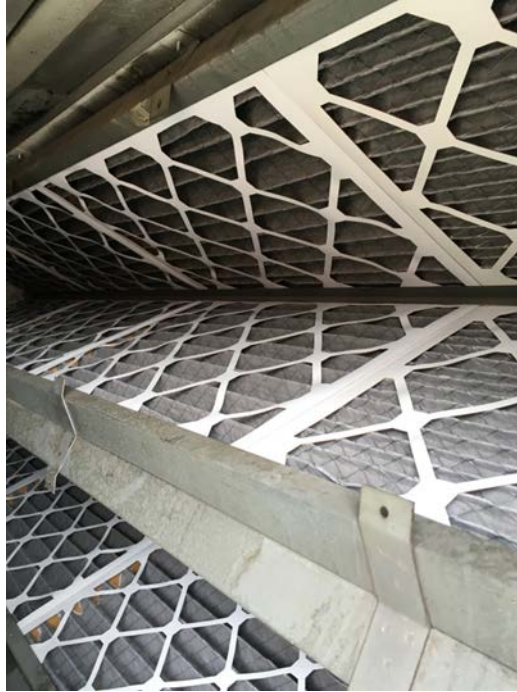
Picture 15

Filters for the AHU should be changed in accordance with manufacturer's instructions (e.g., two to four times a year). The MDPH recommends pleated filters with a Minimum Efficiency Reporting Value (MERV) of 8, which are adequate for filtering out pollen and mold spores (ASHRAE, 2012). Note, although the AHUs appeared to have good/pleated filters, the interior of the units had accumulated dust/debris (Pictures 15 and 16) and should be cleaned out thoroughly (e.g., during regular filter changes).

Bank of pleated filters in AHU

12. Use pleated filters of MERV 8 in AHUs, if these can be used with the current equipment. Ensure filters are changed 2 to 4 times a year. Thoroughly clean inside of AHU cabinets during filter changes.

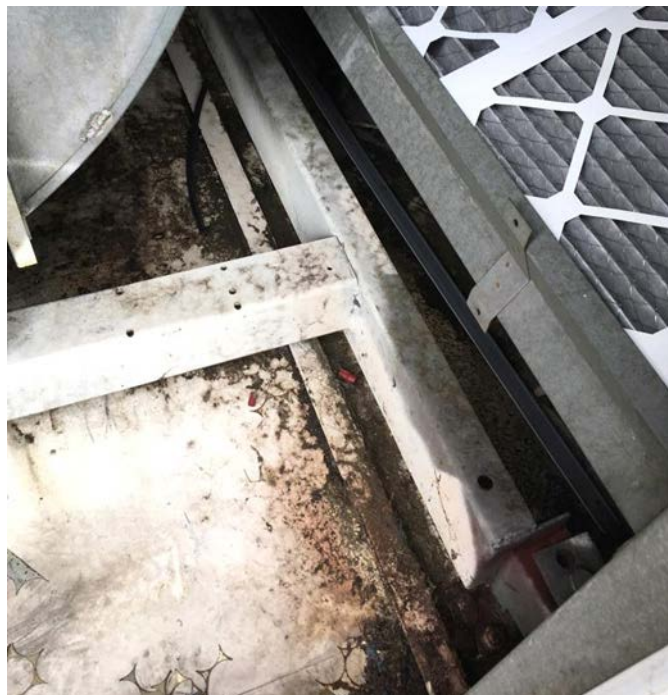
Picture 16

Dust/debris accumulation inside AHU
