WILKINSON ecological design

Seth Wilkinson, President & Restoration Ecologist Wilkinson Ecological Design, Inc.

Why so many Coir-Based Bigengineering Products

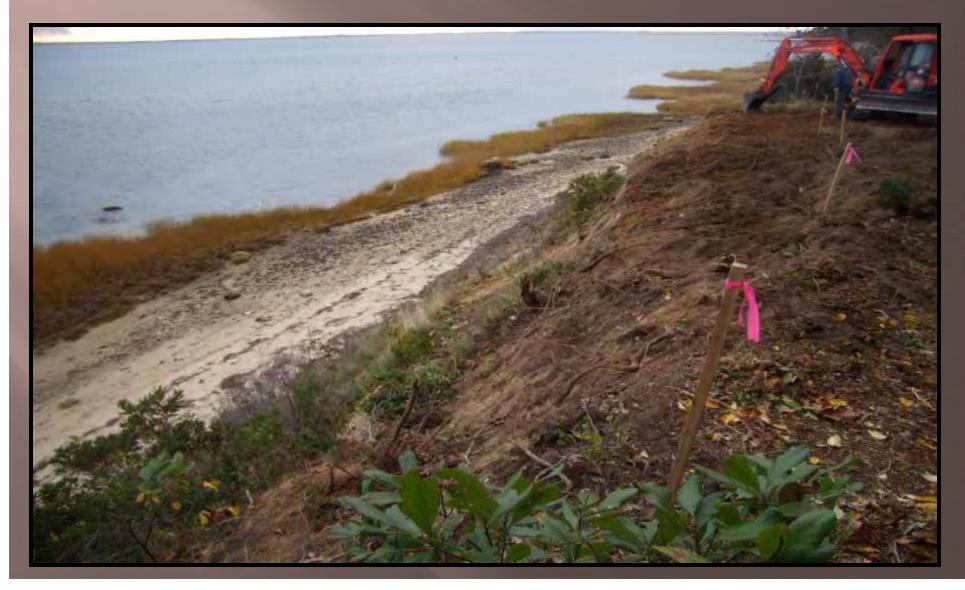
Case Study #1 - Fiber Roll Array Severe Destabilization Prior

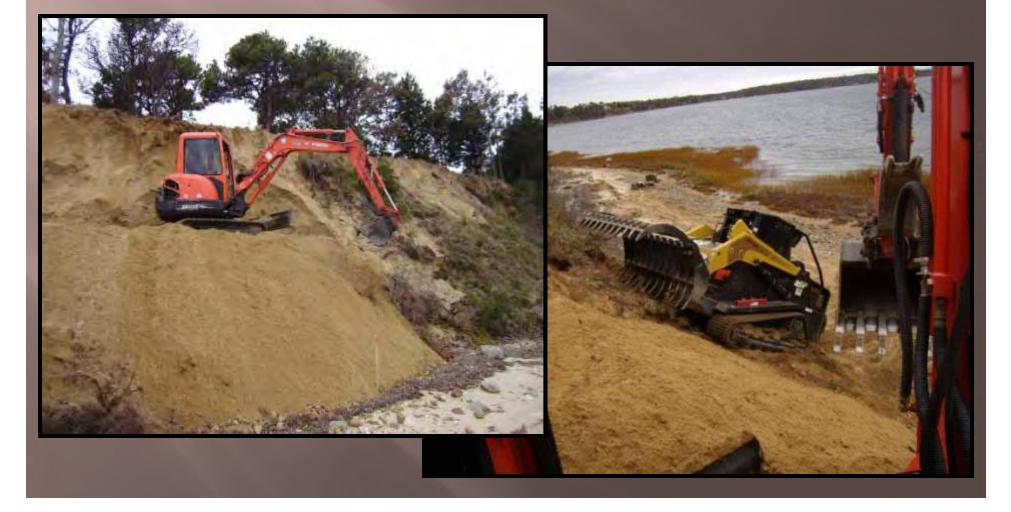
As slope angle was undercut, bank was re-graded to a more stable angle

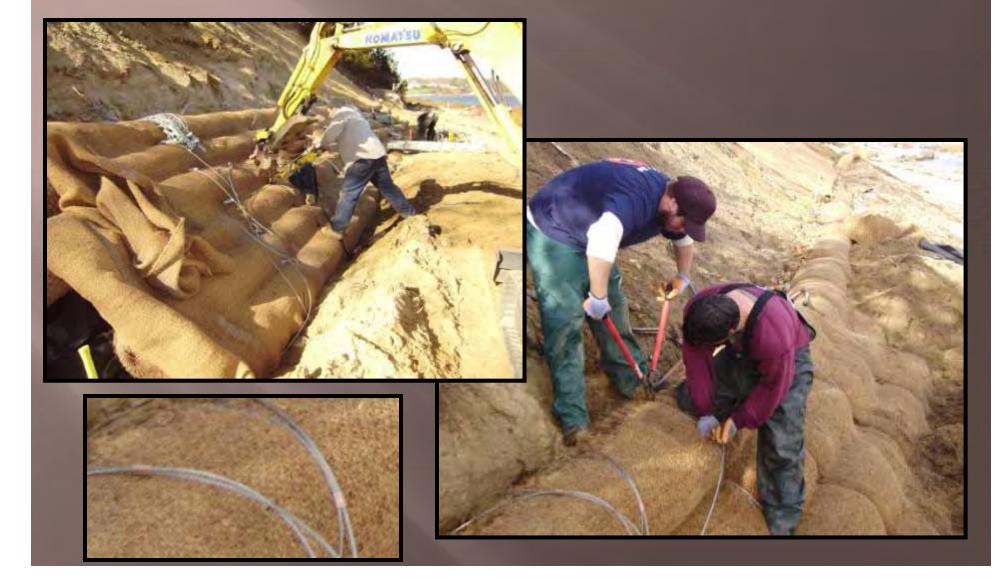
Installation of Fiber Rolls Using More Robust Methods

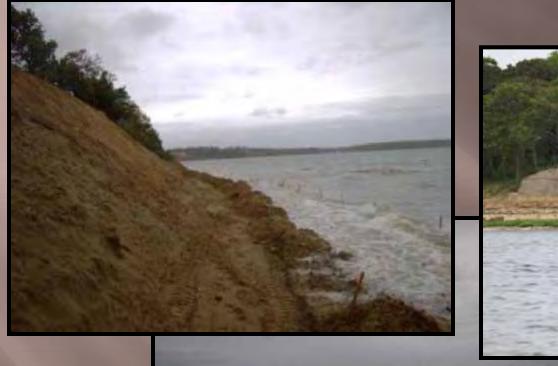
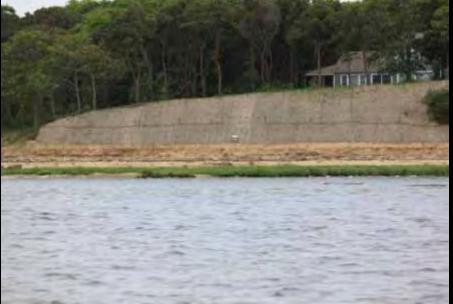
Project was Tested before Completion

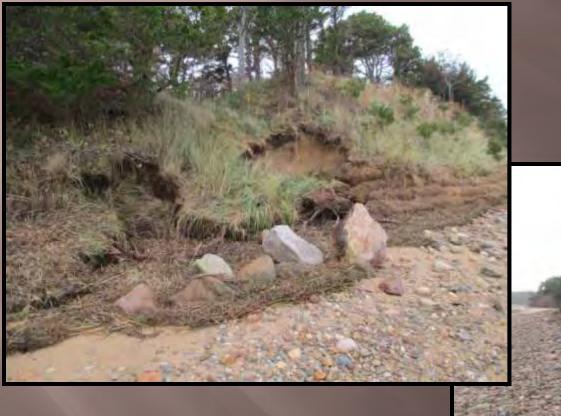
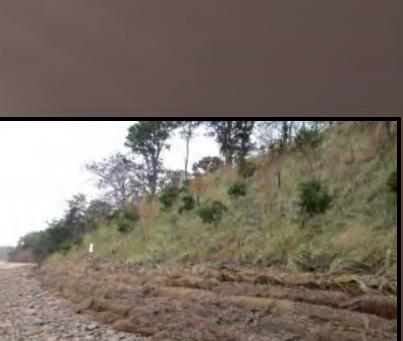
Fiber Roli Array Excelled through Hurricane Sandy

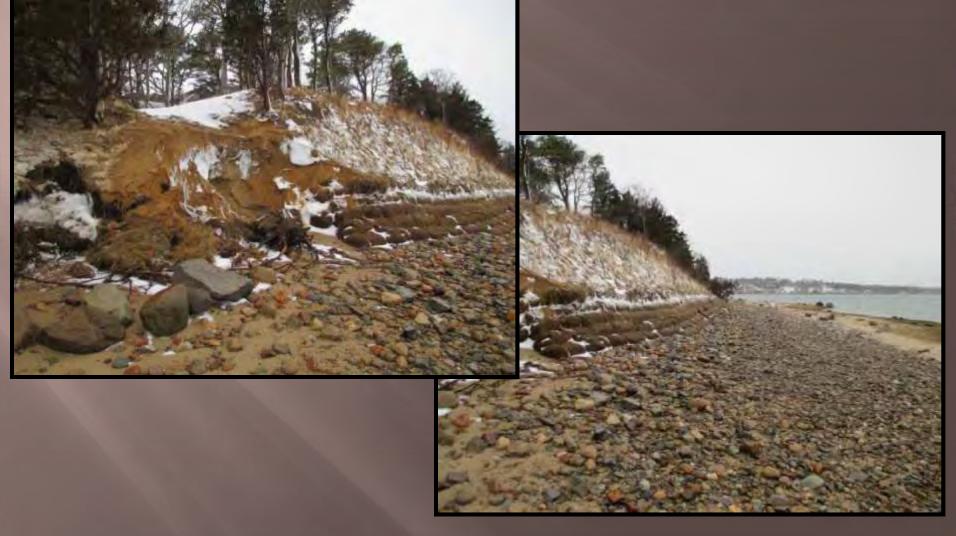
Fiber Roll Array Also Excelled through Nemo and March '13 Nor'easter

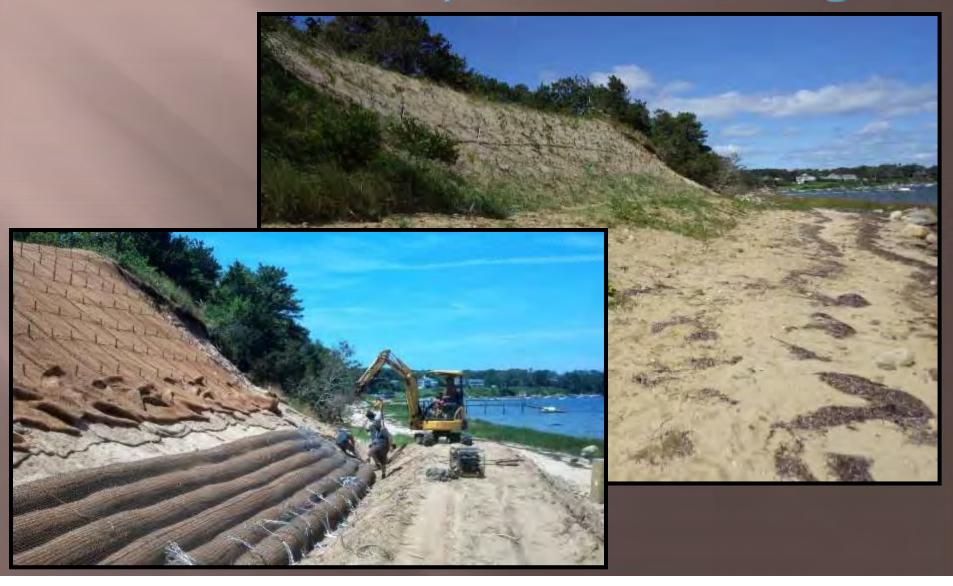
Following Winter 2012 /'13, array was increased by 90 feet in length

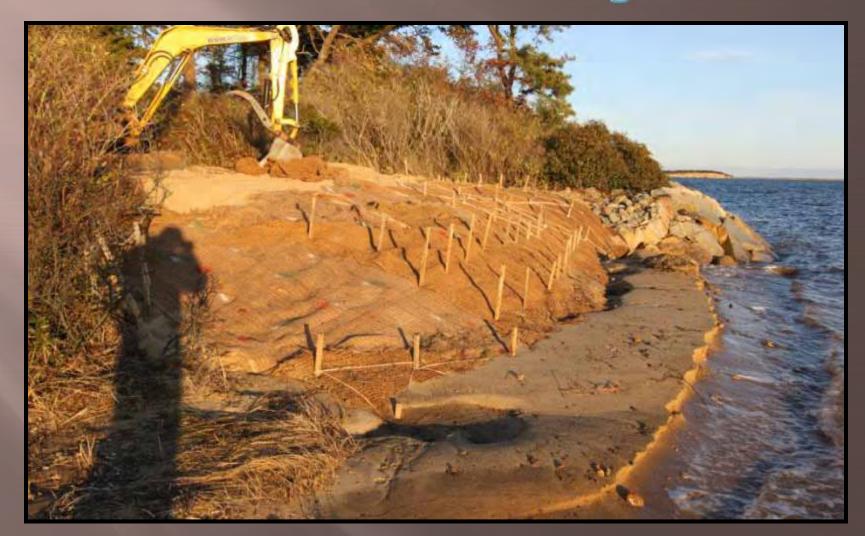
Case Study 2(a)- Goal: Mitigate End Scour & Construct Fringe Marsh

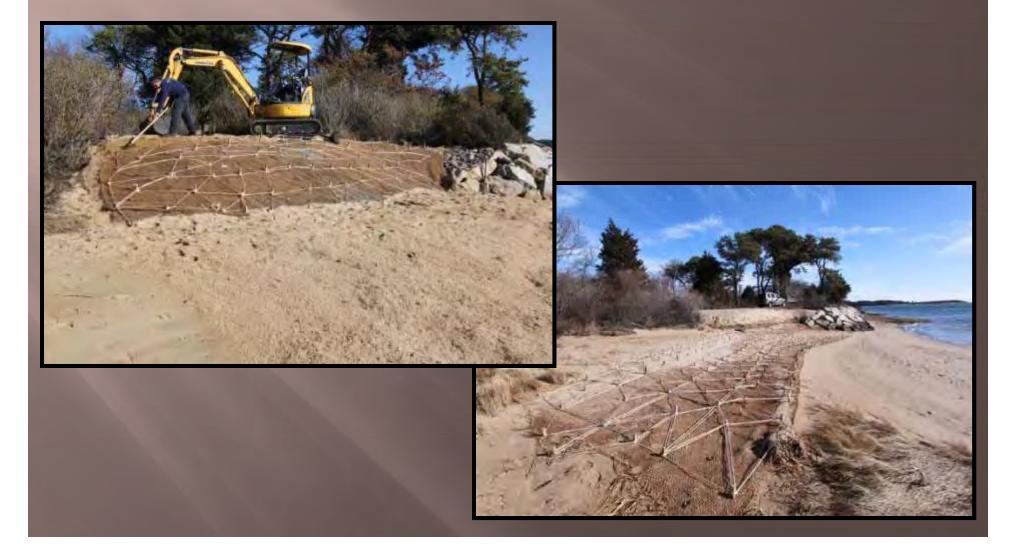
Heavy Coir Erosion Control Blankets to Hold Sediment During Plant Establishment Period

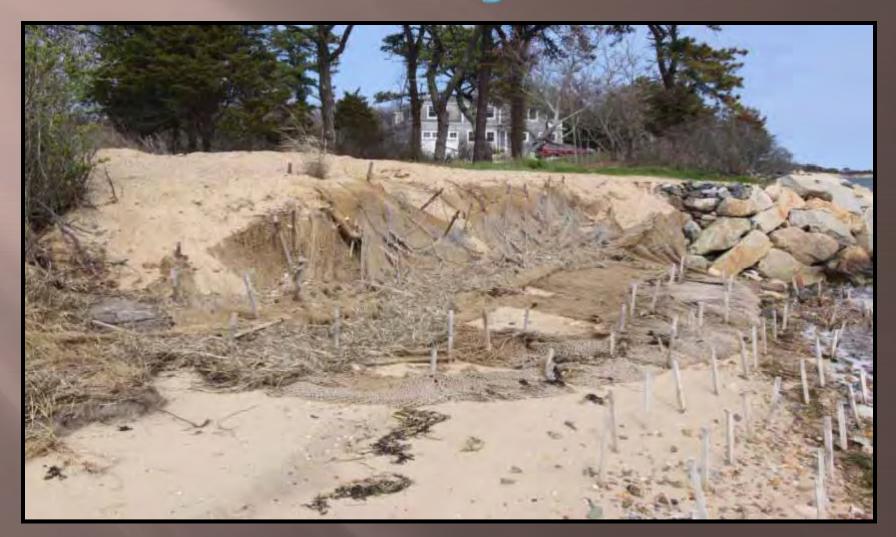
Initial "Lessons" – Erosion Control Blankets & Planting Not Sufficient

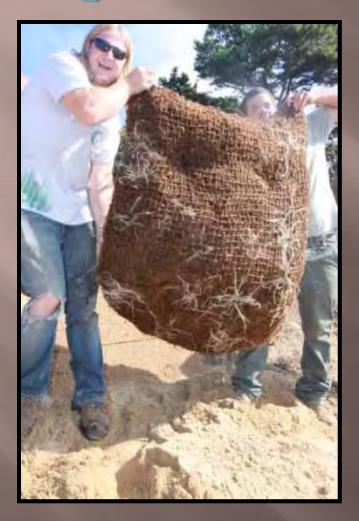
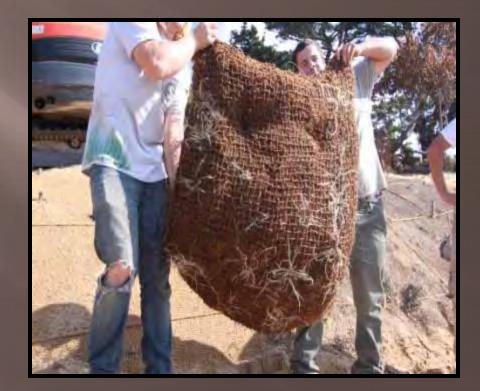
Zet Try - Coir Pillows are Well Vegetated Prior to Installation

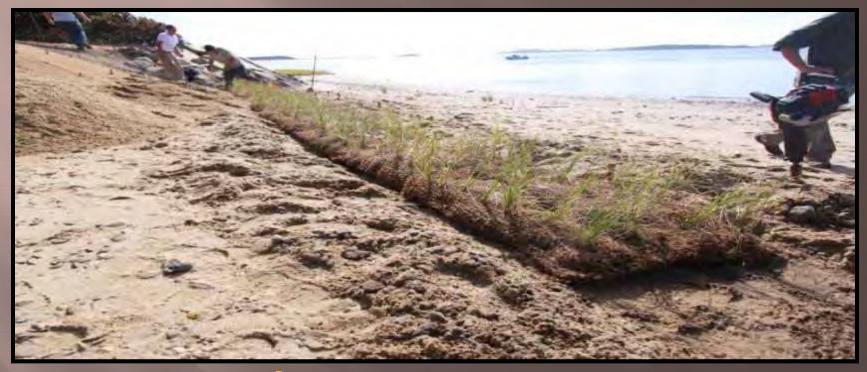
Importance of Fringe Marshes in Coastal Stabilization is Frequently Overlooked

Fringe Marshes can intercept storm energy & stabilize fluctuating beach elevations, which protects nearby upland resources from erosion

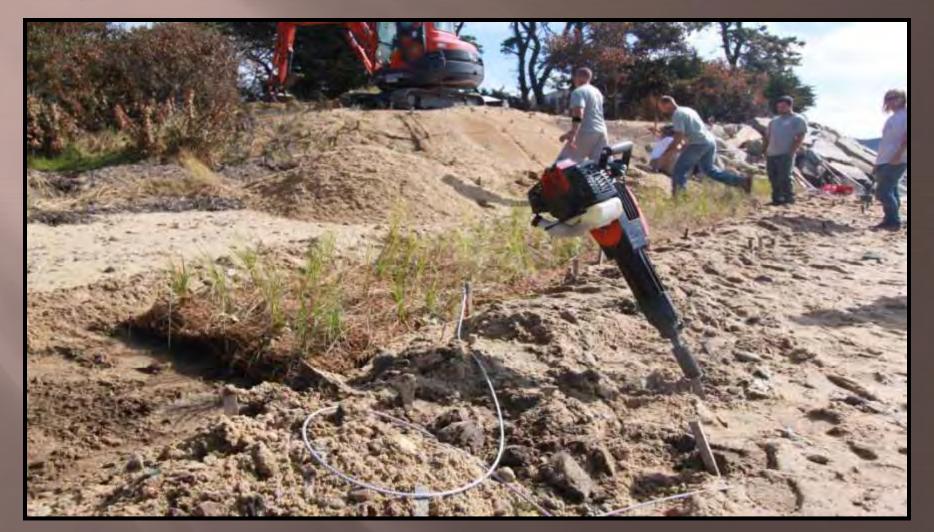
Samulated Salt Marsh" Prevegetated Peat Shelf / Fringe Marsh

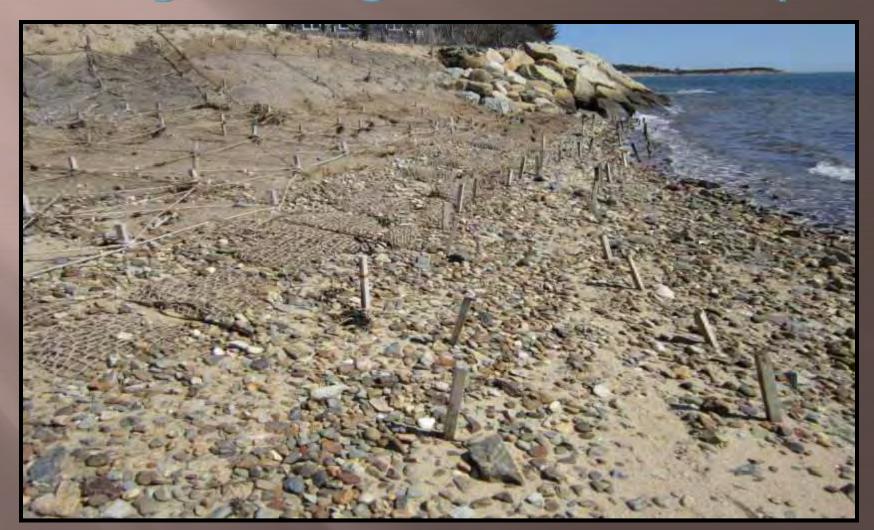
After 1st Winter - Plants Dormant, Bioengineering is in Great Shape

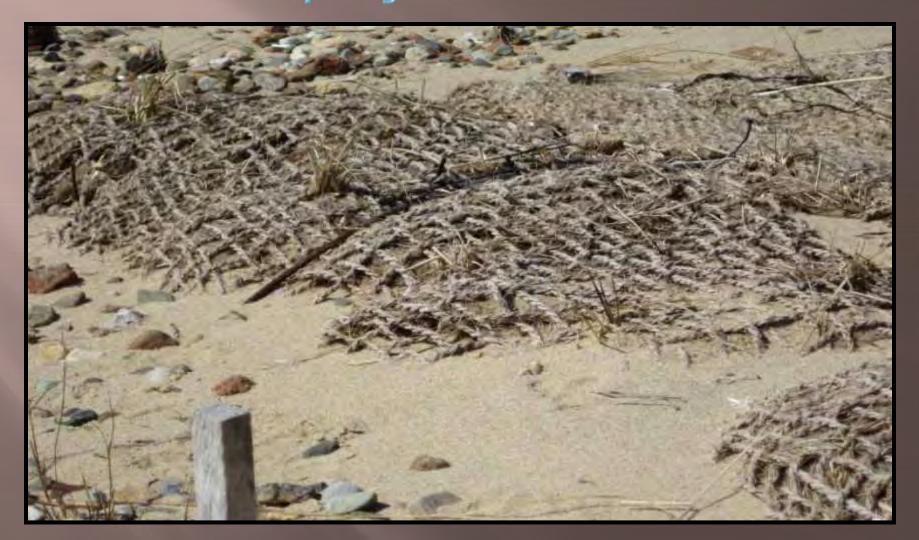
Case Study 2(a) - Vegetation did not take and project not a success

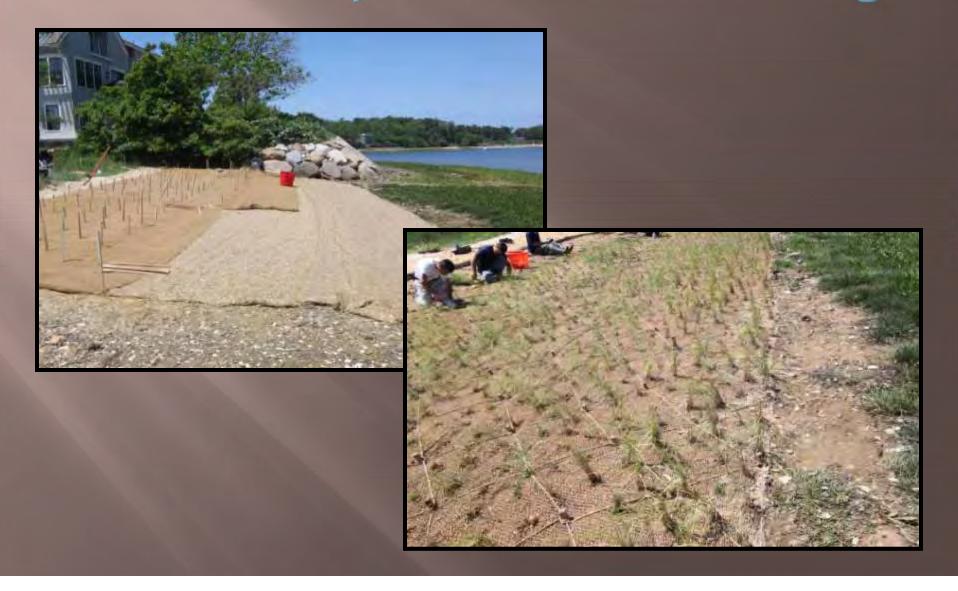
Initial Installation of Coir Blankets Followed by Immediate Planting

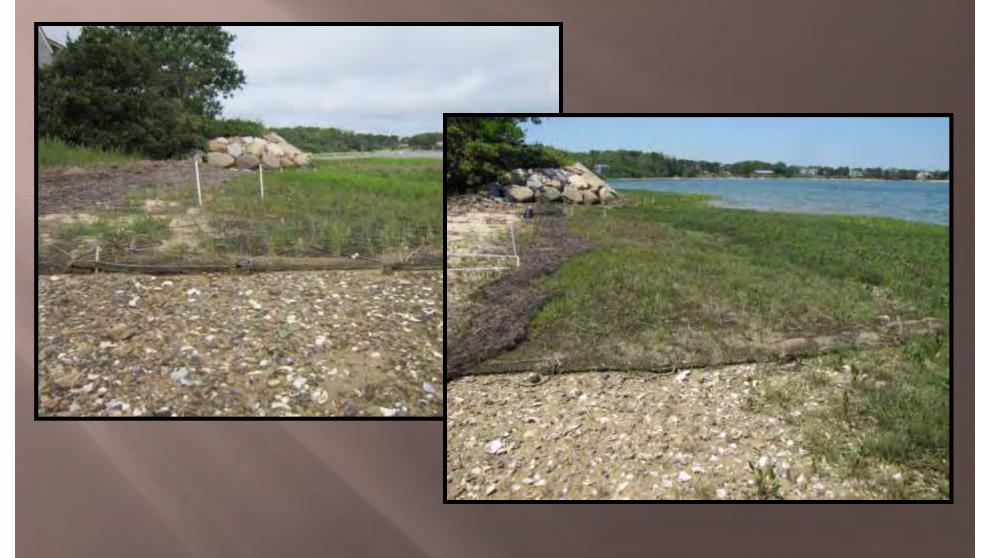
Case Study 2(b) - Great Colonization in 2nd & 3rd Years

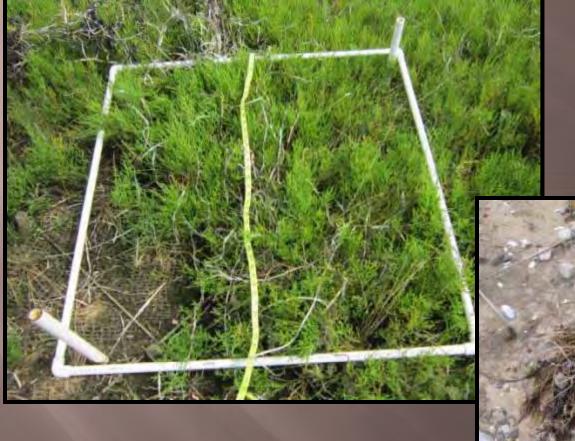
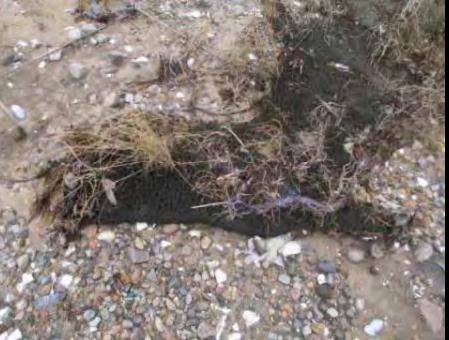
Case Study 2(b) - Monitoring Data & Algae Colonization

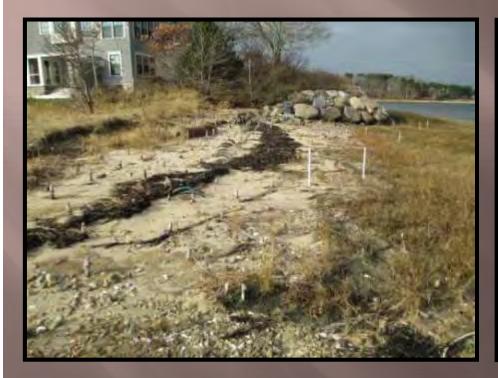
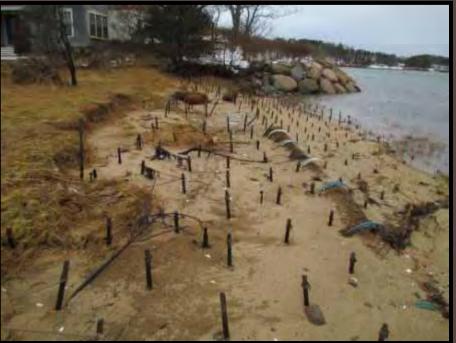
Case Study 2(b) - Storm Performance

POST SANDY

POST NEMO

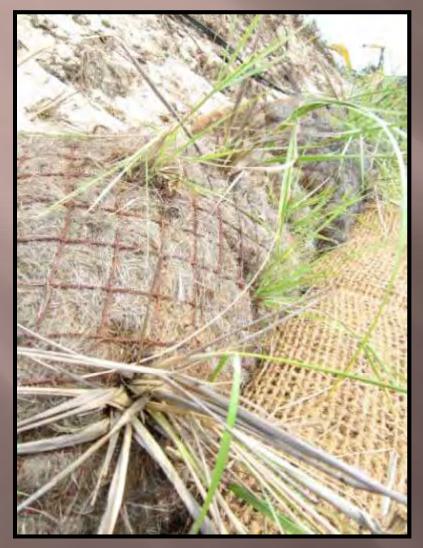
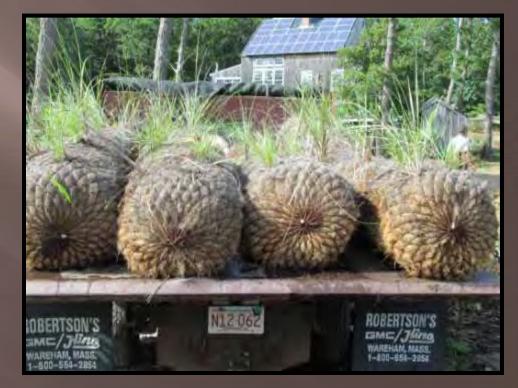
Case Study 3 - Pre-Vegetated Fiber Rolls

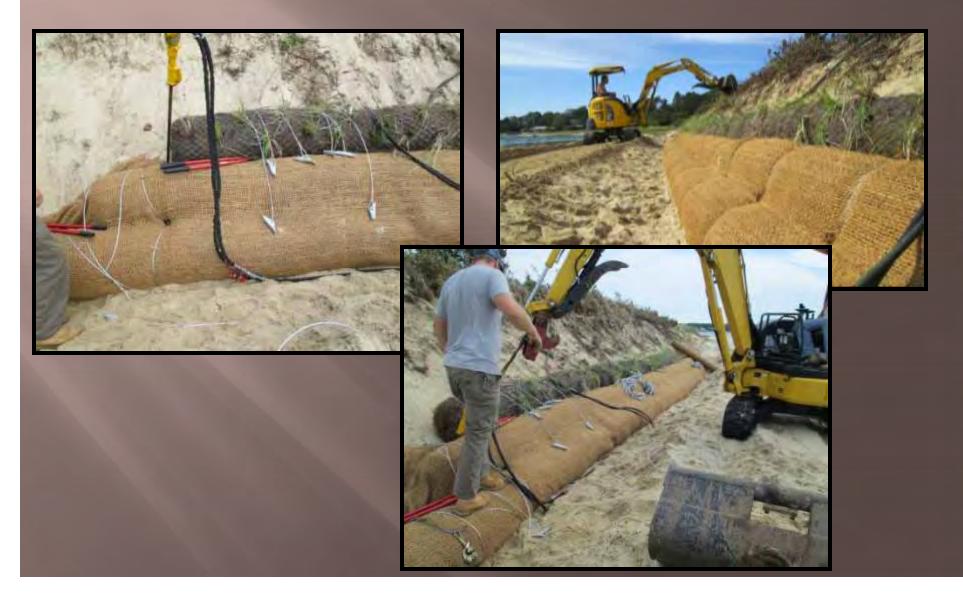
mstalling Fiber Rolls with a Season's Growth Ahead

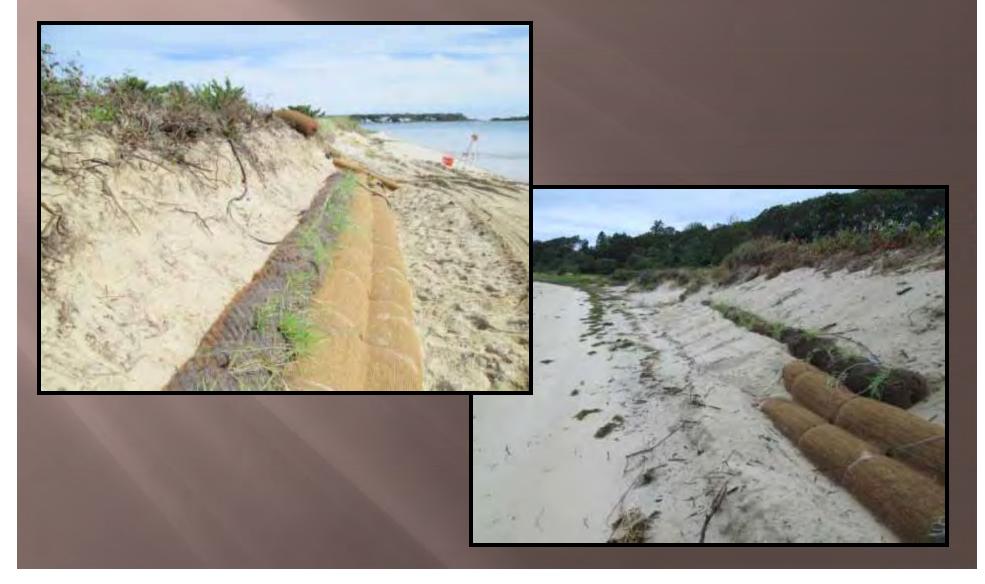
Corr Fiber Rolls are Buried to facilitate Plant Growth & Sunscreen

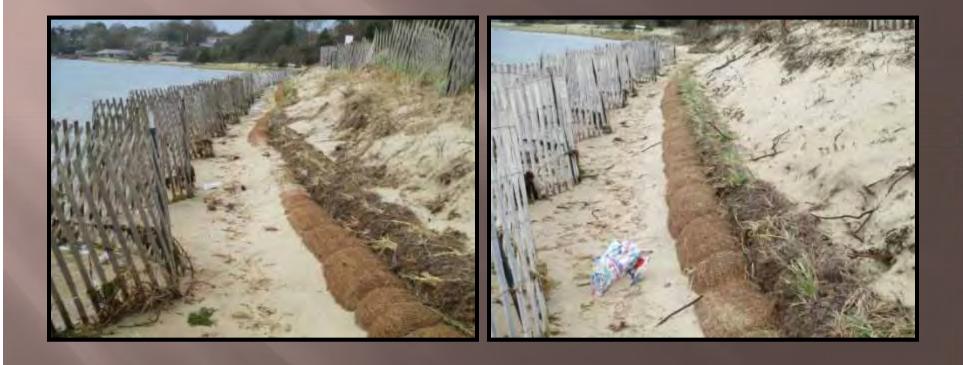
Case Study 3- Post Sandy

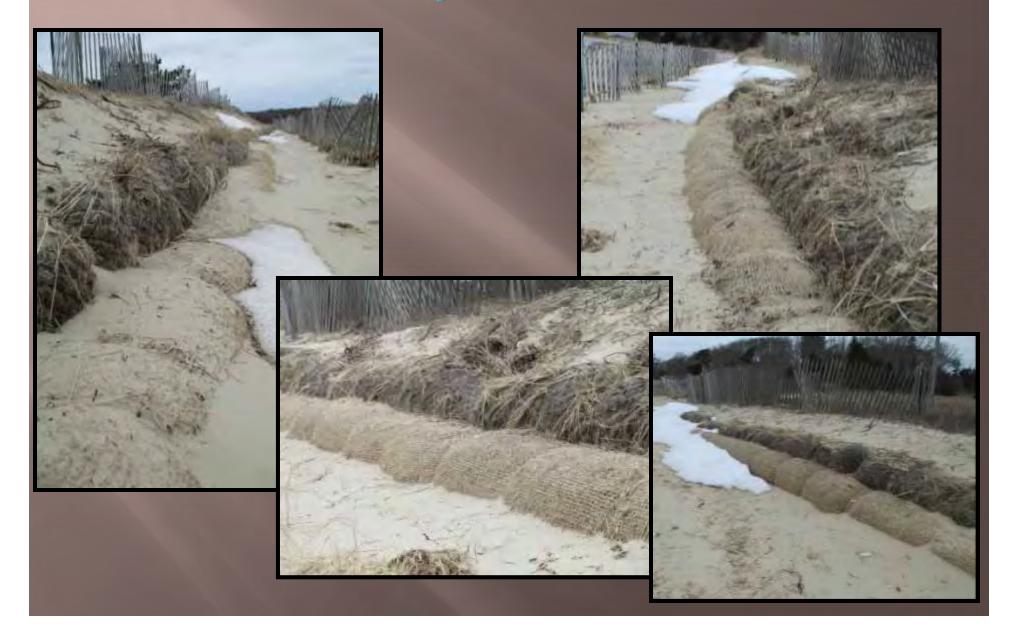
Case Study 3- Post Nemo

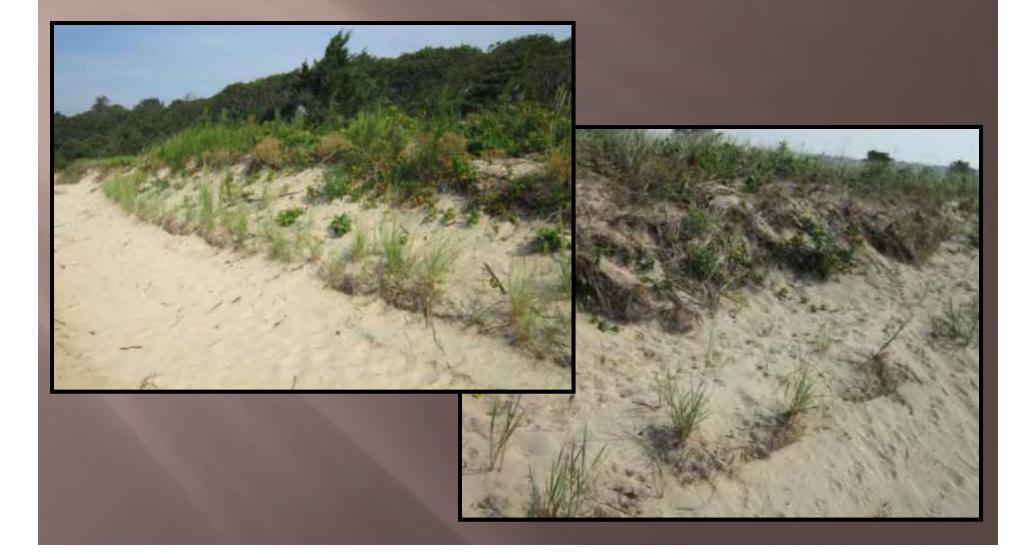
Case Study 3 - 1st Growing Season

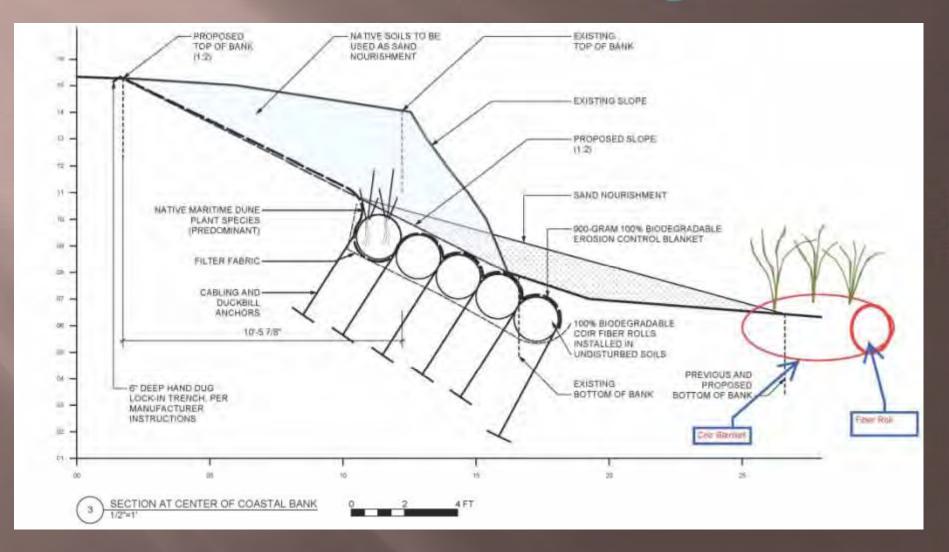
Combined Strategies to Stabilize Beach Elevation and Manage Erosion

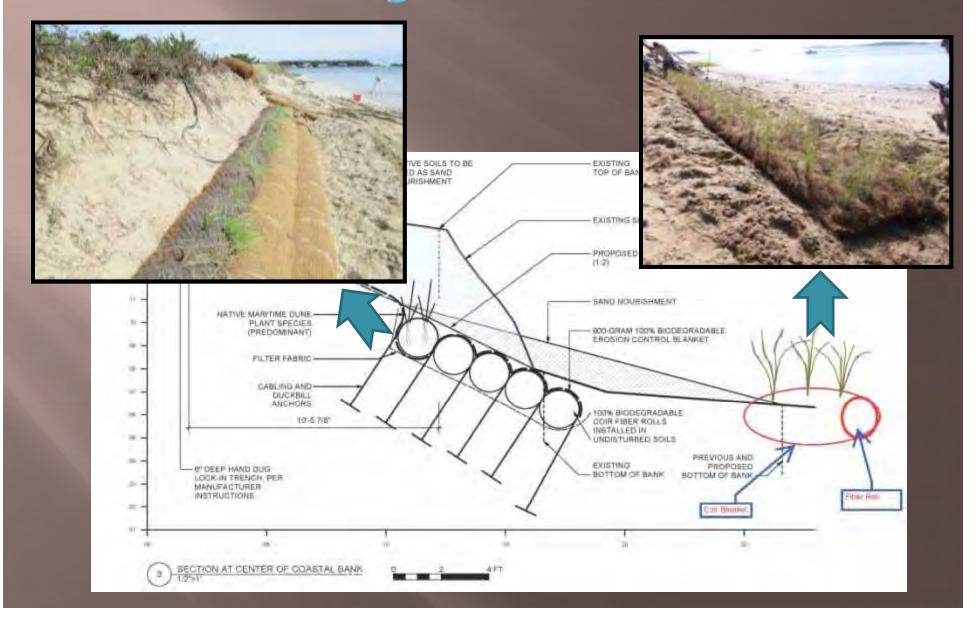
Pre-Vegetated Fiber Rolls Used with Pre-Vegetated Marsh Mats
