**Lynn Juvenile Court
Lynn, MA**

**HVAC SYSTEM
EVALUATIONS
COVID-19**

Office of Court Management
December 26, 2021

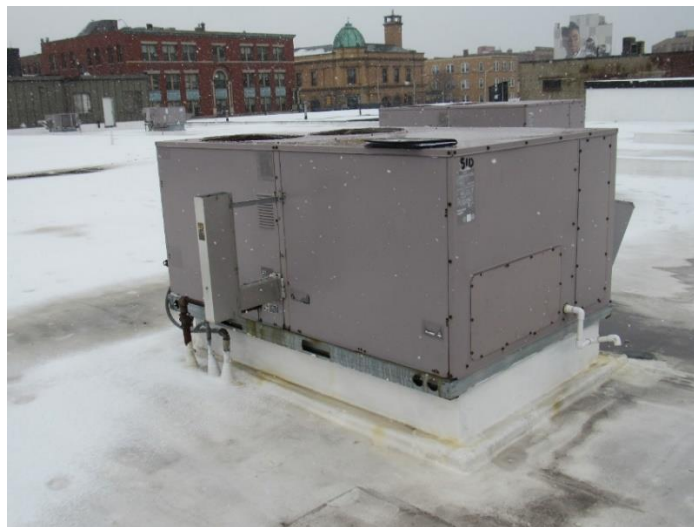
Eight packaged rooftop air handling units (RTU) provide ventilation air to the building. The units appear to be original from the 1999 renovation, and are approximately 22 years old. Each unit contains a supply fan, DX cooling coils, a natural gas furnace, and a 2" MERV 13 filter. All of the RTU's have outdoor air and return air dampers with economizer function. RTU's 5 and 6 were missing exhaust stacks for the gas fired heating section. In several units, the filters had fallen out of the racks due to rusted or loose retaining hardware, and as a result these coils were somewhat dirtier than the rest. The coils were otherwise fairly clean; the owner indicated that they are cleaned twice a year. The supply fans only run when there is a heating or cooling call to the spaces served. There is no ventilation or air circulation when the space is not being heated or cooled.

Photo 1 – Representative Rooftop Air Handler

While generally in good condition and well maintained, the RTU's are nearing the end of their expected service life of 20-25 years. Plan to replace all RTU's over the next five years. Replacement units should have modulating heating and preferably modulating cooling as well. This will improve thermal comfort when operating the fans continuously as outlined in 2.7.1. As mentioned above, occupants may feel cold with the low supply air temperature in the winter without modulating heat to constantly temper the supply air.
