## LYNN JUVENILE COURTHOUSE HVAC SYSTEM EVALUATION SUMMARY

**Lynn Juvenile Court  
Lynn, MA**

**HVAC SYSTEM  
EVALUATIONS  
COVID-19**

March 15, 2021

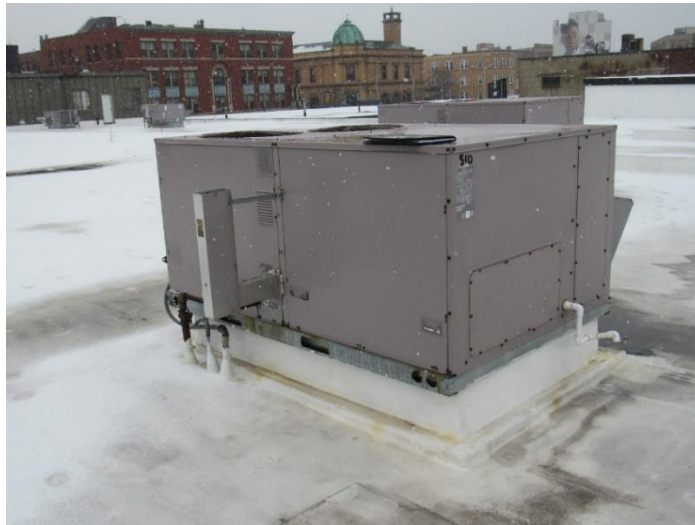
Eight packaged rooftop air handling units (RTU) provide ventilation air to the building. The units appear to be original from the 1999 renovation, and are approximately 22 years old. Each unit contains a supply fan, DX cooling coils, a natural gas furnace, and a 2" MERV 13 filter. All of the RTU's have outdoor air and return air dampers with economizer function. RTU's 5 & 6 were missing exhaust stacks for the gas fired heating section. In several units, the filters had fallen out of the racks due to rusted or loose retaining hardware, and as a result these coils were somewhat dirtier than the rest. The coils were otherwise fairly clean; the owner indicated that they are cleaned twice a year. The supply fans only run when there is a heating or cooling call to the spaces served. There is no ventilation or air circulation when the space is not being heated or cooled.

Photo 1 – Representative Rooftop Air Handler

While generally in good condition and well maintained, the RTU's are nearing the end of their expected service life of 20-25 years. Plan to replace all RTU's over the next five years. Replacement units should have modulating heating and preferably modulating cooling as well. This will improve thermal comfort when operating the fans continuously as outlined in 2.7.1. As mentioned above, occupants may feel cold with the low supply air temperature in the winter without modulating heat to constantly temper the supply air.
