MASSACHUSETTS TRAIL SURFACE CONDITION STUDY

APRIL 2023

This study was performed by Kittelson & Associates, Inc.

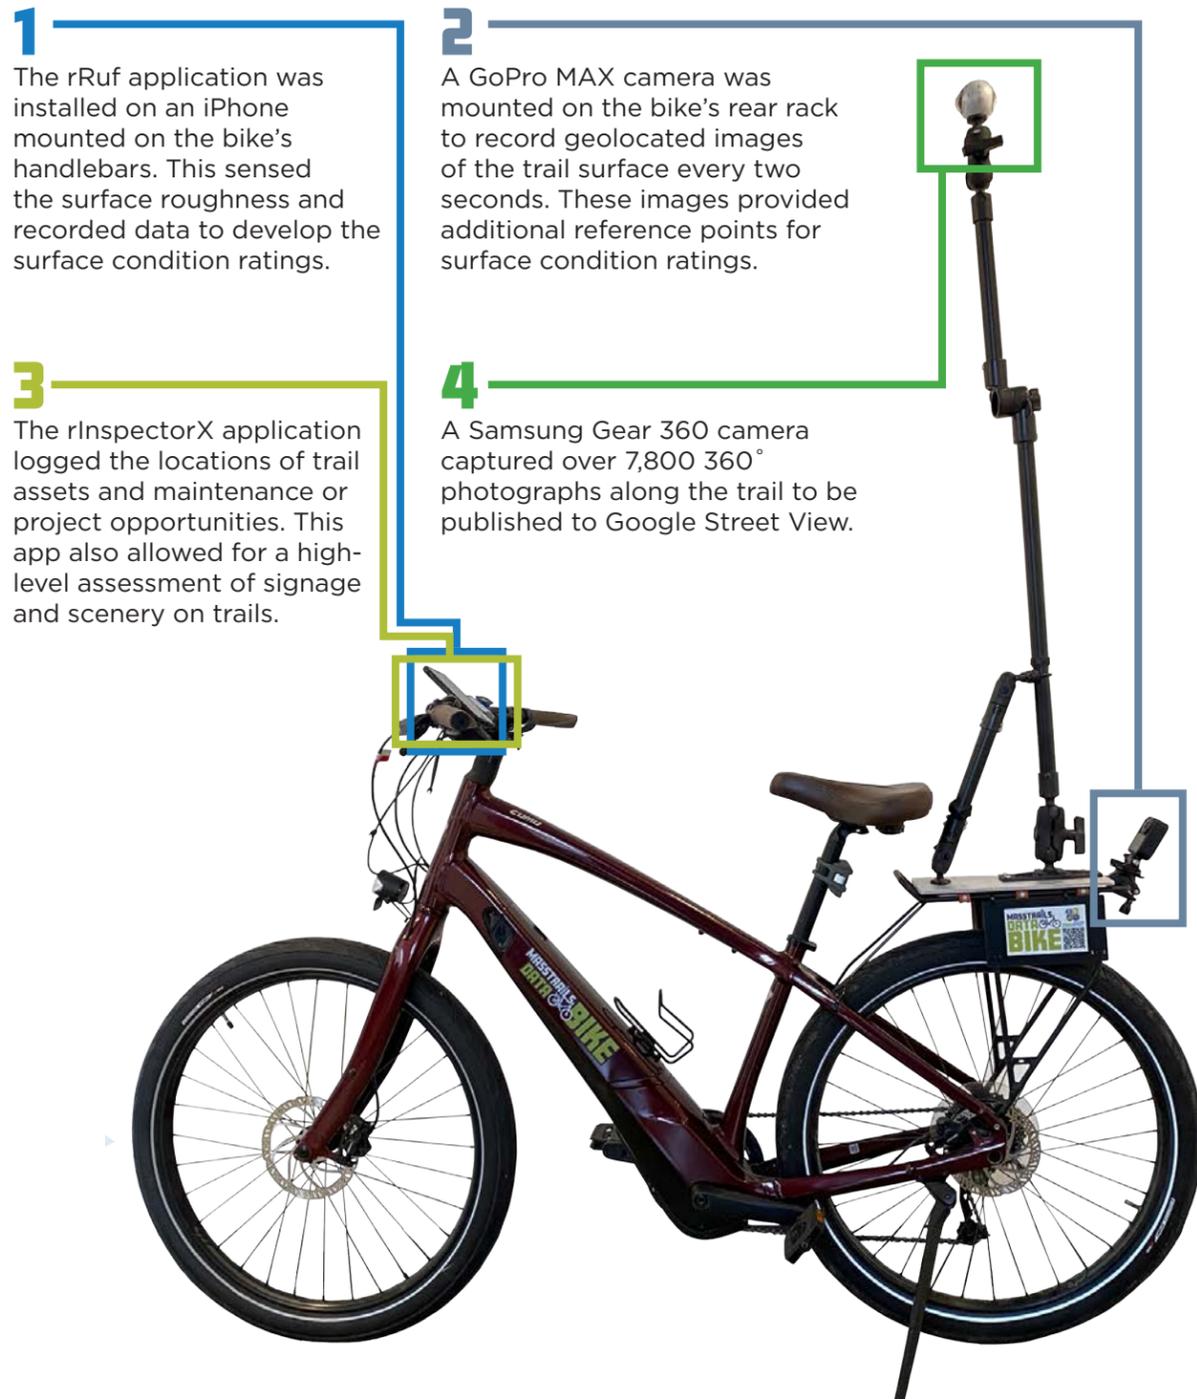
All of the data for this study were collected using the MassTrails Data Bike – an electric bicycle outfitted with special data collection equipment to capture trail conditions. The Data Bike was ridden for over 600 miles between May 2022 and October 2022, capturing measurements and images all along the way. There were four main data collection devices installed on the Data Bike:

1 The rRuf application was installed on an iPhone mounted on the bike’s handlebars. This sensed the surface roughness and recorded data to develop the surface condition ratings.

2 A GoPro MAX camera was mounted on the bike’s rear rack to record geolocated images of the trail surface every two seconds. These images provided additional reference points for surface condition ratings.

3 The rInspectorX application logged the locations of trail assets and maintenance or project opportunities. This app also allowed for a high-level assessment of signage and scenery on trails.

4 A Samsung Gear 360 camera captured over 7,800 360° photographs along the trail to be published to Google Street View.

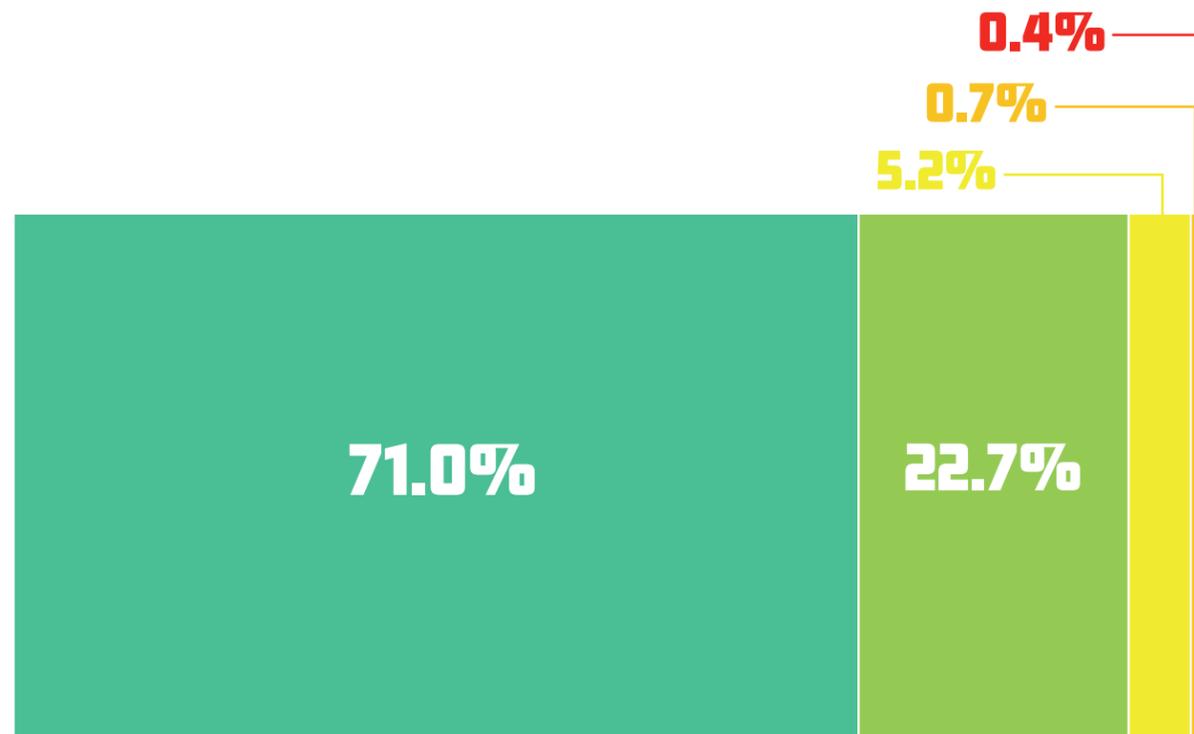
MILES BY CONDITION

■ Excellent
 ■ Good
 ■ Fair
 ■ Poor
 ■ Very Poor

Total mileage may not be exact due to rounding and small lapses in data coverage

When taken together, almost three-quarters of Massachusetts's trail miles are in excellent condition. However, **it is important to remember that excellent trail segments are not always consistent along the full length of a trail, and segments of fair, poor, or very poor conditions - even if short - have a greater impact on the user experience.** In some cases, poor segments can pose safety threats that may negate the benefits of nearby excellent segments.

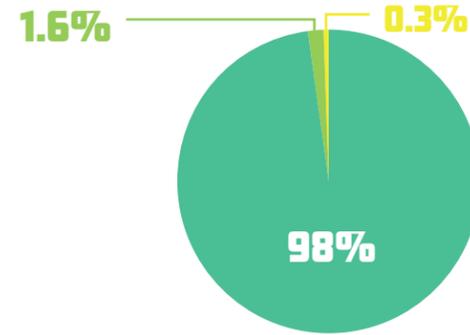
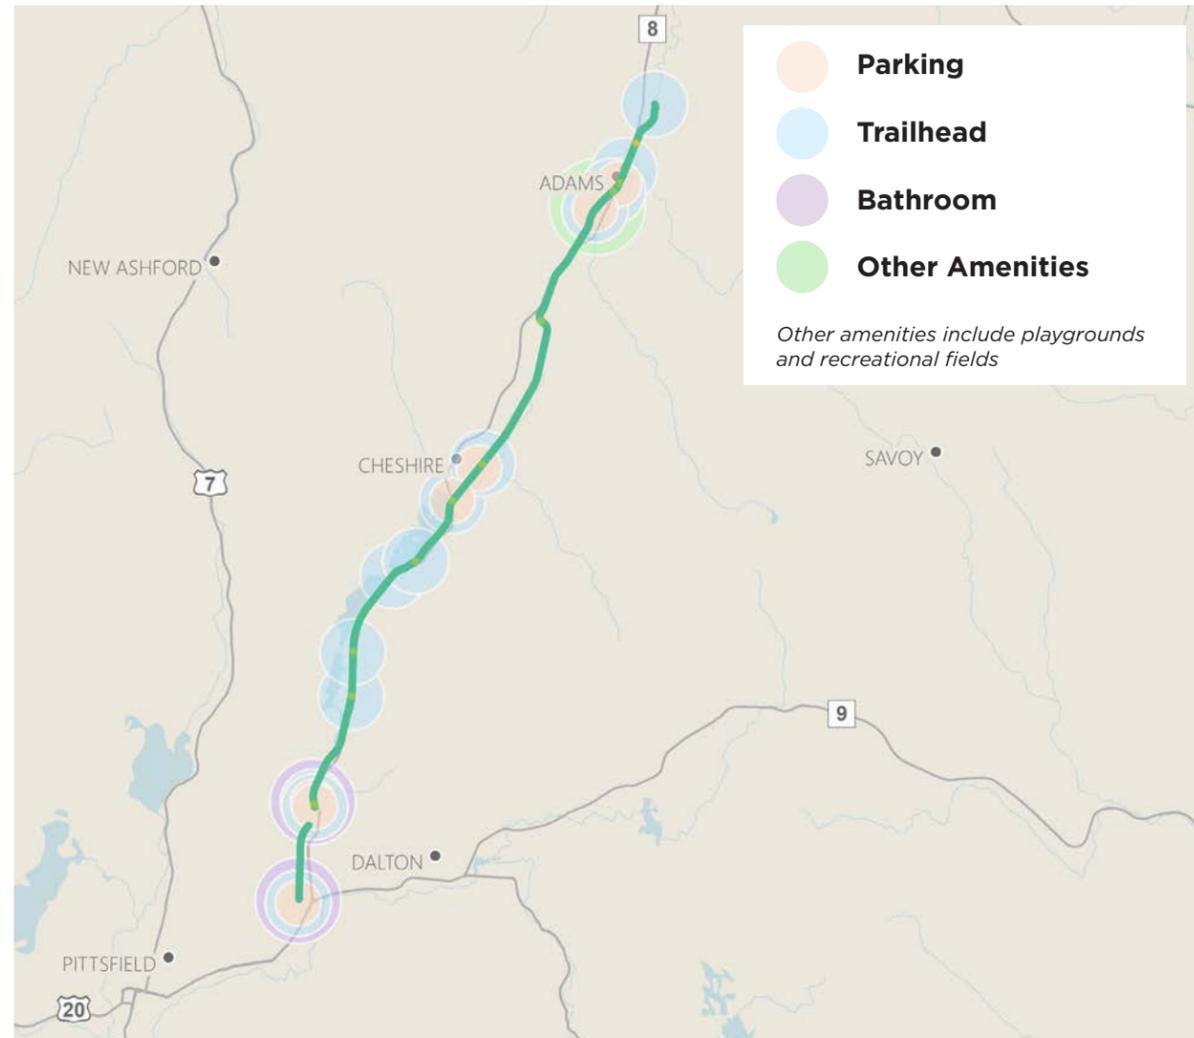
ASHWILLTICOOK RAIL TRAIL

A

- **Scenic views**
- **Signage**
 - » User Etiquette
 - » Wayfinding
 - » Regulatory
 - » Warning
 - » Gateway
 - » Milemarker

Total mileage may not be exact due to rounding and small lapses in data coverage

Note: Ratings do not measure any part of the user experience beyond the smoothness of the trail.

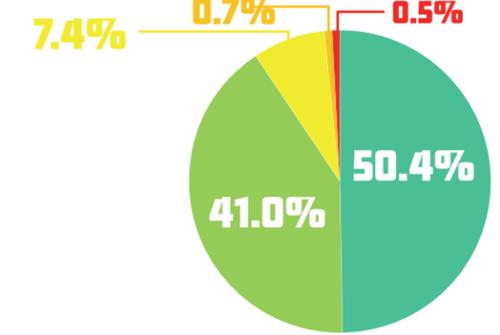
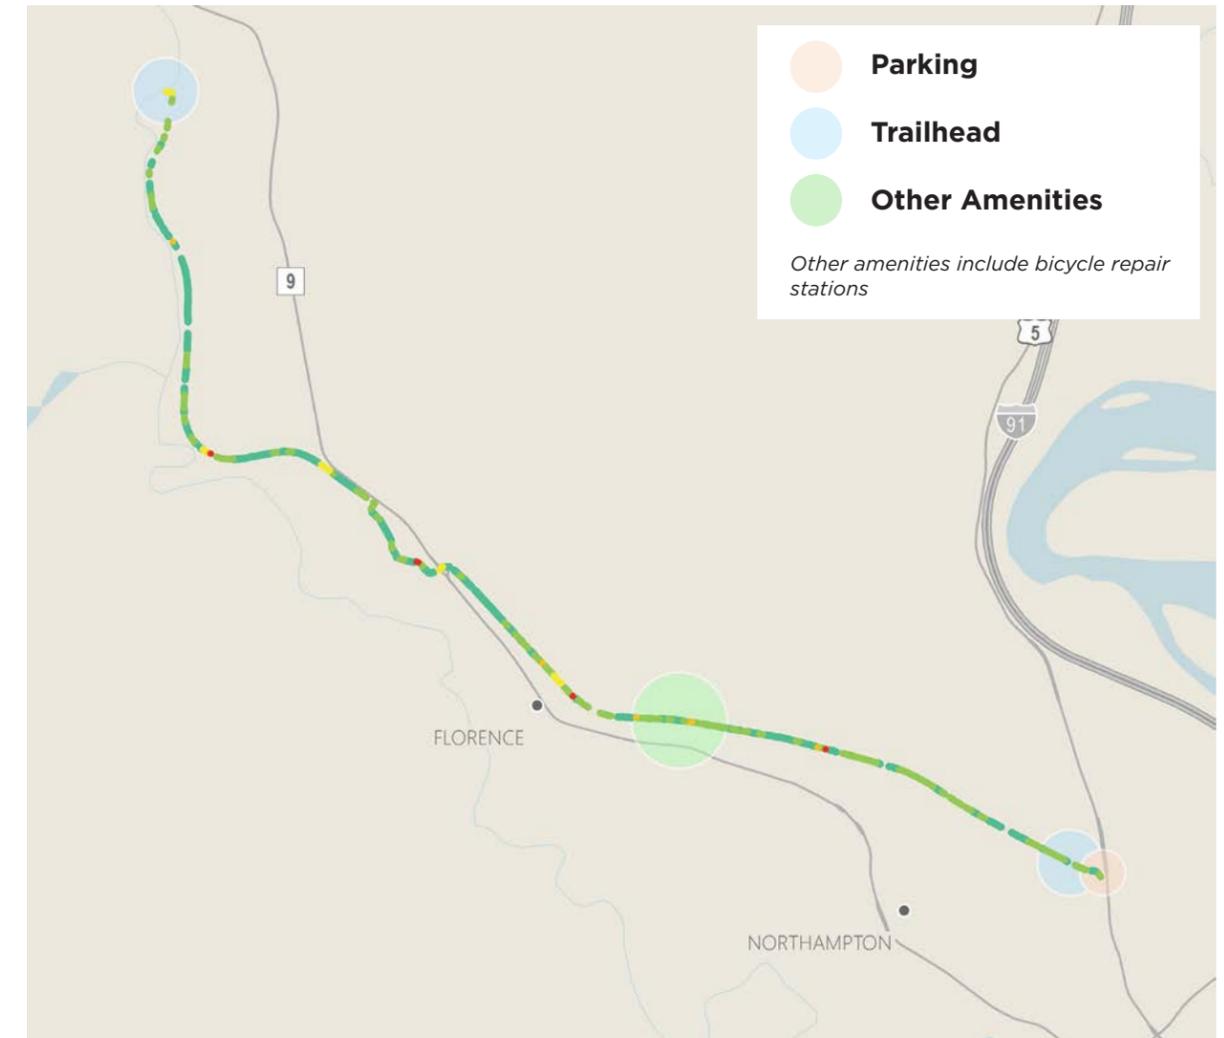
NORTHAMPTON BIKEWAY

B

- **General Scenery**
- **Signage**
 - » User Etiquette
 - » Wayfinding
 - » Regulatory
 - » Warning
 - » Gateway

Total mileage may not be exact due to rounding and small lapses in data coverage

Note: Ratings do not measure any part of the user experience beyond the smoothness of the trail.

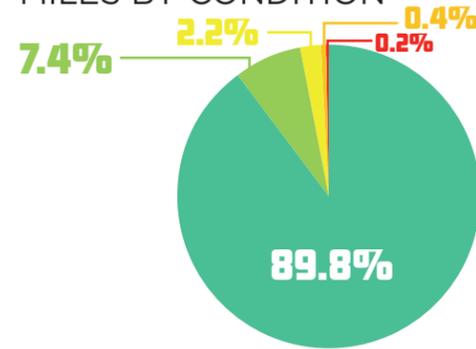
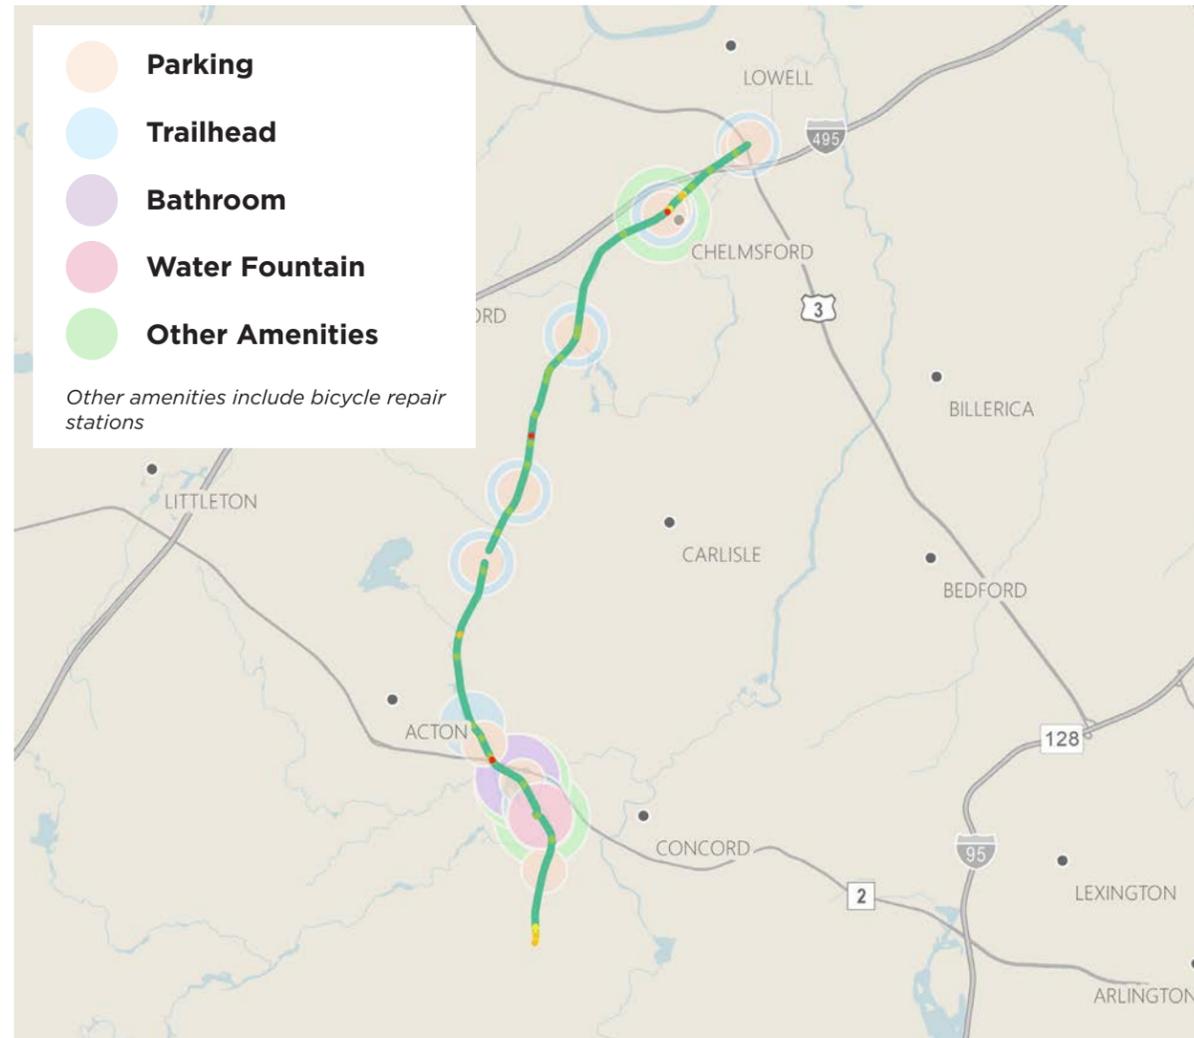
BRUCE FREEMAN RAIL TRAIL

A-

- **Scenic Views**
- **Signage**
 - » User Etiquette
 - » Wayfinding
 - » Regulatory
 - » Warning
 - » Gateway
 - » Milemarker

Total mileage may not be exact due to rounding and small lapses in data coverage

Note: Ratings do not measure any part of the user experience beyond the smoothness of the trail.

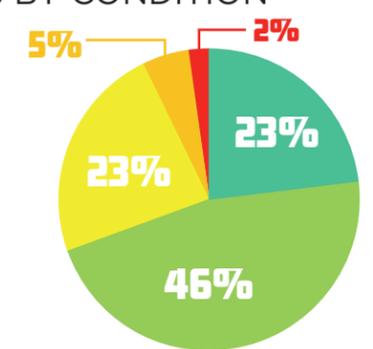
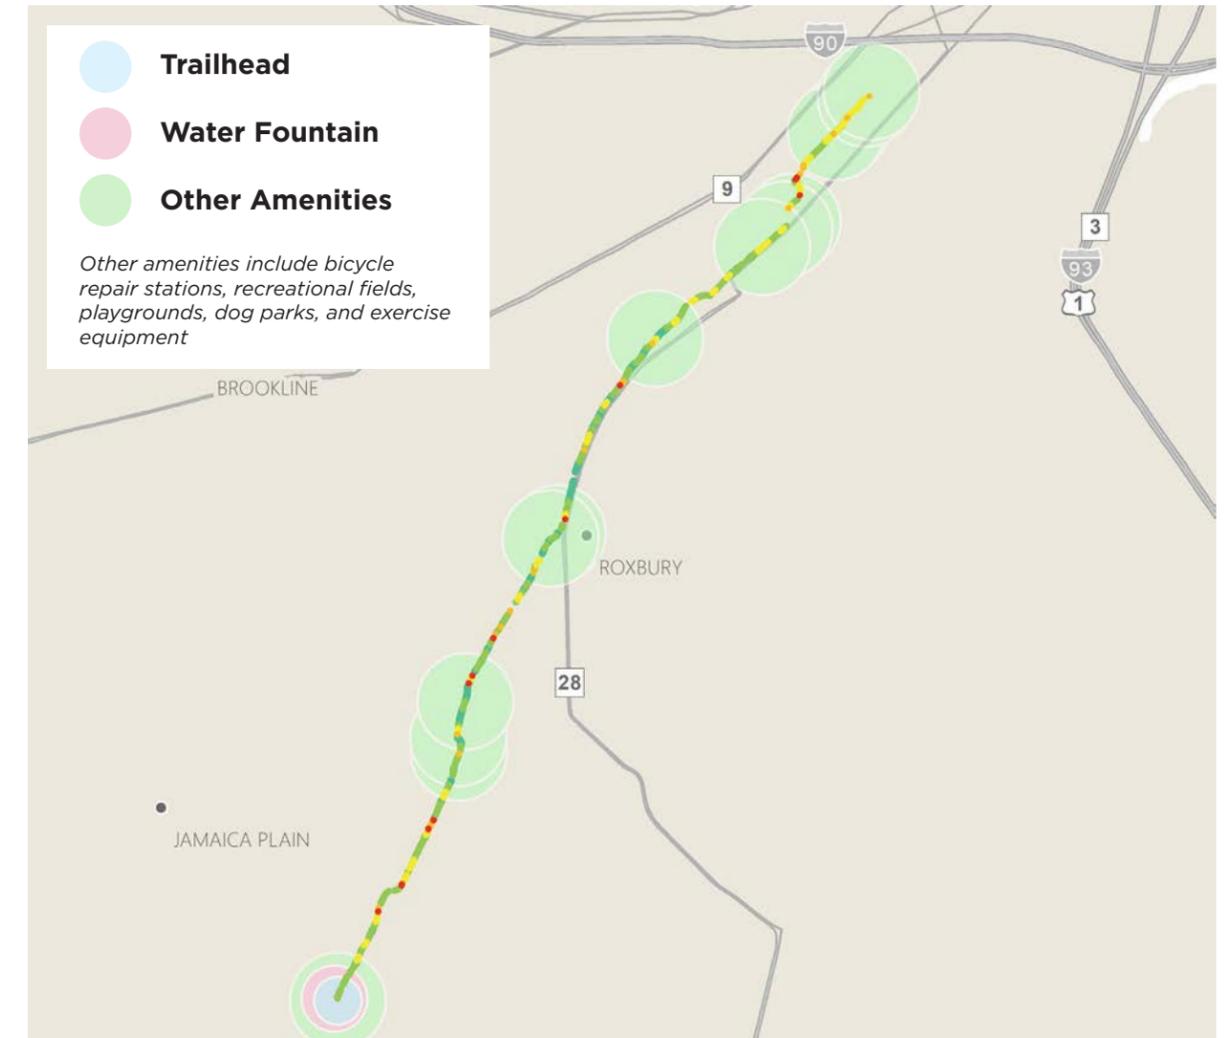
SOUTHWEST CORRIDOR PARK

C+

- **General Scenery**
- **Signage**
 - » User Etiquette
 - » Wayfinding
 - » Regulatory
 - » Warning
 - » Gateway

Total mileage may not be exact due to rounding and small lapses in data coverage

Note: Ratings do not measure any part of the user experience beyond the smoothness of the trail.

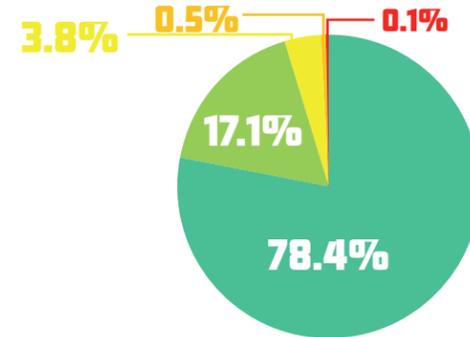
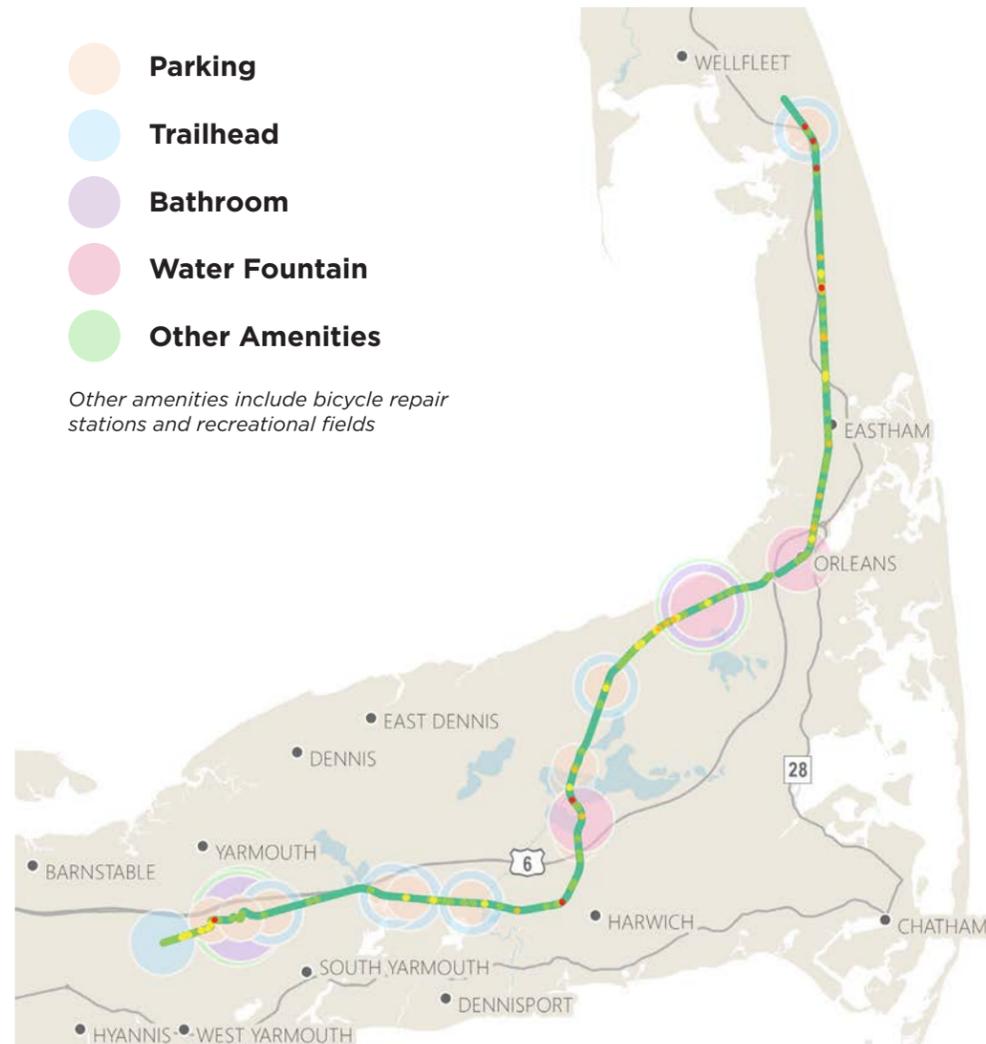
CAPE COD RAIL TRAIL

B+

- **Scenic views**
- **Signage**
 - » User Etiquette
 - » Wayfinding
 - » Regulatory
 - » Warning
 - » Gateway
 - » Milemarker

Total mileage may not be exact due to rounding and small lapses in data coverage

- **Parking**
- **Trailhead**
- **Bathroom**
- **Water Fountain**
- **Other Amenities**

Other amenities include bicycle repair stations and recreational fields

Note: Ratings do not measure any part of the user experience beyond the smoothness of the trail.

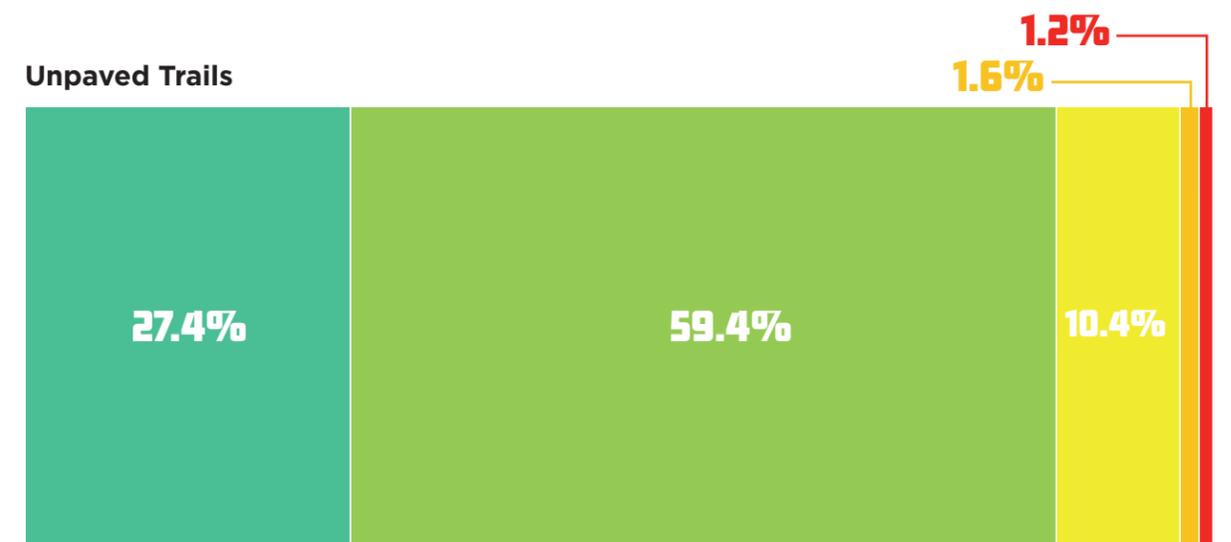
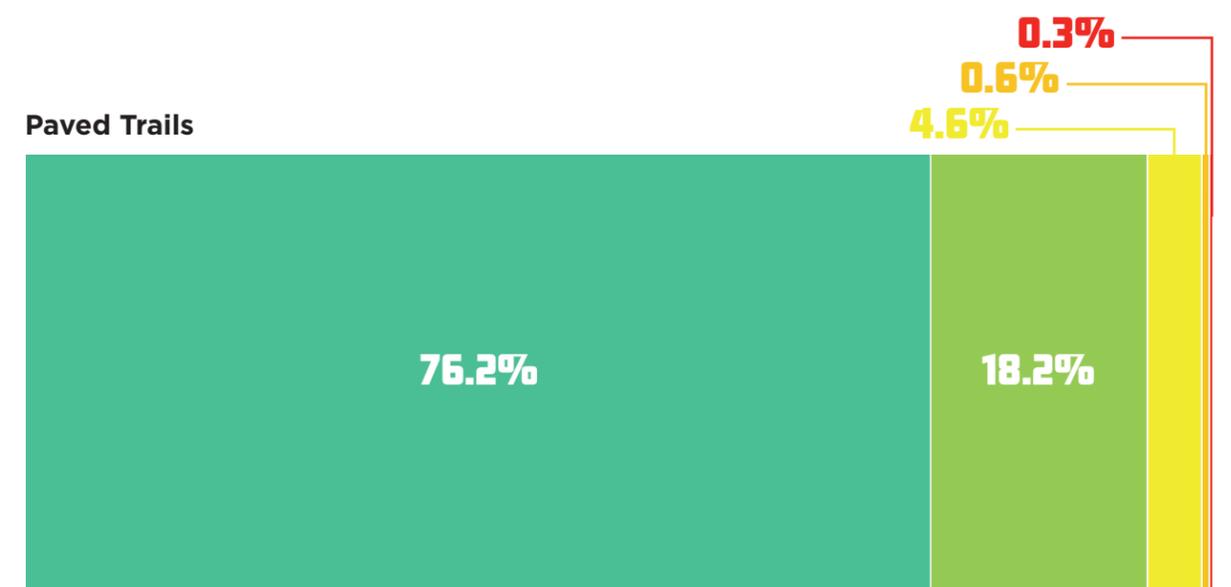
MILES BY CONDITION

This study assessed the surface condition of both paved and unpaved trails. While it is expected that unpaved trails will naturally have more “texture” than paved trails, this assessment was meant to capture larger variations in trail surface condition caused by significant bumps, cracks, or depressions. Even so, unpaved trail segments generally received higher ratings than paved trails. These results do not suggest that all unpaved trails should be paved, rather that unpaved trails have different maintenance requirements and can be more vulnerable to natural effects such as erosion. These factors should be considered when planning for trail maintenance and modernization, particularly on trail systems that include both paved and unpaved segments.

These maps show how the user experience ratings can differ between paved and unpaved segments and how those compare to the overall trailwide rating.

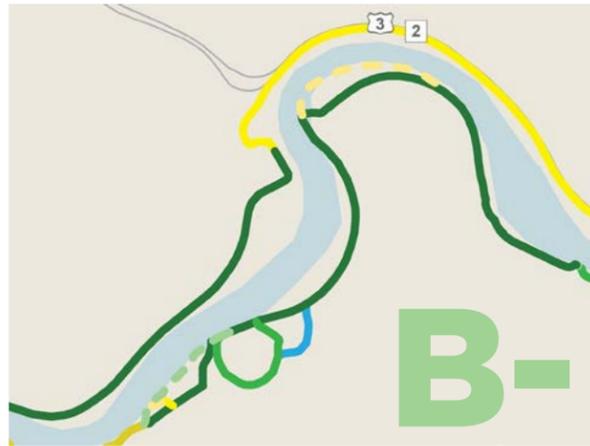
CHARLES RIVER TRAILS

While unpaved segments are generally not as smooth as paved segments, some paved segments can have worse or equivalent roughness ratings as their unpaved counterparts.

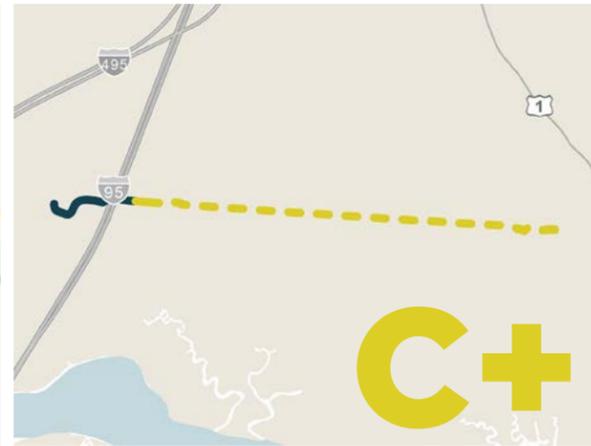
SALISBURY POINT GHOST TRAIL

On trails of mixed surface type, the overall user experience rating can be brought down by unpaved segments.

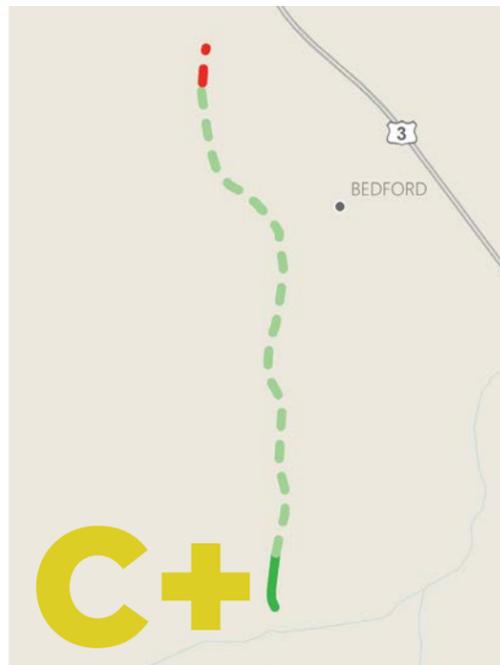
NARROW GAUGE RAIL TRAIL

Unpaved segments can vary widely in their roughness and therefore the user's experience.
