**Eelgrass Mitigation for the Massachusetts Port Authority  
Through Habitat Restoration and Conservation Moorings**

**2019 Final Report**

***Massachusetts Division of Marine Fisheries***

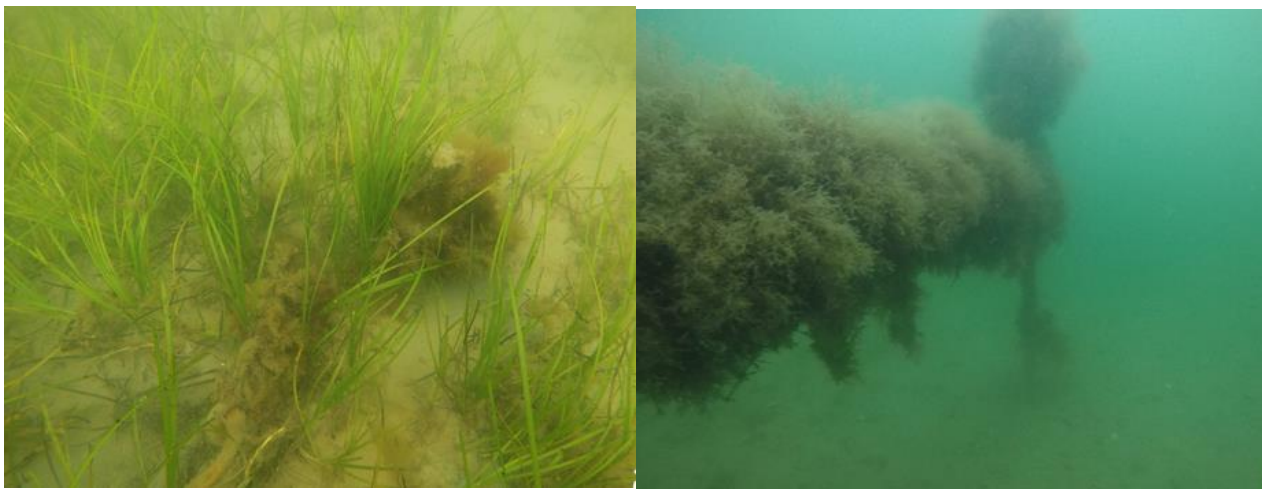
*Field Notes:* Both coves have patchy areas of dense eelgrass over sandy substrate. Hodgkins Cove moorings H-14/H-11 and H-15 each consisted of a bow mooring from a bow and stern moored vessel. At the H-14/H11 mooring, no subsurface buoy was observed, and the rode was on the ground, however, there was eelgrass growing up to the helix (*Fig 1; Appendix C*). The H-15 bow mooring was fouled and floating low, but not grounding at the

time of monitoring, and looked similarly to observations from 2018 with a large and persistent scar (Fig. 2). In Davis Cove, full monitoring was only conducted at mooring DC 13-19. Mooring DC 13-19 had a subsurface buoy present, looked to have been recently cleaned, and was floating with a small amount of chain wrapped around the helix. There was tall eelgrass nearby the mooring and patchy grass near the helix (Fig.3). Moorings DC 10-21 and DC-02 were not at the previously recorded coordinates and a swim-over at mooring DC 14-19 confirmed that it was a conventional chain mooring (converted from an eco-rode back to chain in 2018) with about 50 feet of chain dragging through nearby eelgrass (Fig. 4; Appendix C). See Appendix A for data collected at each mooring and Appendix C for a graph of scar changes over time at each mooring.

Figure 1.(left) H-11 mooring rode on ground with grass growing up to helix; Figure 2.(right) H-15 moorings rode floating with scar around helix

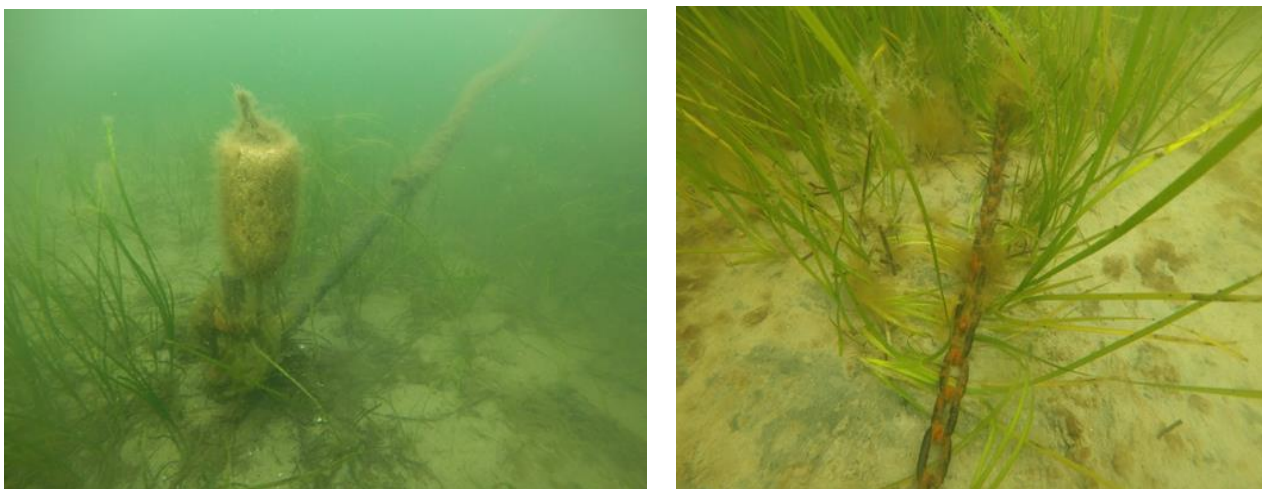
Figure 3. (left) Rode floating above eelgrass at DC 13-19; Figure 4. (right) Chain dragging through eelgrass at DC 14-19

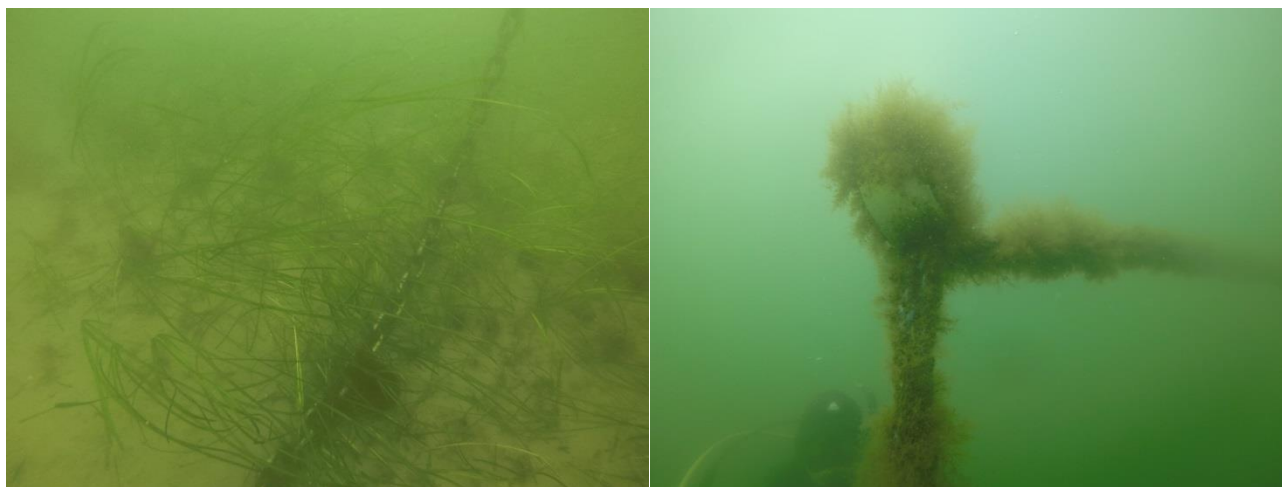
*Field Notes:* Manchester outer harbor is characterized by dense continuous eelgrass over sandy substrate. Mooring 747, a Stormsoft mooring, had a section of chain dragging on the ground, but most of the gear was floating (*Fig. 5*). As in previous years, lobster gear was noted nearby. Mooring 717, also Stormsoft, was functioning properly (*Fig. 6*). This is an improvement from last year when the subsurface buoy and the eco-mooring rode were not buoyant. Moorings 700/G100 and 775/G101 were heavily fouled causing a portion of the rode to drag on the bottom (*Fig. 7a-b*). Mooring 712 was converted to a Dyneema line and all other previous eco-mooring parts were removed from the water (*Fig. 8a*). Divers noted that there was grass growing up to the helix from the northeast and the scar was mostly located to the southwest (*Fig. 8b*). Mooring 778, another Stormsoft, was minimally fouled, but was missing the subsurface buoy and dragging on the bottom within a  $\sim 4$  m diameter scar surrounding the helix (*Fig. 9*). Mooring 745 was a chain mooring (converted from an eco-mooring in 2018). There was  $\sim 2$  m of chain dragging on the bottom (*Fig. 10*). Mooring 749/G49 could not be found in 2019. See Appendix A for the data collected at each mooring and Appendix C for a graph of scar changes over time at each mooring.

**Figure 5. (left) Mooring 747 chain partially dragging through eelgrass; Figure 6. (right) Mooring 717 subsurface buoy floating gear and functioning properly**

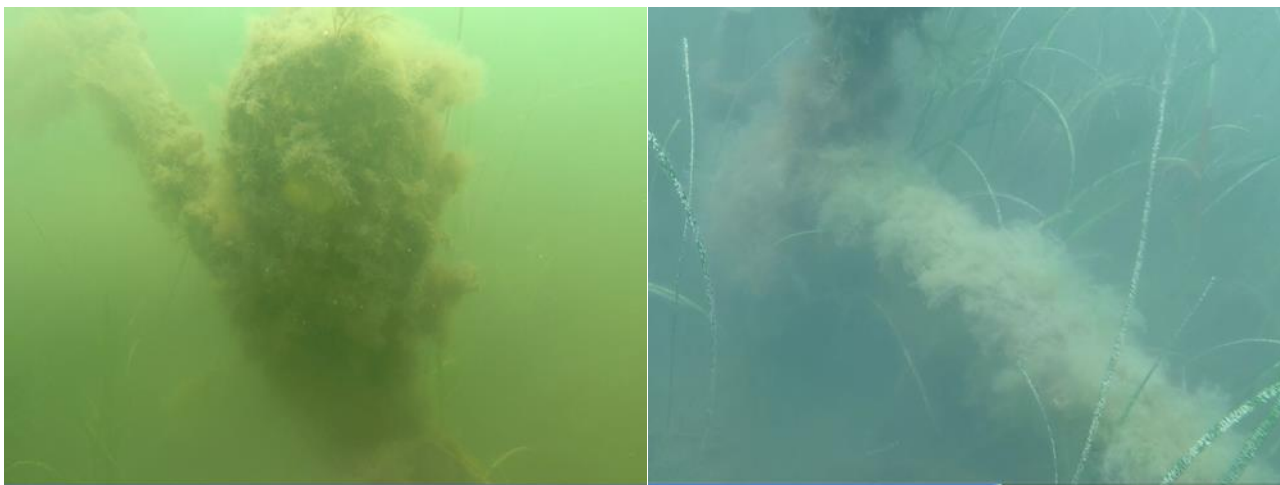
*Field Notes:* The Quissett Harbor site has continuous and moderately dense eelgrass over silty substrate. In Quissett Harbor, the rode and subsurface buoys of eco-moorings 256, 264, 272, 274, 275, 276, and 265 were heavily fouled, but still functioning correctly (Figs. 13, 14, 15, 16 and 17). Encouragingly, eelgrass was seen growing right up to the helices of moorings 272, 274 and 265. In contrast, mooring 275 had a large scar. At mooring 268 the chain connected to the subsurface buoy was dragging on the bottom (Fig. 18).

Figure 13. (left) Heavily fouled subsurface buoy at mooring 264; Figure 14 (right). Mooring 272 floating rode over eelgrass

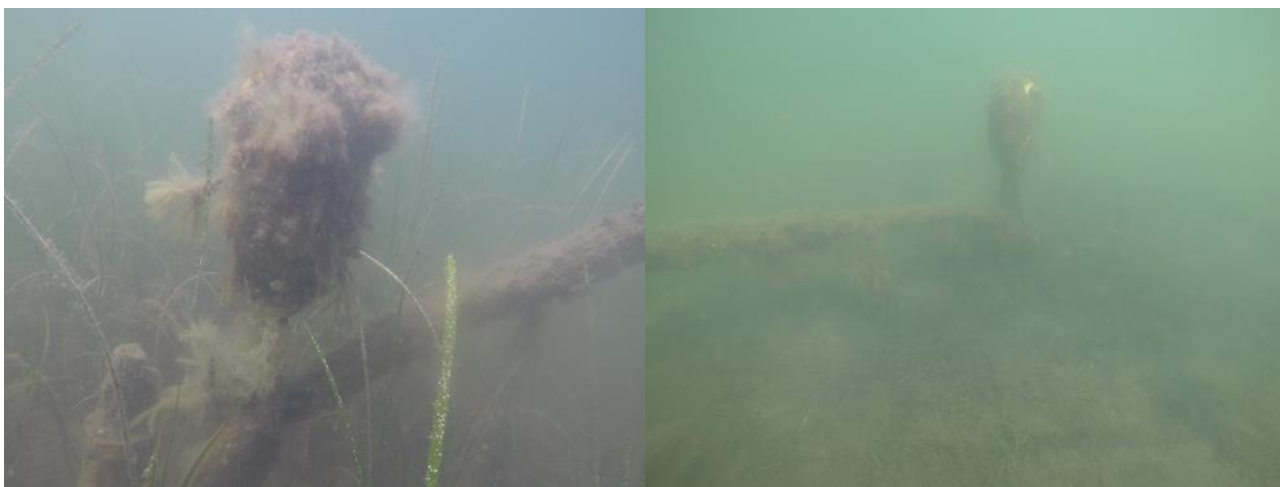
Figure 15.(left) Floating subsurface buoy and rode at mooring 274; Figure 16.(right) Mooring 276 subsurface buoy and floating rode

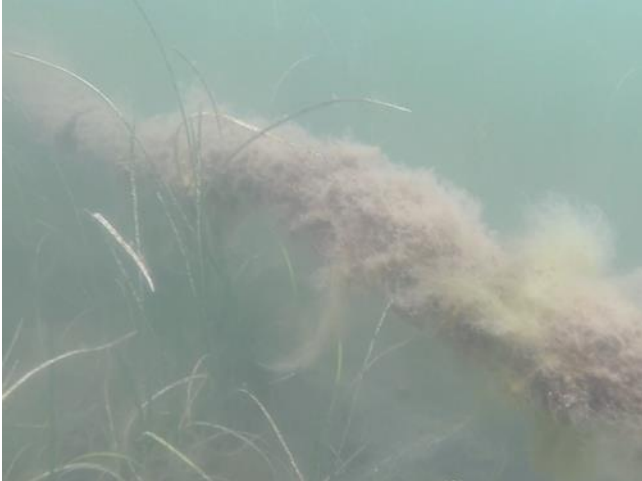
Figure 17. Floating, fouled rode at mooring 265

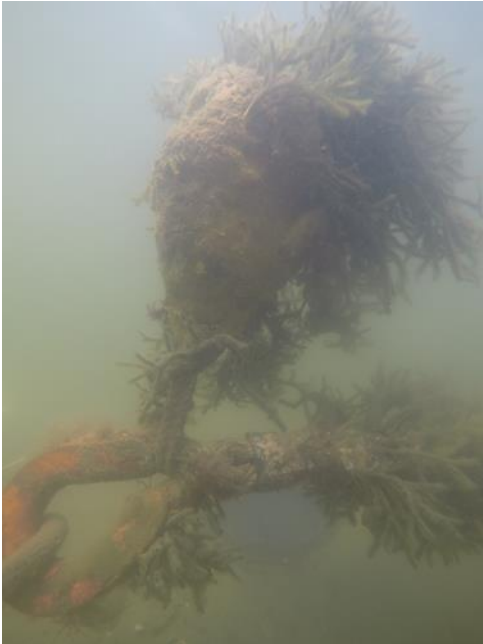
*Field Notes:* West Falmouth Harbor has continuous and dense eelgrass over sandy and silty substrate. At all moorings, the rode and subsurface buoys were heavily fouled with *Codium*, *Didemnum sp.*, *Botrylloides sp.*, and yellow sponge. Moorings 156, 134, 125, 262, 142, and 29 were floating off the bottom and functioning correctly (Fig. 19, 20, 21, 22, 23, 24). The rode of moorings 151 and 107 were dragging on the bottom (Fig. 25).

**Figure 20.** Subsurface buoy and rode of mooring 134 fouled with *Codium*

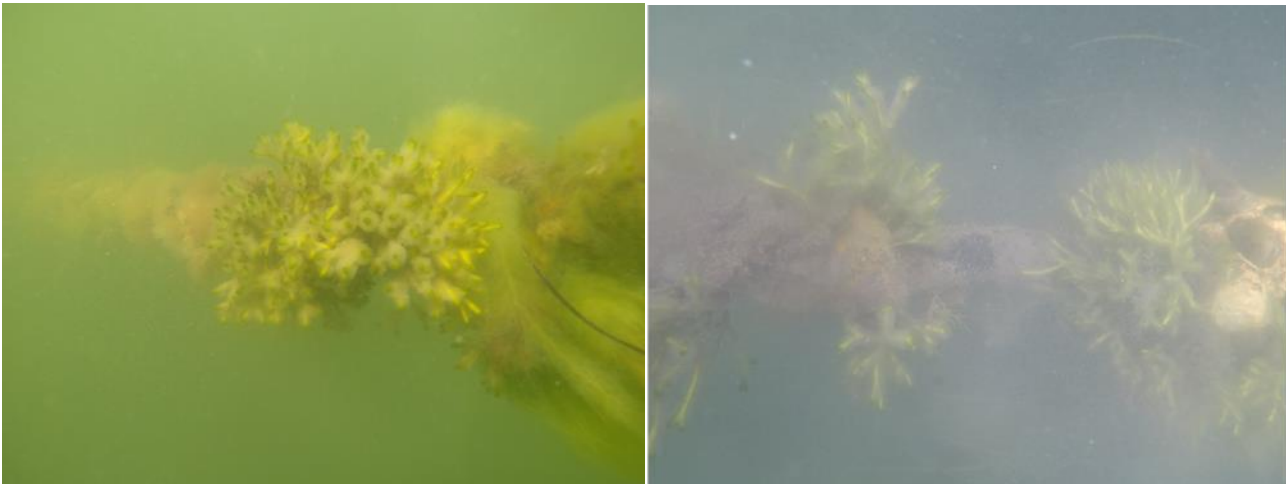
**Figure 21.** Rode of mooring 125 fouled with *Codium*; **Figure 22.** Rode of mooring 107 fouled with *Codium*

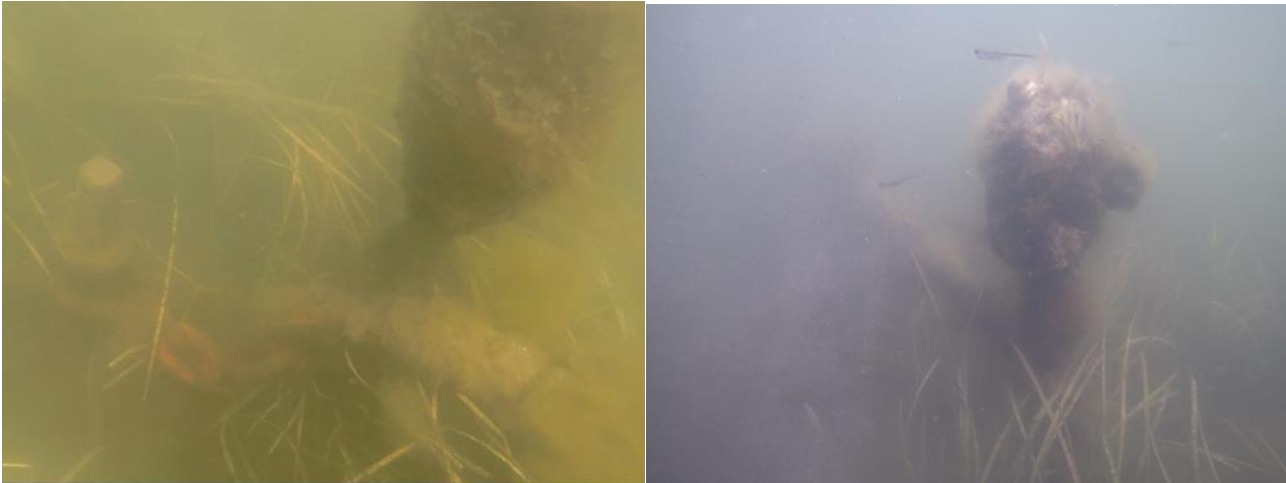
Figure 23. Eelgrass growing up to helix of mooring 142; Figure 24. Eelgrass growing up to helix of mooring 29. Note Atlantic silversides in the picture.

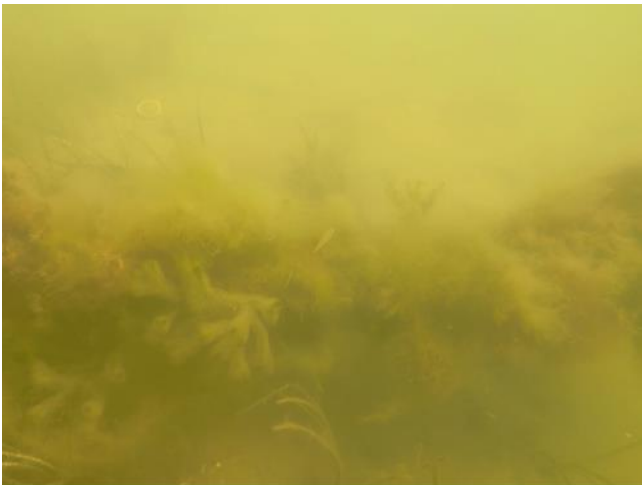
Figure 25. Rode of Mooring 151 fouled and dragging on eelgrass

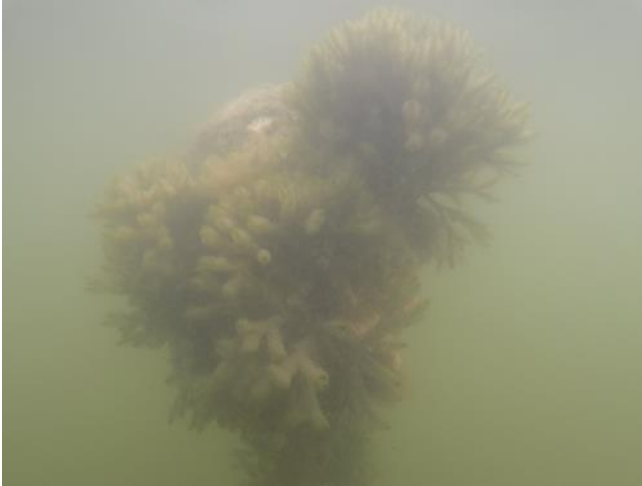
*Field Notes:* The rodes of moorings Town 1/Town 8, 1410, and 1307/525 were fouled and dragging on the bottom over bare substrate (*Fig. 26*). The rode of mooring 1295 was dragging over low density eelgrass. The rode and subsurface buoy of mooring Town 6 was fouled, but not dragging; however, no eelgrass was observed in the area. Eelgrass was observed around mooring 864 in low density with a denser meadow to the west of the scar area.

Figure 26. Heavily fouled subsurface buoy at mooring 1307/525

In sum, to maximize eelgrass recovery in MA harbors, we recommend mooring owners, harbormasters, and mooring installers (1) consider site characteristics (i.e. depth and tidal range) during mooring installation, (2) de-foul conservation moorings regularly (~monthly) over the course of the boating season, (3) remove mooring gear during winter, and (4), once a mooring has been converted to a conservation mooring, do not change it back to a chain mooring or all eelgrass gains will be lost. Finally, we recommend that all moorings that were changed back to chain in Boston, Gloucester and Manchester be re-installed as conservation moorings, utilizing one of the several mooring options that are now available including stormsoft, Dyneema line systems, or EOM mooring systems.
