MERRIMACK RIVER WATERSHED

Merrimack River Watershed

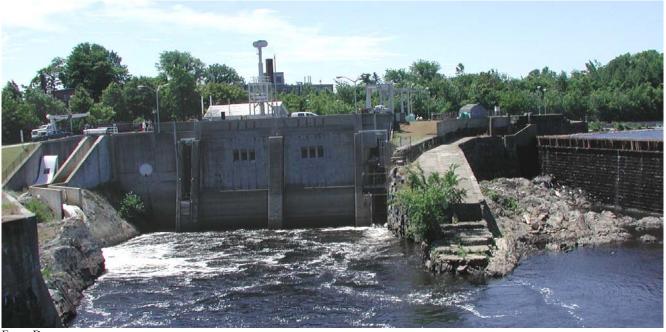
| Obstruction # 1 | | Essex Dam | | Lawrence | | | | | | | |
| 28.8 | Dam | Stone with plywood | 920 | 31 | 0.0 | 1848 | | 42° 41' 57.942" 71° 09' 57.086" | | | |

| Fishway | Present | | | | | | | | |
|---|---|---|---|---|---|---|---|---|---|
| Fish lift | Concrete and aluminum | N/A | N/A | N/A | N/A | N/A | N/A | N/A | Good Passable |

The first two obstructions on the river, the Essex Dam in Lawrence and the Pawtucket Dam in Lowell, have been equipped with fish passage facilities since the mid-19th century. These ladders have been upgraded on several occasions, the latest being in the 1980's when fish lifts were installed at the two dams. The Essex lift is designed specifically to pass 840,000 shad annually. The lift at the Pawtucket Dam is designed for an annual capacity of 720,000 shad. In addition, a modified Ice Harbor fishway at the Pawtucket Dam is functional during high flow periods.

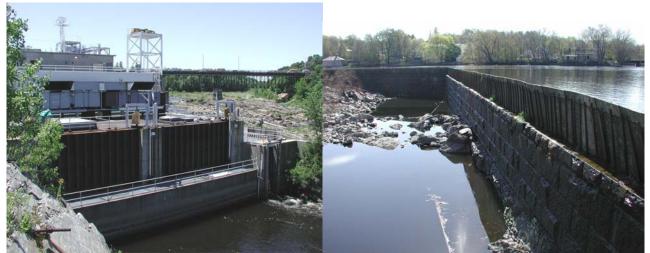
Pawtucket lift and powerhouse

| River Mile | Type | Material | Spillway W (ft) | Spillway H (ft) | Impoundment Acreage | Year Built | | GPS | |
|---|---|---|---|---|---|---|---|---|---|
| 40.2 | Dam | Stone with | 1086 | 15 | 0.0 | 1847 | Consolidated | 42° 38' 54.800" | N |

| Fishway | Present | | | | | | | | |
|---|---|---|---|---|---|---|---|---|---|
| Modified Ice Harbor | Concrete | 292 | 14 | 15 | 16 | Varied (0.0-4.0) | - | 12 | Good inefficient |
| Fish Lift | Concrete, aluminum and wood | | | | | | | | Good Passable |

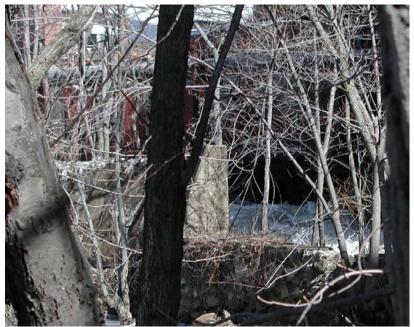
View of Mill Street Dam through the trees (structure is under the building).

Fishway None

The Powwow River enters the Merrimack River in Amesbury. A dam at Mill Street presents a very difficult fish passage problem and, when combined with the cost of providing passage at the large dam at Lake Gardner, eliminates any development potential here. Bluebacks are known to enter the system in small numbers.

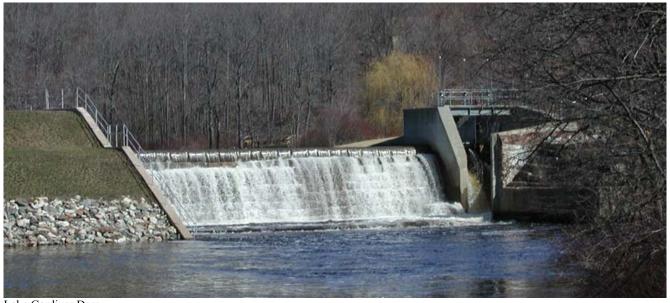
Lake Gardiner Dam

| Obstruction # 2 | | Lake Gardiner Dam | | | Amesbury | | | | | |
|---|---|---|---|---|---|---|---|---|--|--|
| 2.1 | Dam | Concrete | 73 | 18 | 71.0 | , | | 42° 51' 33.094" 70° 56' 17.240" | | |

Fishway None

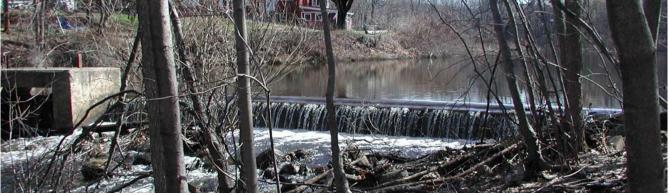
| Obstruction # 1 Cla | | Clark | ks Pond D | am | Amesbury | | | | | | |
|---|---|---|---|---|---|---|--|---|--|--|--|
| 0.4 | Dam | Concrete with wooden stop logs | 70 | 3 | 6.8 | - | | 42° 51' 37.663" 70° 55' 35.866" | | | |

Clarks Pond Dam, partial view.

Fishway None

Back River is a tributary to the Powwow River and joins it below the Mill Street dam. A relatively low head dam blocks passage into the 6.8 acres of potential habitat provided by Clarks Pond. Small numbers of river herring have been observed in the stream and a fishway could be installed at a reasonable cost. The small size of the impoundment, however, relegates the stream to a low priority for development.

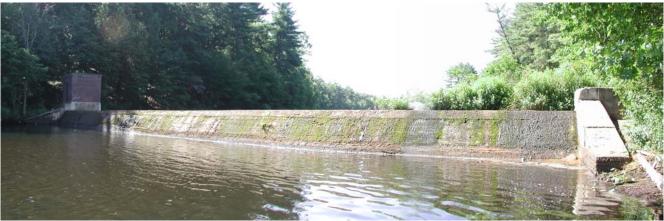
Upper Artichoke Reservoir Dam

| Obstruction # 3 | | Upp | er Articho | ke Reserv | W. Newbury, Newburyport | | | | |
|---|---|---|---|---|---|---|---|---|--|
| 1.2 | Dam | Concrete | 136 | 5.8 | 196.0 | 1920 | 5 | 42° 48' 22.436" 70° 55' 54.895" | |

The Artichoke River is a tributary of the Merrimack River and enters it well downstream of the dam at Lawrence. Although the stream's three impoundments offer a total of 261 acres of potential habitat, the upper two are used as public water supplies resulting in reduced and inconsistent outflow. This and the cost of passage at three large dams severely limits the development potential.

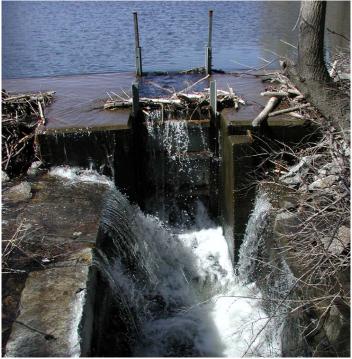
Dam at Mill Pond

| Obstruction # 1 | | 171111 | 1 Ond Dan | 11 | West Newbury | | | | | |
|---|---|---|---|---|---|---|---|---|--|--|
| 1.0 | Dam | Concrete with steel stop logs | 4 | 8 | 14.8 | 1937 | Town of West Newbury | 42° 48' 23.727" 70° 58' 01.553" | | |

Fishway None

This small stream enters the Merrimack River in West Newbury. It forms a 14.8 acre impoundment called Mill Pond. While the pond offers an attractive habitat, the spillway configuration and its proximity to the Rt. 113 road culvert make fishway installation difficult and lower the site's priority for development.

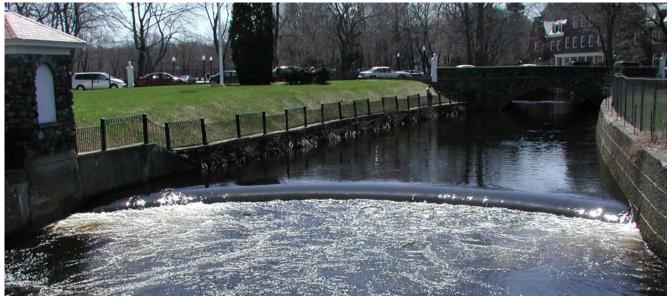
Dam at Route 133, Andover

Fishway None

The Shawsheen River enters the Merrimack just below the Essex Dam in Lawrence. A culvert under Rt. 495 is passable but may collect debris, which could hinder fish movement. A low head dam at Rt. 133 in Andover presents the first real obstruction. Passage could easily be achieved at this point with a ladder or a partial breach. However, two dams immediately upstream present costly fishway installation issues which reduce the restoration potential of this stream. River herring and American shad have been observed in the lower river.

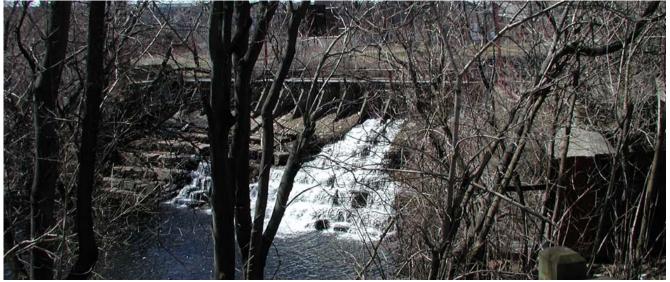
Spickett River Dam

Fishway None

Spickett River flows through the City of Lawrence and joins the Merrimack below the Essex Dam. Although American shad have been observed at the mouth, a large dam just upstream of the confluence with the Merrimack River as well as several other obstructions preclude any anadromous fish development.

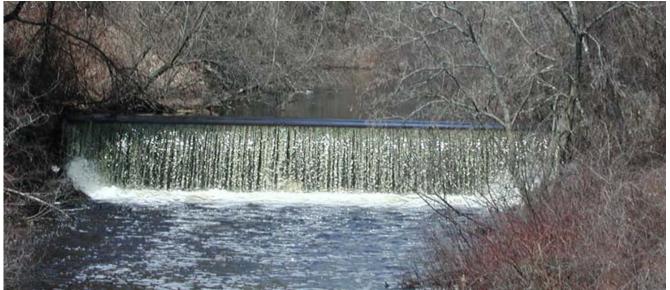
River Meadow Brook Dam

| River Mile | Type | Material | | - · · · · | Impoundment Acreage | | Owner | GPS | |
|---|---|---|---|---|---|---|---|---|---|
| 0.6 | Dam | Concrete | ~40 | ~6 | 0.0 | - | = | 42° 37' 54.400" | N |

Fishway None

River Meadow Brook is a tributary to the Concord River, which it enters at river mile 1.04. Fish ascending the Concord are free to enter River Meadow Brook but a dam 0.55 miles from the mouth prevents further access. Development of fish passage facilities on this stream would not contribute substantially to anadromous fish populations of the Concord River watershed due to limited potential spawning habitat.

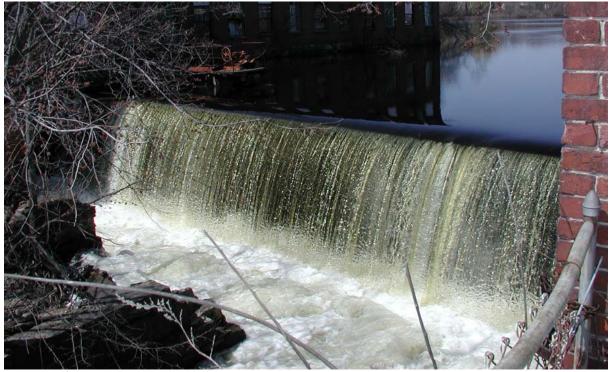
Beaver Brook Dam

| Obstruction # 1 | | Beaver Brook Dam | | | | | | | |
|---|---|---|---|---|---|---|---|---|--|
| 0.5 | Dam | Stone and concrete | ~50 | 15 | 0.0 | 1850 | | 42° 39' 51.971" 71° 19' 22.569" | |

Fishway None

Beaver Brook flows into the Merrimack River below the Pawtucket Dam in the city of Lowell. Although it appears to offer substantial potential riverine habitat, a large dam just upstream from the mouth as well as other obstructions on the lower river, diminishes any potential for development of anadromous fish in this system.
