Milford District Court Milford, MA

HVAC SYSTEM EVALUATIONS COVID-19

Office of Court Management July 21, 2022

Section 1 Existing Conditions & Site Observations

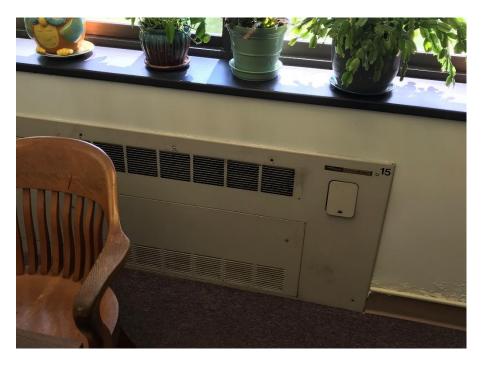
The FCU's appear to be from the original construction in 1967 and are in poor condition. All of the FCU's are two-pipe with heating and cooling being switched seasonally. The units have a supply fan, chilled/hot water cooling coil, MERV 11 filters, and according to the drawings provide ventilation air to the building. The outdoor air dampers and actuators were not accessible during the visit.

Photo 2 - Representative Fan Coil Unit

2.6.2 Replace Fan Coil Units

The existing FCUs serving the main and lower levels are approximately 54 years old and are past the end of their useful life. The average life expectancy for FCUs is 25-30 years. As far as we know all the FCUs are functional, but in poor condition and could fail at any time. While immediate replacement may not be necessary at this time, we recommend developing a capital plan to replace these units in 2-5 years.
