MILLERS RIVER WATERSHED SMART MONITORING PROGRAM 2000-2004 Technical Memorandum TM-35-8

Prepared By: Therese Beaudoin December 2013

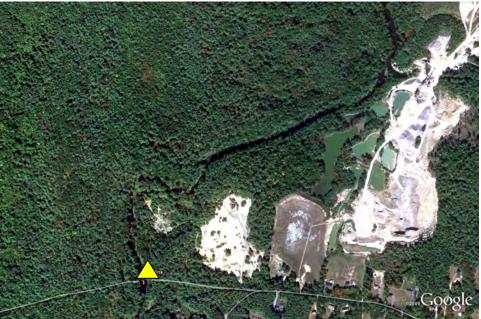
Figure 2 Googe Earth view of Station MI14 area

Land uses near this station included forest, sand/gravel extraction, residential, and a large downstream flood control project (Birch Hill Dam; <u>Birch Hill Flood Control Project</u>) which impounds the river in this reach (Figure 2) during flood management operations (USACOE 2013, Google Earth 2011a). The western side of the Millers River corridor in this area lies within the Birch Hill State Wildlife Management Area (see <u>northquabbinwoods.org</u> for a description of the BHSWMA and <u>Birch Hill Wildlife Management Area</u> for a map) (North Quabbin Woods, 2011; Mass Wildlife 2011b). Massachusetts State Wildlife Management Areas (SWMA) were "designed to forever ensure the survival, health and viability of all our native wildlife communities" (MassWildlife, 2011a). The Massachusetts Department of Fish and Game stocks this reach of the Millers River with trout (Norris 2011). The Winchendon WWTP discharge is located 1.6 miles upstream, and Winchendon Center lies an additional 2.5 miles above this. There are no large water withdrawals upstream.

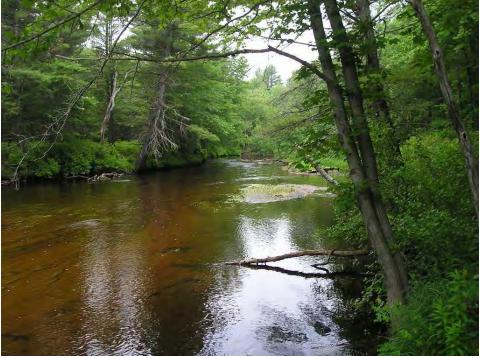
Figure 3 Station MI14 upstream

The river is a run in this area, approximately 70 feet wide, typically less than 3 feet deep and roughly uniform across the channel throughout the year (Figure 3). Deciduous and evergreen trees provide shade along the stream corridor edges, but the canopy does not generally cover the channel. The bottom is sand and muck, with moderate to dense coverage with sedges (*Scirpus* sp.). Other aquatic macrophytes observed at Station MI14 included American eelgrass (*Vallisneria* sp.), duckweed (*Lemna* sp.), watermeal (*Wolffia* sp.), pondweed (*Potamogeton* sp.), rushes (*Juncus* sp.), and arrowhead (*Sagittaria* sp.). Although the observation of periphyton was often limited by the angle of light on the water surface and/or the deeply tannic color of the water column, filamentous algae was noted on 2 events, and "rusty spots" on vegetation on another. Evidence of beaver activity was noted in this area, including downed trees, partially severed trunks, and stripped bark. A vernal pool populated by wood frogs (*Rana sylvatica*) and spring peepers (*Pseudacris crucifer*) is adjacent to the river northwest of Sibley Road. Dense populations of mosquitoes are common after rain events.

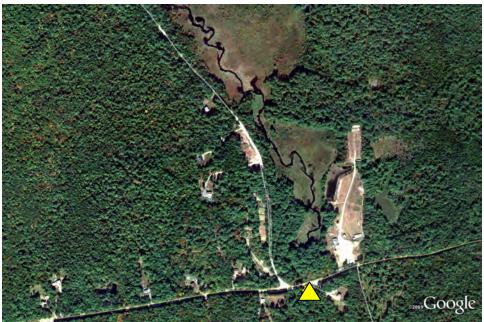
Figure 4 Google Earth view of Station PR01 area

The land use surrounding this area is primarily forested and wetland, with very little development (Figure 4) (Google Earth 2011b). From Fitzwilliam, New Hampshire, Priest Brook flows through forestland and several palustrine wetlands. There are no municipal or industrial discharges in the Priest Brook watershed or water supply withdrawals. Most of the Priest Brook corridor lies within the Birch Hill SWMA, as well as the flood control zone for the Birch Hill Dam project. The Massachusetts Department of Fish and Game stocks Priest Brook with trout (Norris 2011).

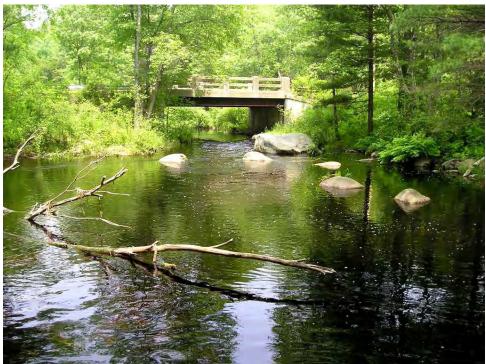
Figure 5 Station PR01 upstream

The river at this location is a run, approximately 20 feet wide shaded with nearly complete canopy cover of a mixture of conifers and deciduous trees, although the area at and upstream of the bridge is mainly open sky (Figure 5). The stream bottom consisted of a mixture of gravel and cobble with some sand; numerous boulders are scattered in the channel upstream. The most commonly noted periphyton was dense moss covering all visible submerged rock surfaces. Aquatic macrophytes included sedges (*Scirpus* sp.), American eelgrass (*Vallisneria* sp.), pickerelweed (*Pontedaria cordata*), rushes (*Juncus* sp.), *Potamogeton* sp. (pondweed), and *Elodea* sp. (waterweed). A wood turtle (*Clemmys insculpta*), a species of special concern in Massachusetts, was noted at Station PR01 in May 2003; documentation was provided to NHESP staff for the designation of this area as Priority Habitat. Beaver activity included a dam at the upper side of the Winchendon Road Bridge (removed mid-2002), downed trees, and stripped bark. Dense populations of mosquitoes are common after rain events.

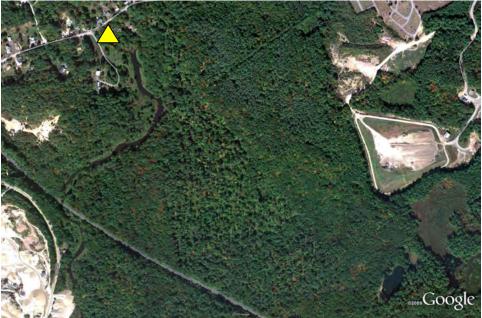
Figure 6 Google Earth view of Station OT05 area

Land uses near and upstream of OT05 included forest, sand/gravel extraction, and minor residential development (Figure 6)(Google Earth 2011c). The Massachusetts Department of Fish and Game stocks the Otter River with trout (Norris 2011). The Gardner WPCF discharge is located 3.5 miles upstream, and Gardner center lies in the same area. A small dam is approximately 300 feet above Station OT05.

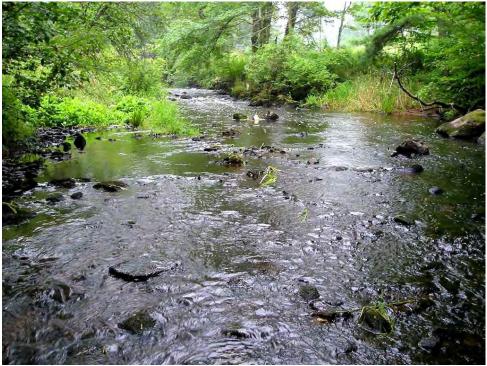
Figure 7 Station OT05 upstream

The river flows through a short rapids, with a channel approximately 20 feet wide and mostly shaded (Figure 7). The bottom consisted of gravel and cobble, with some sand and a few boulders. Periphyton was common and often dense, including film and filamentous algae, as well as moss, throughout the year. Aquatic macrophytes were present only along the periphery of the stream channel, and included sparse grasses (Graminae) and sedges (*Scirpus* sp.), and "star weed", possibly a species of starwort (*Callitriche* sp.). Beaver activity was noted in the area, including downed trees and partially severed trunks. Mallard ducks were observed here. Dense populations of mosquitoes are common after rain events.

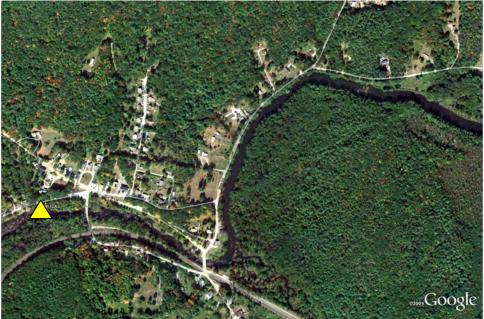
Figure 8 Google Earth view of Station MI10A area

Land uses near and upstream of this station include forest, residential, and a large downstream flood control project which alters the river flow through this reach under specific conditions (Figure 8)(Google Earth 2011d). Much of the proximal watershed up- and downstream of this station lies within the Otter River State Forest and the Birch Hill SWMA. The Massachusetts Department of Fish and Game stocks this reach of the Millers River with trout (Norris 2011). Upstream discharges (below Station MI14) include Gardner, Seaman Paper Company (Templeton), and Templeton. A small number of water withdrawals are located in the area, serving a few people.

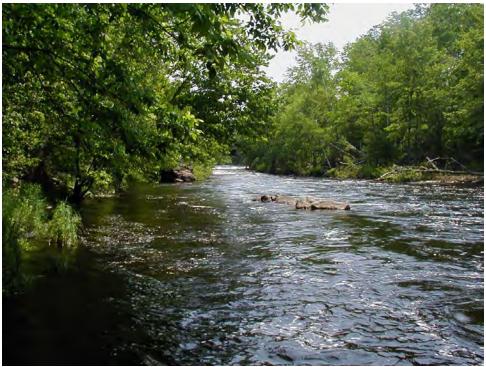
Figure 9 Station MI10A upstream

The river is a run in this area, approximately 95 feet wide, and the channel is typically too deep to wade (Figure 9). Deciduous trees provide shade along the stream corridor edges only; the channel is almost entirely open to the sun. The bottom consisted of boulder, cobble, gravel and sand when visible, often with a thin layer of silt. Aquatic macrophyte growth was sparse, and plants noted here included grasses (Graminae), American eelgrass (*Vallisneria* sp.), duckweed (*Lemna* sp.), pickerelweed (*Pontedaria cordata*) and sedges (*Scirpus* sp.). Periphytic growth ranged from none to dense, and consisted of moss, film and filamentous algae, and floc. Evidence of beaver activity included a lodge against the southern bank, downed trees, partially severed trunks, and stripped bark. Other aquatic wildlife noted were mussels, crayfish, frogs, and a flock of geese. Dense populations of mosquitoes are common after rain events. Damselflies and dragonflies (adults) were abundant during summer sampling events.

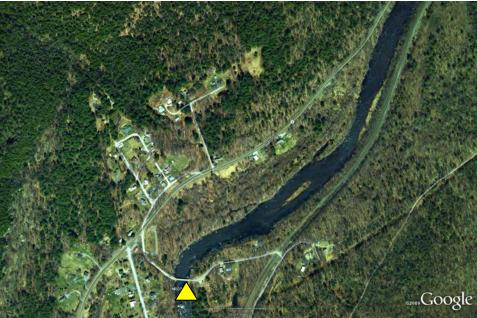
Figure 10 Google Earth view of Station MI03 area

Land uses near and upstream of this station include forest, residential, roadways, and town centers (Erving, Orange, Athol; Figure 10) (Google Earth 2011e). The Massachusetts Department of Fish and Game stocks this reach of the Millers River with trout (Norris 2011). Upstream discharges (downstream of Station MI10A) include South Royalston WWTP, L. S. Starrett Company (Athol), Athol WWTP, Orange WWTP, the Erving Center WWTP, and the Farley POTW. As the station was moved to be outside of the potential influence of the Farley POTW, the closest of these is the Erving WWTP, located approximately 3.3 miles upstream. The Erving Paper company has two large (>100,000 MGD) withdrawals in that area, including a groundwater well and a surface water intake. Several small non-community water supplies are located in the same area.

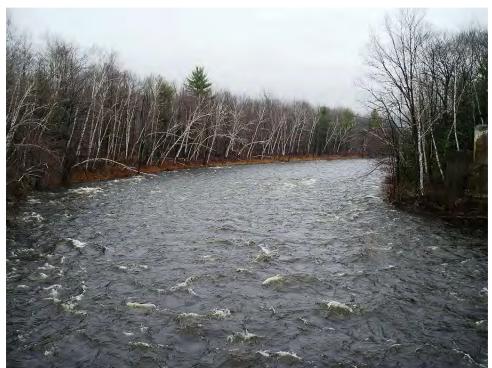
Figure 11 Station MI03 upstream

The river is a run in this area, bounded by rapids up- and downstream (Figure 11). The channel is approximately 110 feet wide and typically too deep to wade across. Deciduous trees provide shade along the stream corridor edges only; the channel is almost entirely open to the sun. The bottom consisted of boulder, sand and traces of silt when noted. Aquatic macrophyte growth was sparse and mostly limited to the shoreline. Plants noted here included grasses (Graminae), American eelgrass (*Vallisneria* sp.), waterweed (*Elodea* sp.), arrowhead (*Sagittaria* sp.) and a thin-leaf form of pondweed (*Potamogeton* sp.). Periphytic growth was noted on 3 events, ranging from sparse to moderate, including filamentous algae, algal mats, and rusty spots. Evidence of beaver activity was noted in this area, including downed trees, partially severed trunks, and stripped bark. Stoneflies (adults and exuviae) were abundant at this station; dragonflies, caddisflies and damselflies were also noted. Other aquatic wildlife noted were mussels, frogs, and northern water snakes (*Nerodia sipedon*). This stretch of the Millers River is stocked annually. Fly fishermen were observed on numerous dates.
