Monitoring and Analysis of Eight Salt Marsh Tidal Restoration Projects on Cape Cod, Massachusetts

May 2024

Prepared by: Association to Preserve Cape Cod

Prepared for: Massachusetts Division of Ecological Restoration

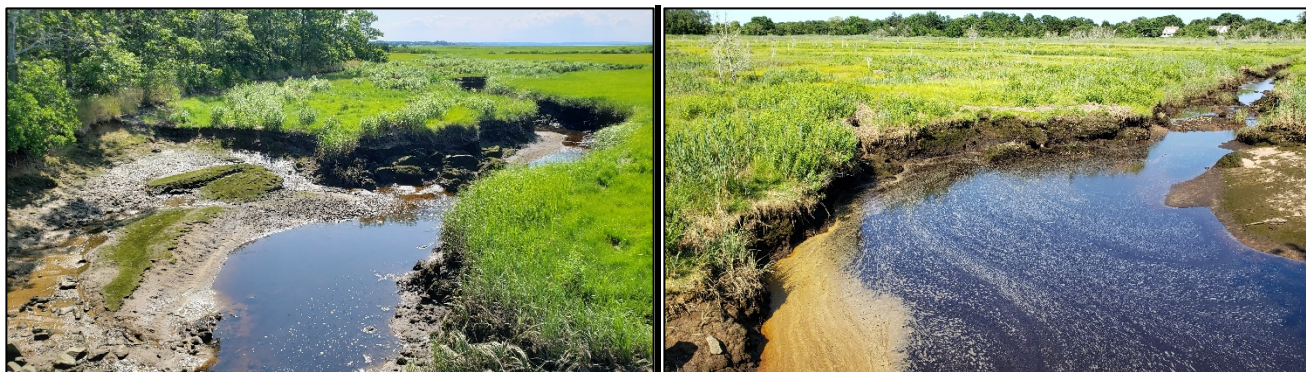
1. Bass Creek, Yarmouth

Reference marsh (left) and study marsh (right) photos taken on July 25, 2019.

During the 2019 field visit, erosion was observed along the tidal creek near the culvert in the reference and study marshes. Slumping was also observed in the reference marsh along the tidal banks farther away from the culvert. Additionally, clumps of peat were washed up on the surface of the study marsh with *S. alterniflora* growing on them, suggesting that the peat clumps eroded from the banks and floated onto the surface of the marsh during a high tide (for more details regarding the 2019 site visits, see Appendix E).

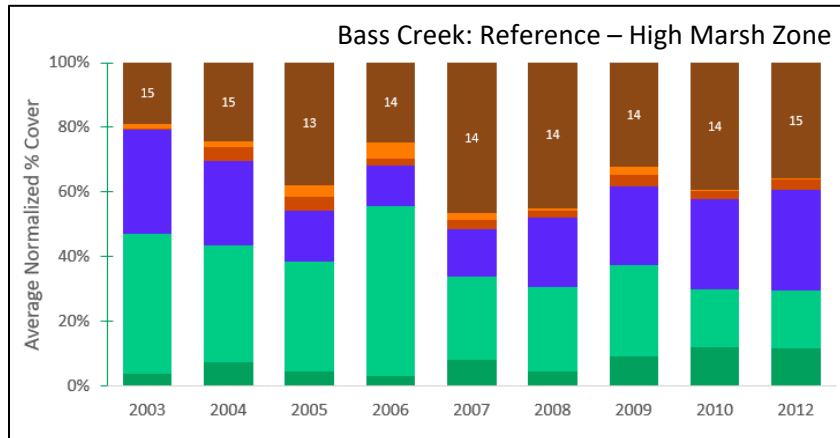
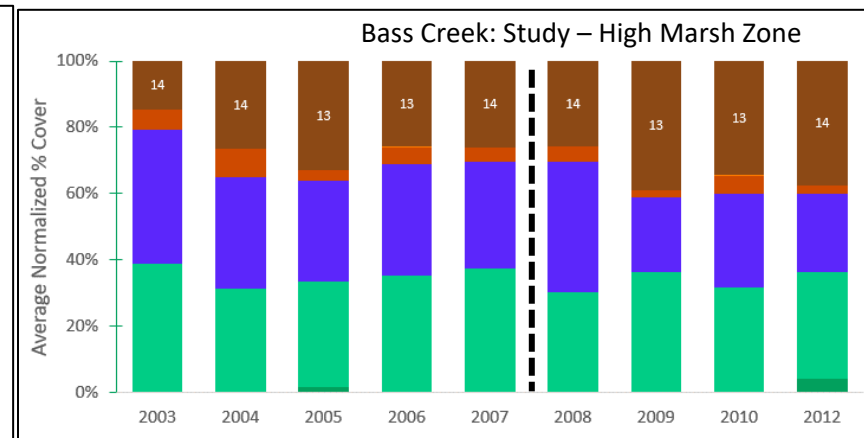
No plots in the low marsh zone of the restored marsh area.

No plots in the upland transition zone of the reference area.

Figure 4: Average normalized percent cover for five major vegetation types across three marsh zones in Bass Creek, Yarmouth, MA. "Other" represents unvegetated area such as bare sediment, wrack, and/or dead plants. Black dashed line indicates when restoration occurred. Column numbers represent plot sample size. No monitoring occurred in 2011.

Bass Creek was restored in early 2008. Pre- and post-restoration monitoring of the reference and study areas occurred between 2003 and 2012. Figure 4 shows the average annual percent covers of the major vegetation types. Data from the first (2003) and last (2012) years of monitoring were used for all statistical comparisons. See Appendix A for a map of the plots in the reference and study marsh areas at Bass Creek.

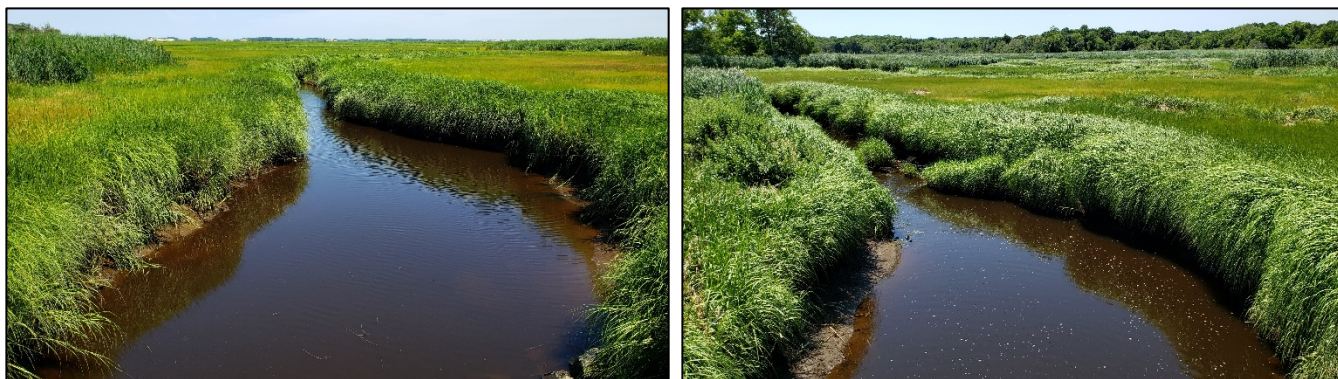
2. Bridge Creek, Barnstable

Reference marsh (left) and study marsh (right) photos taken on July 25, 2019.

In 2019, APCC staff noted that both concrete box culverts under Route 6A and the train tracks were in good condition and showed no signs of degradation. There were also no signs of erosion along the creek edges of the reference or study marshes (for more details regarding the 2019 site visits, see Appendix E).

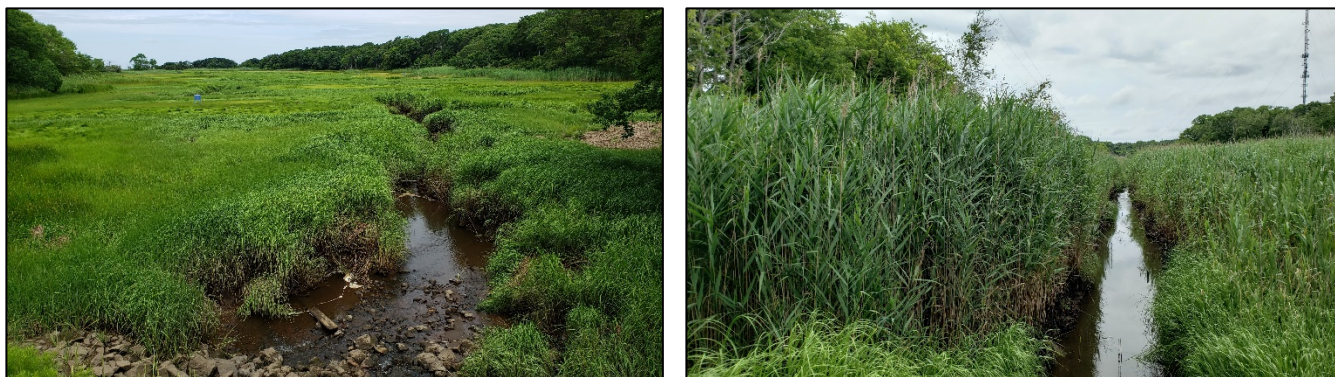
3. Namskaket Creek, Brewster

Reference marsh (left) and study marsh (right) photos taken on July 24, 2019.

Between 2007 and 2011, there were no significant trends in any of the plant community types within the reference marsh. During the 2019 site visit, there was a build-up of wrack observed along the upland transition edge of the eastern side of the reference marsh. There was also noticeable bank slumping and some erosion on the reference side of the marsh. Most of the erosion was observed at the bends in the tidal creek.

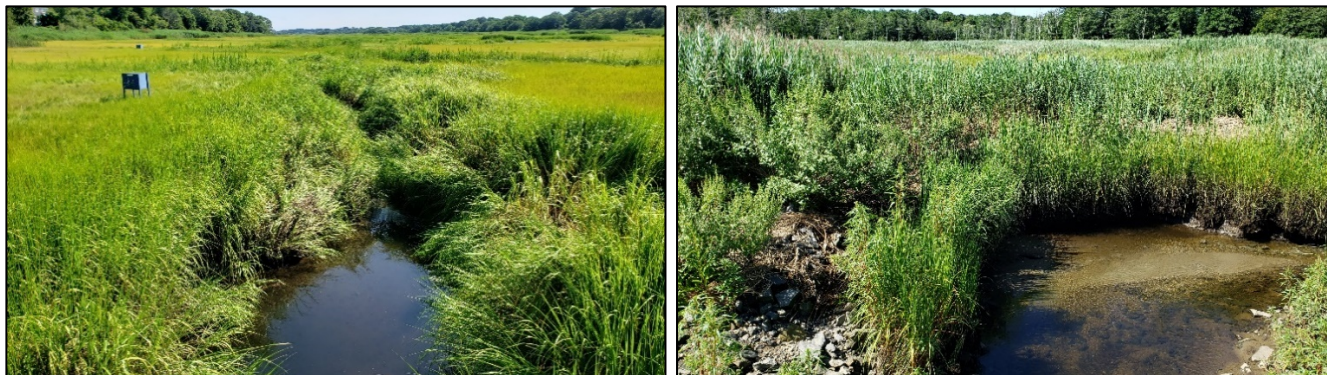
4. Quivett Creek, Dennis

Reference marsh (left) and study marsh (right) photos taken on August 15, 2019.

During the 2019 field visit, APCC staff noted that *Phragmites* was still limited in its distribution to upland transition areas at the edges of the reference marsh. Also, *Phragmites* within the study marsh was still present in similar locations and approximately the same height. These observations corroborate the trends analysis which showed no change in *Phragmites* at Quivett. APCC staff also noted that although the box culvert appeared in good condition, there were three boards in place across the top of the culvert. Additional details from the 2019 site visit are available in Appendix E.

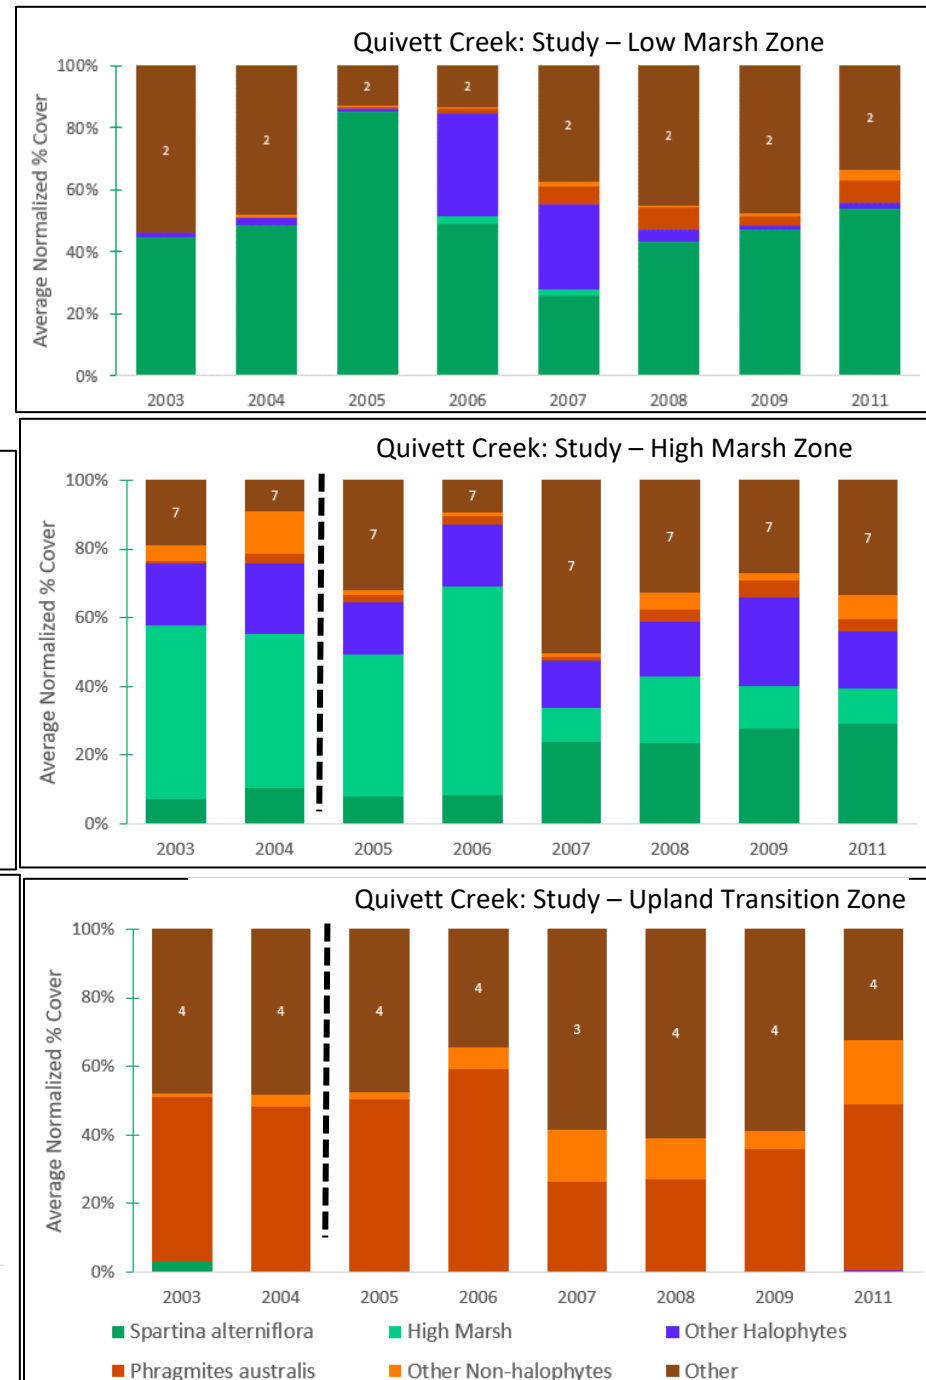
No plots in the low marsh zone of the restored marsh area.

Figure 7: Average normalized percent cover for five major vegetation types across three marsh zones in Quivett Creek, Dennis, MA. “Other” represents unvegetated area such as bare sediment, wrack, and/or dead plants. Black dashed line indicates when restoration occurred. Column numbers represent plot sample size. No monitoring occurred in 2010.

Quivett Creek was restored in March 2005. Pre- and post-restoration monitoring of the reference and study areas occurred between 2003 and 2011. Figure 7 shows the average annual percent covers of the major vegetation types. Data from the first (2003) and last (2011) years of monitoring were used for all statistical comparisons. See Appendix A for a map of the plots and transects.

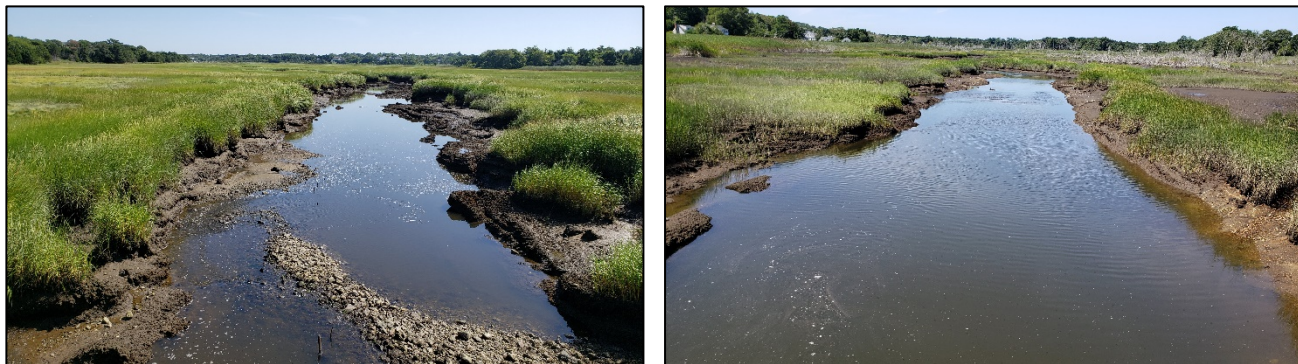
5. Sesuit Creek, Dennis

Reference marsh (left) and study marsh (right) photos taken on August 20, 2019.

Observations from the 2019 field site visit included a note regarding the culvert, which was found to be in good condition and was not blocked by sediment or rocks. APCC staff noted that in both the reference and

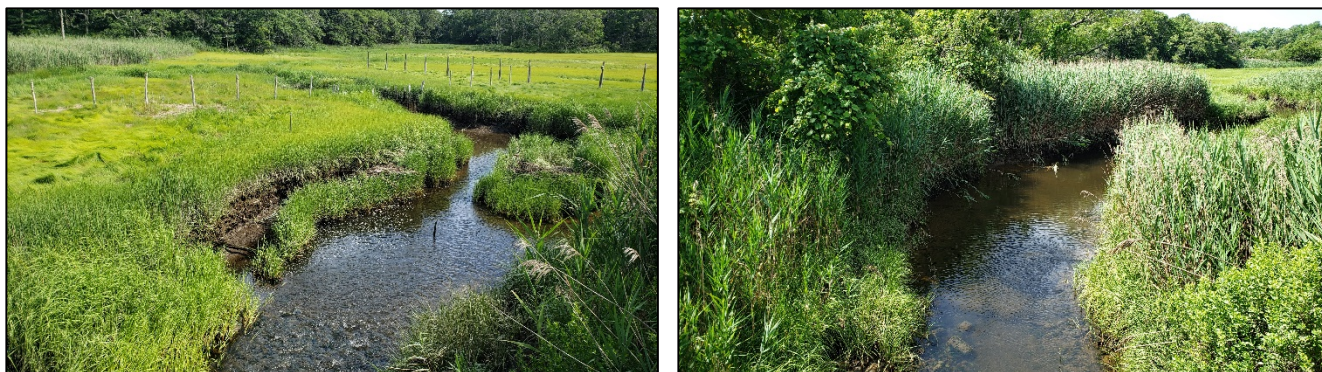
6. State Game Farm, Sandwich

Reference marsh (left) and study marsh (right) photos taken on July 25, 2019.

During the 2019 site visit, APCC staff noted that the culvert opening for the restoration project appeared to be in good condition, but some stones along the edges of the culvert had slumped into the tidal creek. On the reference side, there were some areas where the creek appeared to be undercutting the banks and causing erosion. However, the creek banks on the study marsh did not appear to show signs of erosion or change. Additional details from the 2019 site visit are available in Appendix E.

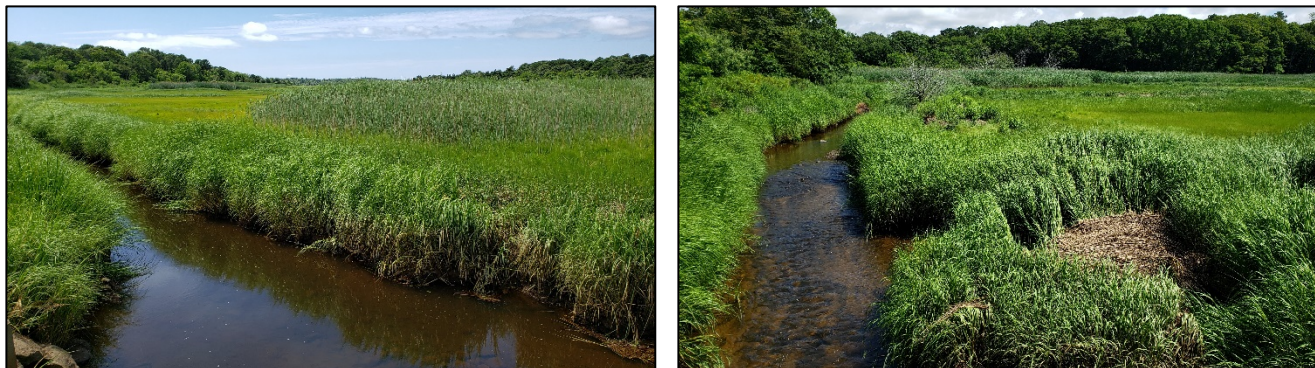
7. *Stony Brook, Brewster*

Reference marsh (left) and study marsh (right) photos taken on July 24, 2019.

During the 2019 field assessment visit, there was no visible evidence of bank erosion on the reference or study side of the marsh. The culvert was unblocked and in good condition. Additional details from the 2019 site visit are available in Appendix E.

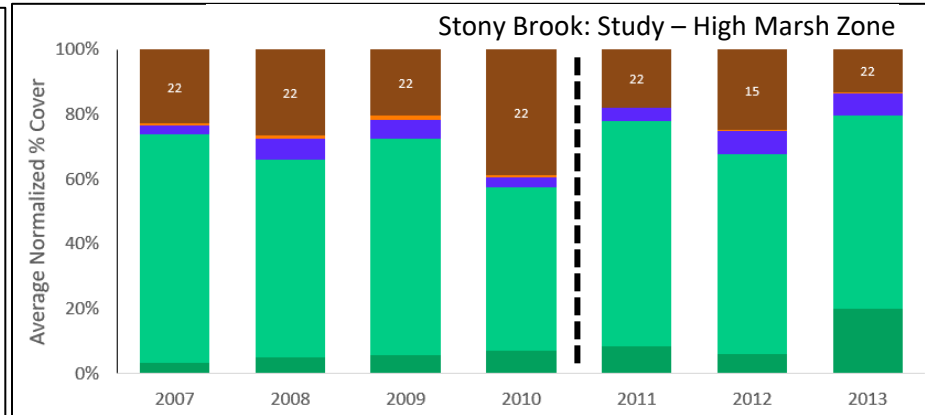
No plots in the low marsh zone of the reference marsh area.

Figure 10: Average normalized percent cover for five major vegetation types across three marsh zones in Stony Brook, Brewster, MA. “Other” represents unvegetated area such as bare sediment, wrack, and/or dead plants. Black dashed line indicates when restoration occurred. Column numbers represent plot sample size.

Stony Brook was restored in the Fall of 2010. Pre- and post-restoration monitoring of the reference and study areas occurred between 2007 and 2013. Figure 10 shows the annual average percent cover of the major vegetation types. Data from the first (2007) and last (2013) years of monitoring were used for all statistical comparisons. See Appendix A for a map of the plots and transects.

Between 2007 and 2013, in the study high marsh zone, *S. alterniflora* significantly increased ($p = 0.03$; 3% to 20%, $n = 22$) and there was a potential increasing trend in other halophytes and potential decreasing trend in unvegetated area “Other”. 2019 field observations noted the transition from non-halophyte species to *S. alterniflora* in the study marsh. In the study upland transition zone high marsh species increased significantly ($p = 0.02$, 4% to 39%, $n = 10$) and unvegetated area decreased significantly ($p < 0.01$, 44% to 11%, $n = 10$). No other significant trends were found in the study marsh, however, observations from the 2019 field visit indicated that *Phragmites* was migrating up the tidal creek and away from the former tidal restriction.

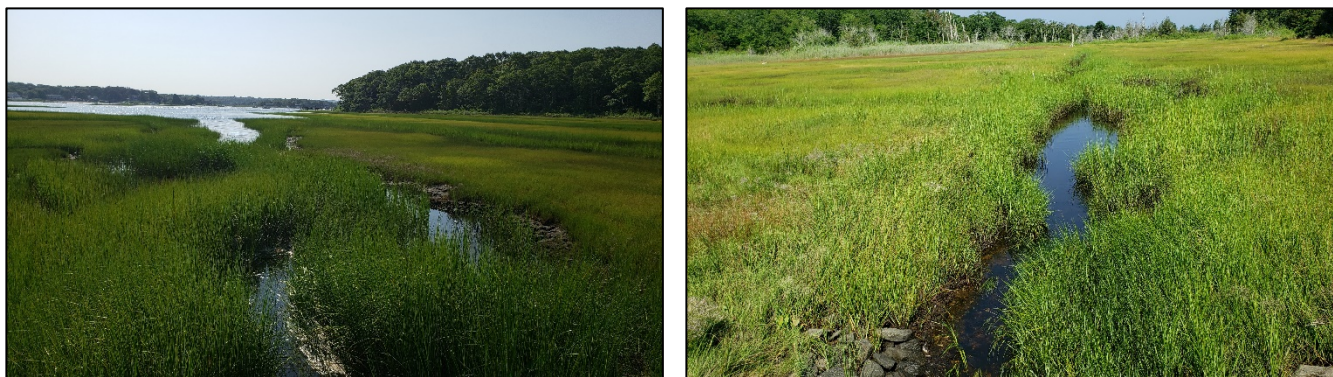
8. Wings Neck, Bourne

Reference marsh (left) and study marsh (right) photos taken on July 31, 2019.

During the 2019 site visit assessment, APCC staff noted that the edges of the tidal creek in the reference marsh had bare areas and the stems of *S. alterniflora* had a shredded appearance, which can be indicative of *Sesarma reticulatum* (purple marsh crab) herbivory. The study marsh also showed signs of dieback along the creek banks. Most of this dieback was located closer to the culvert and was not noted farther up the tidal creek. *Phragmites* was observed on the edges of the study marsh and did not appear to be expanding into the marsh interior. Additional details from the 2019 site visit are available in Appendix E.

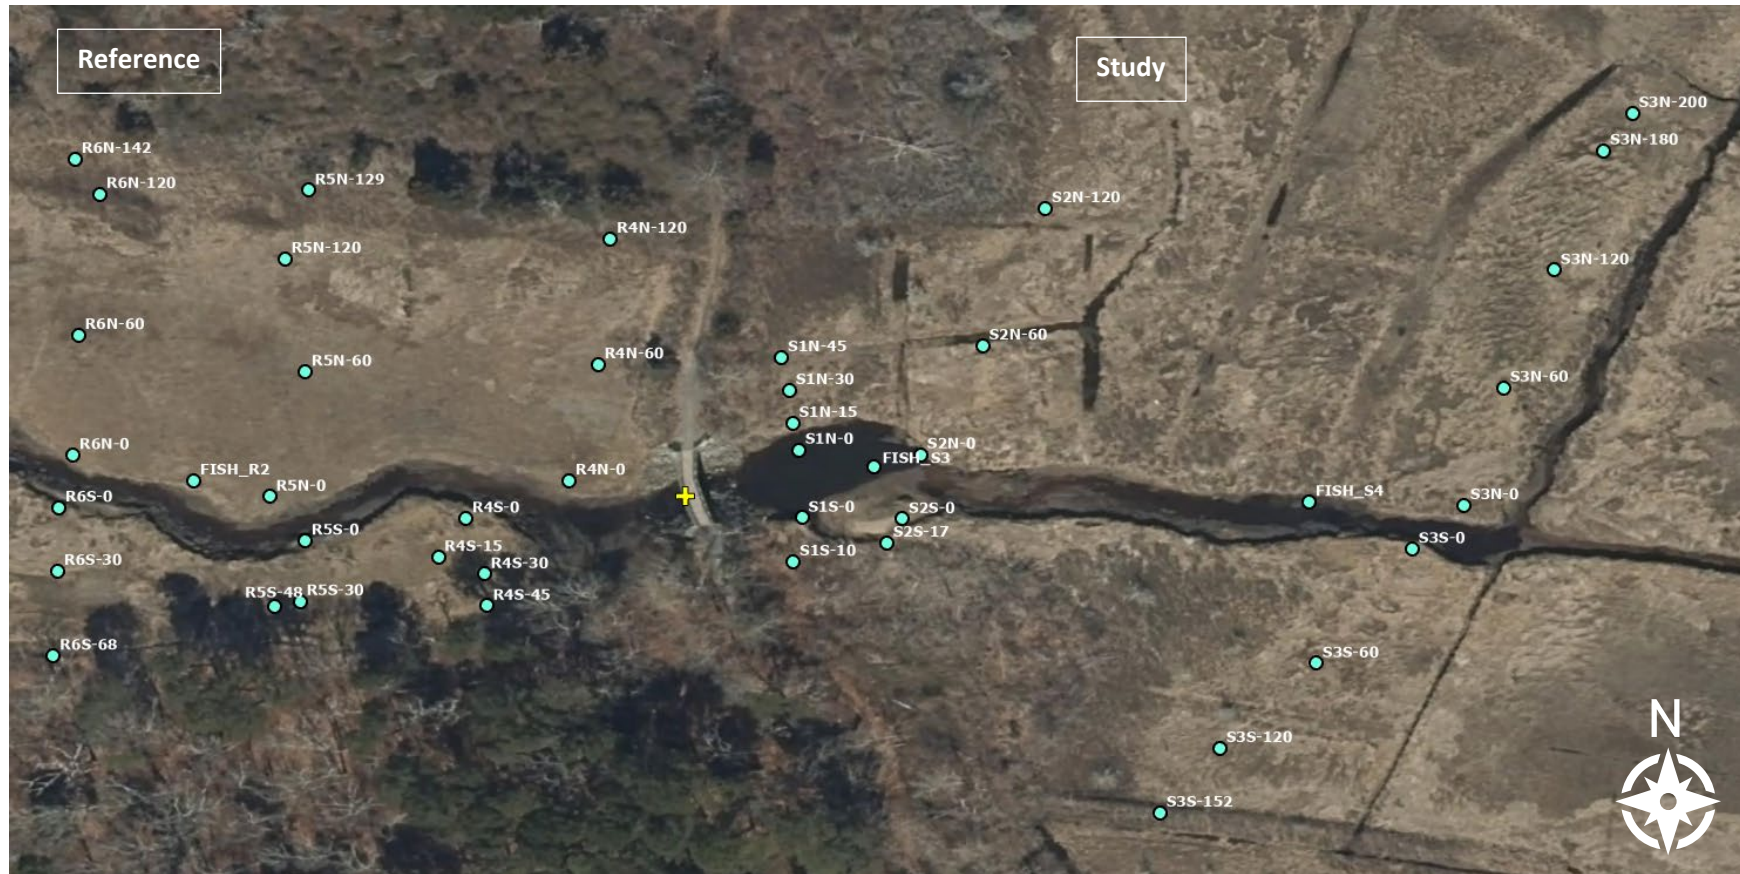
Figure A1: Vegetation plots at Bass Creek salt marsh restoration site in Yarmouth, MA. Yellow marker indicates location of former tidal restriction.

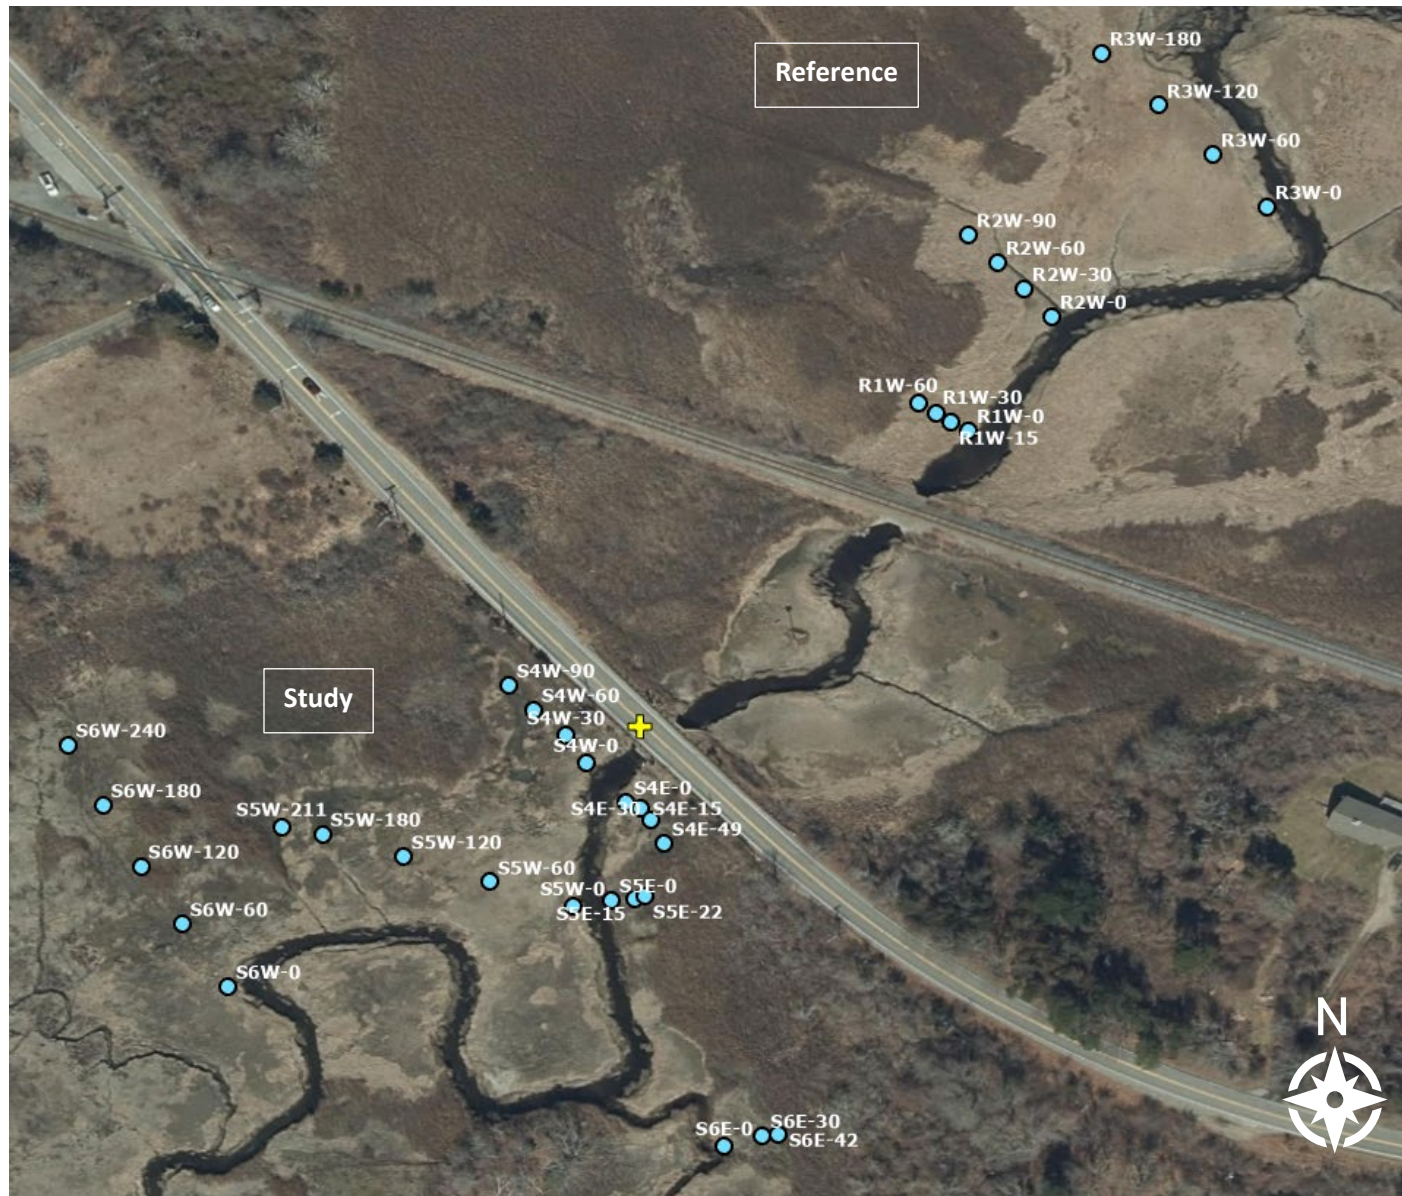
Figure A2: Vegetation plots at Bridge Creek salt marsh restoration site in Barnstable, MA. The yellow marker represents the former tidal restriction removed in 2005. The Bridge Creek restoration project occurred in two phases. In 2003 an under-sized culvert beneath an active railroad line was replaced. In 2005 an under-sized culvert beneath Route 6A was replaced. The restoration monitoring data presented in this report were collected for the second phase of the project.

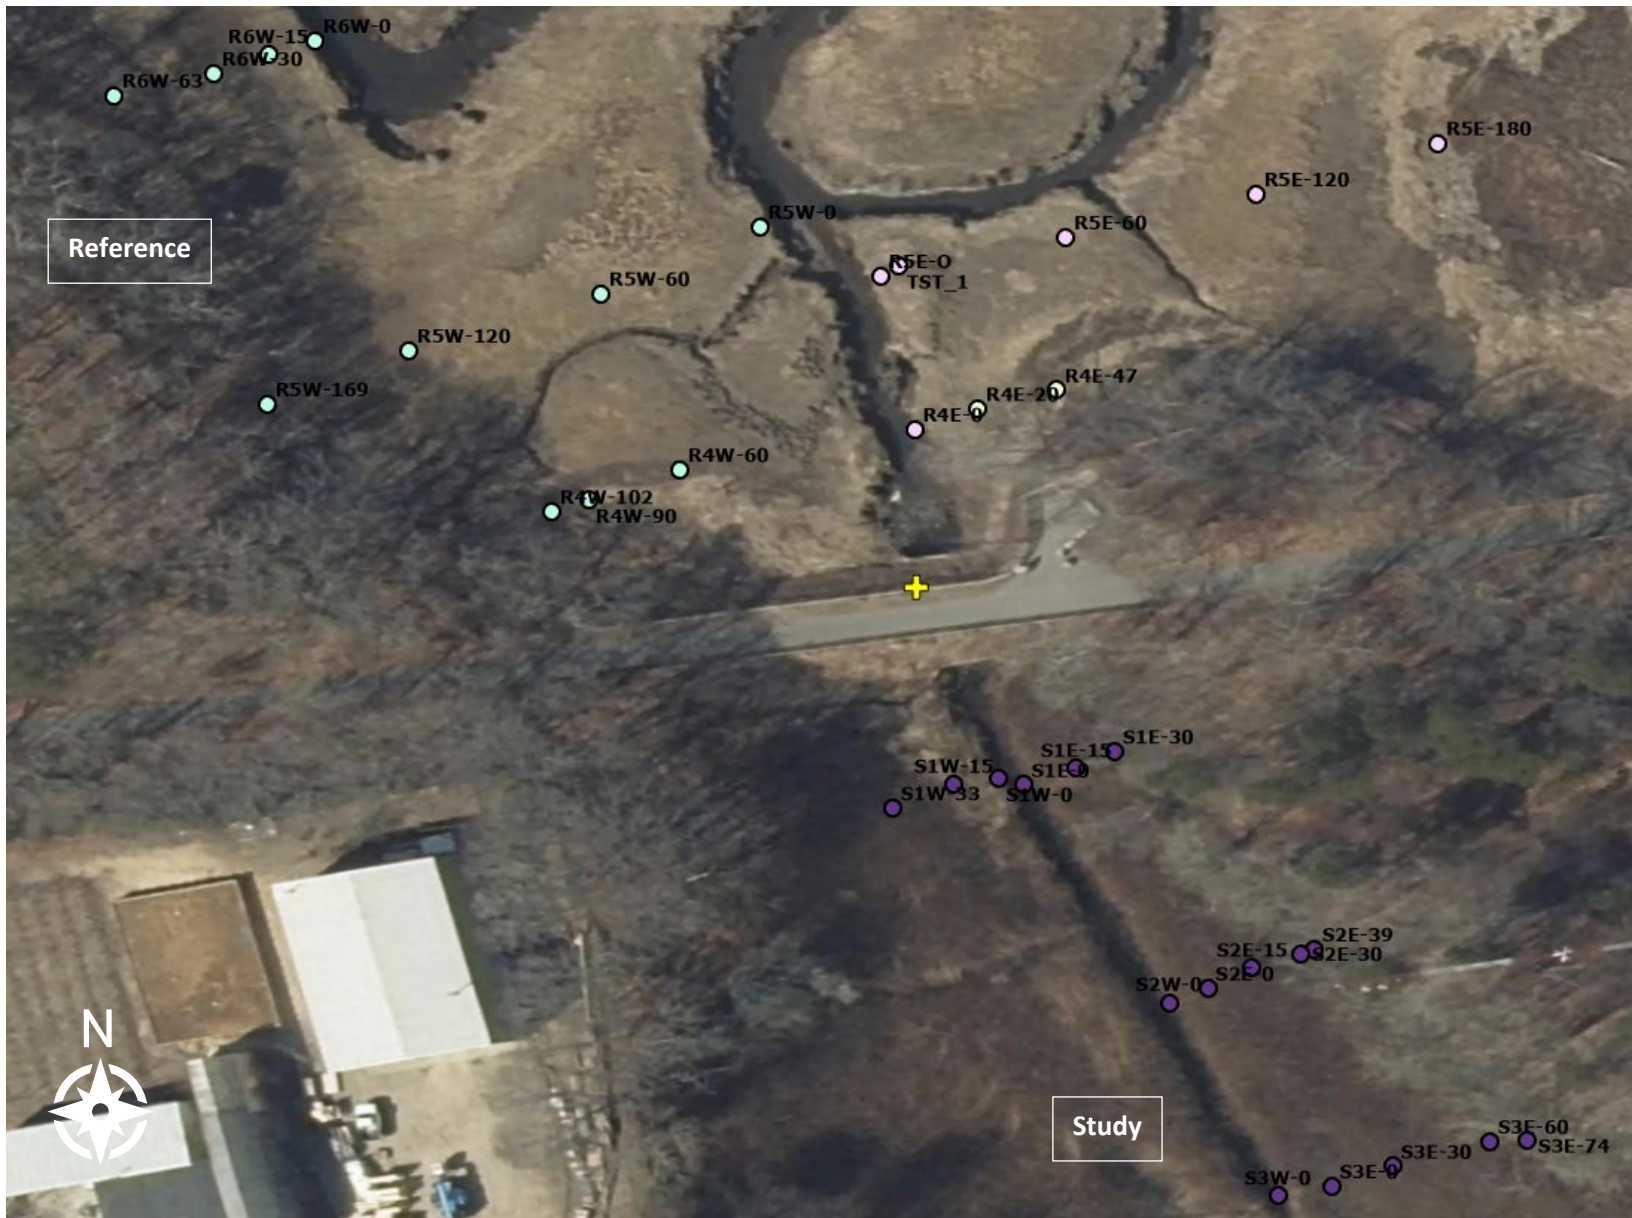
Figure A3: Vegetation plots at Namskaket Creek salt marsh restoration site in Brewster, MA. The yellow marker represents the former tidal restriction.

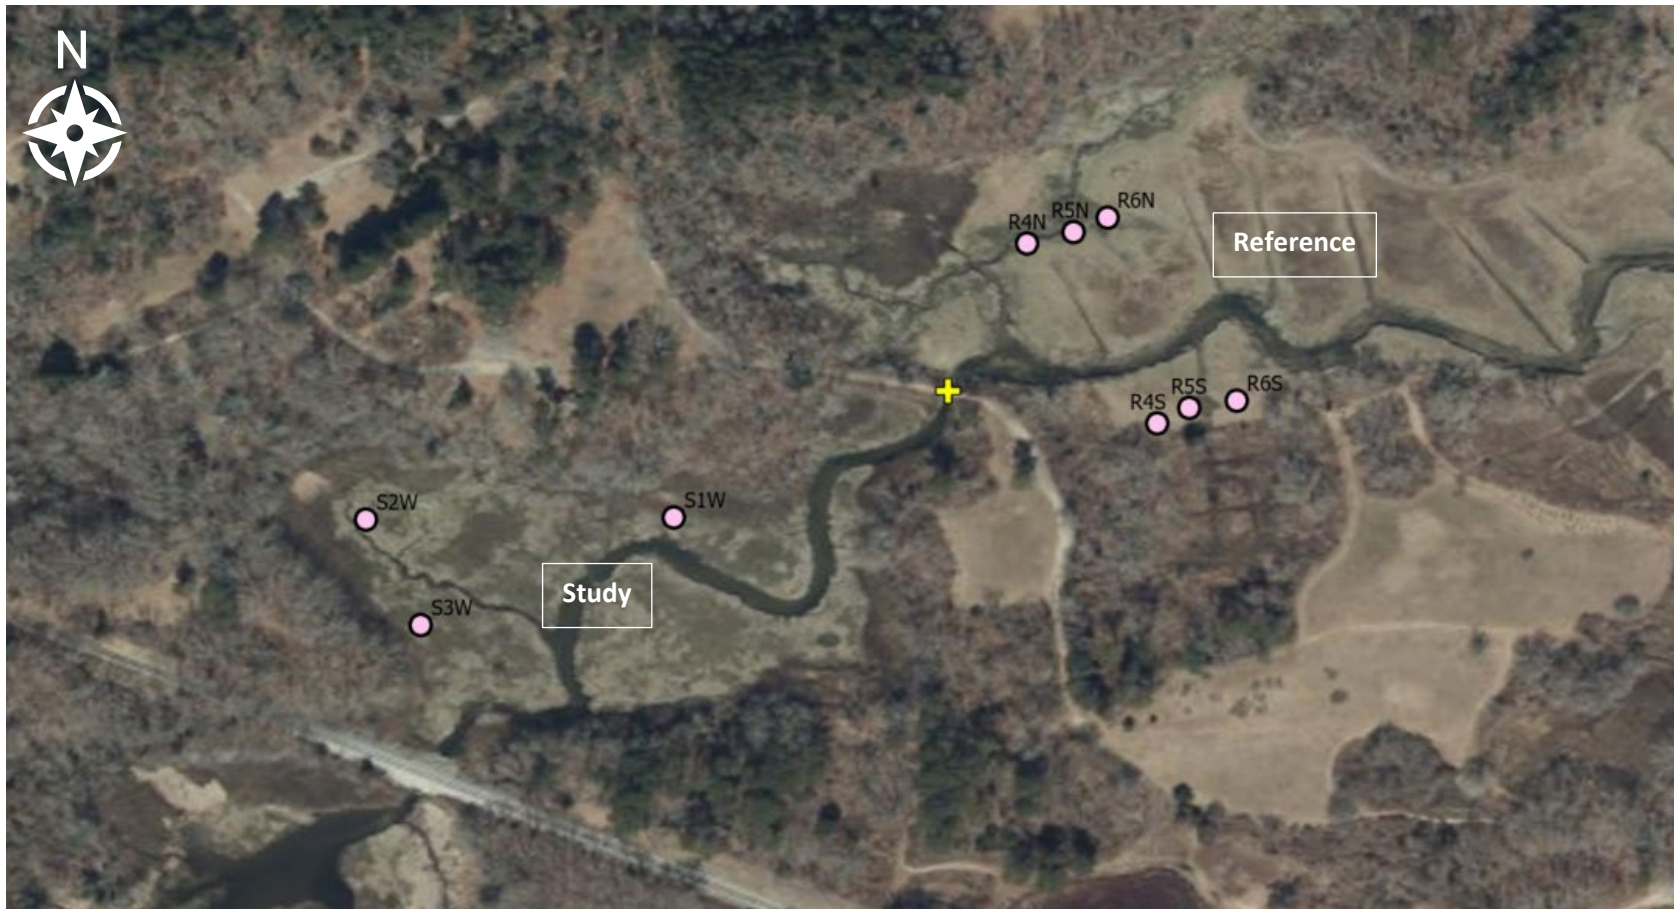
Figure A5: Starting point for each transect at State Game Farm in Sandwich, MA. The yellow marker represents the former tidal restriction. Note: plot points are unavailable.

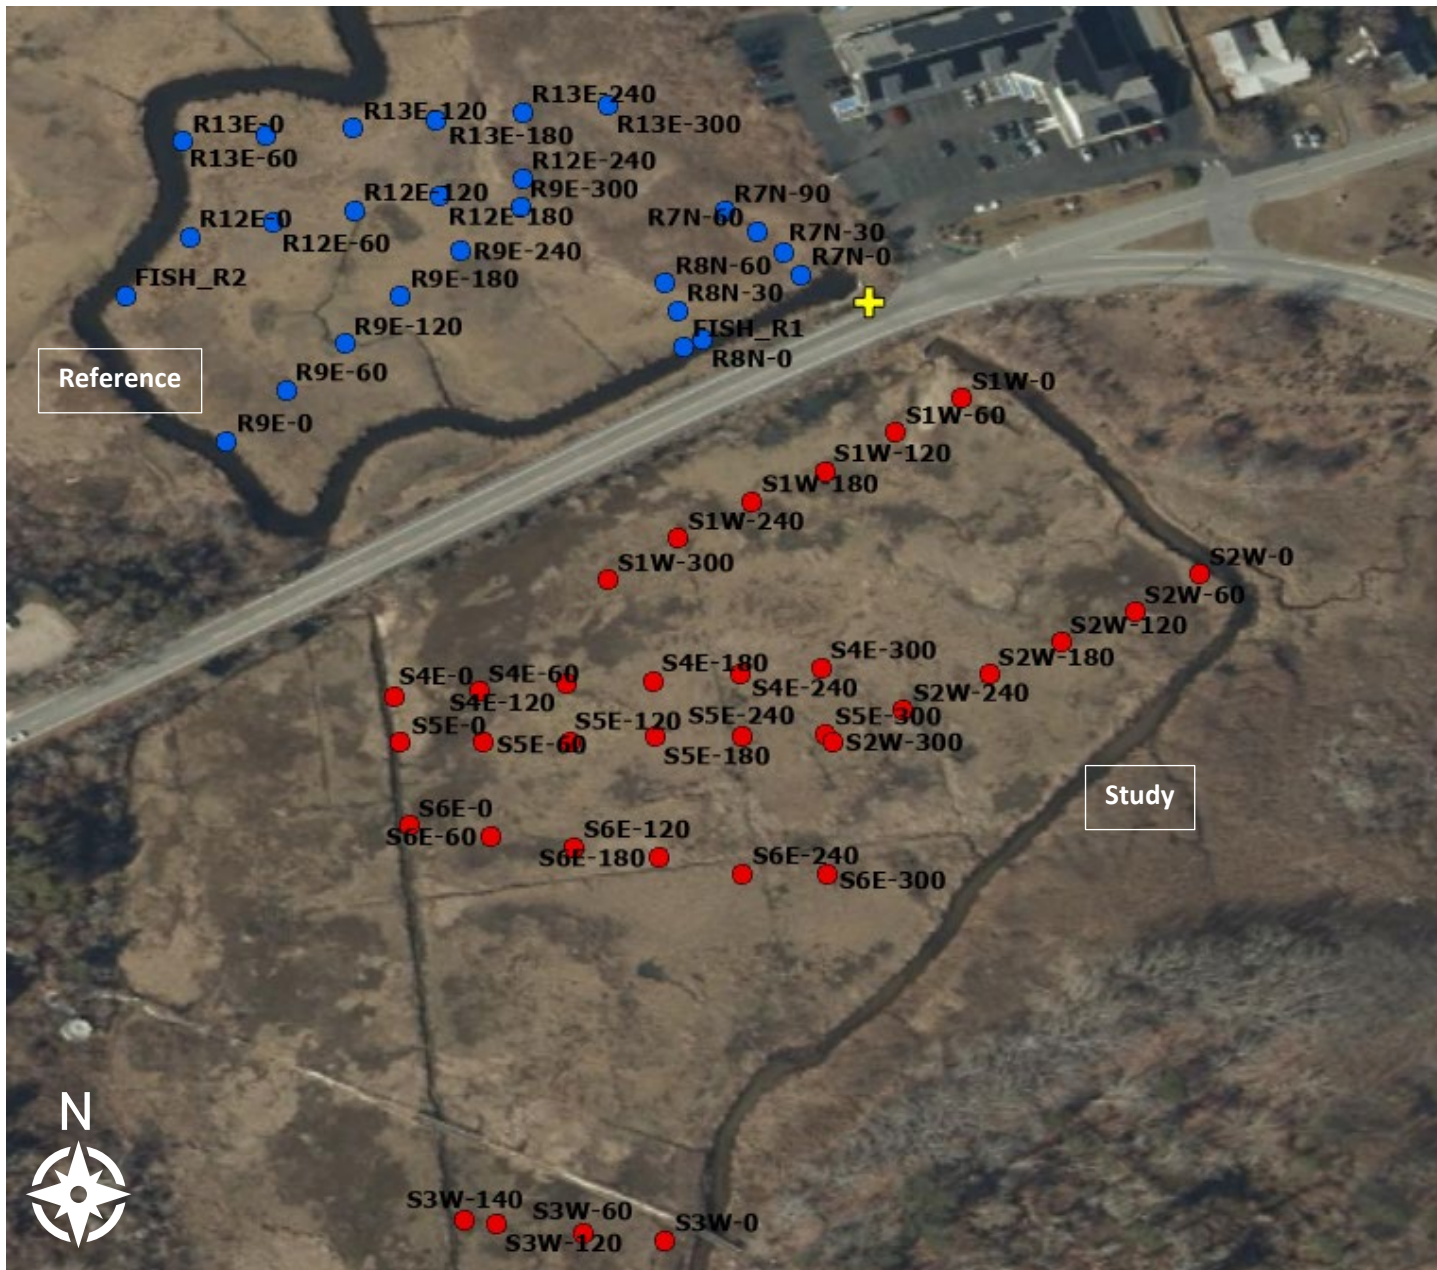
Figure A7: Starting point for each transect at Stony Brook in Brewster, MA. The yellow marker represents the former tidal restriction.

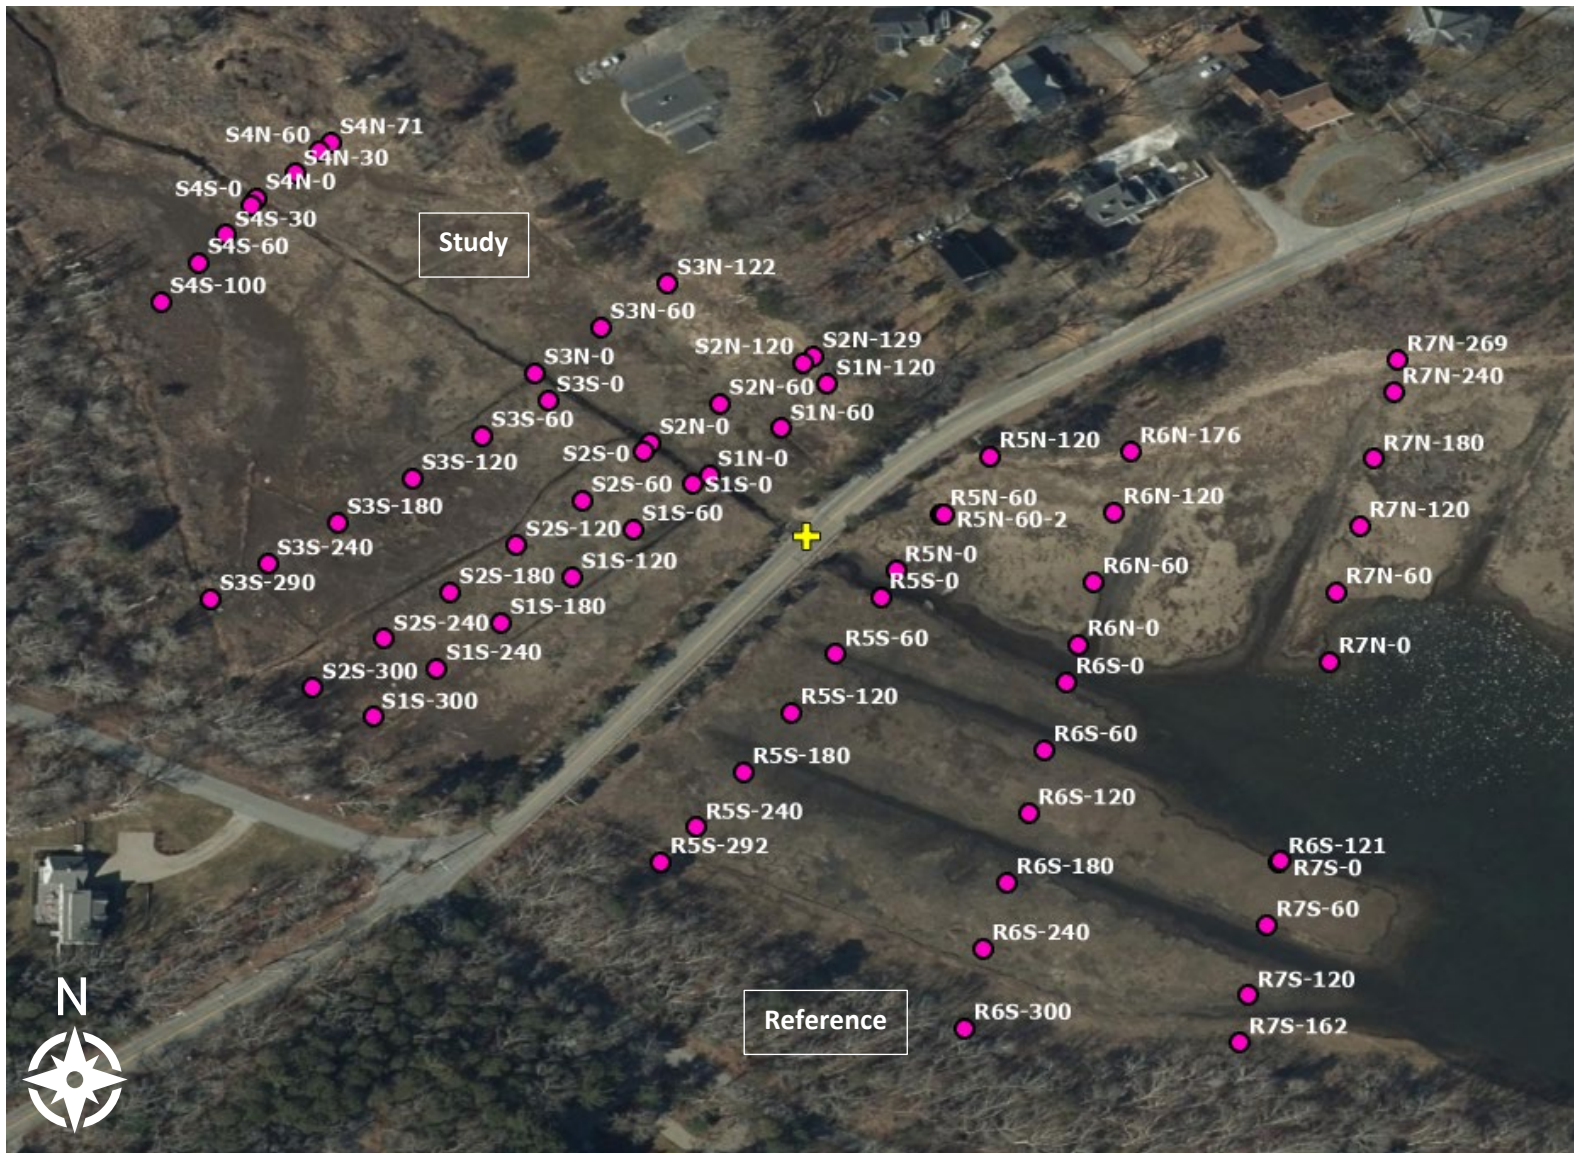
Figure A8: Starting point for each transect at Wings Neck in Bourne, MA. The yellow marker represents the former tidal restriction.

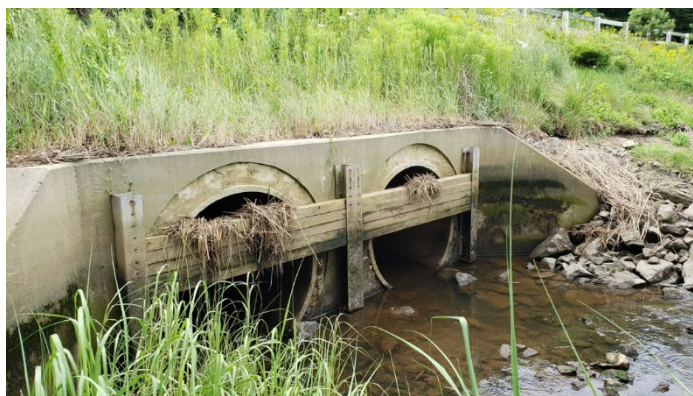
No stakes were found along transects R6W, R6E, and R7E. There was noticeable evidence of bank slumping and some erosion on the reference side of the marsh. Most of the erosion was observed at the bends in the tidal creek. Based on data from monitoring up to 2011, many of the halophytes seem to be unchanged on

the reference side, and there was a healthy middle to high marsh plant community growing on the reference side. Native *Phragmites* was found on the western side of the reference marsh during past mapping efforts. Two river otters were observed in the tidal creek on the reference side. Also, salt reedgrass (*Spartina cynosuroides*) was growing along transect R6E. Ten boards were blocking the two circular culverts (five boards on each culvert) which appeared to be reducing the tidal flow during high tide into the restored side of the marsh (see photo).

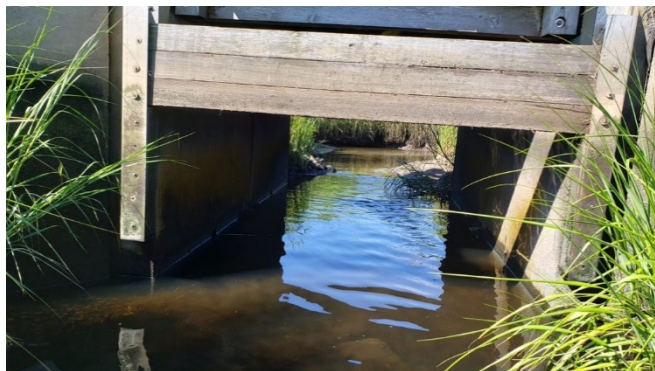
The plant community on the reference side of the marsh appeared very similar to the previous monitoring data at plots observed within the marsh. *Lileopsis chinensis* was present in the understory of taller salt marsh plants. *S. cynosuroides* was growing along the creek edges and up mosquito-control channels. The only stake found on the south side of the marsh was at R4S-0 (see Appendix A for plot and transect locations). The plant community at this stake consisted of *S. robustus*, *S. patens*, and *S. cynosuroides*. *Phragmites* was still limited in its distribution to upland transition areas at the edges of the marsh. More plot stakes were still in place on the northern side. R4N-120 had approximately 94% *S. alterniflora* growing nearby. Two end stakes were located at R5N which had mostly *S. alterniflora* (55-94%) growing nearby and a smaller percentage of *S. depressa* (15%). *Glaux maritima* was not observed on the reference side of the marsh like it was in the past. The salinity in the creek channel near the culvert during low tide was 0 ppt taken three times. The salinity during high tide with an incoming tide was an average of 10 ppt. There was no erosion on the banks, and healthy, tall stands of *S. alterniflora* and *S. cynosuroides* covered the banks. No stakes were found along transect R6N. The concrete box culvert appeared to be in good shape, and there were three boards in place across the top of the culvert. Salt marsh sparrows, *Ammospiza caudacuta*, were observed on the reference side.
