Monitoring and Analysis of Five Salt Marsh Tidal Restoration Projects on the North Shore, Massachusetts

May 2025

Prepared by: Salem Sound Coastwatch

Prepared for: Massachusetts Division of Ecological Restoration

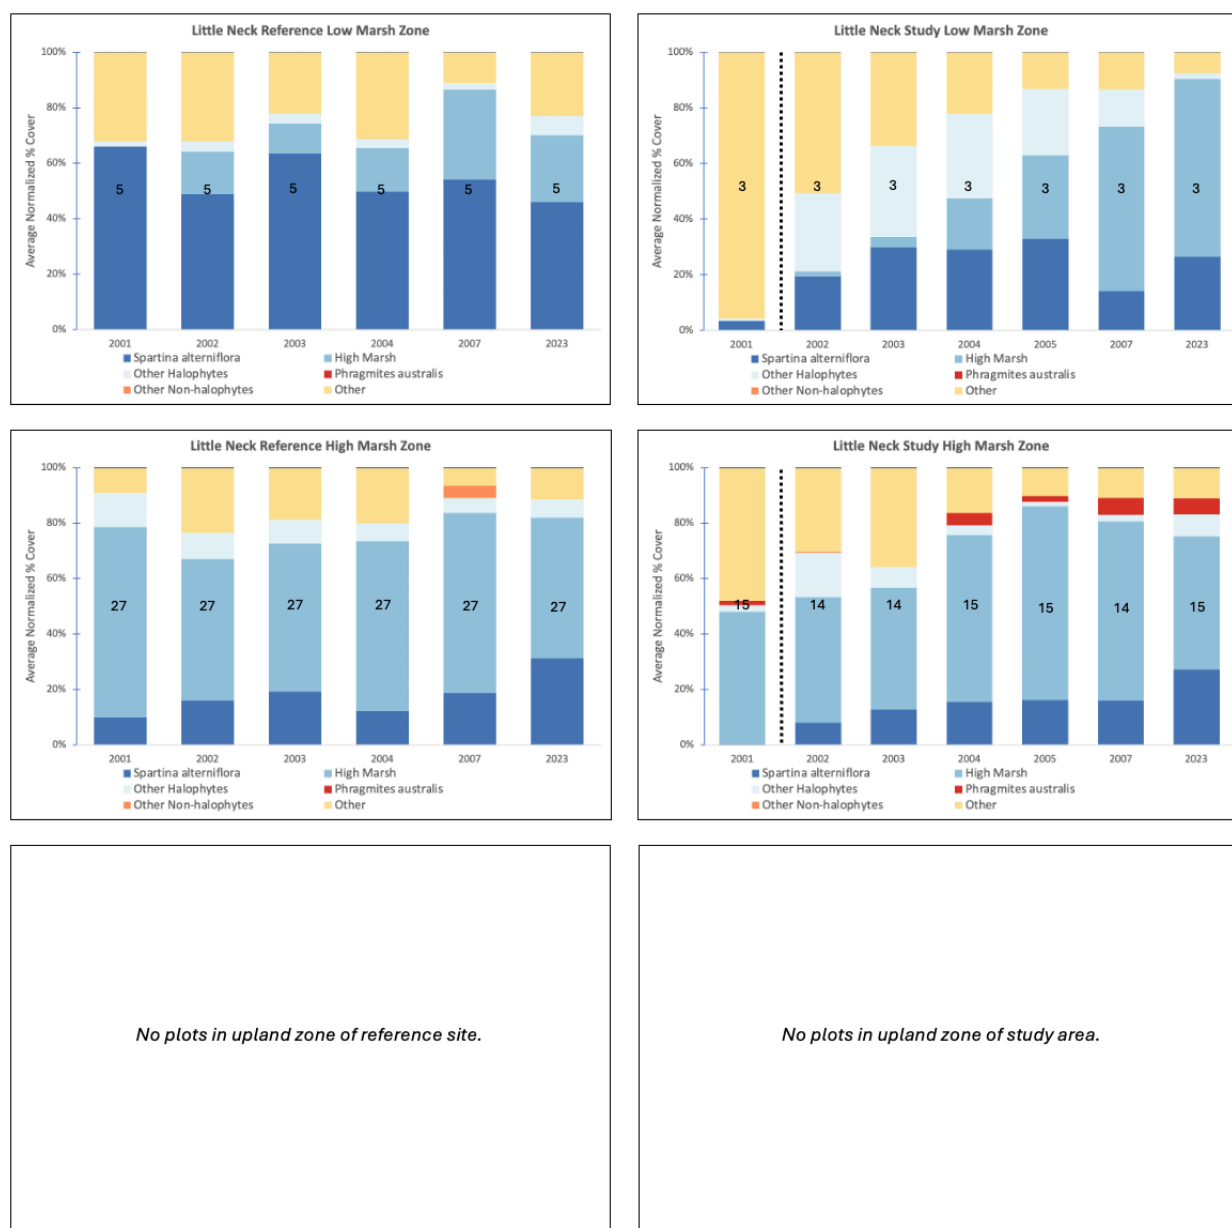
Figure 4: Average normalized percent cover for five dominant plant community types across three marsh zones within the reference and study areas of Little Neck, Ipswich, MA. “Other” represents unvegetated area, such as bare sediment, wrack, standing water, and/or dead vegetation. Column numbers represent plot sample size. The vertical dotted line indicates when tidal restriction restoration occurred.

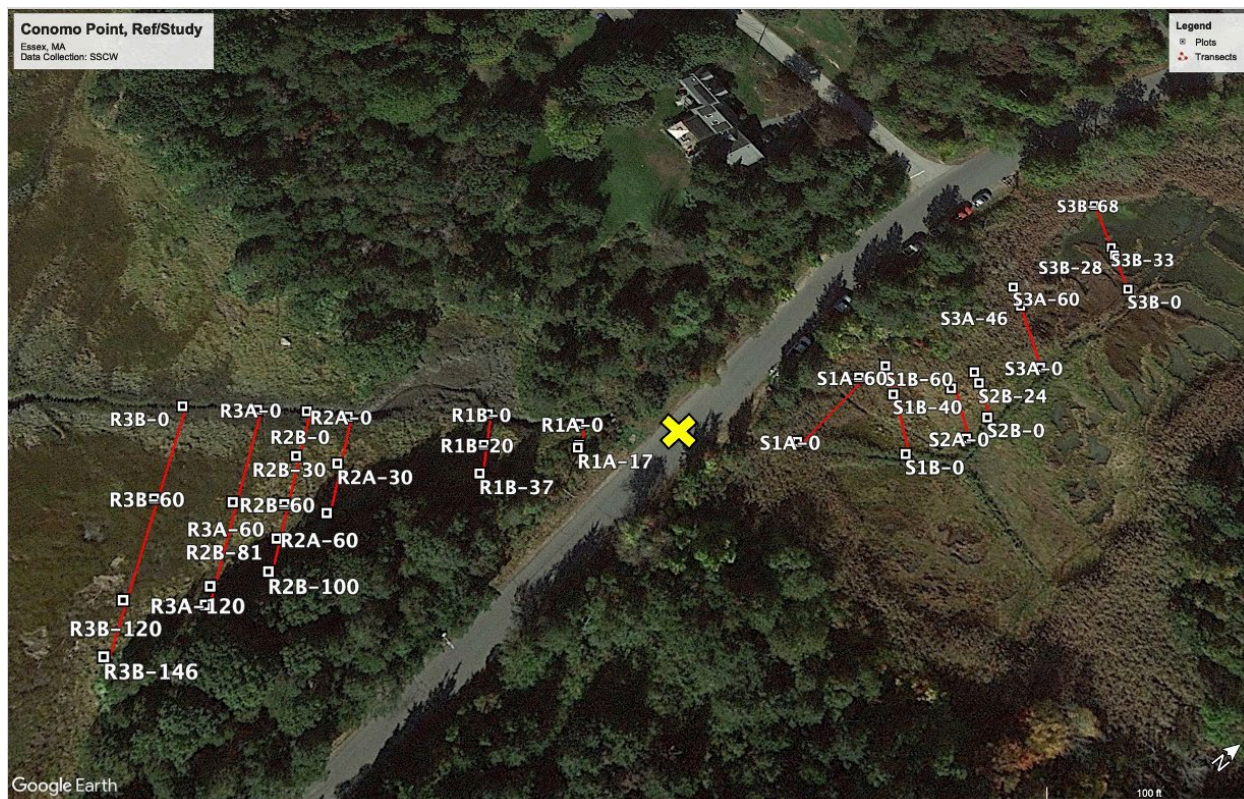
Figure A1: Vegetation plots at Conomo Point salt marsh restoration site in Essex, MA. Transects labeled “R” represent the reference marsh, while transects labeled “S” represent the study marsh. The yellow X represents the location of the former tidal restriction.

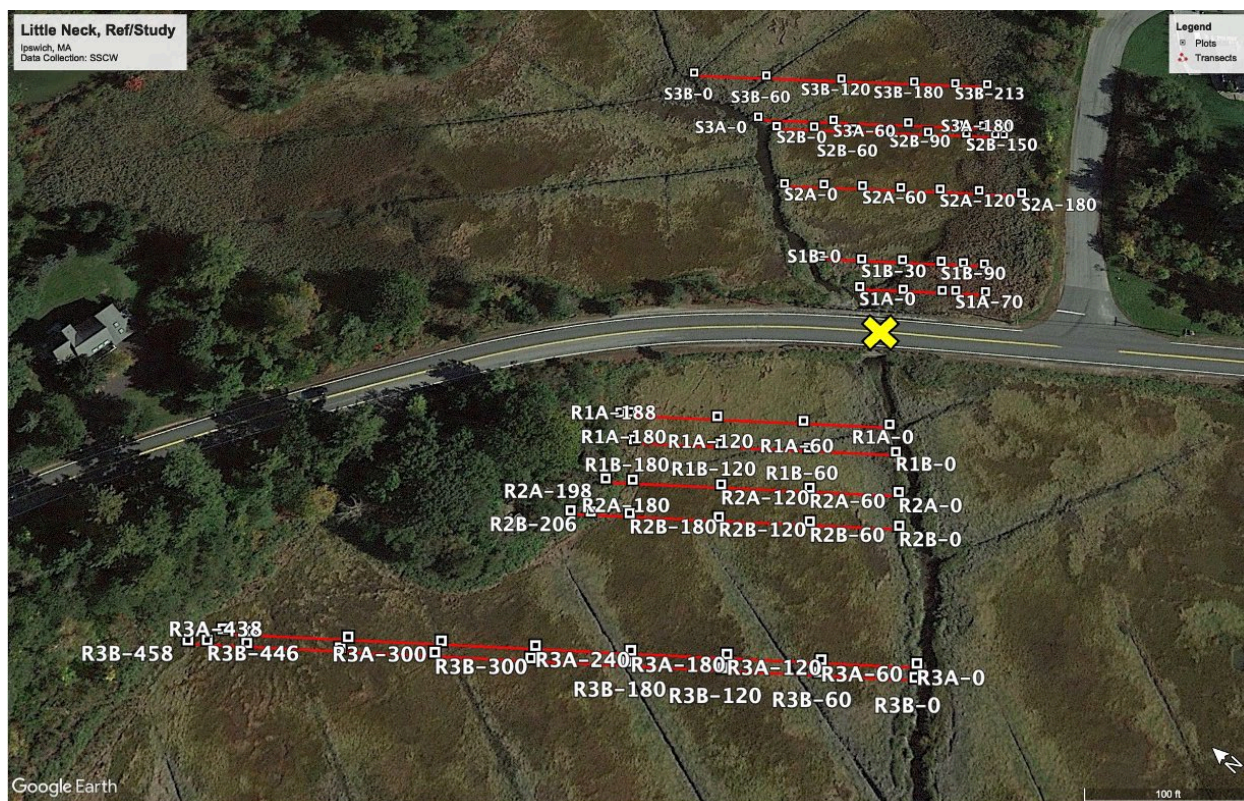
Figure A4: Vegetation plots at Little Neck salt marsh restoration site in Ipswich, MA. Transects labeled “R” represent the reference marsh, while transects labeled “S” represent the study marsh. The yellow X represents the location of the former tidal restriction.

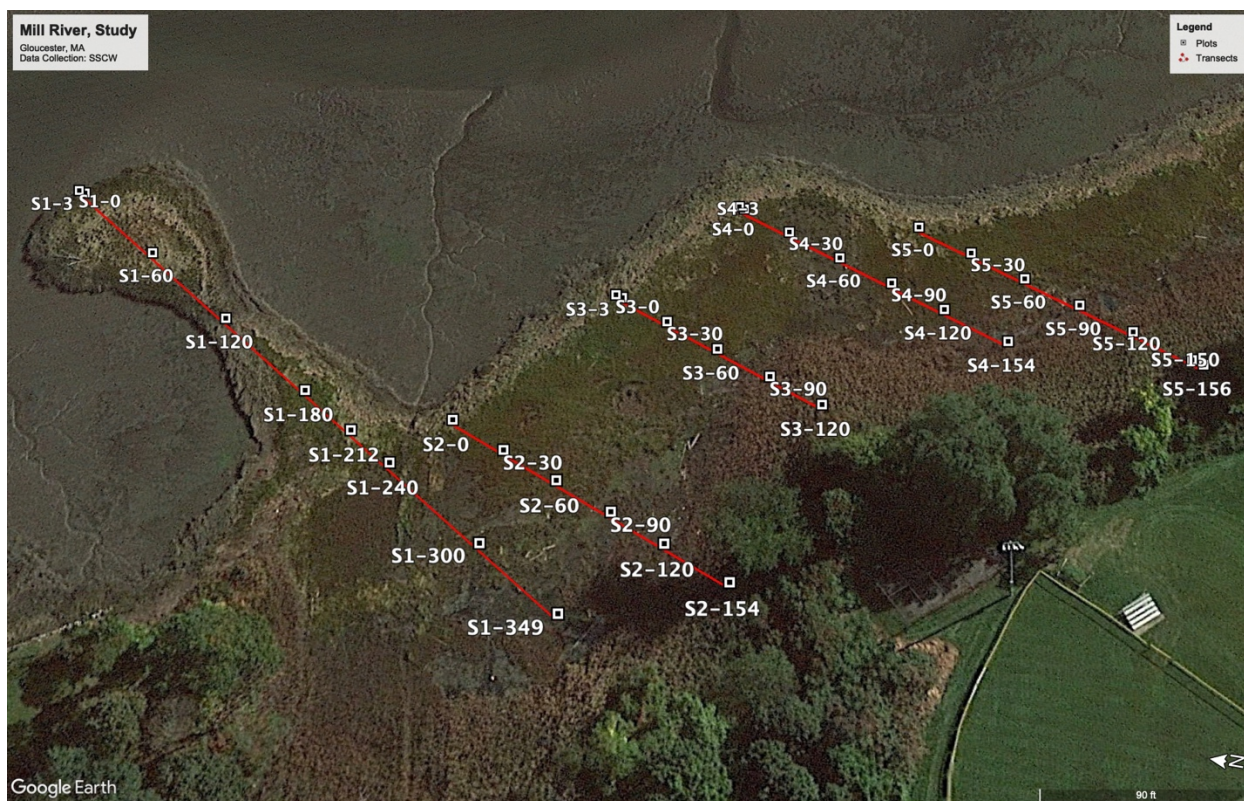
Figure A5: Vegetation plots at Mill River salt marsh restoration site in Gloucester, MA. Transects labeled “S” represent the study marsh. Mill River did not have a corresponding reference marsh. The former tidal restriction was a tide gate north of the marsh area.

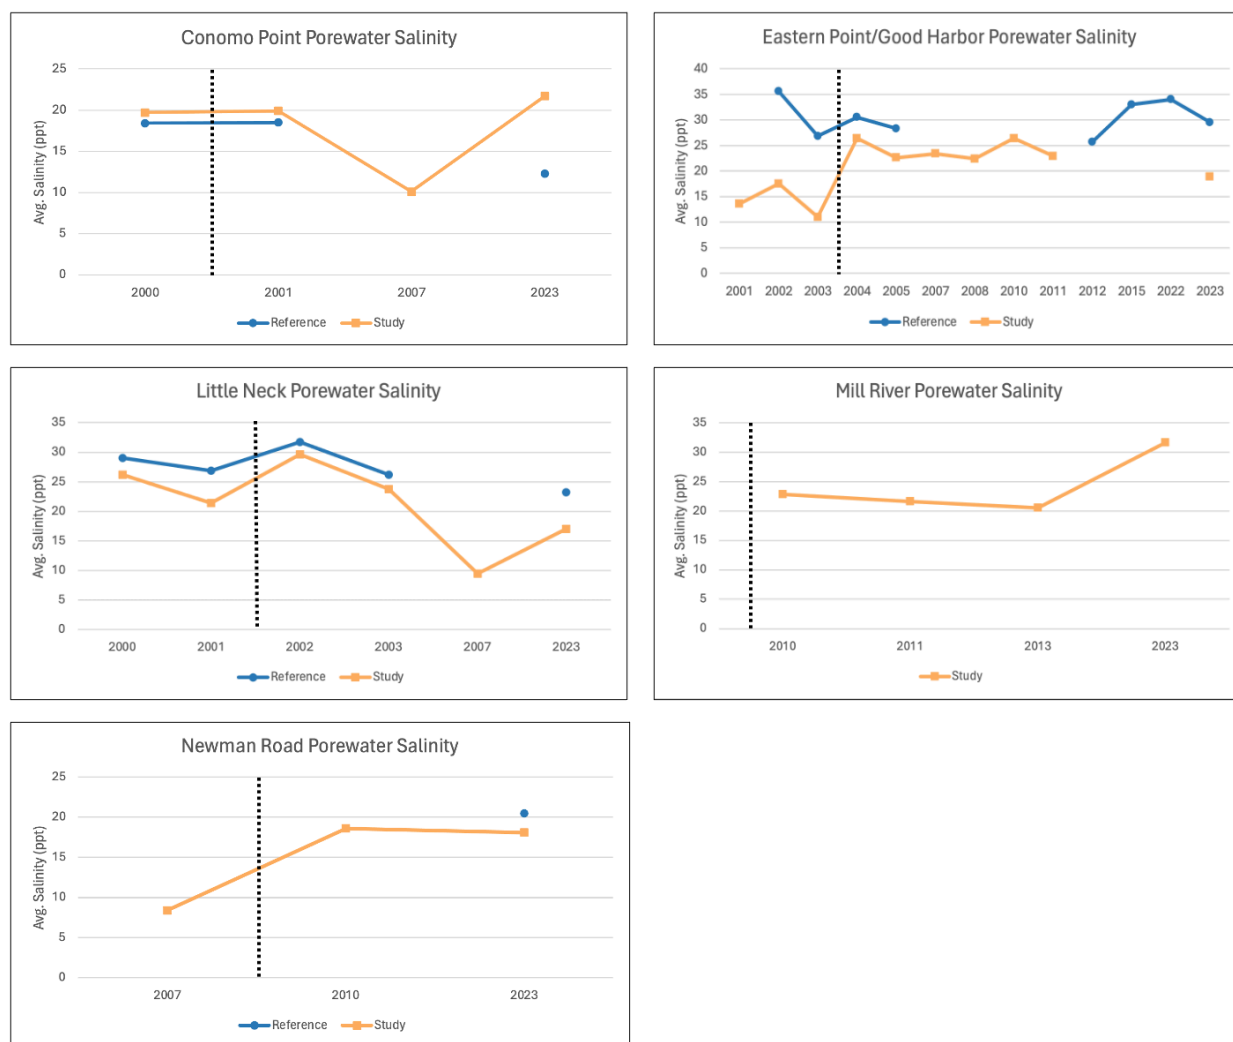
The porewater salinity of three study sites (Eastern Point, Little Neck, and Newman Road) increased immediately following restoration (Fig. D1). These three sites experienced an average porewater salinity increase of 11ppt in the monitoring year directly following restoration. For three sites (Eastern Point, Little Neck, and Newman Road), the porewater salinity was typically higher in the reference marsh throughout the entire monitoring period. Throughout the monitoring timeframe, the reference marshes’ porewater salinity was, on average, 7.2ppt higher than the study marsh. Conomo Point’s study marsh, however, had a slightly higher salinity than its reference site. This coincides with the 1999 report that noted the study site had a higher salinity due to increased evaporation and reduced tidal flow (Kookan et al., 1999). Mill River did not have a representative reference site, so comparisons were not possible.

Figure D1: Average summer porewater salinity in the reference and study sites within each of the five monitored salt marshes. Good Harbor represents the reference site for Eastern Point (study). Salinity at the reference marshes was not sampled in 2007 and 2010. The dotted line indicates the time of tidal restoration.

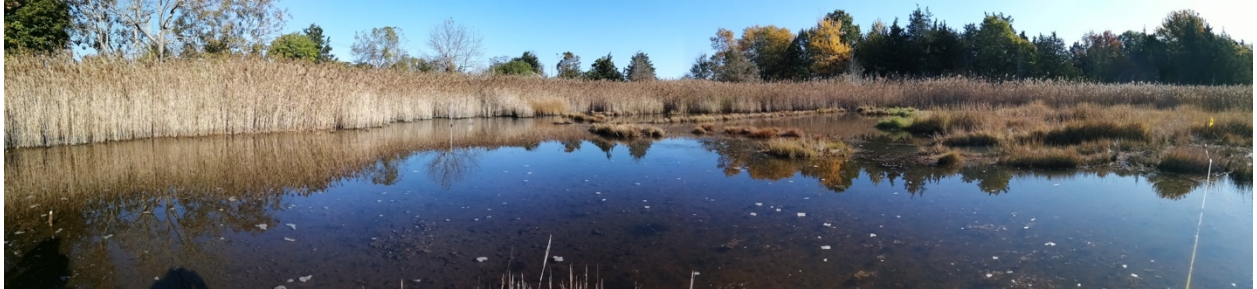
Image F1: Pool of standing water in study marsh

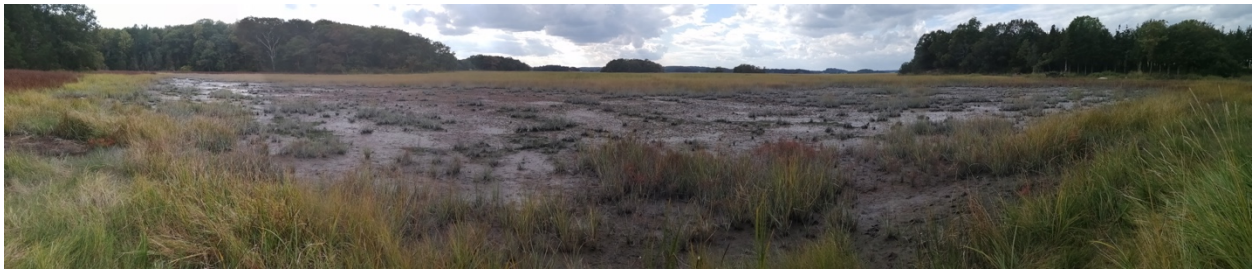
During the 2023 site visit, SSCW staff observed large, muddy die-off areas mid-marsh (Image F2), as well as an expanding creek (Image F3) in the reference site. However, the culvert was clear and unobstructed (Image F4).

Field observations of the reference marsh in 2023 noted a striking increase in muddy die-back zones in the high marsh platform (Image F2). Analysis of the high marsh data supports this observation. Bare mud ("other") and other halophytes, most notably *Salicornia europaea*, showed an increasing trend in the high marsh that coincided with a significant decline in high marsh species (Image F5). *Salicornia spp.* is an opportunistic species that can thrive in high saline conditions and is a frequent colonizer of disturbed areas. These trends are not only consistent with more frequent inundation by salt water, but also ponding of water in the high marsh, causing wide-spread die-back of high marsh vegetation. The upland zone of the reference marsh abruptly transitions to a steep, forested hill, which could impede future migration of the high marsh zone. Further investigations should monitor the extent of saturated die-back areas as sea levels continue to impact this marsh system.

Image F2: Muddy die-back areas in reference marsh

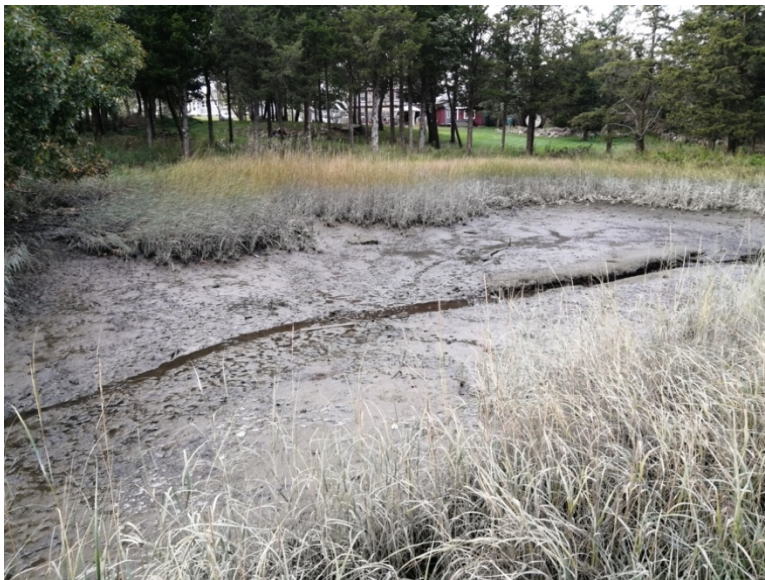
Image F3: Expanding creek width at reference marsh

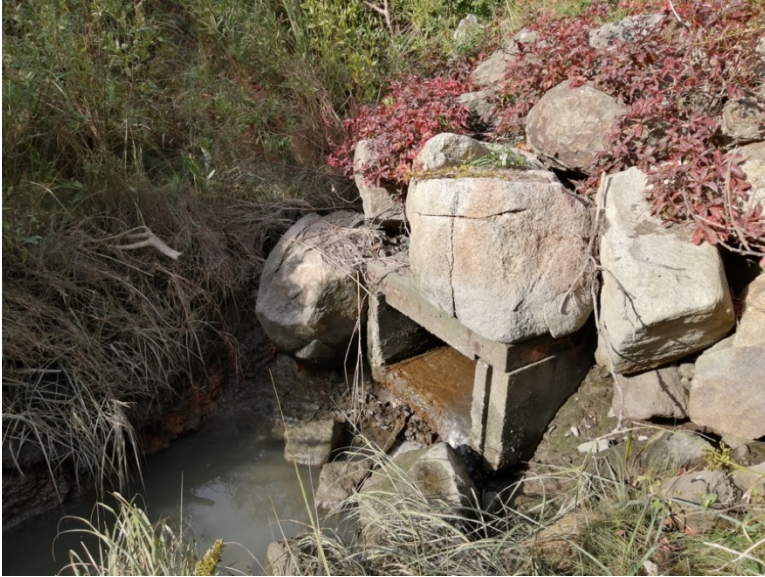
Image F4: Clear and unobstructed culvert at reference marsh

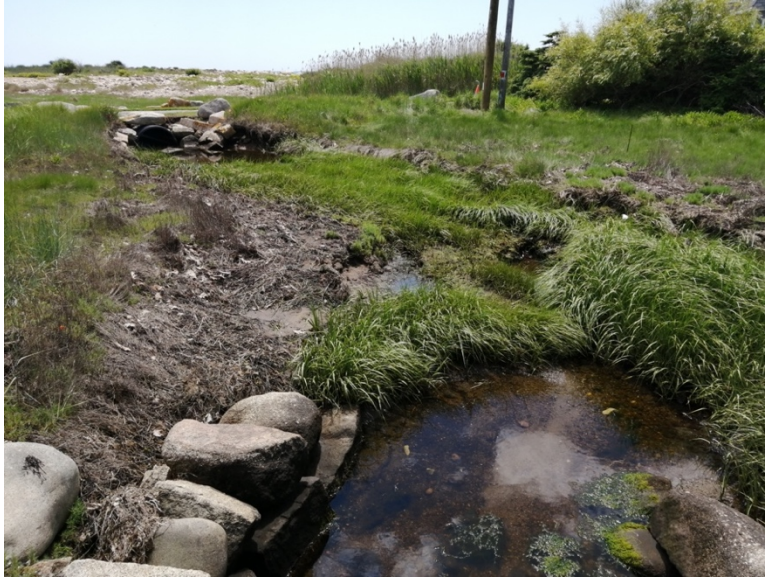
Image F6: Blocked culvert leading to restored marsh

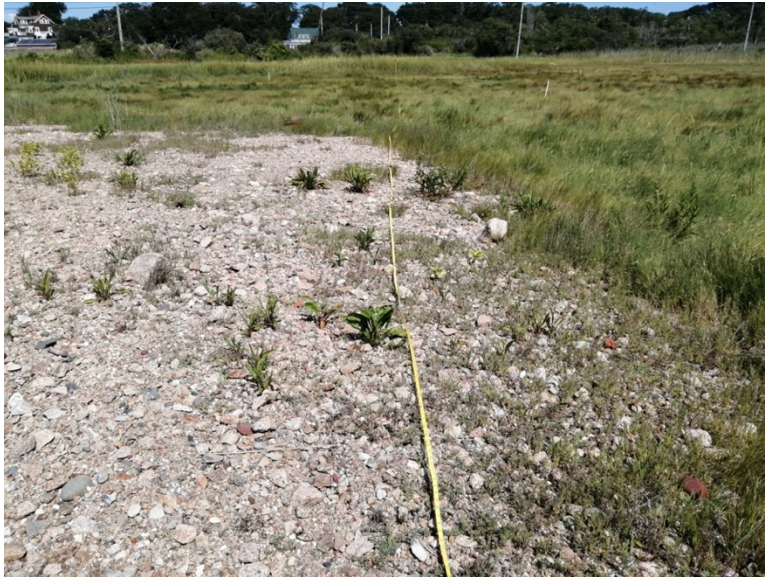
Image F7: Cobble on restored marsh from storms

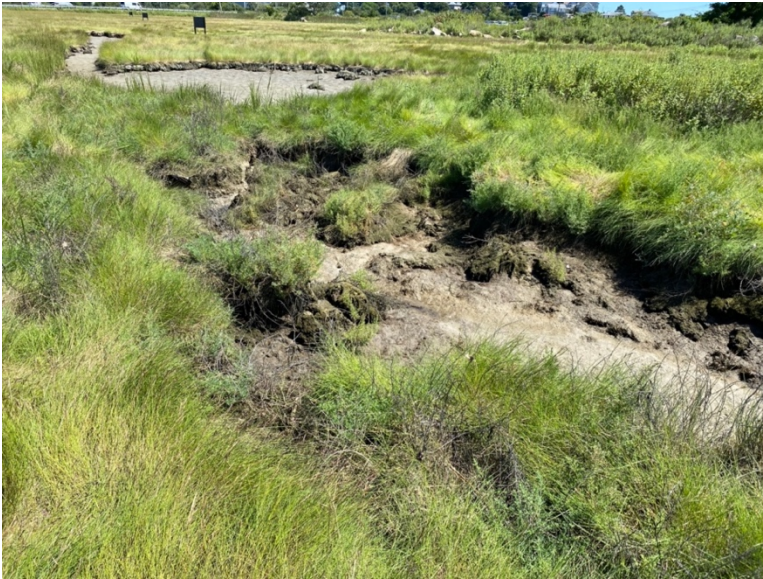
Vegetation in the high marsh zone of the Good Harbor reference marsh remained fairly stable over the monitoring time period (2001-2023), though other halophytes significantly decreased ($p = 0.02$, 16% to 7%, n=35). During the 2023 site visit, SSCW staff noted slumping of the marsh platform at the end of a distributary channel that led to a panne

(Image F8). The creek in the Good Harbor marsh had widened in some areas (a permanent stake on the marsh platform was located in the creek; Image F9) and die-back of the bank edge was evident in some locations.

patula, which have lower tolerances to flooding and/or salinity. This could represent the first signal of the impacts from sea level rise, particularly since observations in 2023 noted an area of marsh-collapse within the high marsh platform (Image F8).

Image F8: Marsh platform collapse at Good Harbor reference marsh

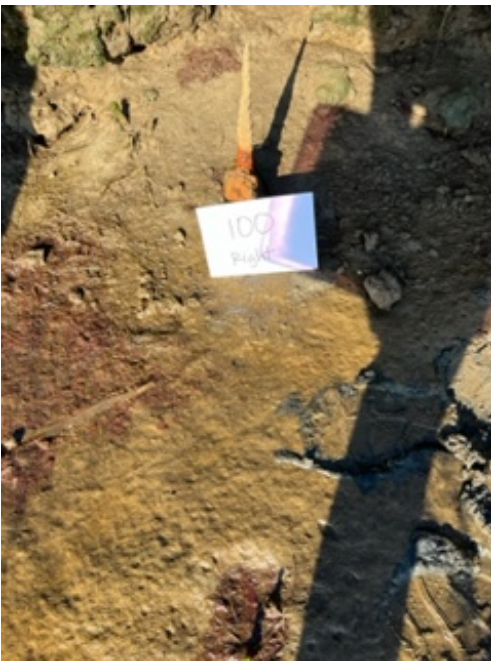
Image F9: Rebar stake that was once on marsh platform, located in creek

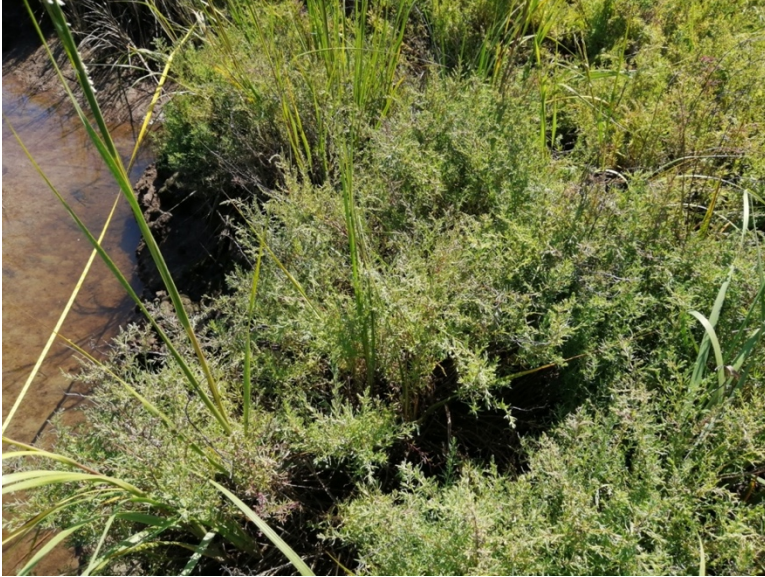
Image F10: *Suaeda linearis* along creek bank

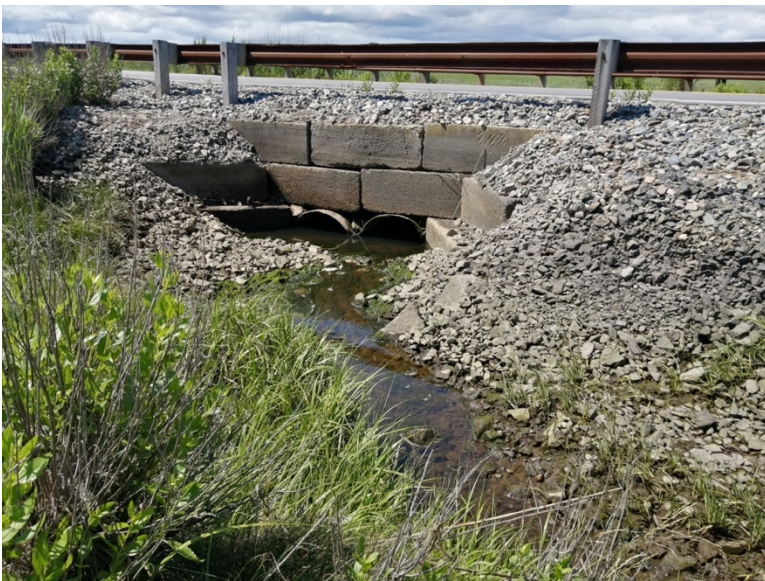
Image F11: Little Neck culvert

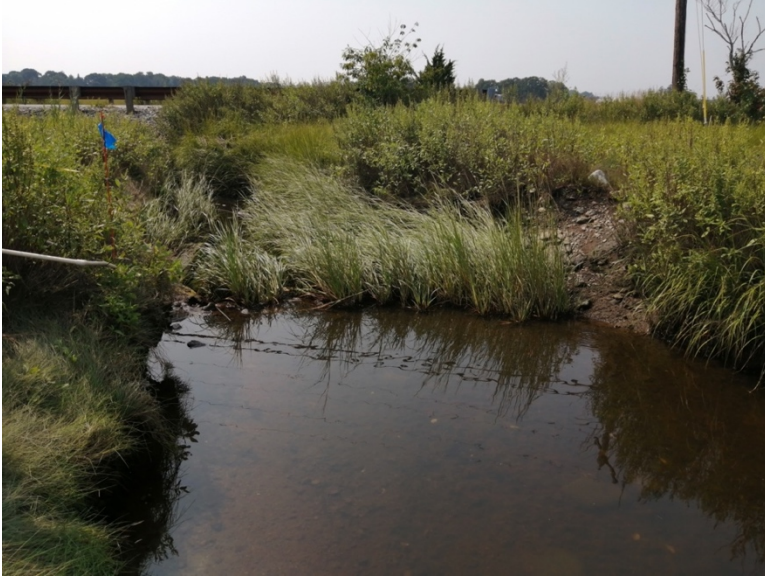
Image F12: *Iva frutescens* along bank edge in study area

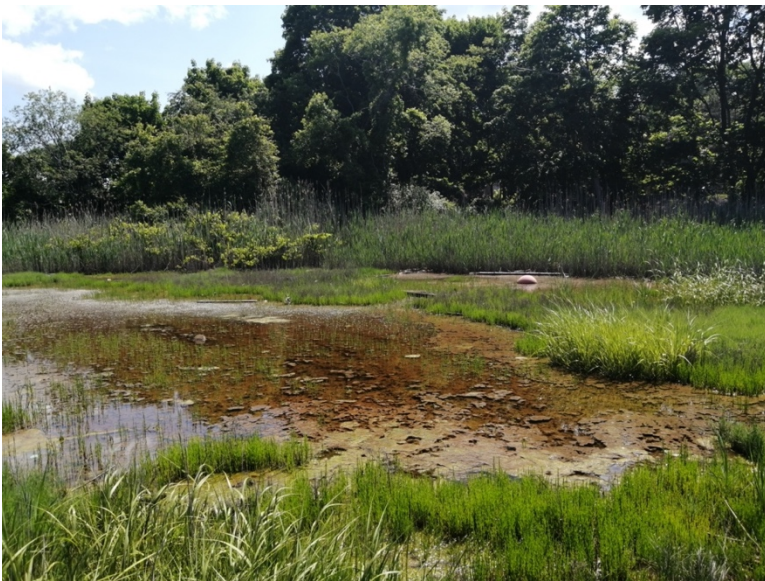
During the 2023 site visit, SSCW staff noted water ponding with *Salicornia* on the landward end of transect 1 (Image F13), bank die-back and erosion (Image F14), and substantial amounts of wrack and debris deposited on the marsh platform (Image F15). Additional notes from the 2023 site visit are provided in Appendix E.

Image F13: Ponding in high marsh

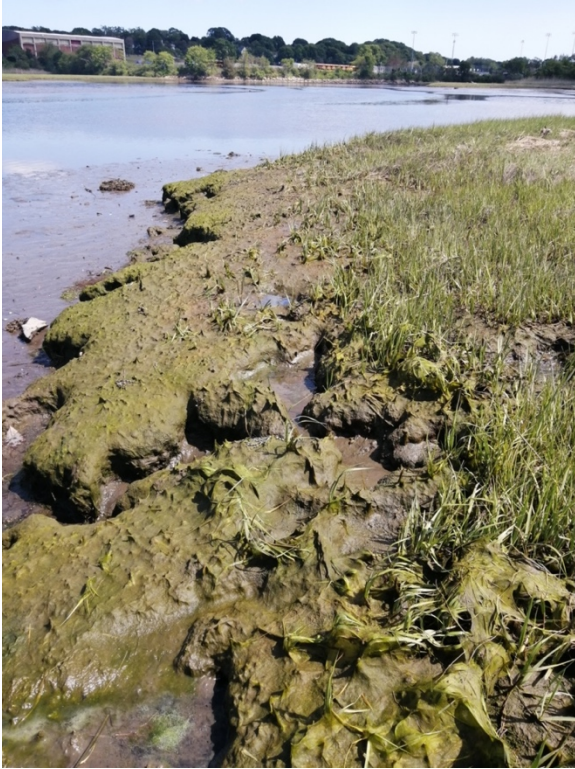
Image F14: Erosion and die-back of marsh edge

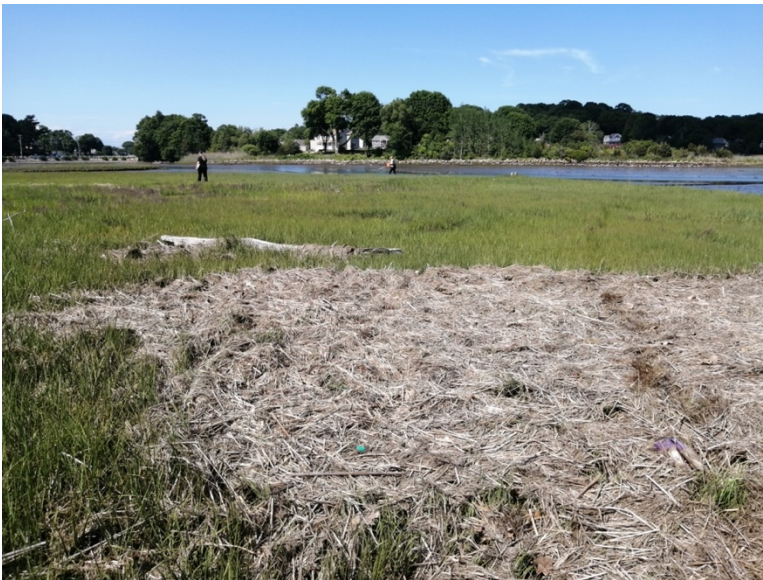
Image F15: Excessive wrack and debris on Mill River marsh

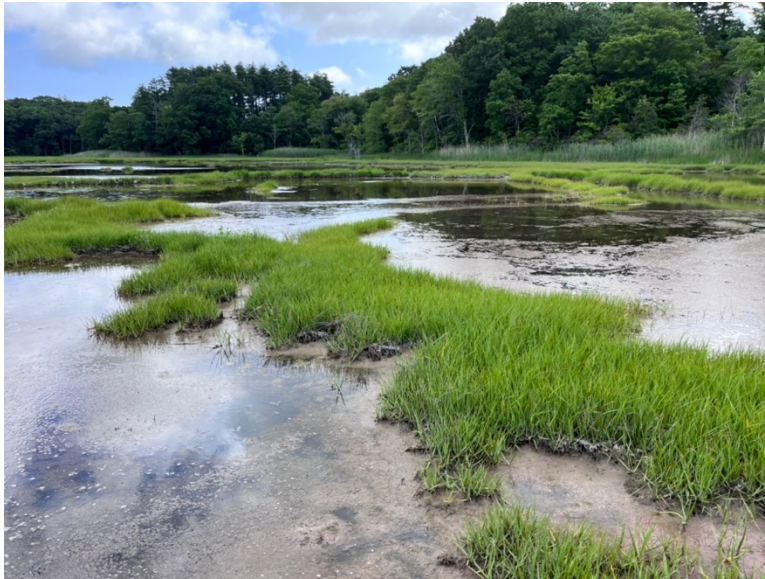
Image F16: Ponding of water in Newman Road study area

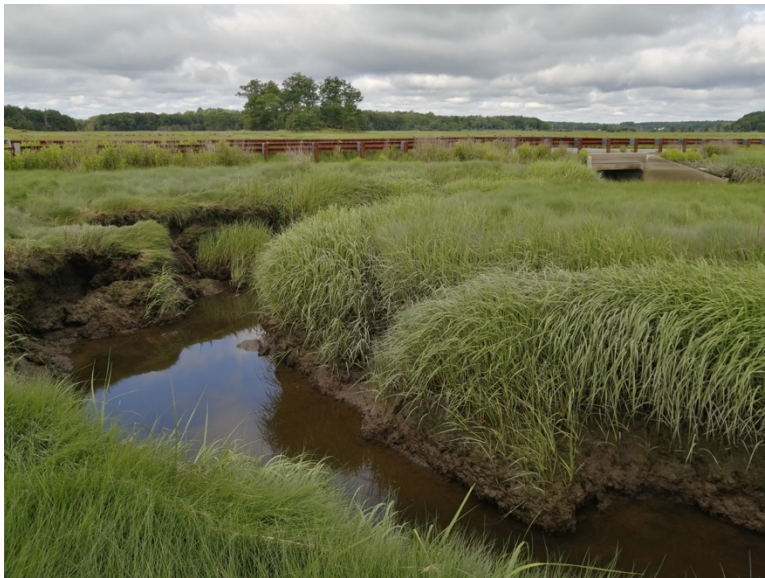
Image F17: Slumping of creek bank at Newman Road study site
