Post-Planting Assessment Report – IL17 Nantucket Eelgrass Restoration
Nantucket Land Council
Submitted: December 2022

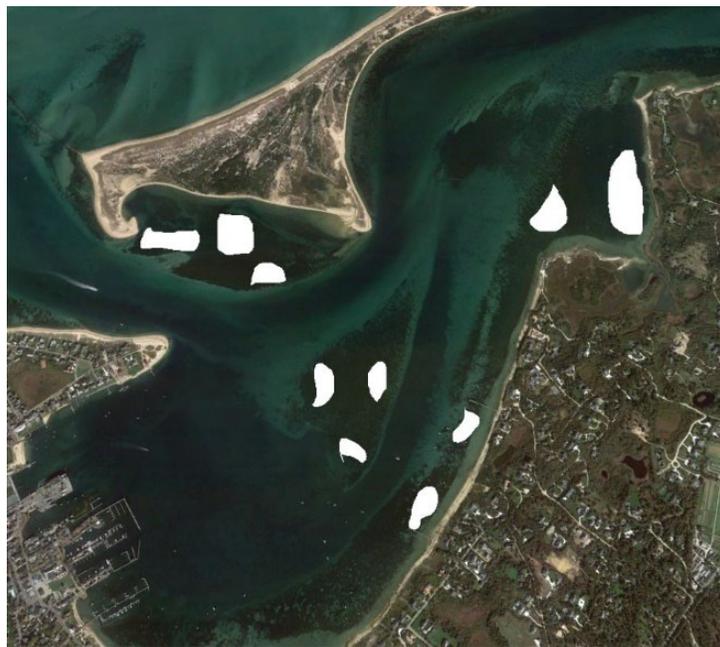
In June 2022, we collected 21,000 reproductive eelgrass shoots (with a total of 300,000 seeds) from ten sites in Nantucket Harbor (Figure 1).

Figure 1. Map showing locations where reproductive shoots were harvested for the restoration at both sites.

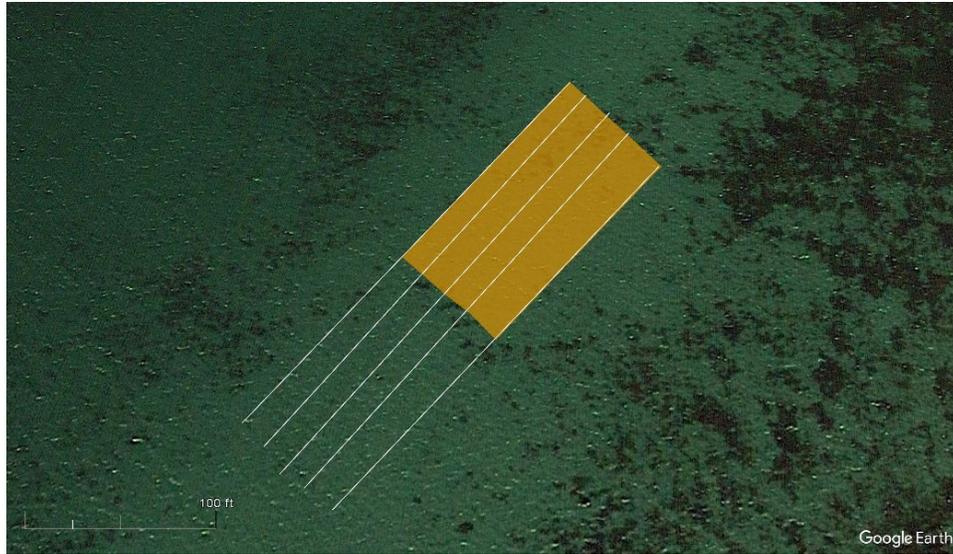
Restoration Site A, located near Monomoy, is a sandy location within/adjacent to an area where NLC has been actively transplanting since the fall of 2017. Eelgrass at this site completely disappeared during a shoaling event in 2012. Transplanting at this location has been successful and expansion of eelgrass within and around the site is notable. In Fall 2022, we evenly dispersed 250,000 seeds within the remaining 0.25-acre plot located in the eastern section of the restoration site (Figure 2). Assuming 10% of the seeds successfully germinate, our restoration efforts at Monomoy are complete and we will begin the monitoring phase of our 0.5 acre site next summer.

Figure 2. Map showing area planted with seeds at Monomoy in Fall 2022 (denoted in orange).
