## NEWBURYPORT DISTRICT COURTHOUSE HVAC SYSTEM EVALUATION SUMMARY

**Newburyport District Court  
Newburyport, MA**

# **HVAC SYSTEM EVALUATIONS COVID-19**

March 22, 2021

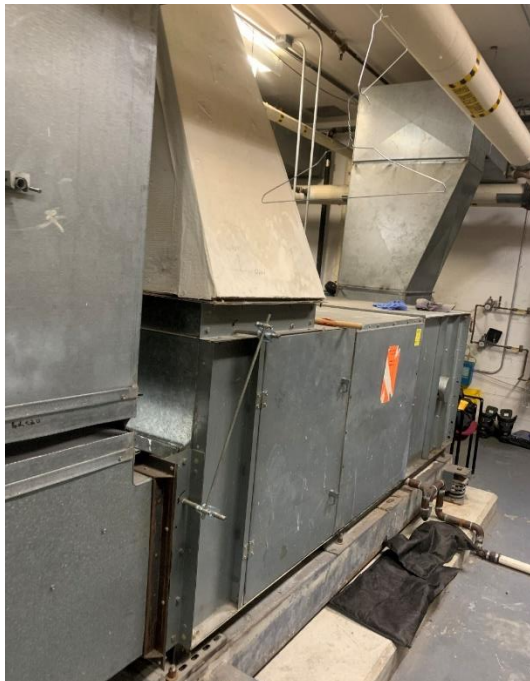
Photo 1 – Air Handler AHU-1

The air handling unit (AHU-1) contains a supply fan, hot water heating coil, chilled water cooling, and 2" MERV 8 filters. The air handling unit appears to be original from 1991 is in poor condition. The heating and cooling coils are in poor condition. There are holes in one of the coils. The cooling coil condensate pan is rusted and was flooded at the time of the visit. Since the condensate drain pan isn't draining properly, the condensate trap may be incorrectly sized. The outdoor air damper is rusty, in poor condition, and was closed during our site investigation. The actuator appeared to be newer.

There are several issues with AHU-1. One of the coils contains a hole, which affects the performance of the coil. The outdoor air damper is rusted and may need replacement and a properly sized condensate trap should be installed to allow the unit to drain properly. As an alternative, replacing the entire air handler should be considered. The unit is 30 years old and is in fair to poor condition and nearing the end of its useful life.

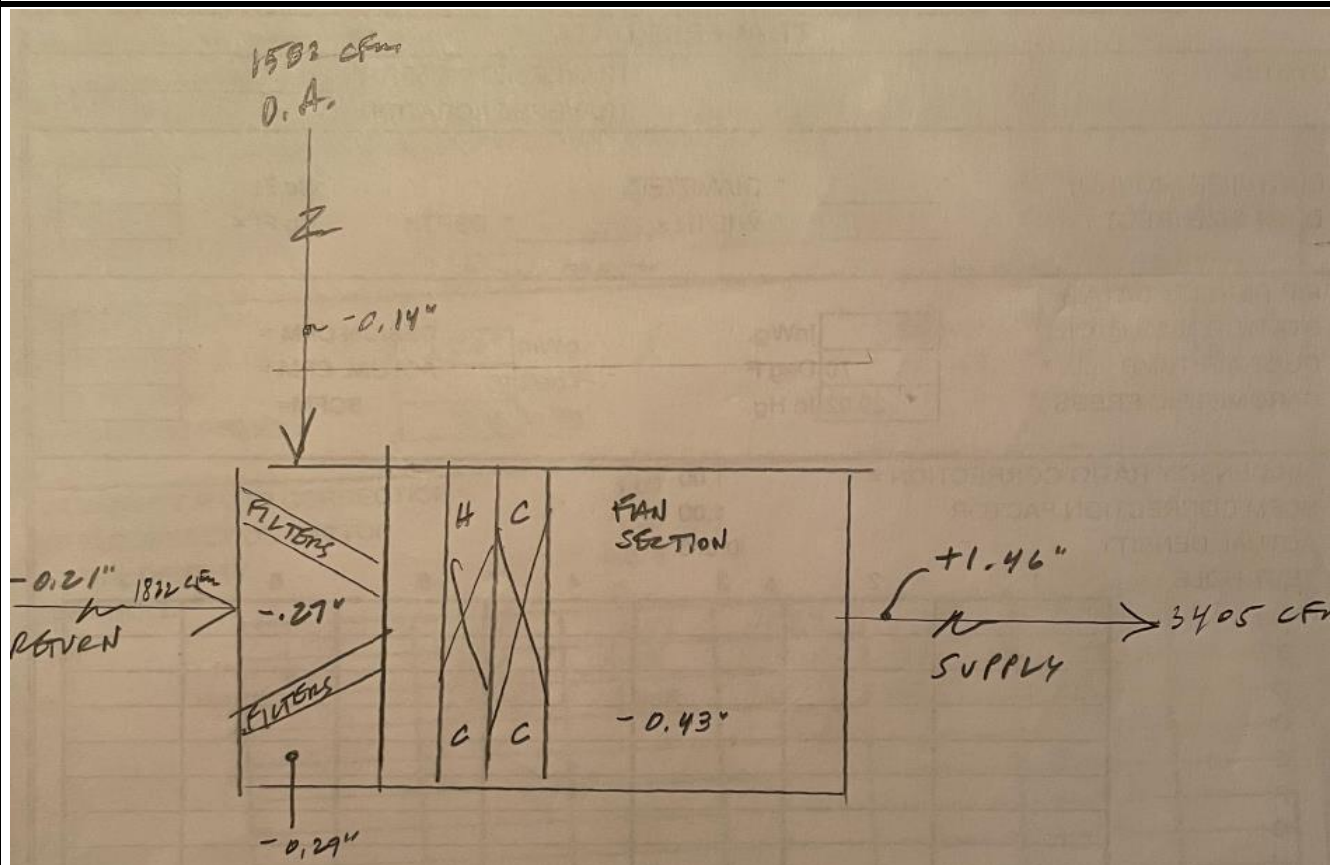
### STATIC PRESSURE PROFILE AHU-1

1. AHU-1 was tested at 3,387 CFM and is designed for 4,950 CFM. A fan sheave change would be required in order to increase the airflow to design. The new motor sheave would need to be a 1VP71 x 1 1/8" with an BX78 Belt.
