**Newton District Court
West Newton, MA**

**HVAC SYSTEM
EVALUATIONS
COVID-19**

Office of Court Management

March 30, 2022

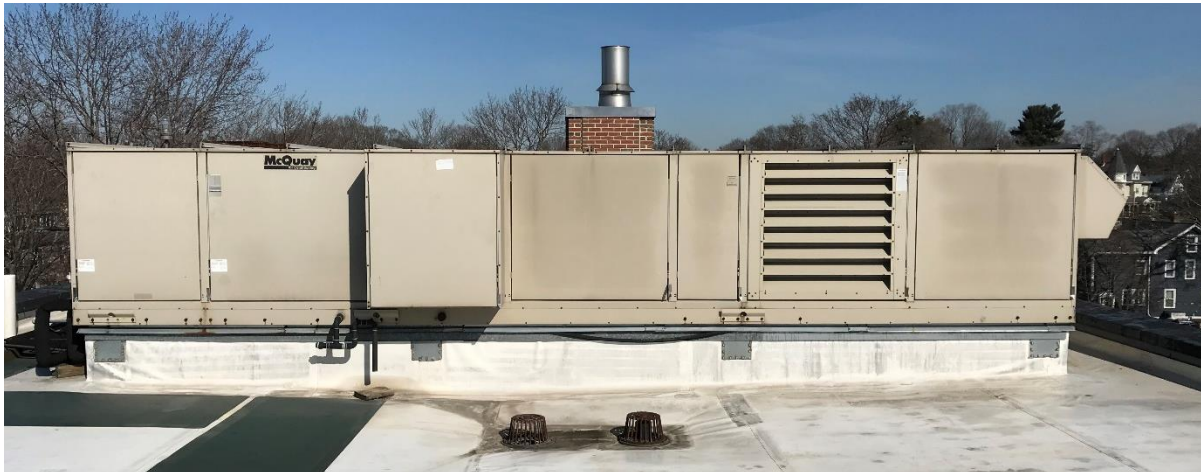
Photo 1 – Representative Air Handler

The units are from a renovation in 2000 and are in fair condition. The outdoor and return air dampers are in good condition. The actuators were not able to be observed during the site visit. The heating and cooling coils are in fair condition.

RTU-1 did not match the reading that was shown on the BMS system. The system said that the outdoor air damper was 90% open, however when the unit was observed, the outdoor air damper was almost totally shut. There also appeared to be a leak in the heating coil in RTU-1.

The existing RTUs are approx. 21 years old and are approaching the end of their useful life. These units are in fair condition and likely have approximately 5-8 years of useful life remaining. While immediate replacement is not necessary at this time, we would recommend developing a capital plan to replace these units ~5years.
