Massachusetts Department of Public Health
Bureau of Environmental Health

Updates on Environmental Radiation
Monitoring Activities at
Pilgrim Nuclear Power Station (PNPS)

November 2015

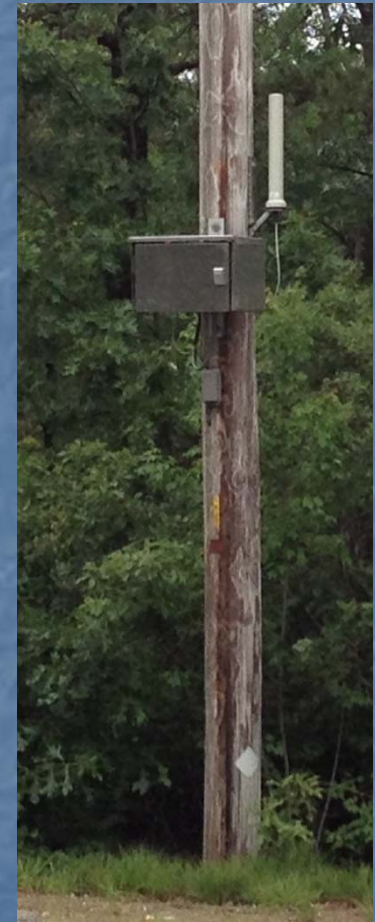
- MDPH-owned network of 15 radiation monitors
 - 14 located in Plymouth
 - 1 in Duxbury (purchased with town funds)
- Measure gamma radiation in real time
- Data are reported to a central computer remotely accessible and routinely checked by MDPH staff
- Emergency alerts sent to senior MDPH officials and MEMA staff when radiation detected above three times typical background readings

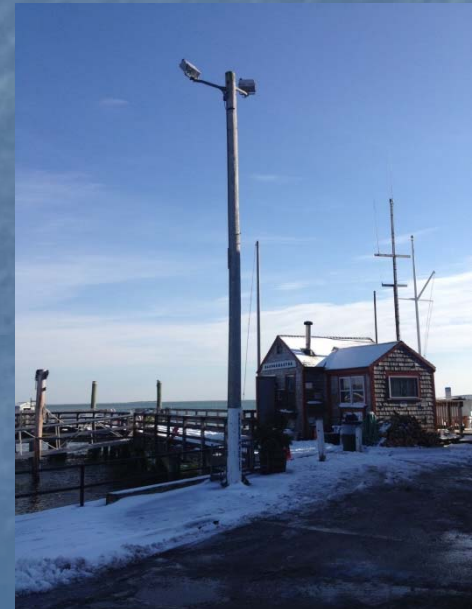
- Three existing monitors were relocated in 2013
 - Gurnet Point
 - Plymouth Waterfront
 - Old Colony Place
- Duxbury monitor integrated in 2014
 - Funding provided by Town of Duxbury
 - Memorandum of Agreement signed November 22, 2013 (MDPH maintains ownership)

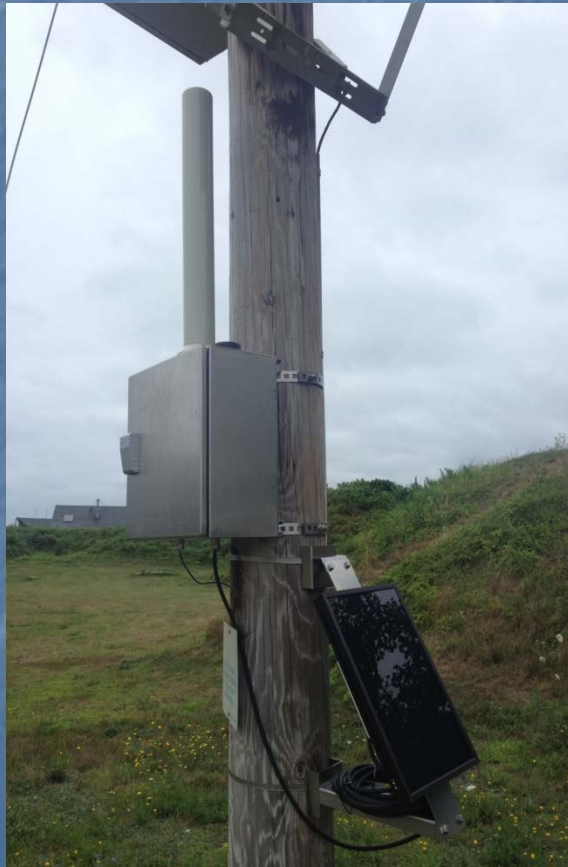
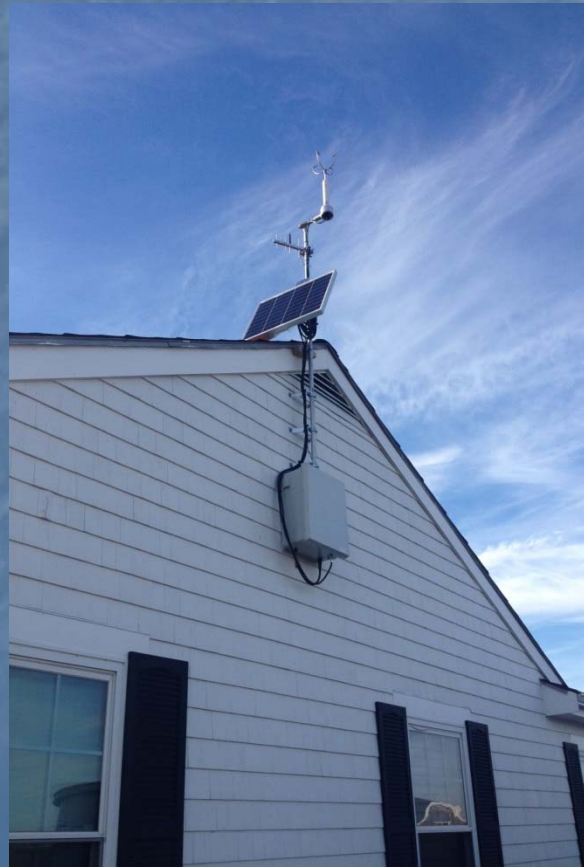
- Real-time radiation monitor system has been enhanced with state-of-the-art anemometers (wind speed and direction sensors) that are solar powered and transmit data wirelessly to a central computer
- MDPH consulted with experts to ensure anemometers were placed at optimal locations designed to take the sea breeze effects into account:
 - Plymouth Waterfront
 - Gurnet Point
 - Old Colony Place
 - Duxbury
- Continuous wind speed and direction data are being logged at 1 minute, 10 minute, and hourly intervals and transmitted to a central location remotely accessible by MDPH staff like the radiation data

- Real-Time radiation monitor and anemometer at Gurnet Point:

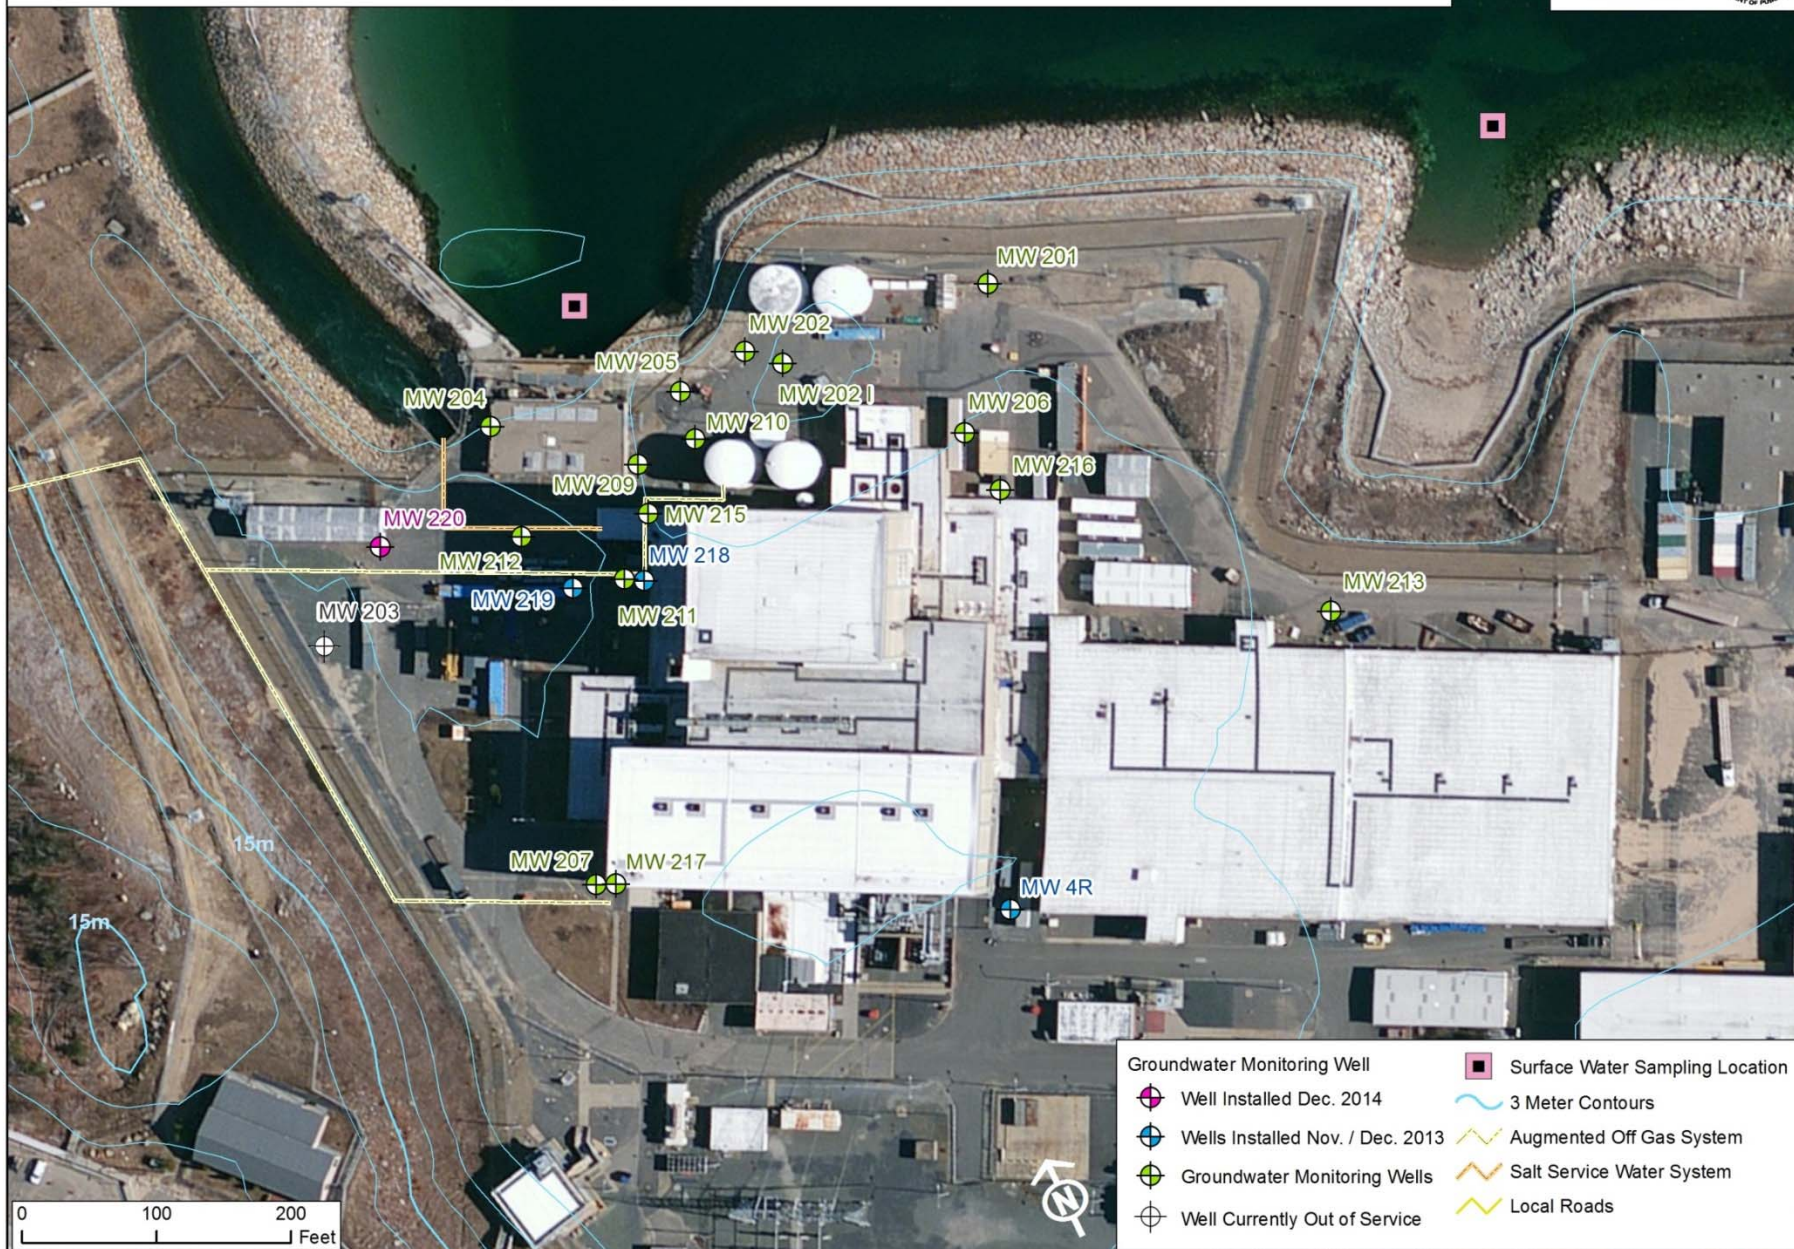
Approximate Locations of Groundwater Monitoring Wells & Surface Water Samples - Focused Area Pilgrim Nuclear Power Station - Plymouth, MA

- Since September 2010, MDPH has provided regular updates on the on-going tritium investigation, which has resulted in the installation of additional groundwater monitoring wells to evaluate specific sources of interest, bringing the current total to 23
- Regular updates and data collected to date can be found on MDPH's website:
http://www.mass.gov/dph/environmental_health
- No offsite impacts from tritium in the groundwater have been detected offsite from PNPS

- MW-219 (west side) installed December 2013
 - Elevated tritium detected following discharges to catch basin (CB) 10 in December 2013
 - The suspected tritium source for MW-219 is CB 10, located along the permitted neutralization sump discharge pathway
 - This is consistent with tritium detections downgradient, on the west side of the reactor building (MW-205, MW209, MW211, MW-215)
- Inspection, investigation and cleaning of CB10 completed in Fall 2014
- To date, tritium detections have followed a decreasing trend
 - 2015 results are all below NRC reporting level of 3,000 pCi/L

- MW-218 (west side) installed November 2013
- The suspected source for MW-218 is residual tritium contamination from the break in the neutralization sump discharge line identified in 2013
 - Pipeline extended from the reactor building to CB 10 and taken out of service in Spring 2013
 - Consistent with tritium levels in downgradient wells on the west side of the reactor building (MW-205, MW-209, MW-211, MW-215)
- 2015 weekly results range from 1,210 pCi/L to 4,247 pCi/L

- MW-216 (east side) installed September 2012: Well is up gradient of MW-206 and MW-201
- 2015 weekly results range from 472 pCi/L to 3,572 pCi/L
- Theories under investigation:
 - Catch Basins / Roof Drains
 - Historic Spills
 - Seismic Gaps
- Cyclical fluctuations of tritium observed with higher levels detected during October and early November
