INDOOR AIR QUALITY ASSESSMENT

**Robert G. O'Donnell Middle School
212 Cushing Street
Stoughton, Massachusetts 02072**

Prepared by:
Massachusetts Department of Public Health
Center for Environmental Health
Emergency Response/Indoor Air Quality Program
January 2007

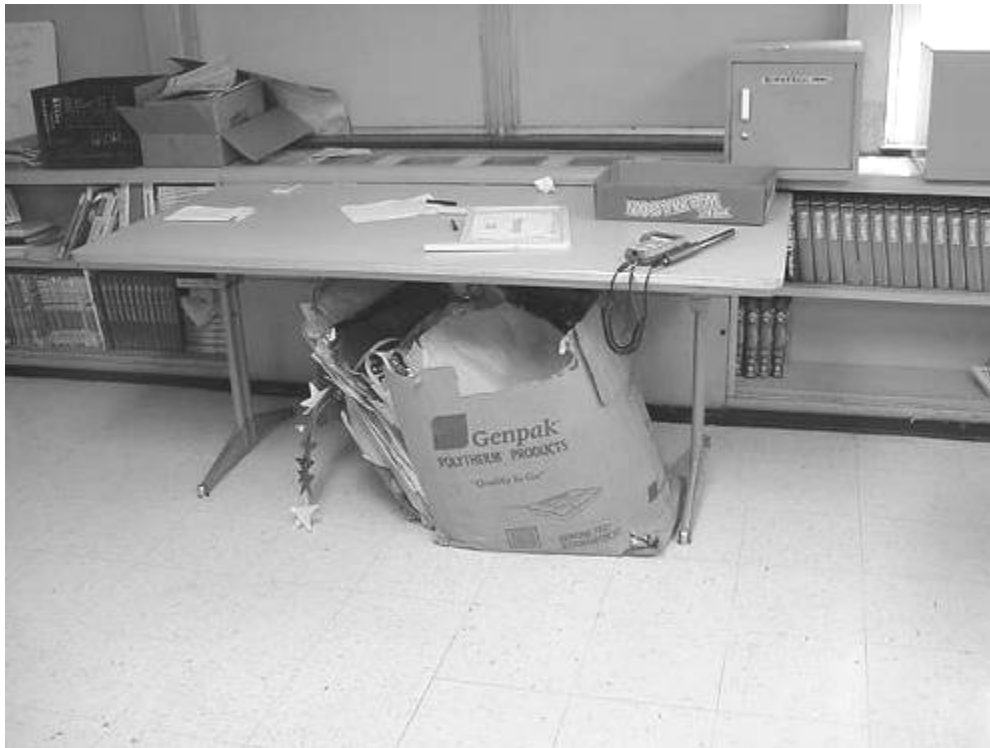
Picture 1

It can be seen from the Table 1 that carbon dioxide levels were above 800 parts per million (ppm) in twenty-one of fifty-seven areas surveyed, indicating a lack of adequate air exchange in those areas. Fresh air in classrooms is supplied by unit ventilator (univent) systems ([Figure 1](#)). A univent draws air from the outdoors through a fresh air intake located on the exterior wall of the building and returns air through an air intake located at the base of the unit. Fresh and return air are mixed, filtered, heated and provided to classrooms through an air diffuser located in the top of the unit. Adjustable louvers control the ratio of outside to recirculated air. Univents were found deactivated in some rooms (Table 1). Obstructions to airflow, such as items stored on or in front of univents were seen in a number of areas (Picture

1). In order for univents to provide fresh air as designed, units must be activated while rooms are occupied and air diffusers should remain free of obstructions.

Classroom Items Obstructing Univent Return Vent (Bottom Front of Unit)

5. Remove all blockages from univents and exhaust vents to ensure adequate airflow.
6. Close classroom doors to improve air exchange.

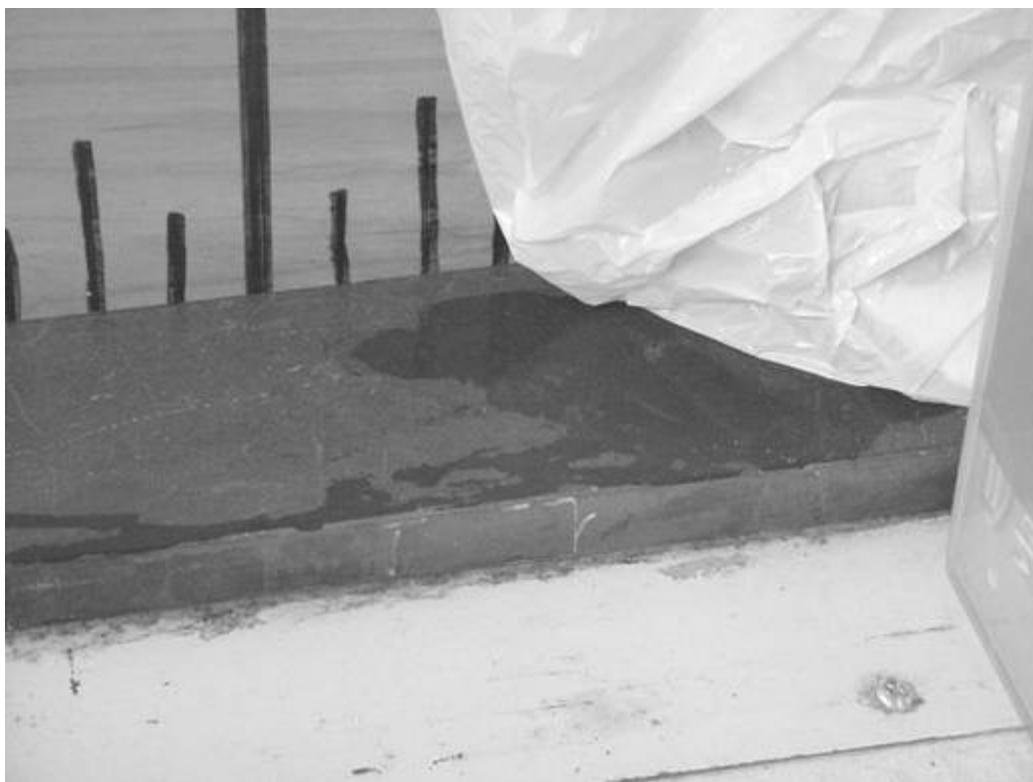
Picture 4

Occupants did however report window leaks in rooms 205, 206 and 210. In rooms 206 and 210 occupants were storing porous items in the general areas of window leaks and they had become water damaged (Pictures 3 and 4). Water-damaged porous materials can serve as a medium for mold and should be discarded or relocated *away* from moisture sources.

Standing Water on Windowsill Room 206

9. Work with school staff to identify window leaks and make repairs to prevent further water infiltration.
10. Do not store porous items (boxes, papers, books, etc.) in areas of suspected water leaks.

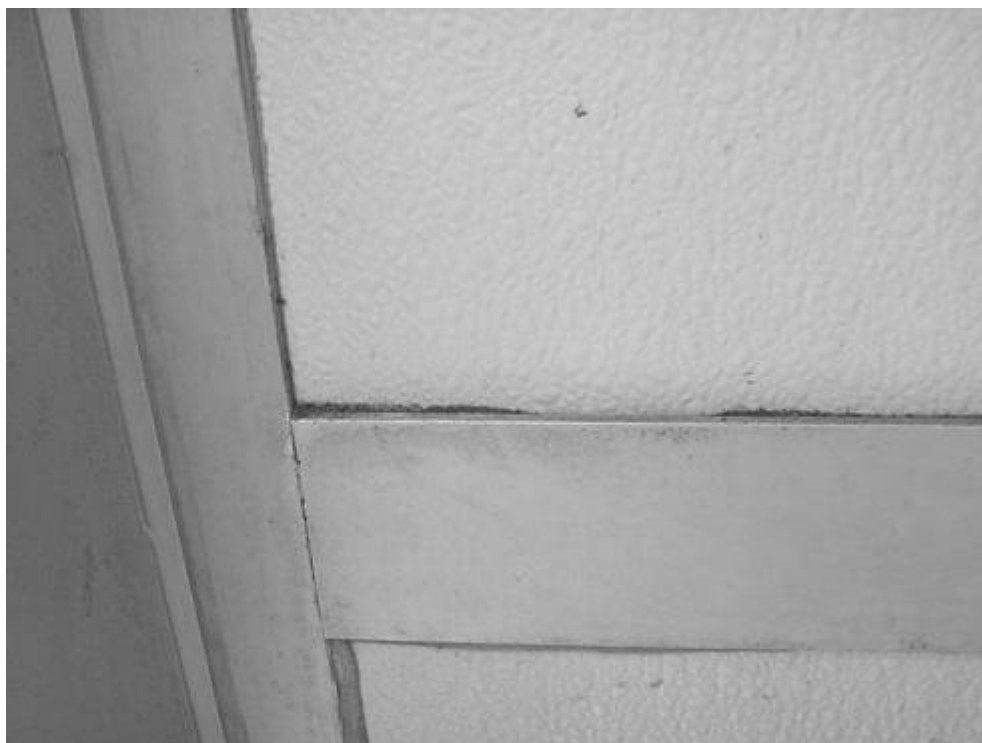
Picture 5

Occupants in several classrooms had concerns about a mold growth around interior window panels. These panels were recently sealed by the SPS maintenance department using a gel-like caulking material. CEH staff examined these window panels and found that the sealant had a tacky texture, as a result airborne dirt and dust had become adhered to the surface of the sealant (Picture 5).

Black Dust/Debris Adhered to Sealant around Window Frames in Rooms 118 & 119

11. Continue to remove/replace water damaged ceiling tiles. Make repairs to “bowed” ceiling tile systems in classrooms 104 and 105.
12. Clean black debris on window sealant in classrooms 118 and 119.

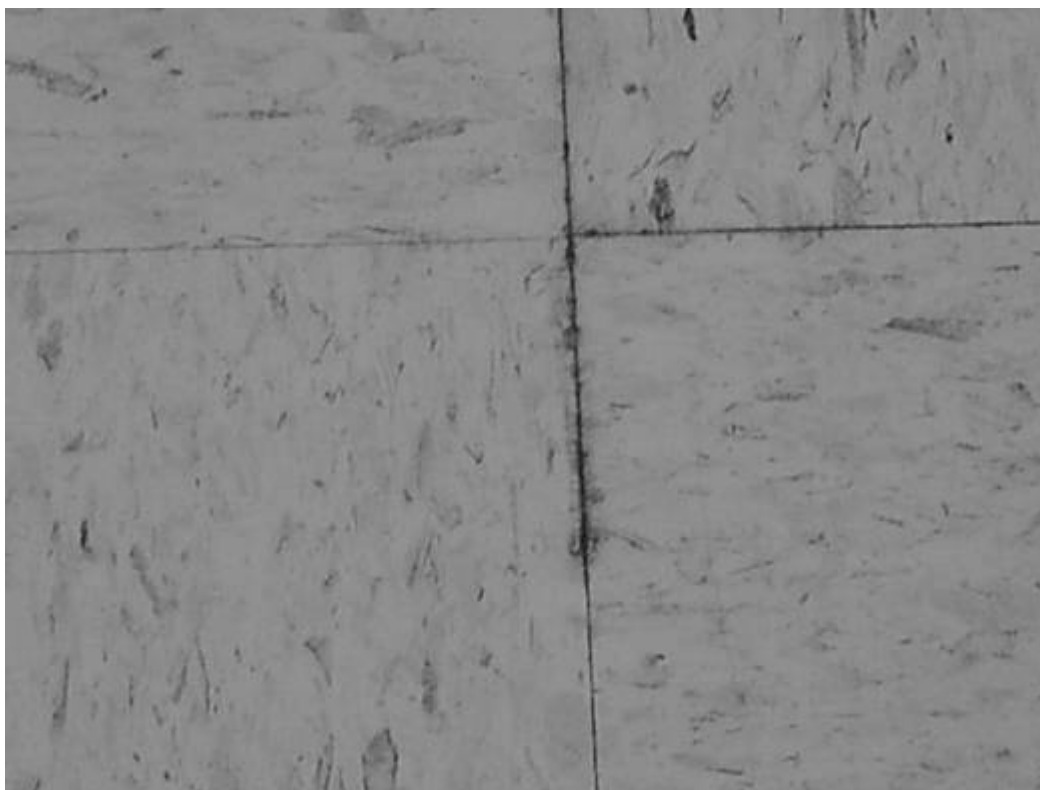
Picture 6

Occupant in rooms 104 and 105 had concerns of stained floor tiles believed to be possible mold growth. CEH staff examined tiles in these rooms and observed a gum-like substance (Picture 6). The material appeared to be mastic/glue that had seeped around tiles.

Gum-Like Material (Mastic) around Floor Tiles in Rooms 104 and 105 I

13. Clean gum-like/mastic substance around floor tiles in rooms 104 and 105 with a mild detergent. If continued accumulation/damage to floor tiles in the building recurs, consideration should be given to contacting a reputable flooring contractor to remove/replace old tiles and mastic. Slab should be completely cleaned, prepped and sealed using a proper sealant.

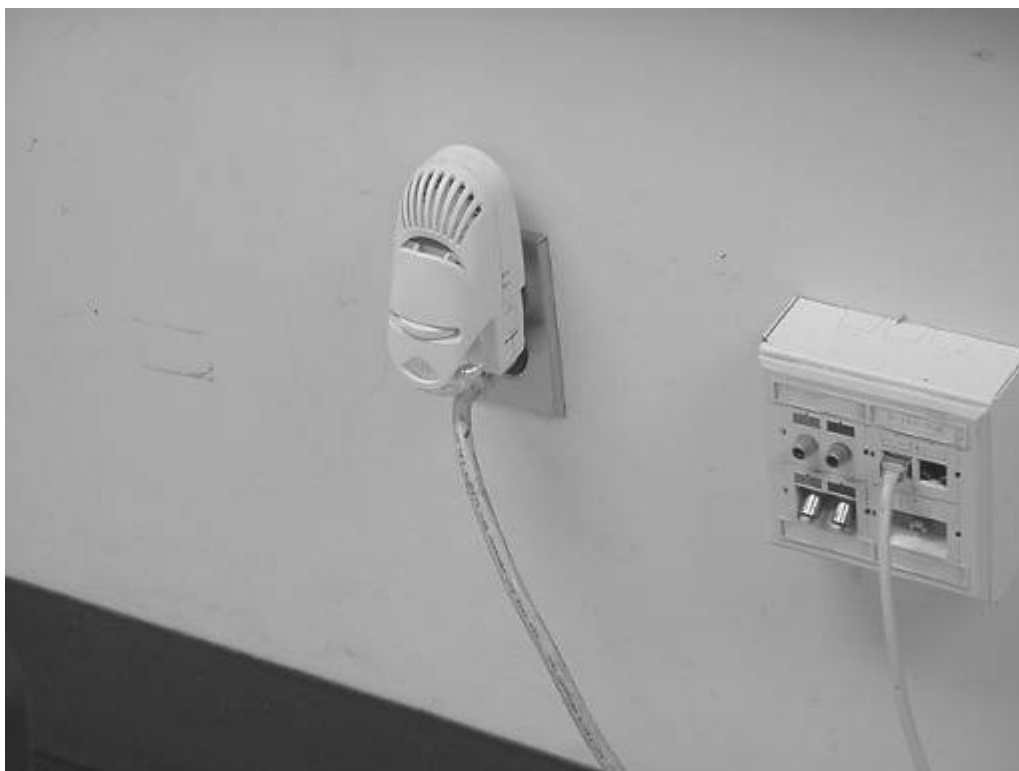
Picture 7

Several classrooms had plug-in type air fresheners (Picture 7). Air fresheners contain chemicals that can be irritating to the eyes, nose and throat of sensitive individuals. Furthermore, air fresheners do not remove materials causing odors, but rather mask odors that may be present in the area.

Plug-In Air Freshener in Classroom

17. Clean chalkboards and dry erase board trays regularly to avoid the build-up of particulates.
18. Refrain from using strongly scented materials (e.g., air fresheners) in classrooms.

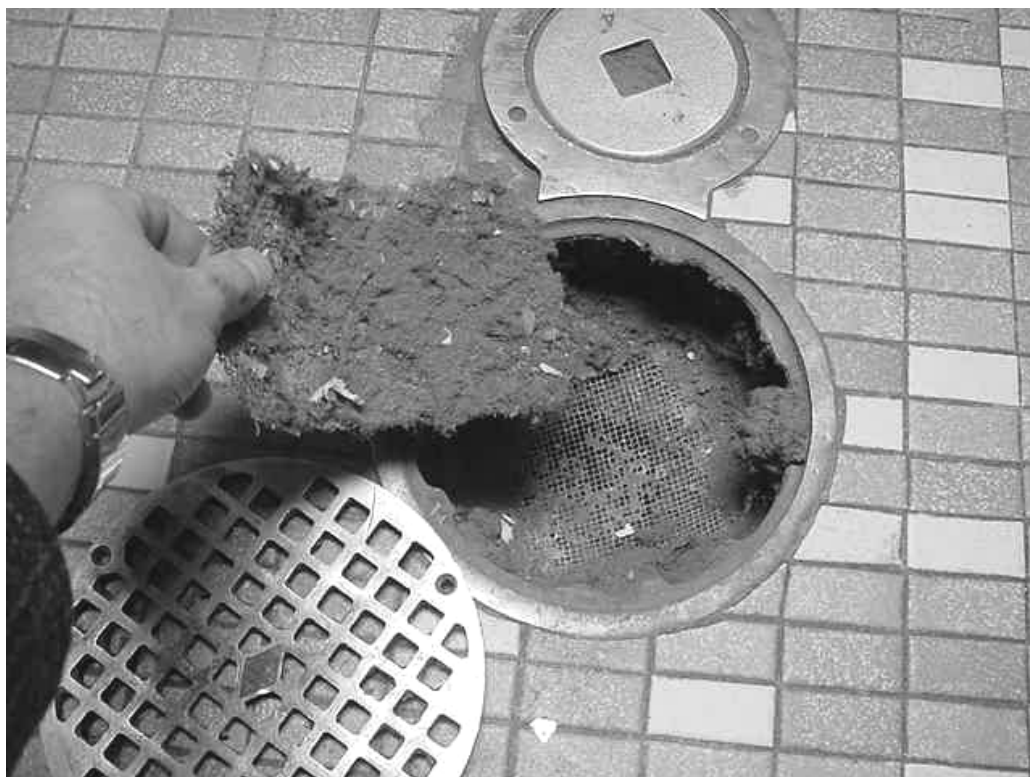
Picture 9

Finally periodic sewer gas odors were reported by occupants in room S17. The room formally served as a locker/restroom and contains a floor drain that was clogged with debris (Picture 9). Drains are usually designed with traps in order to prevent sewer odors/gases from penetrating into occupied spaces. When water enters a drain, the trap fills and forms a watertight seal. Without a periodic input of water (e.g., every other day), traps can dry, breaking the watertight seal. Without a watertight seal, odors or other material can travel up the drain and enter the occupied space.

Accumulated Debris in Floor Drain of Room S17

19. Seal the floor drain in room S17 or ensure water is poured into the drains every other day (or as needed) to maintain the integrity of the traps.
20. Conduct lawn mowing activities that are in close proximity to the building during unoccupied periods to prevent the entrainment of odors, particulates and other products of combustion.

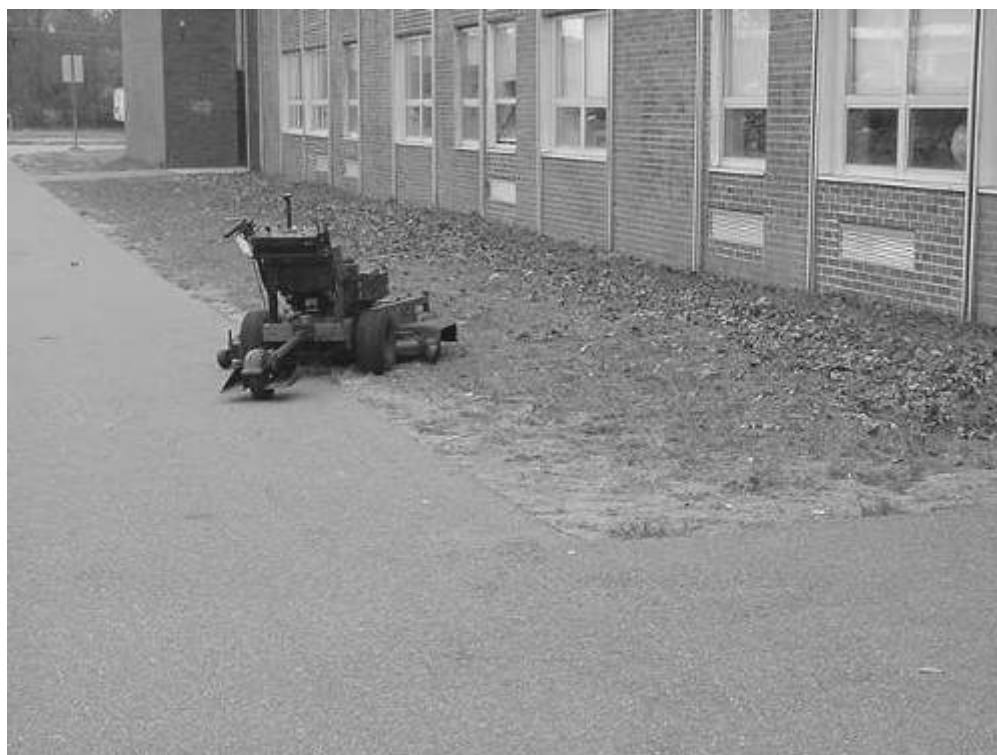
Picture 10

Finally, a running lawnmower was observed unattended outside the building located in close proximity to univent air intakes/open windows during the school day (Picture 10). Gas-powered lawn equipment can give off carbon monoxide, particulates and other products of combustion that can be a source of respiratory irritation. Activities such as these in close proximity to the building should be conducted during unoccupied periods.

Unattended Lawnmower Operating in Close Proximity to Univent Air Intakes During School Hours
