**Orange District Court  
Orange, MA**

# **HVAC SYSTEM EVALUATIONS COVID-19**

Office of Court Management

July 18, 2022

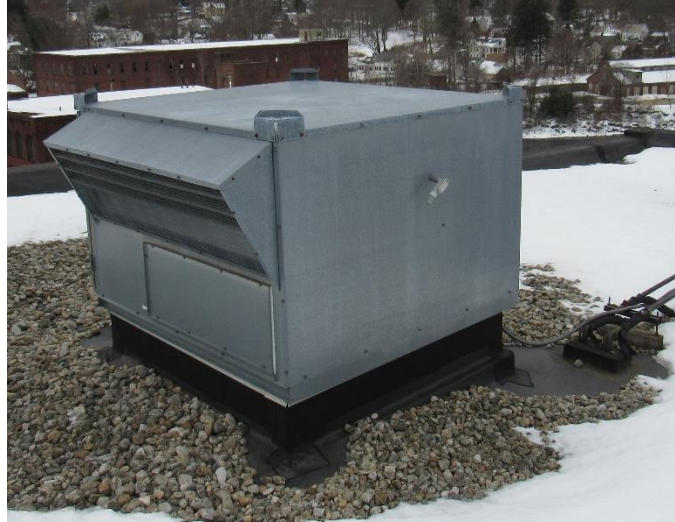
Photo 1 – Typical ERV

Two rooftop energy recovery ventilators (ERV's) provide all ventilation air to, and all exhaust air from the building. Each ERV unit serves roughly half of the building. The units contain 2" MERV 10 supply and exhaust filters, a supply fan, exhaust fan, and a total energy recovery (enthalpy) heat exchanger core. The south ERV unit is not operational, as the heat exchanger is damaged from a failed belt. Damage to other sections of the heat exchanger from previous belt failures was also visible, and it appeared that the three sections had been repositioned over time. Aside from the damaged heat exchanger in the south ERV, the units are in fair condition. According to the Owner, parts were on order to repair the damaged unit. A DX cooling coil and a hot water coil are located in the downstream supply air ducts to keep the outdoor air within a comfortable temperature range. According to the technician, the hot water coil serving the north ERV had burst as a result of freezing and was not operable.

As the ERV's are the sole source of outdoor air and ventilation to the building, it is important that these are well maintained. The damaged heat exchanger cores in the south ERV should be replaced. As it appears that belt failures have caused repeated damage to the cores, the pulleys should be carefully aligned, and fixed sheaves should be installed. If a root cause to the belt failures cannot be identified, consider installing a metal belt guard to prevent future damage to the cores.

The hot water coil in the north ERV supply duct should also be replaced or repaired. Ensure the freeze stat for the coil is in place and operational.

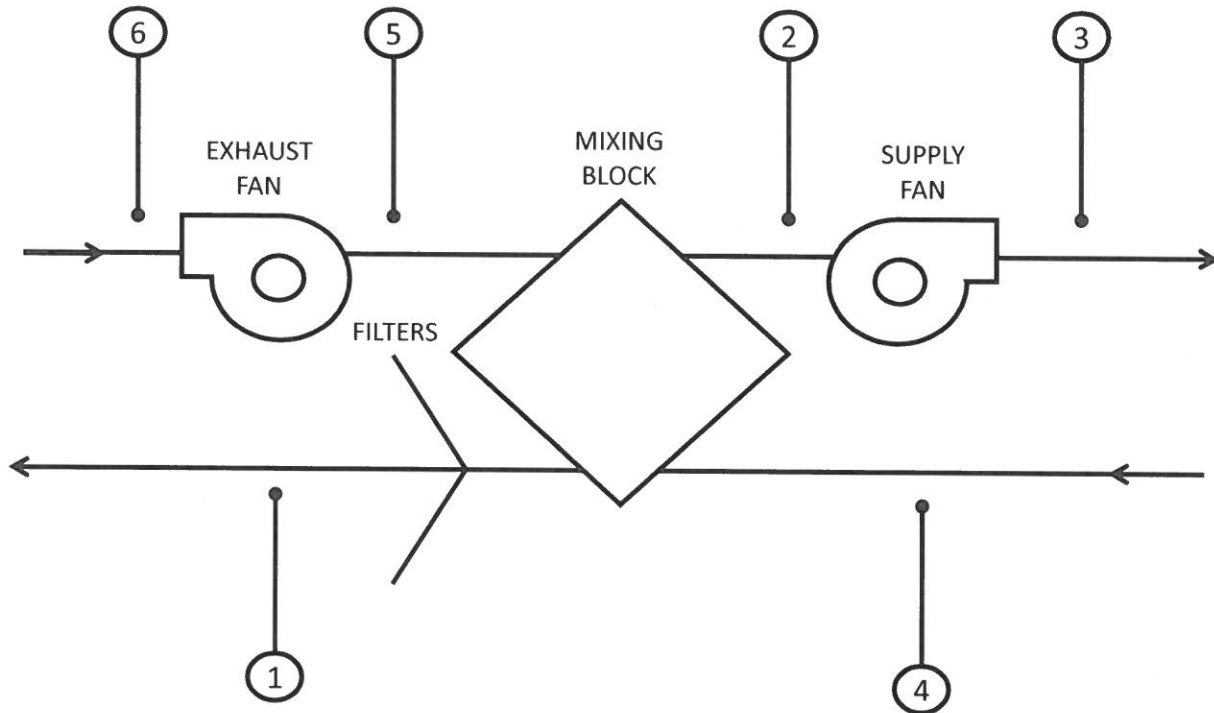
**SYSTEM STATIC PRESSURE PROFILE****PROJECT:** Orange District Court**DATE:** 4/4/22**SYSTEM/AREA:** ERVs**TECH:** BS

UNIT	1	2	3	4	5	6	7	8	NOTES
ERV-N Supply	-0.21"	-0.67"	+0.61"						
ERV-N Exhaust	-0.24"	-0.75"	+0.70"						
ERV-S Supply	-0.14"	-0.55"	+0.51"						
ERV-S Exhaust	-0.36"	-0.83"	+0.91"

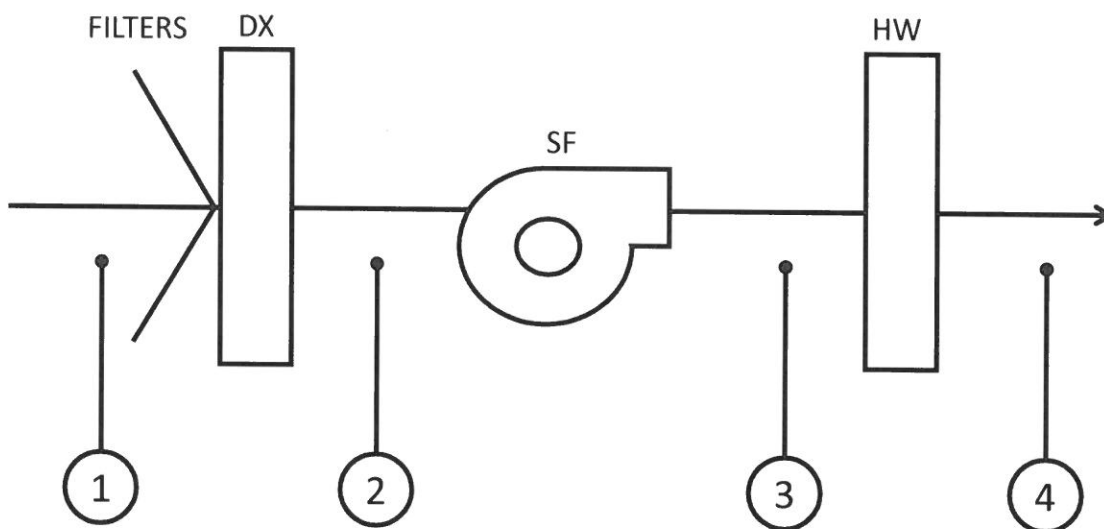
**SYSTEM STATIC PRESSURE PROFILE****PROJECT:** Orange District Court**DATE:** 4/7/22**SYSTEM/AREA:** FCUs**TECH:** BS

UNIT	1	2	3	4	5	6	7	8	NOTES
FCU-1	-0.16"	-0.65"	+0.44	+0.35"					
FCU-2	-0.05"	-0.59"	+0.26"	+0.21"					
FCU-3	-0.14"	-0.49"	+0.48"	+0.41"					
FCU-4	-0.18"	-0.59"	+0.37"	+0.27"					
FCU-5	-0.09"	-0.37"	+0.51"	+0.42"					
FCU-6	-0.21"	-0.48"	+0.44"	+0.35"					
FCU-7	-0.13"	-0.60"	+0.51"	+0.43"					
FCU-8	-0.11"	-0.76"	+0.44"	+0.32"					
FCU-10	-0.22"	-0.39"	+0.31"	+0.26"					
FCU-11	-0.36"	-0.79"	+0.31"	+0.18"
