# Ponkapoag Pond Master Plan

Canton & Randolph, MA

### PART TWO EXISTING CONDITIONS ASSESSMENT

### PART THREE RECOMMENDATIONS AND OPPORTUNITIES

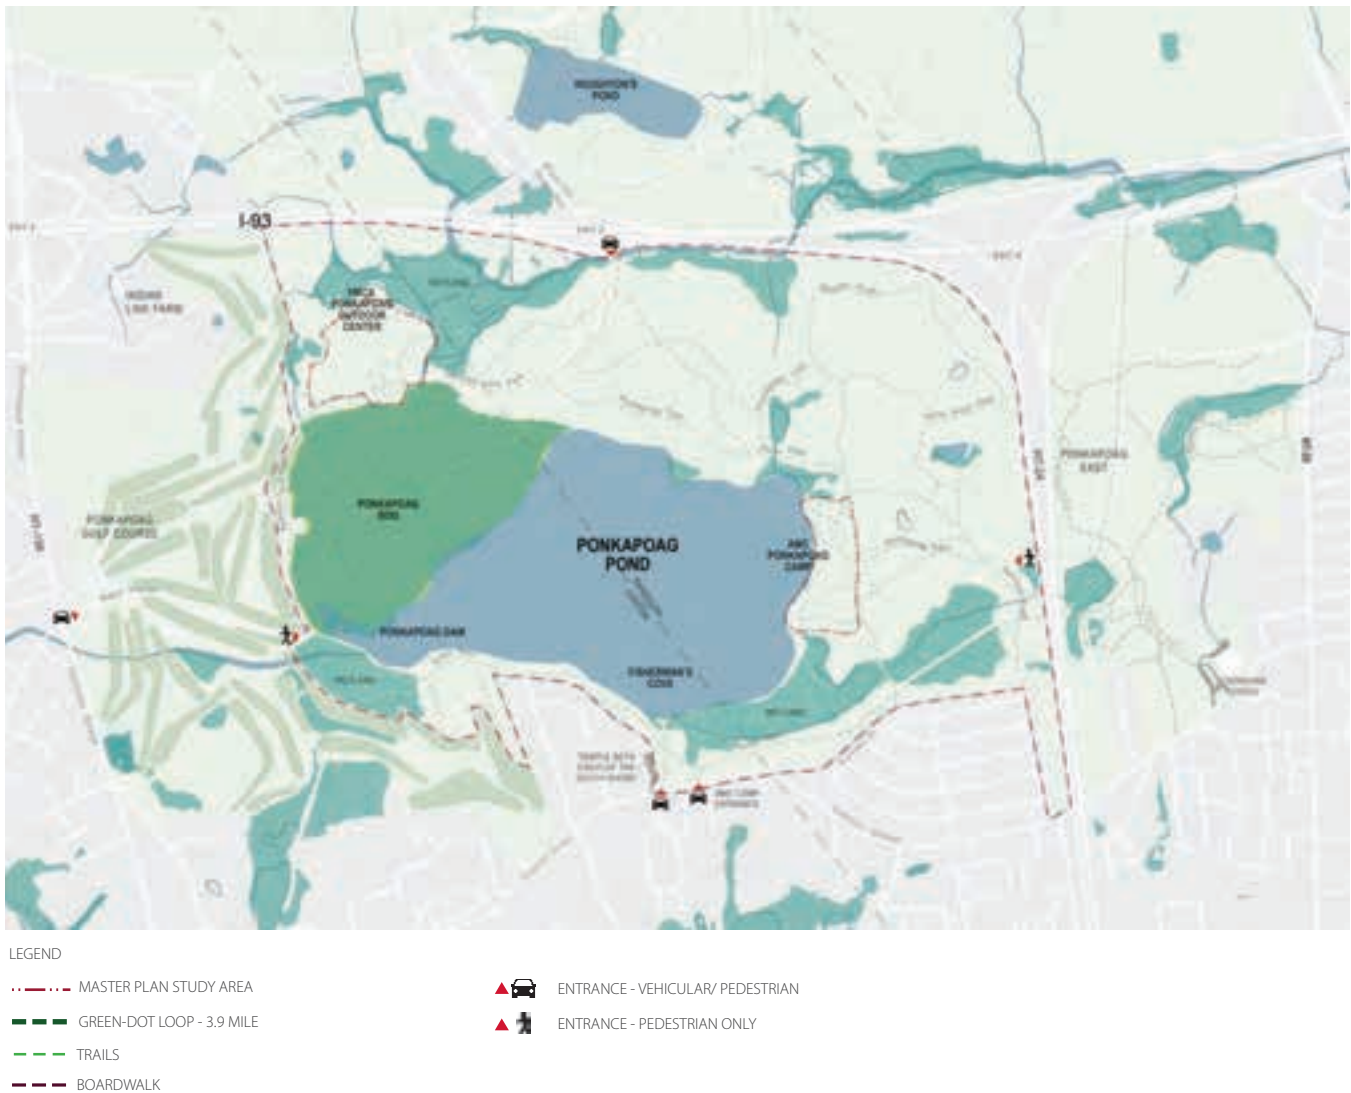
Figure 1-6. Ponkapoag Pond Master Plan Study Area

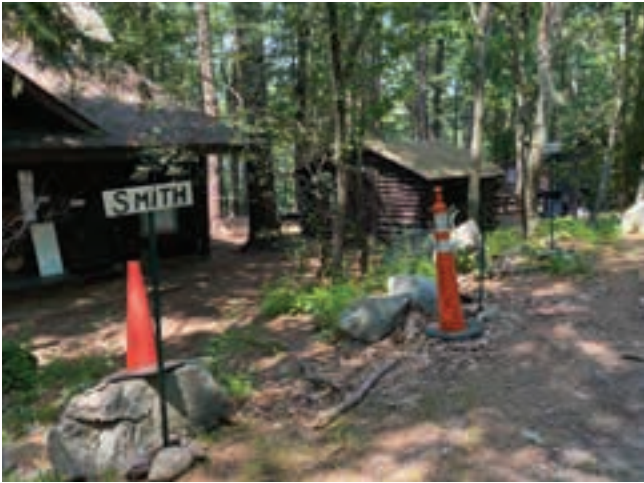
Figure 2-15. AMC permit parking lot in front of the lodge

**6. AMC Ponkapoag Camp Permitted Parking Lot:** AMC Ponkapoag Camp located internally on the east side of the pond has a total of 30 parking spaces limited to registered campers and staff parking only. Parking resources include a small parking area adjacent to the lodge and restrooms, several spaces adjacent to cabins and a day-use parking lot providing parking spaces for cabin and tent users. The day use parking lot location is an aggregate surface which interrupts the Green Dot Loop and is located on a slope resulting in erosion gullying and sediment runoff to adjacent natural areas.

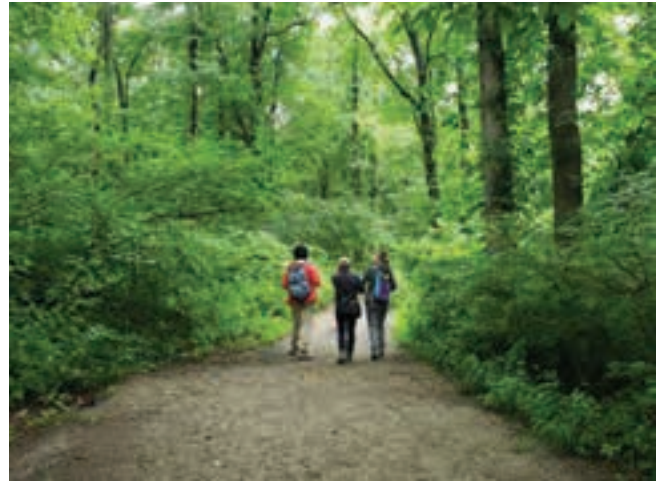
**Figure 2-17.** General characteristics of Green Dot Trail at the southbound.

The Green Dot Loop trail is relatively level (slope is less than 5%) consisting of a compacted gravel surface along the south and west of the pond (see Figure 2-22, PT-1 clockwise to PT-2). The trail meanders along wetland edges and wooded areas in close proximity to residential neighborhoods, as well as between the golf course and Ponkapoag Bog. The westerly trail is routed east of the golf course and then crosses through the middle of the fairway at Course 2 hole #3. At this section, conflicting uses between golfers and trail users frequently result in unsafe situations.

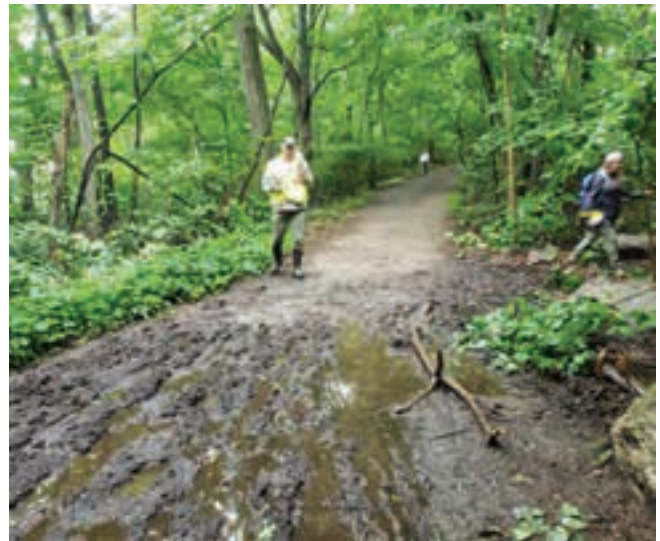
**Figure 2-18.** Green Dot Trail with drainage problems

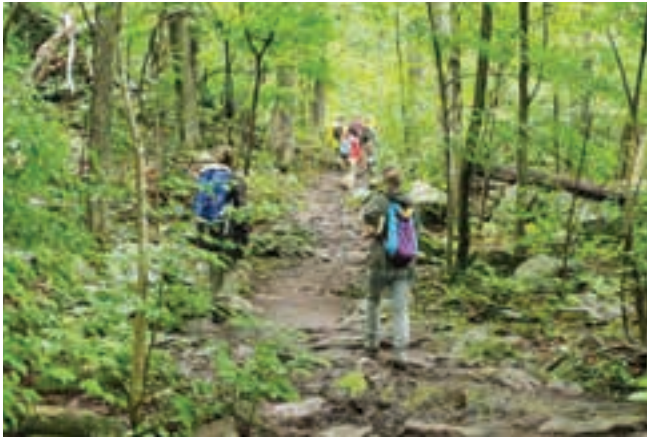
**Figure 2-20.** General characteristics of Green Dot Trail at the northbound.

The terrain rises 90 feet above water level as the trail progresses northeast of the pond (see Figure 2-22, PT-2 clockwise to PT-1) where the Green Dot Loop trail narrows through hilly natural terrain that results in a series of topographic changes consisting of steep slopes. The trail surface is compacted native soils consisting of large aggregate. While the natural terrain and trail surfacing make accessibility challenging and impractical, this section of trail presents a unique upland forest walking/hiking experience compared to the flatter portions of the trail bordered by wetlands to the south.

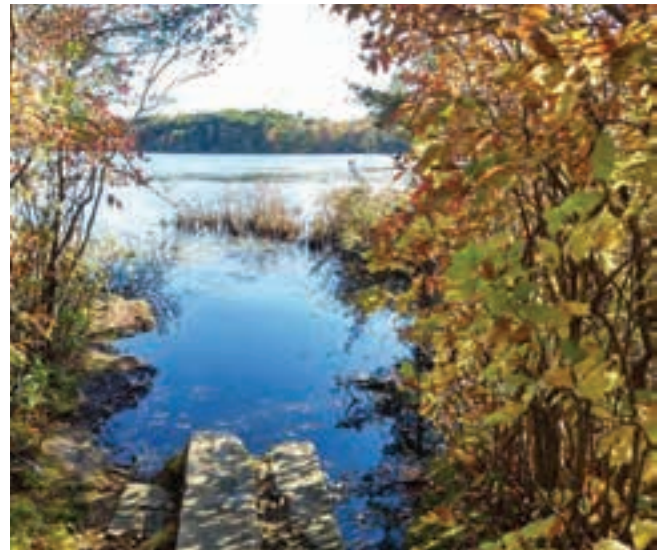
Figure 2-24. View at the end of Ponkapoag Bog boardwalk

The current boardwalk, approximately 2,000 feet long, winds through small islands of cedars and skunk cabbage on the bog's floating mat of sphagnum moss and emerges at the open water of the pond. The boardwalk is seasonally submerged below the water surface and is not passable without water gear. Typically, boardwalk users are able to walk the first half of the boardwalk and beyond that requires waterproof boots or hip waders.

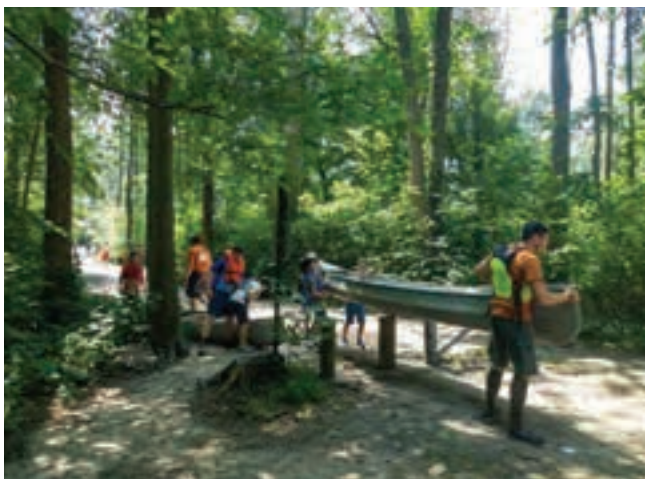
Figure 2-27. Deficient boat loading/ unloading at the gate

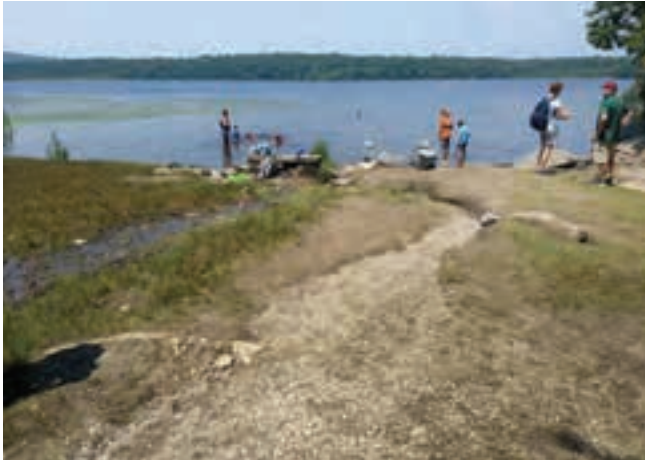
**Figure 2-29.** Rutting and erosion along the path all the way down to the water at Fisherman's Cove

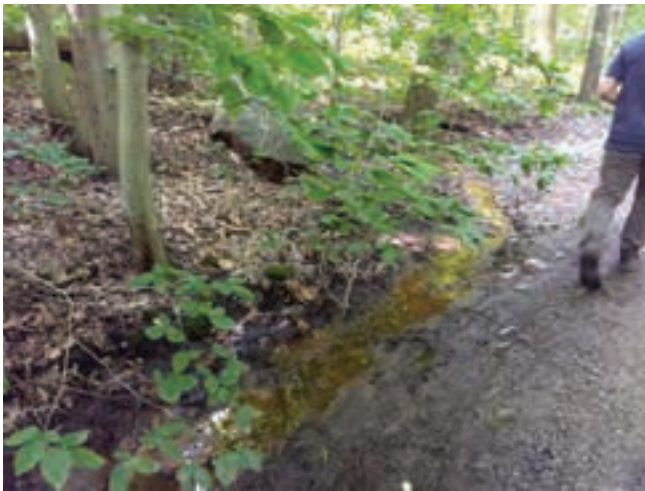
**Figure 2-30.** Pockets of ponding along the Green Dot Loop trail

Multiple segments of the Green Dot Loop are adversely affected by poor drainage resulting in muddy/wet path conditions that diminish accessibility and usability. As trail users traverse off the trail to avoid wet areas, they widen the trail resulting in loss of vegetation, habitat alteration and soil compaction. Erosion also degrades water quality of the pond and adjacent wetlands. In addition, nitrification from stormwater runoff and pollutants from the developed neighborhood and golf course represent a threat to the sensitive wetland and bog ecosystem.

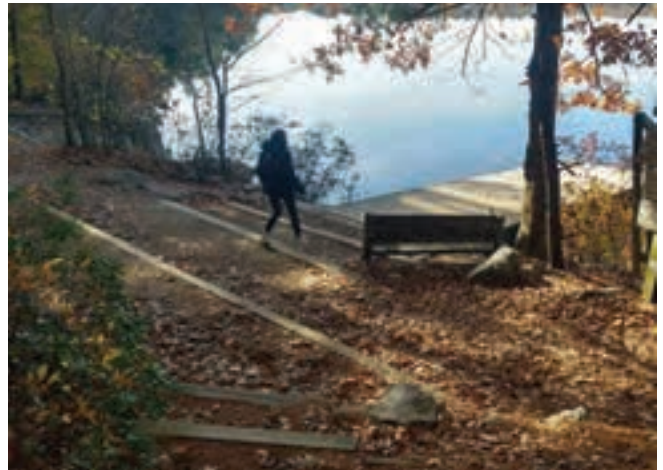
**Figure 2-37.** Stair and retaining wall at the swimming area

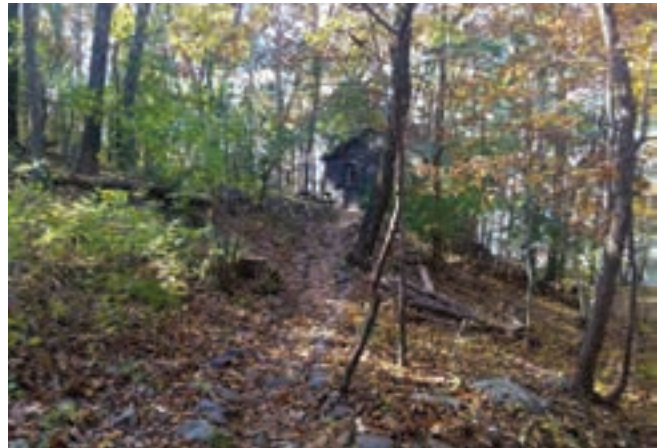
**Figure 2-38.** non- accessible path to a cabin

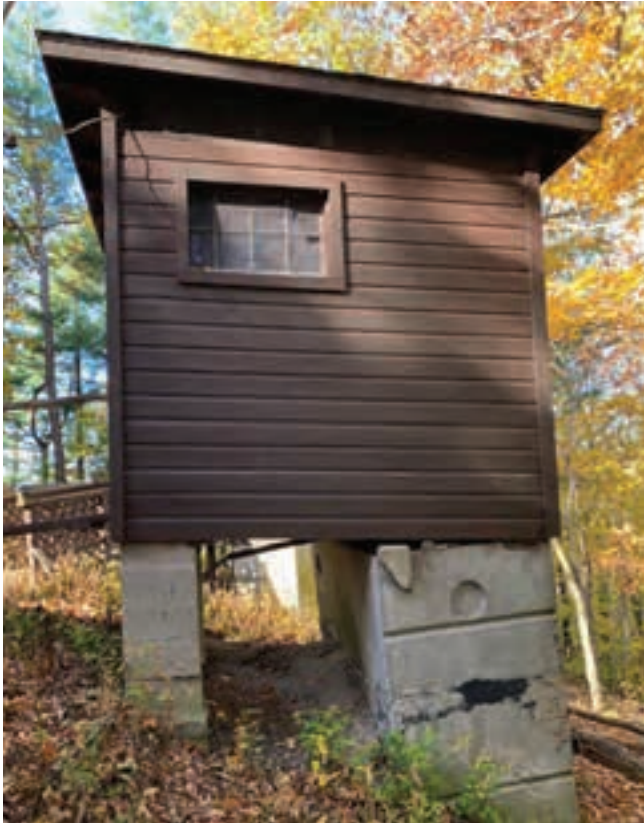
Figure 2-43. Uneven settlement of structural elements

The buildings all exhibit signs of structural failure, with uneven settlement visible at the existing septic tank base and CMU footing elements. Located along a steep slope, the surcharge of the hillside is slowly moving these foundation elements out of level. Existing settlement is significant enough to suggest that full building replacement may be a more cost-effective approach than stabilization and repair.

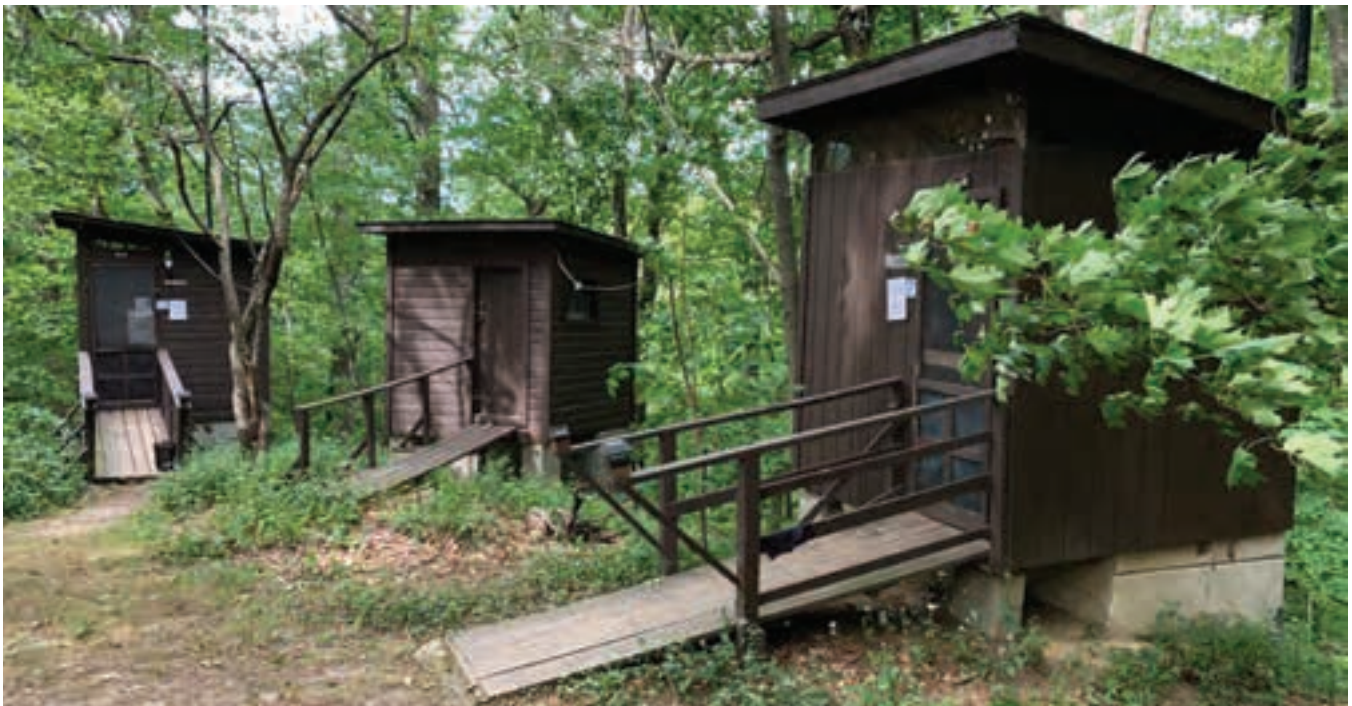
Figure 2-44. The Camp's restroom facilities, with men and women facilities at left and right and a storage shed is in the center.

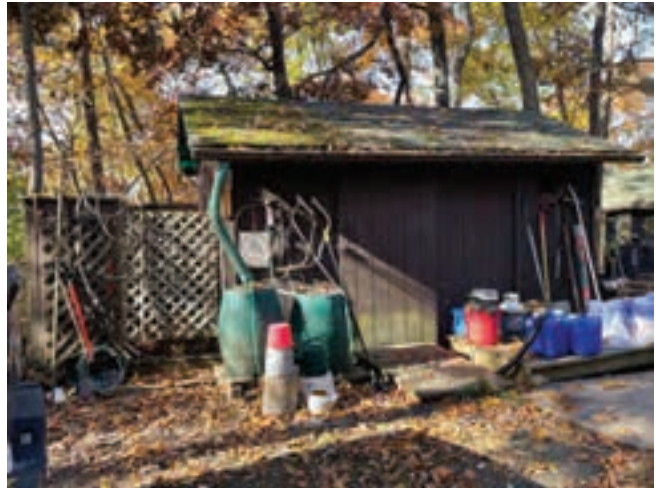
**Figure 2-45.** Sheldon Cabin's accessory storage shed showing cisterns for non-potable rainwater collection. Also shown are potable water jugs for drinking water and a propane tank used for heating/cooking.

Sheldon Cabin's current living conditions are rudimentary. A wood stove is the primary source of heat. A propane generator provides power for back-up heat and to run a refrigerator, a c. 1925 stove, a few lights, and a television. There is no running water and potable water jugs are used at the kitchen sink for general cleaning and dish washing. The cabin also has a chemical toilet. The exterior conditions of the cabin and shed are generally stable. There is evidence of localized wood rot and the shed's T-111 cladding needs to be replaced. On both structures, gutters, downspouts, and roofs are all approaching the end of their service lives.

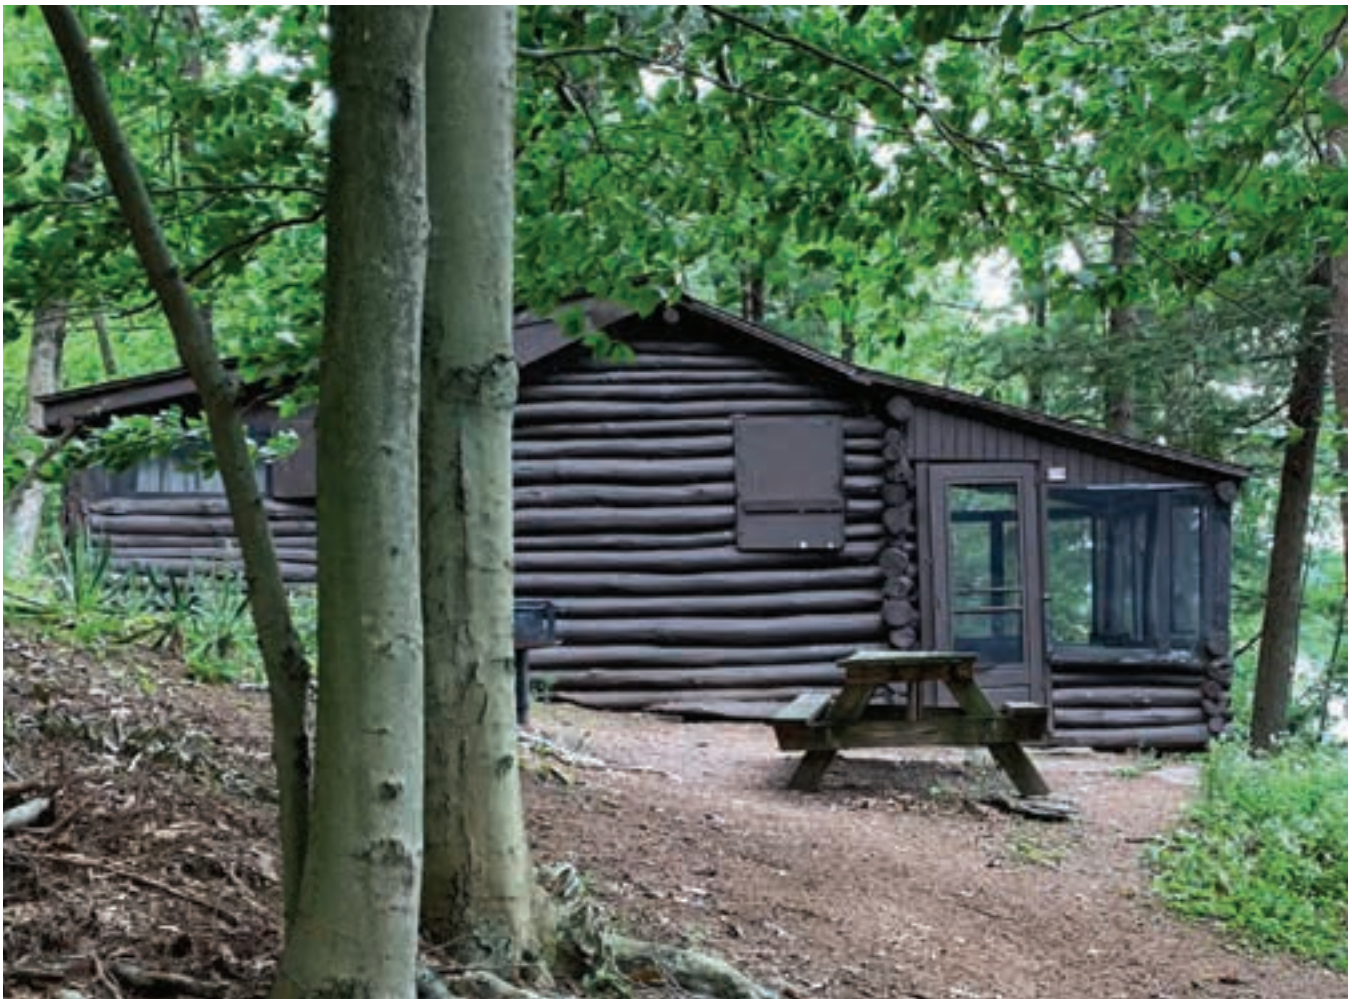
**Figure 2-48.** Folsom Cabin today

original form and materials to varying degrees. All three remaining cabins are in need of stabilization and repair. Of the three, Folsom shows the most significant signs of structural failure from insect infestation and moisture, most visible in the chestnut log structural elements. Damage to North and Spang's log structures appears to be less significant, although there are signs of similar deterioration. Original window and door elements as well as roofs, wall cladding, and trim are also in need of critical repair and restoration at all three cabins. A detailed assessment of original and replacement materials will be needed to determine best preservation strategies that follow the Secretary of the Interior's Standards for Preservation. This assessment should be paired with a near-term treatment and stabilization plan to prevent further degradation.

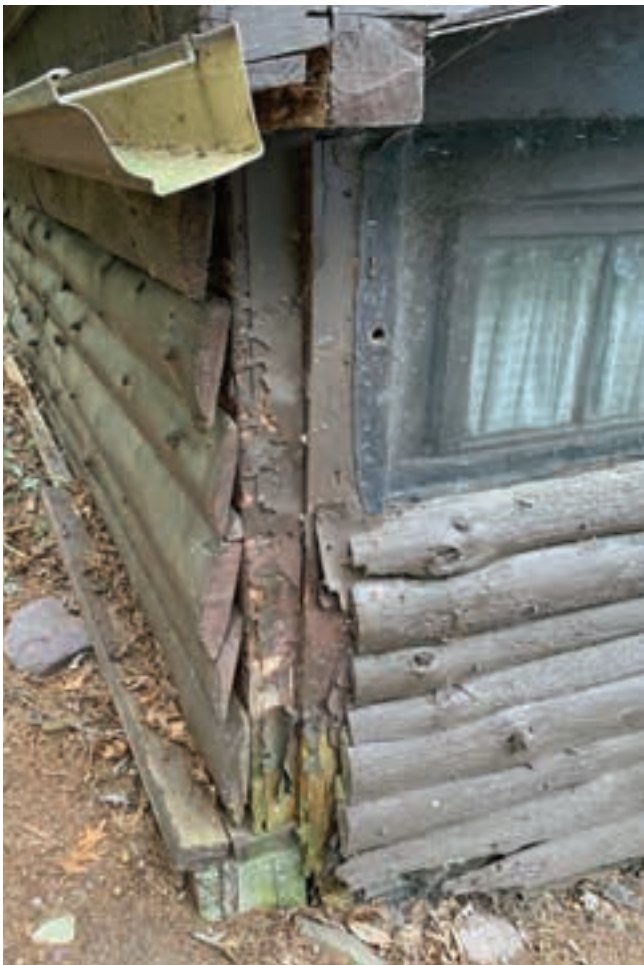
**Figure 2-49.** Folsom's signs of material degradation due to moisture and insect infestation.

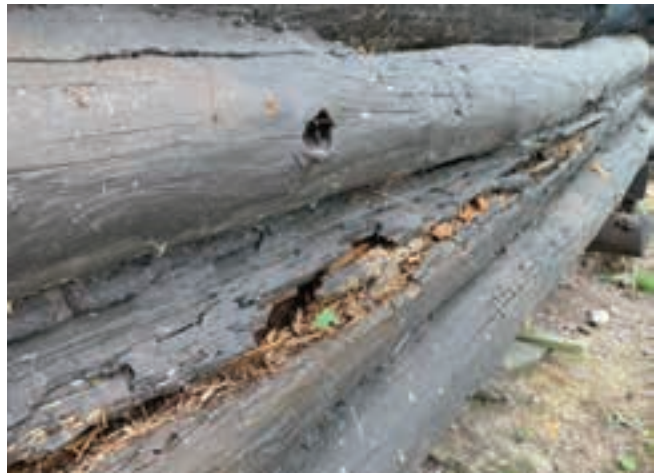
**Figure 2-50.** Evidence at Folsom of insect infestation within Chestnut logs

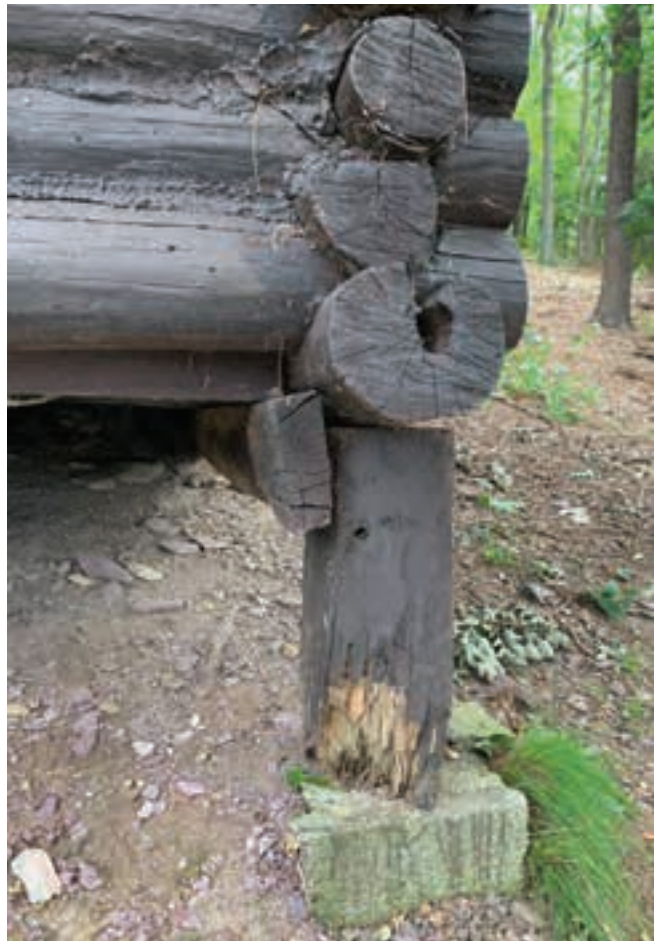
**Figure 2-51.** Structural degradation of Folsom cabin's support posts.

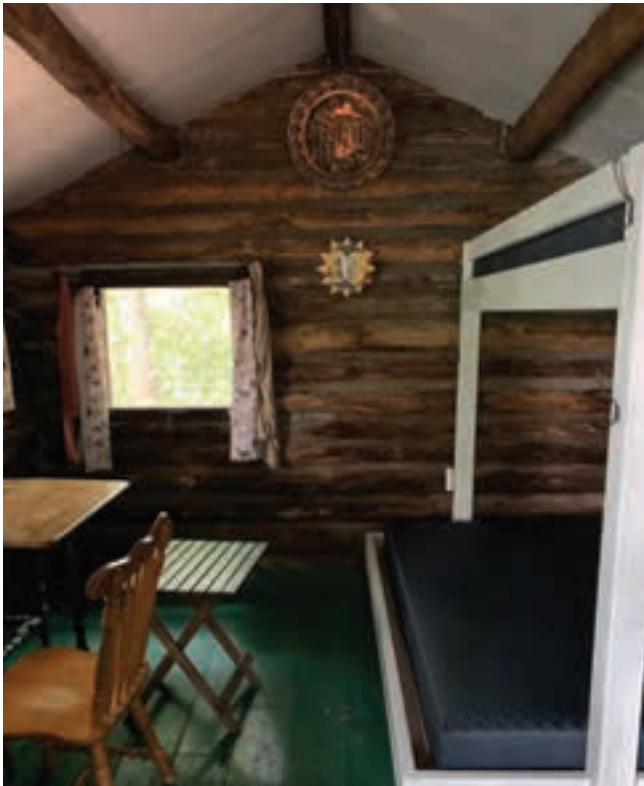
**Figure 2-52.** Spang's interior condition with exposed chestnut logs. Camp volunteers provide regular maintenance of the chinking between logs.

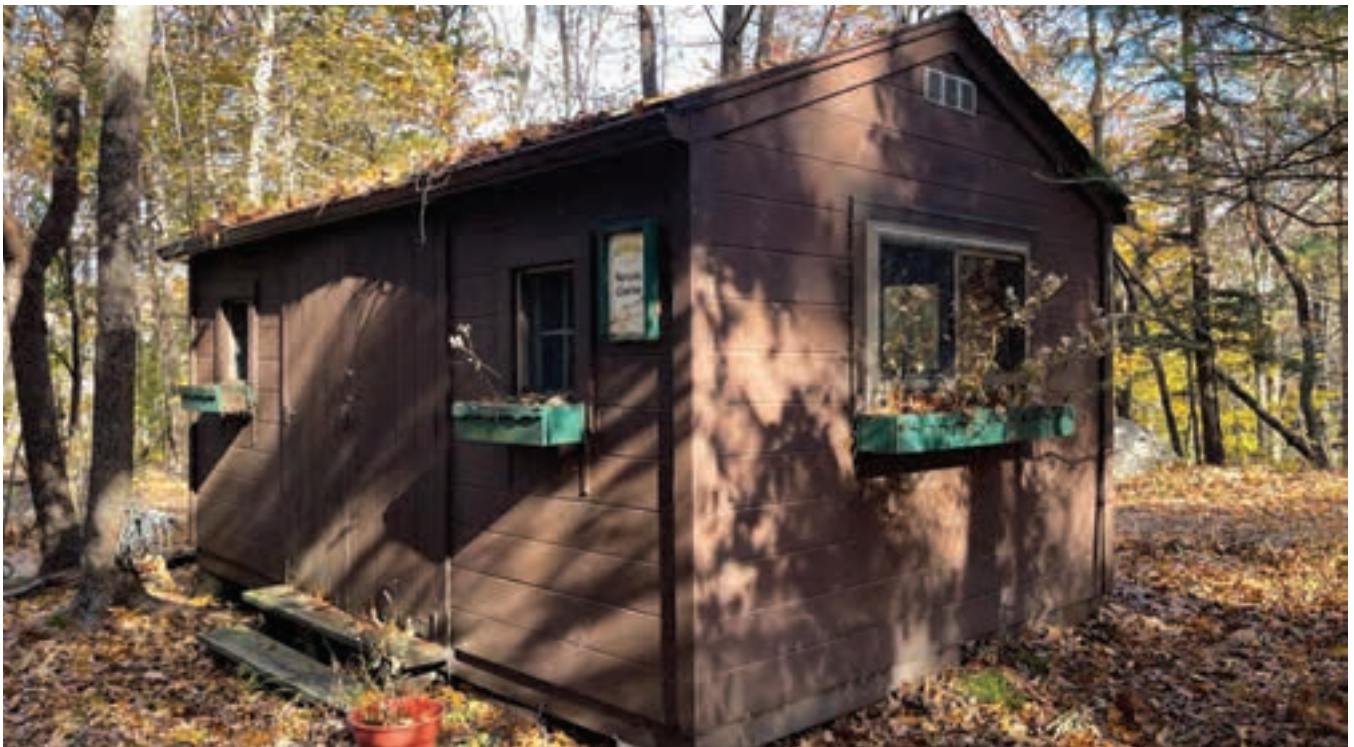
Figure 2-68. The Camp's Nature Center

The structure's asphalt roof and painted clapboard exterior are both generally in good condition, although there are signs of deferred maintenance. The double hinged entrance doors are both showing signs of rot at their base. The uninsulated building's interior is simple and rustic. There is no electricity or running water in the building. Existing thru-vents provide a minimal amount of air ventilation.

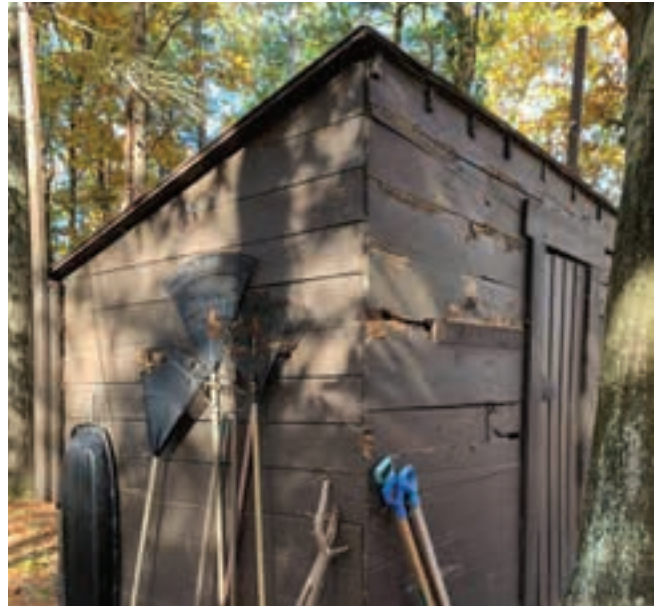
Figure 2-71. Signs of exterior deterioration

The AMC Ponkapoag Camp does have several small storage buildings interspersed throughout the camp. the largest structure is located near the Lodge and central picnic area and accommodates tools and equipment that are used to maintain the camp. Potentially dating back to the camp's earliest years, it is a single-story wood-clad structure that sits on a stone foundation. Its exterior is in poor condition with broken and rotting wood cladding and heavily warped and rotting access doors. Its roof shows deformity given years of movement and its rolled asphalt sheet roofing is also deteriorating on its edges.

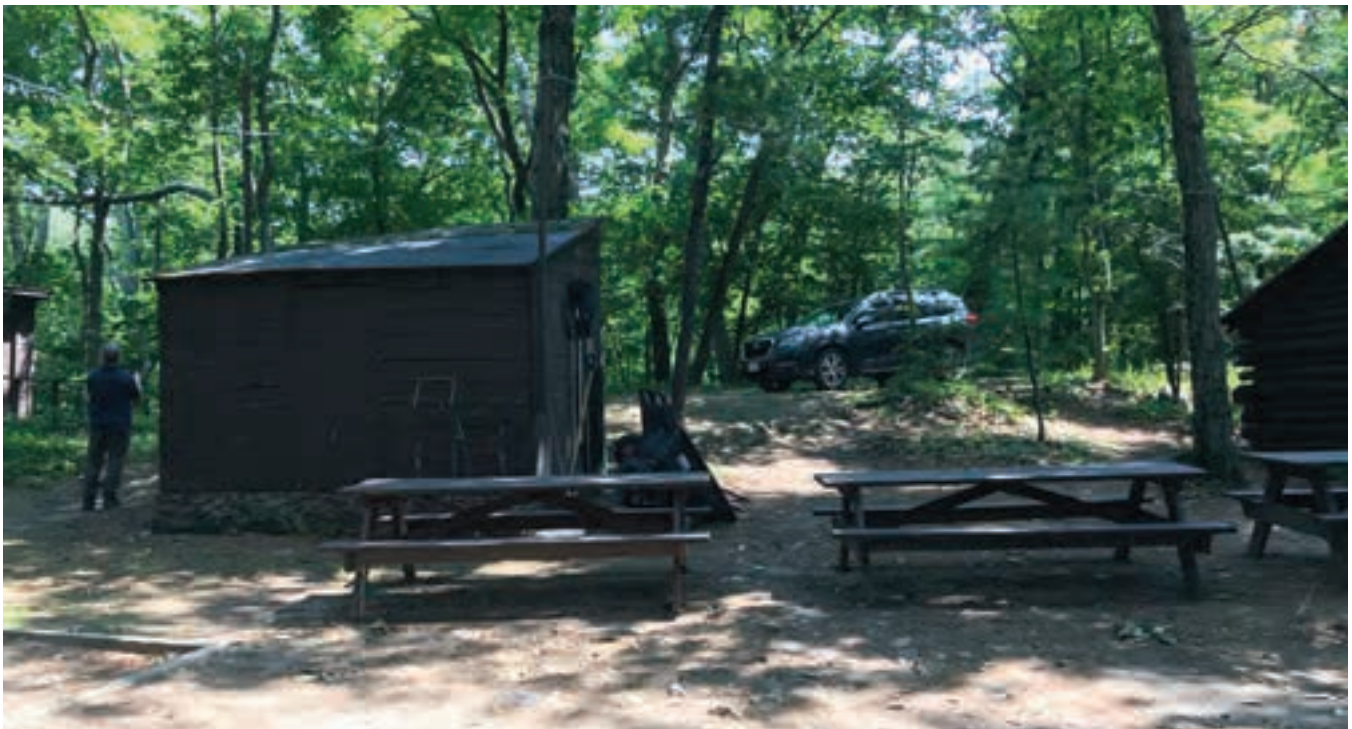
Figure 2-70. The storage building showing its stone foundation.

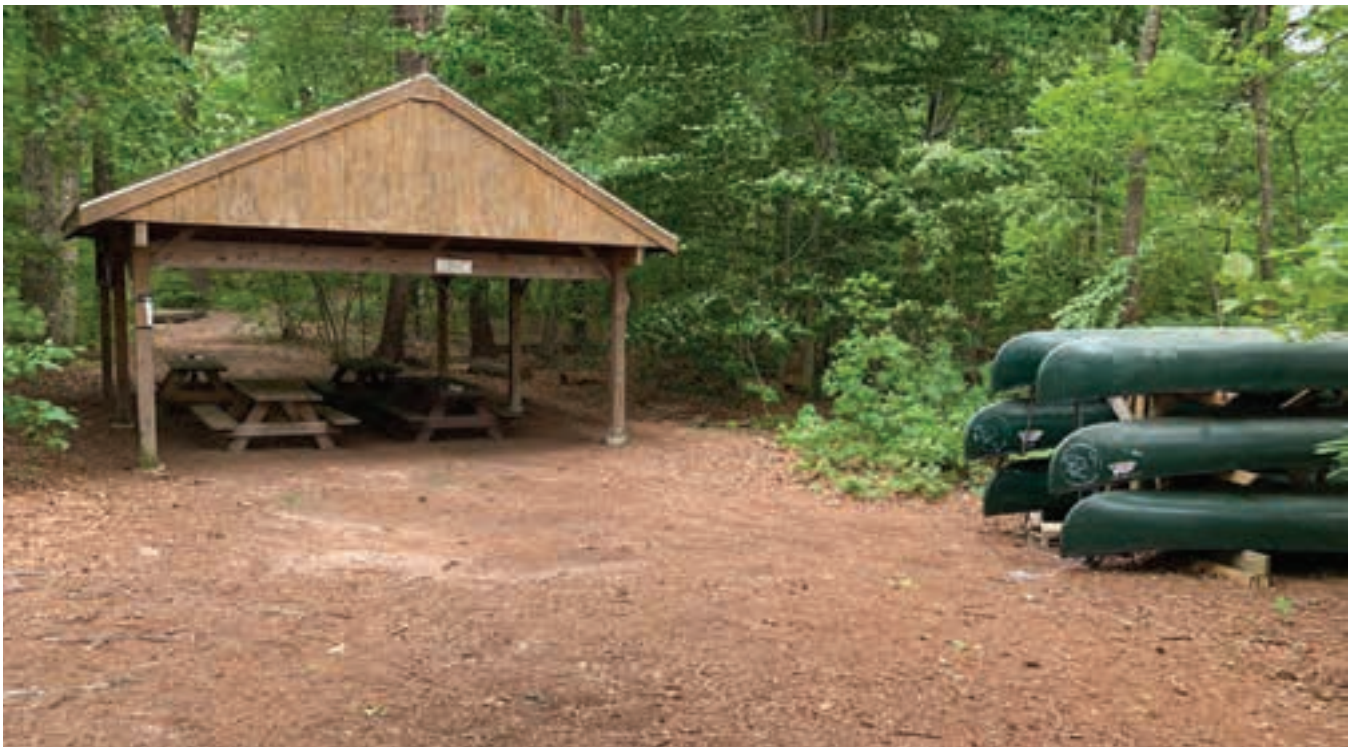
Figure 2-73. The Tent Site Pavilion

The pavilion is located at Missionary Point and is used by the AMC's Youth Opportunities Program, although it is a permanent structure that is available to all camp-goers. The unpainted pavilion consists of prefabricated wood trusses supported by 6"x6" pressure-treated wood posts on sonotube concrete footings. The roof is made up of asphalt shingles over plywood sheathing. There is no electricity or running water at the pavilion. The pavilion appears to be approximately twenty years old and is in good condition.

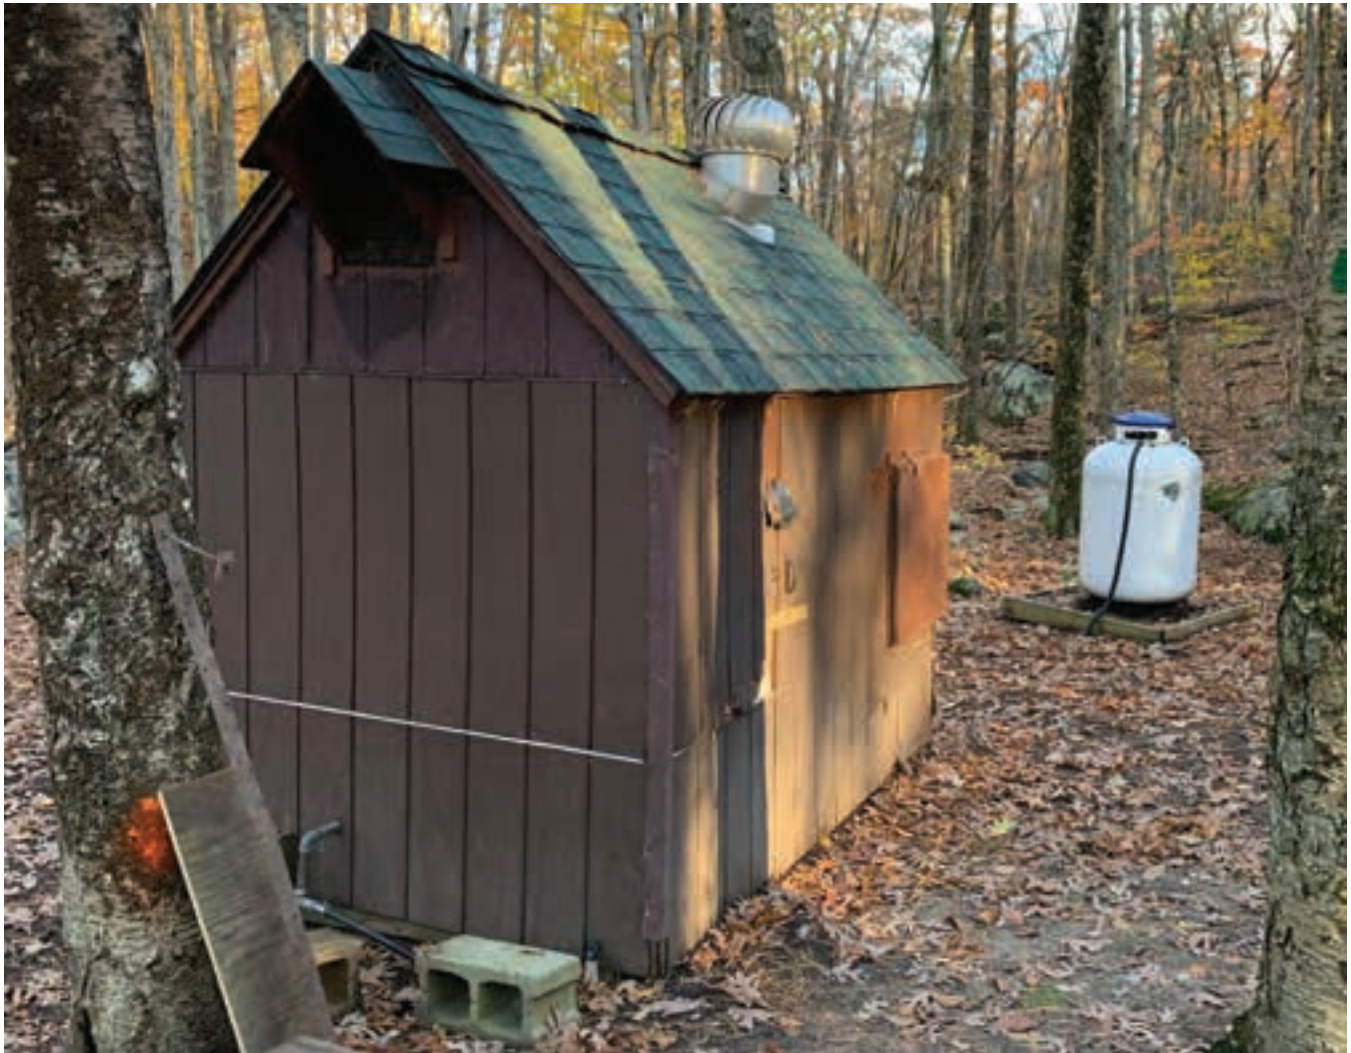
Figure 2-74. The Generator Shed with its remote propane tank

The existing generator shed supports a deep cycle well that serves the camp. The propane-fired generator provides power for the well pump that supplies non-potable water from a well tank uphill to the camp's restroom structures and Lodge. The generator shed is well maintained, but is remote from the camp's many structures and somewhat unsightly along the park's Green Dot Loop trail. Well pump operations are also currently reliant on fossil fuels. Ideally a new location for a potable well can be identified closer to camp buildings, with a new a pump that could possibly be served by new on-site renewable energy sources.

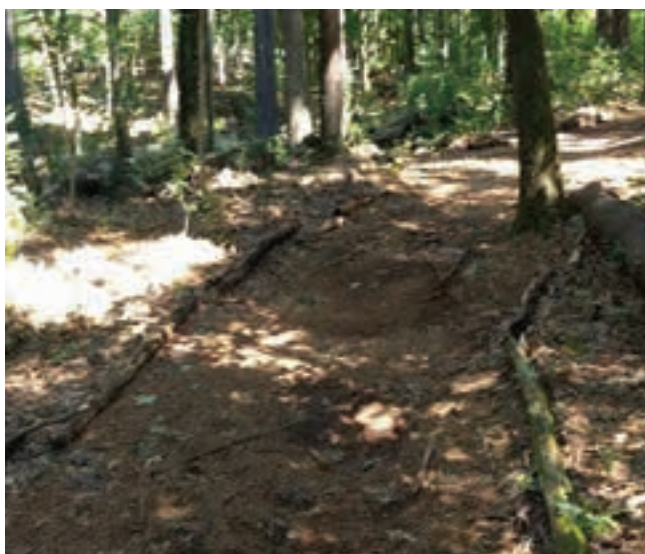
Figure 2-75. Non-accessible path

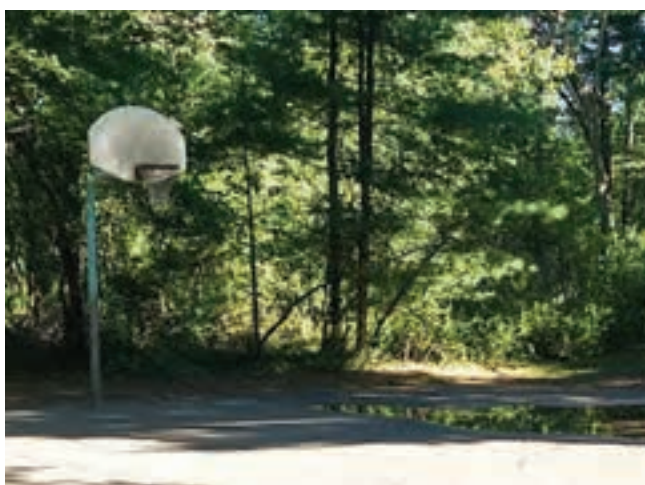
Figure 2-76. Basketball court surface in need of renovation

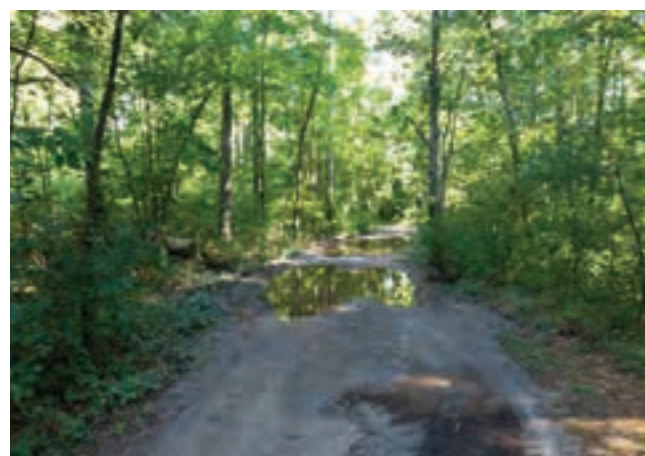
Figure 2-77. Water ponding in some section of the access road and the parking lot

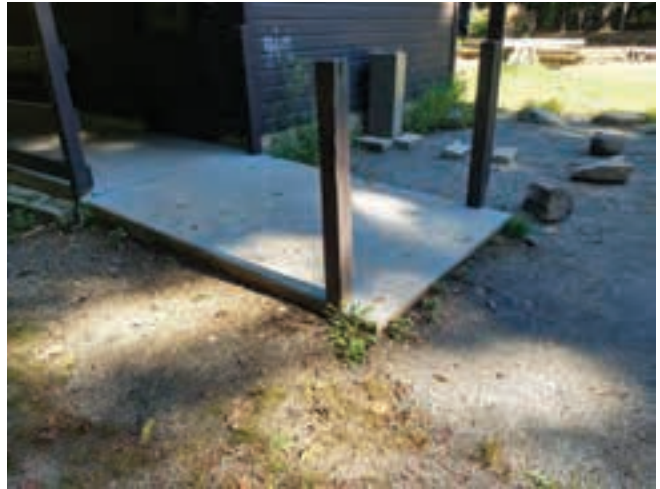
**Figure 2-79.** Non-accessible drinking fountain and restrooms

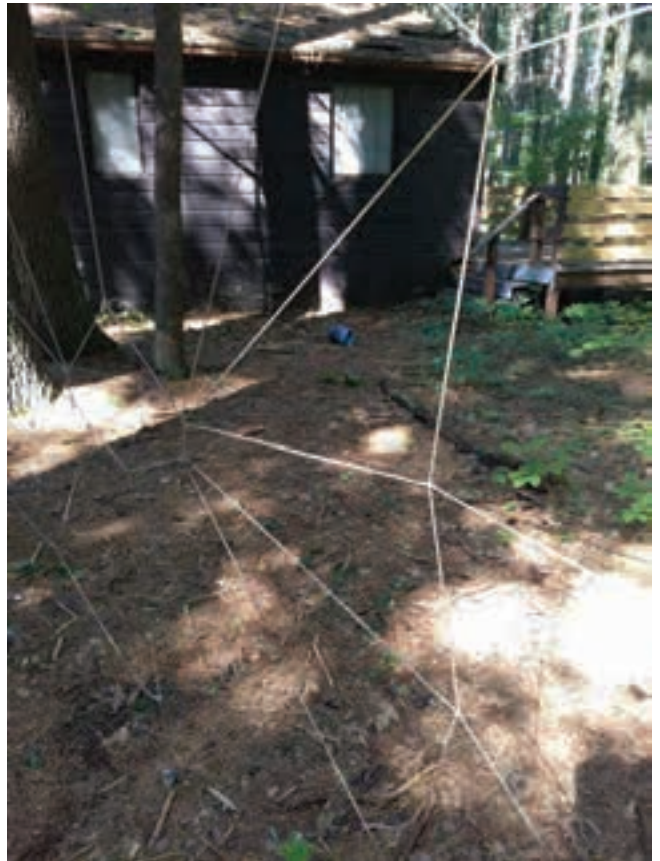
4. Shallow pool is non-functioning
5. Basketball court surfacing in poor condition
6. Surfacing and ropes course are not safety compliant
7. Limited accessibility due to non-ADA compliance surfacing materials
8. Lack of clear circulation route between facilities
9. Lack of accessible parking space
10. Invasive and poisonous plants within camp premises
11. Need more space for additional programs

**Figure 2-80.** Surfacing and ropes course are not safety compliant

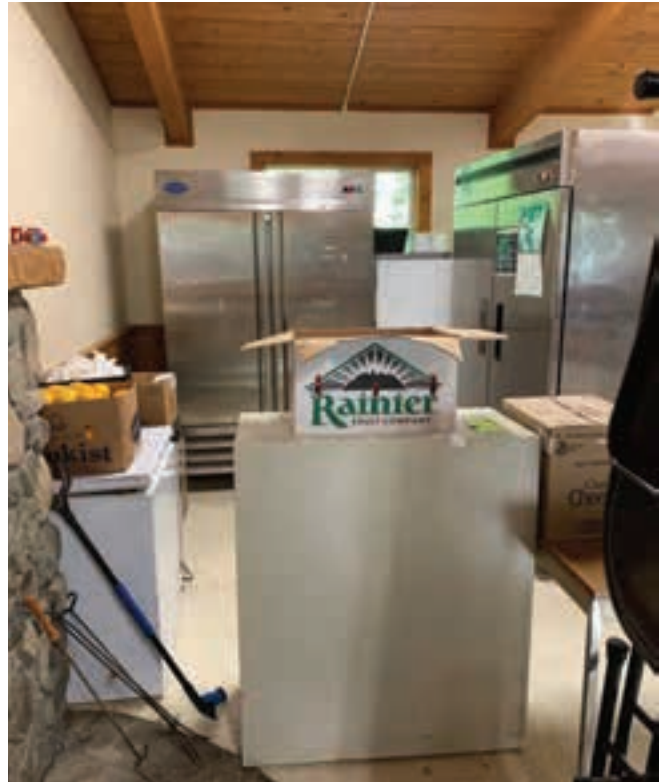
The Lodge's most significant maintenance issue is roof replacement, which was recently funded and will likely be carried out in 2022. Primary issues going forward include lack of air conditioning (the building is very stuffy even with fans) and current use and layout. Storage rooms are overflowing with supplies and equipment, offices are being used for additional storage and food service operations are impacting the functionality of the multi-purpose room (see Figure 2-82). Future study is required to see how best to re-purpose the former apartment to better accommodate current storage needs and food service functions.

**Figure 2-83.** Commercial refrigerators and storage cabinets serves as the Center's summer camp food/lunch storage station. This ad hoc station currently occupies a fairly sizable corner of the Lodge's multi-purpose room (see location in plan below).

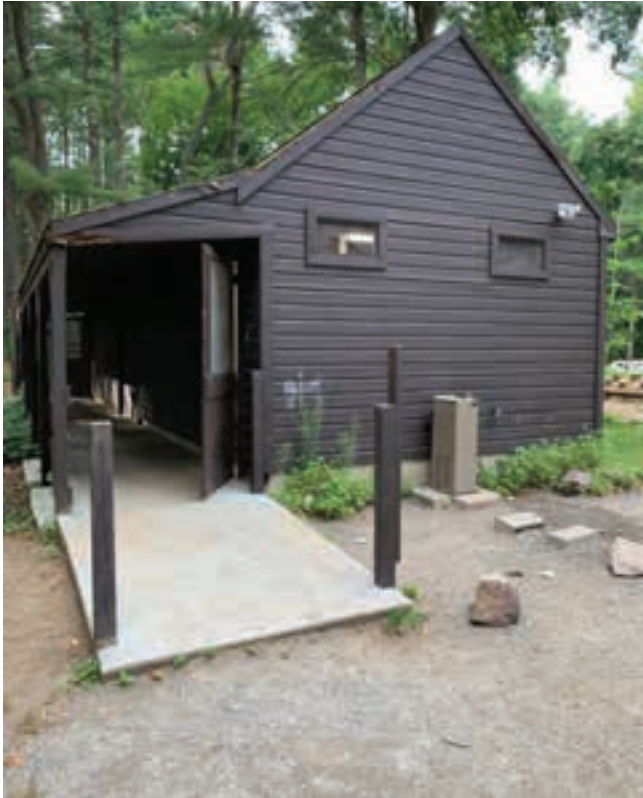
**Figure 2-84.** The existing stepped ramp and drinking fountain station both show existing accessibility deficiencies.

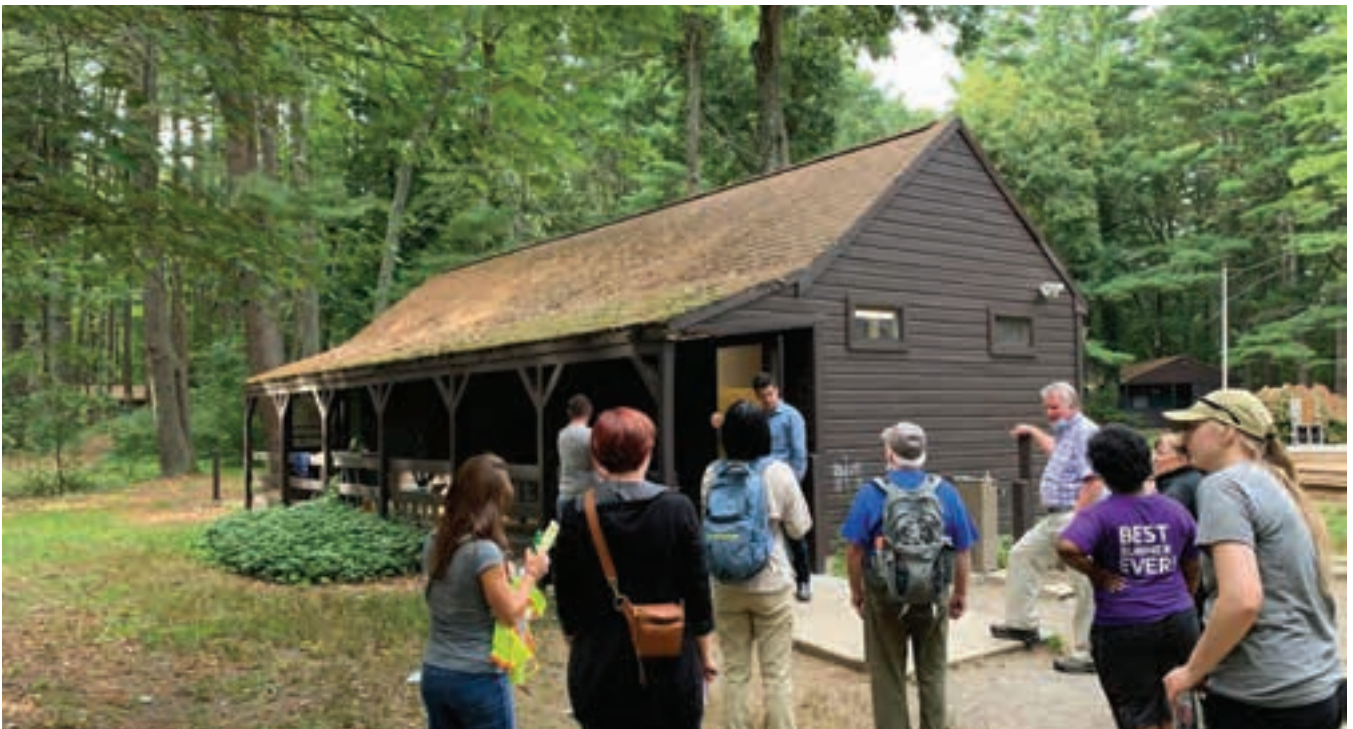
The restroom building is currently uninsulated and is therefore for seasonal use only. The girls and boys facilities do not currently meet accessibility standards and show signs of unsanitary conditions and disrepair. Moreover, a single, interior model, fixed-height drinking fountain station is found outside the building and does not meet accessibility standards. Early analysis suggests that an accessibility retrofit of the existing building might be possible, however future study will be required to determine whether a new or renovated building is the most cost-effective approach to bring the facilities up to current code/life safety and accessibility standards.

**Figure 2-85.** The Center's primary restroom facility housing multi-fixture girls and boys bathrooms

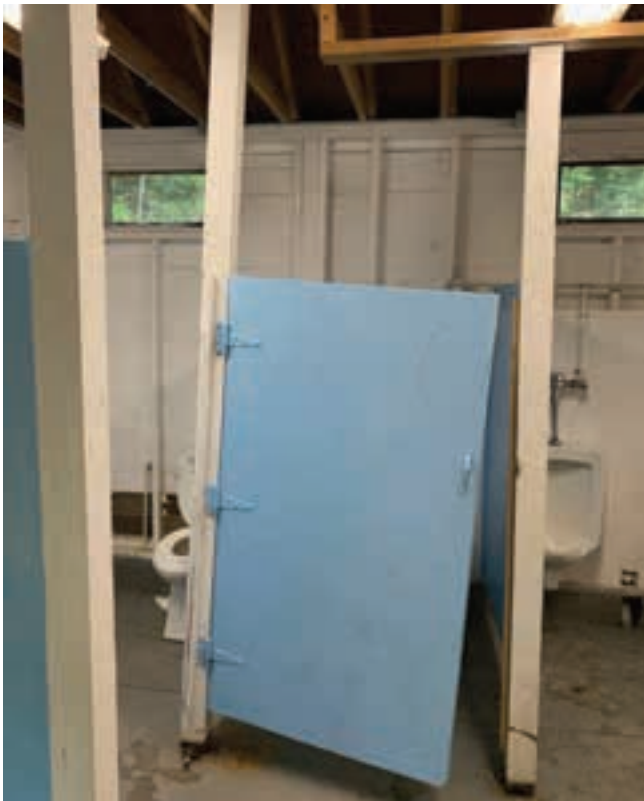
**Figure 2-86.** The interior conditions of the restroom facility show signs of disrepair, including failing toilet stall doors.

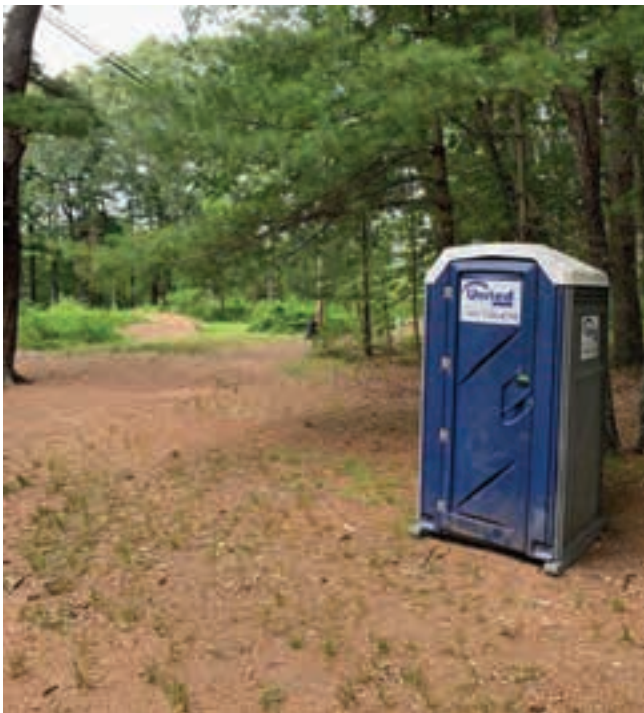
**Figure 2-88.** Portable inaccessible restroom facilities serving more remote activities. This suggests the potential need for several smaller accessible restroom facilities interspersed throughout the site, as opposed to a more centrally-located single facility.
