# Ponkapoag Pond Master Plan

Canton & Randolph, MA

### PART TWO EXISTING CONDITIONS ASSESSMENT

### PART THREE RECOMMENDATIONS AND OPPORTUNITIES

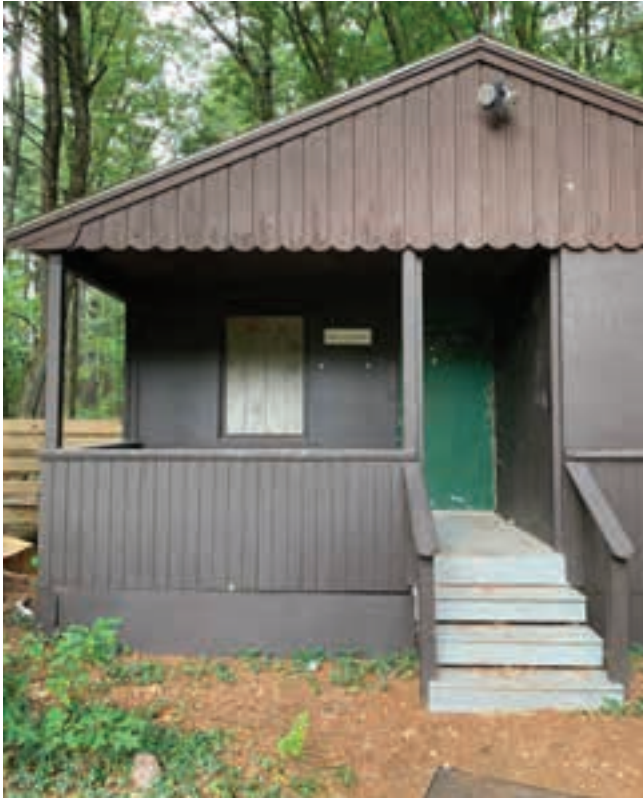
**Figure 2-89.** The existing Arts and Crafts Cabin. Boarded windows suggest recent inactivity.

The Cabin currently shows signs of deferred maintenance and lack of use. Windows are boarded up, paint is peeling and board siding is showing signs of rot and insect infestation (see Figure 2-91). Newer wood railings and decking at the open-air porch suggests either a recent deck expansion, or replacement of deteriorating materials. In order to accommodate 13-15 campers at a time, the Cabin will need to be renovated to include accessibility upgrades treatment and/or replacement of materials to address moisture damage and insect infestation, new lighting, and new painting.

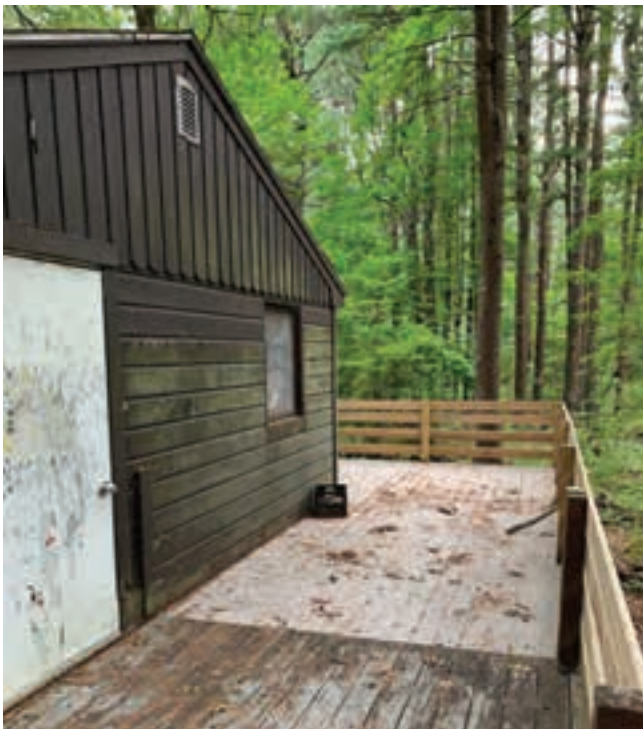
**Figure 2-90.** The back deck showing a more recent expansion or replacement of deteriorated materials

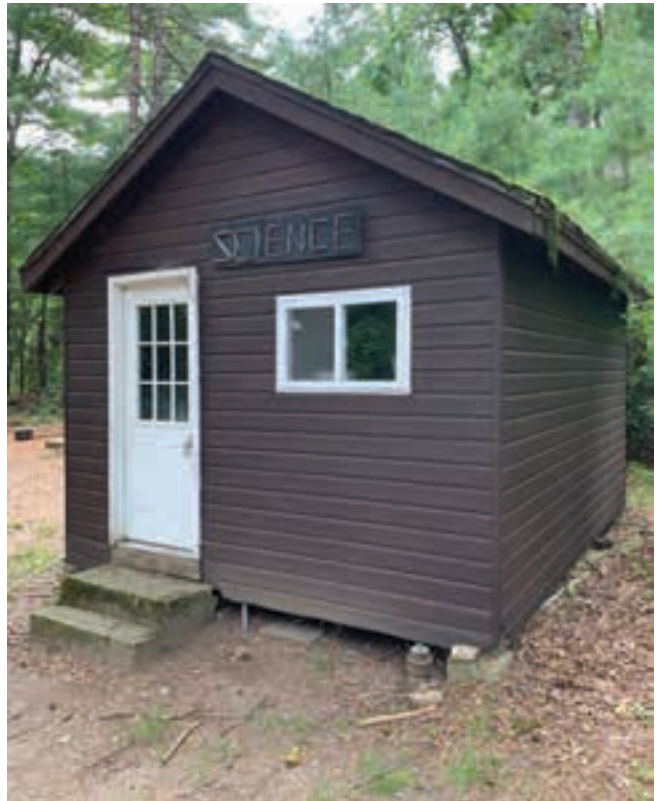
Given several steps up to its finished floor, the Cabin is currently inaccessible to disabled patrons. The Cabin is also exhibiting signs of material and structural degradation, especially around the entry door as well as at the concrete footing bearing points. A metal and plexiglass bay window on the south side of the building appears to be poorly constructed and in need of replacement. The Cabin's existing crawl space below the floor framing is also open around the building perimeter. Without a barrier, this covered space beneath the building is an inviting home for insects and rodents.

Figure 2-93. The Science Cabin's entry door.

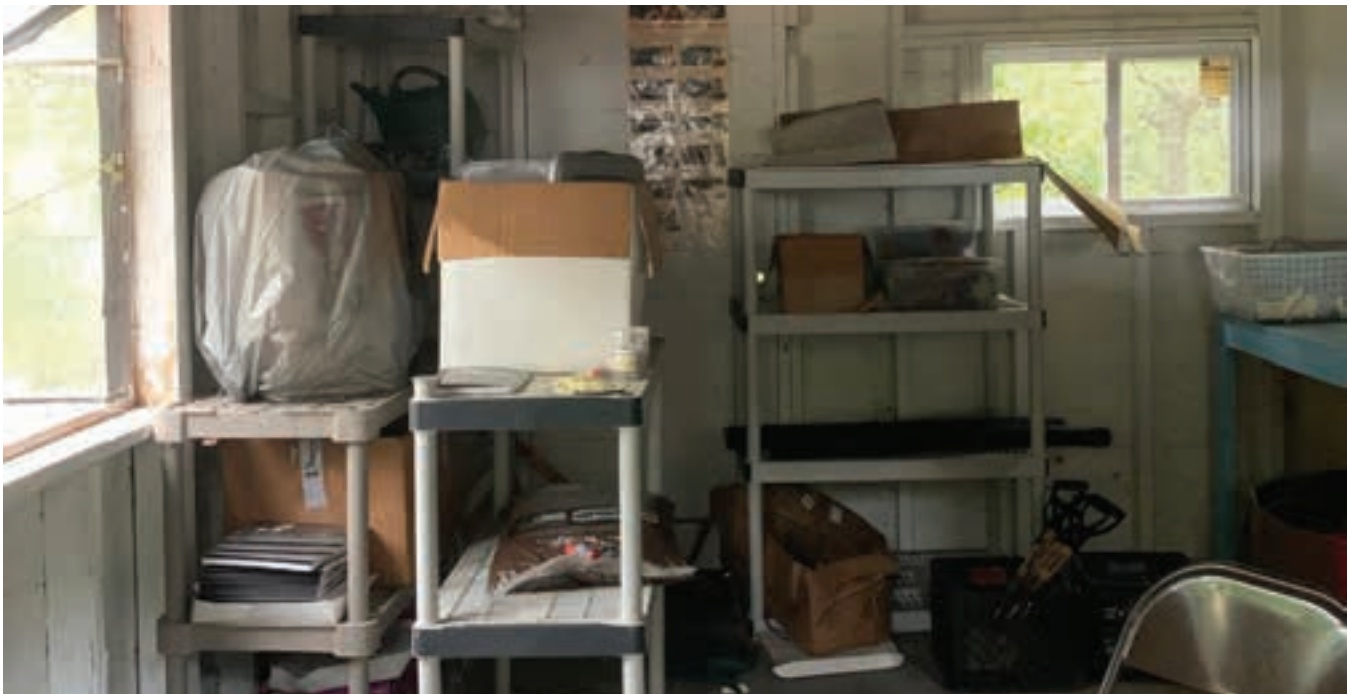
Figure 2-92. The Science Cabin's interior condition showing exposed wood stud framing and wood board sheathing

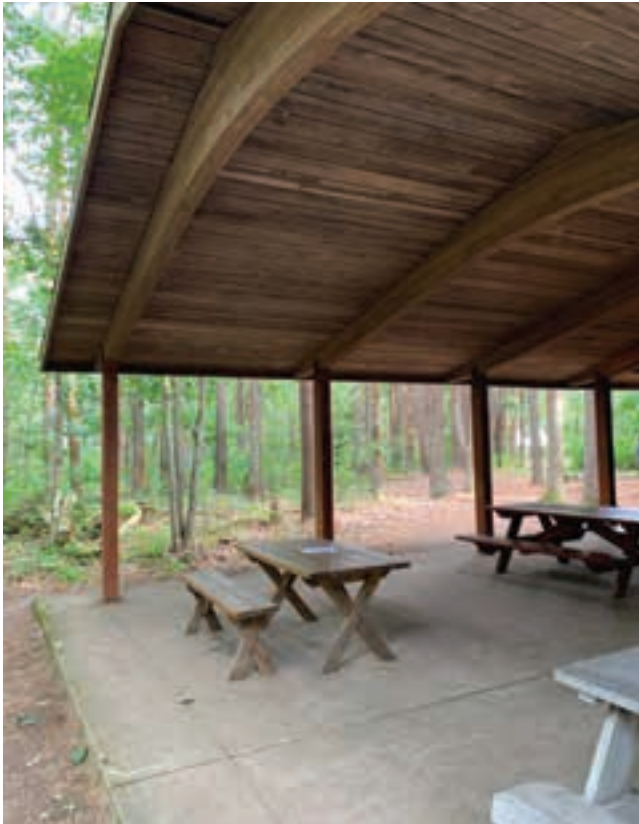
**Figure 2-95.** The pavilion's clear-span laminated timber structure

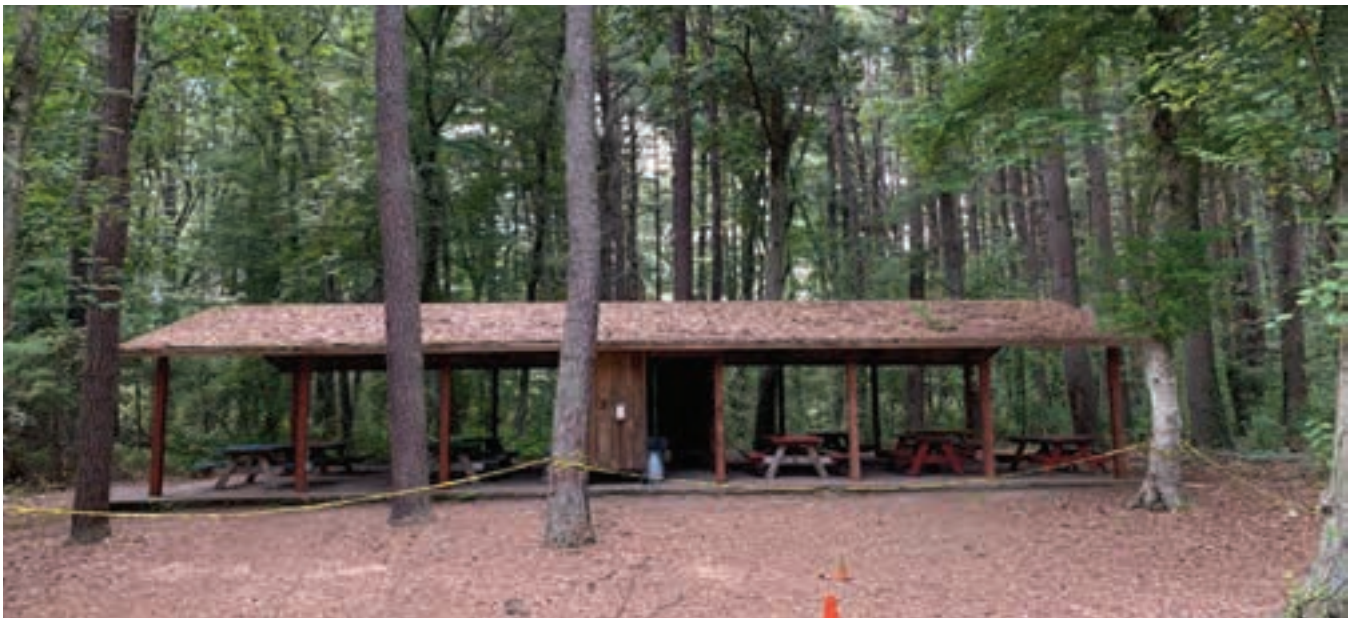
The pavilions are seasonal structures with no electricity or running water. They are in excellent condition, but are missing critical space and infrastructure to support the programs offered there. Secure, fully-enclosed storage spaces are needed to accommodate and protect supplies such as whiteboards and crafts. Moreover, added wall space (perhaps as sliding wall panels) would provide display surfaces while simultaneously offering protection from the elements. Lastly, adding lighting would enhance use of the pavilions in low light, cloudy conditions.

**Figure 2-94.** Pavilion elevation showing two covered activity areas separated by a wood-clad storage area in the middle

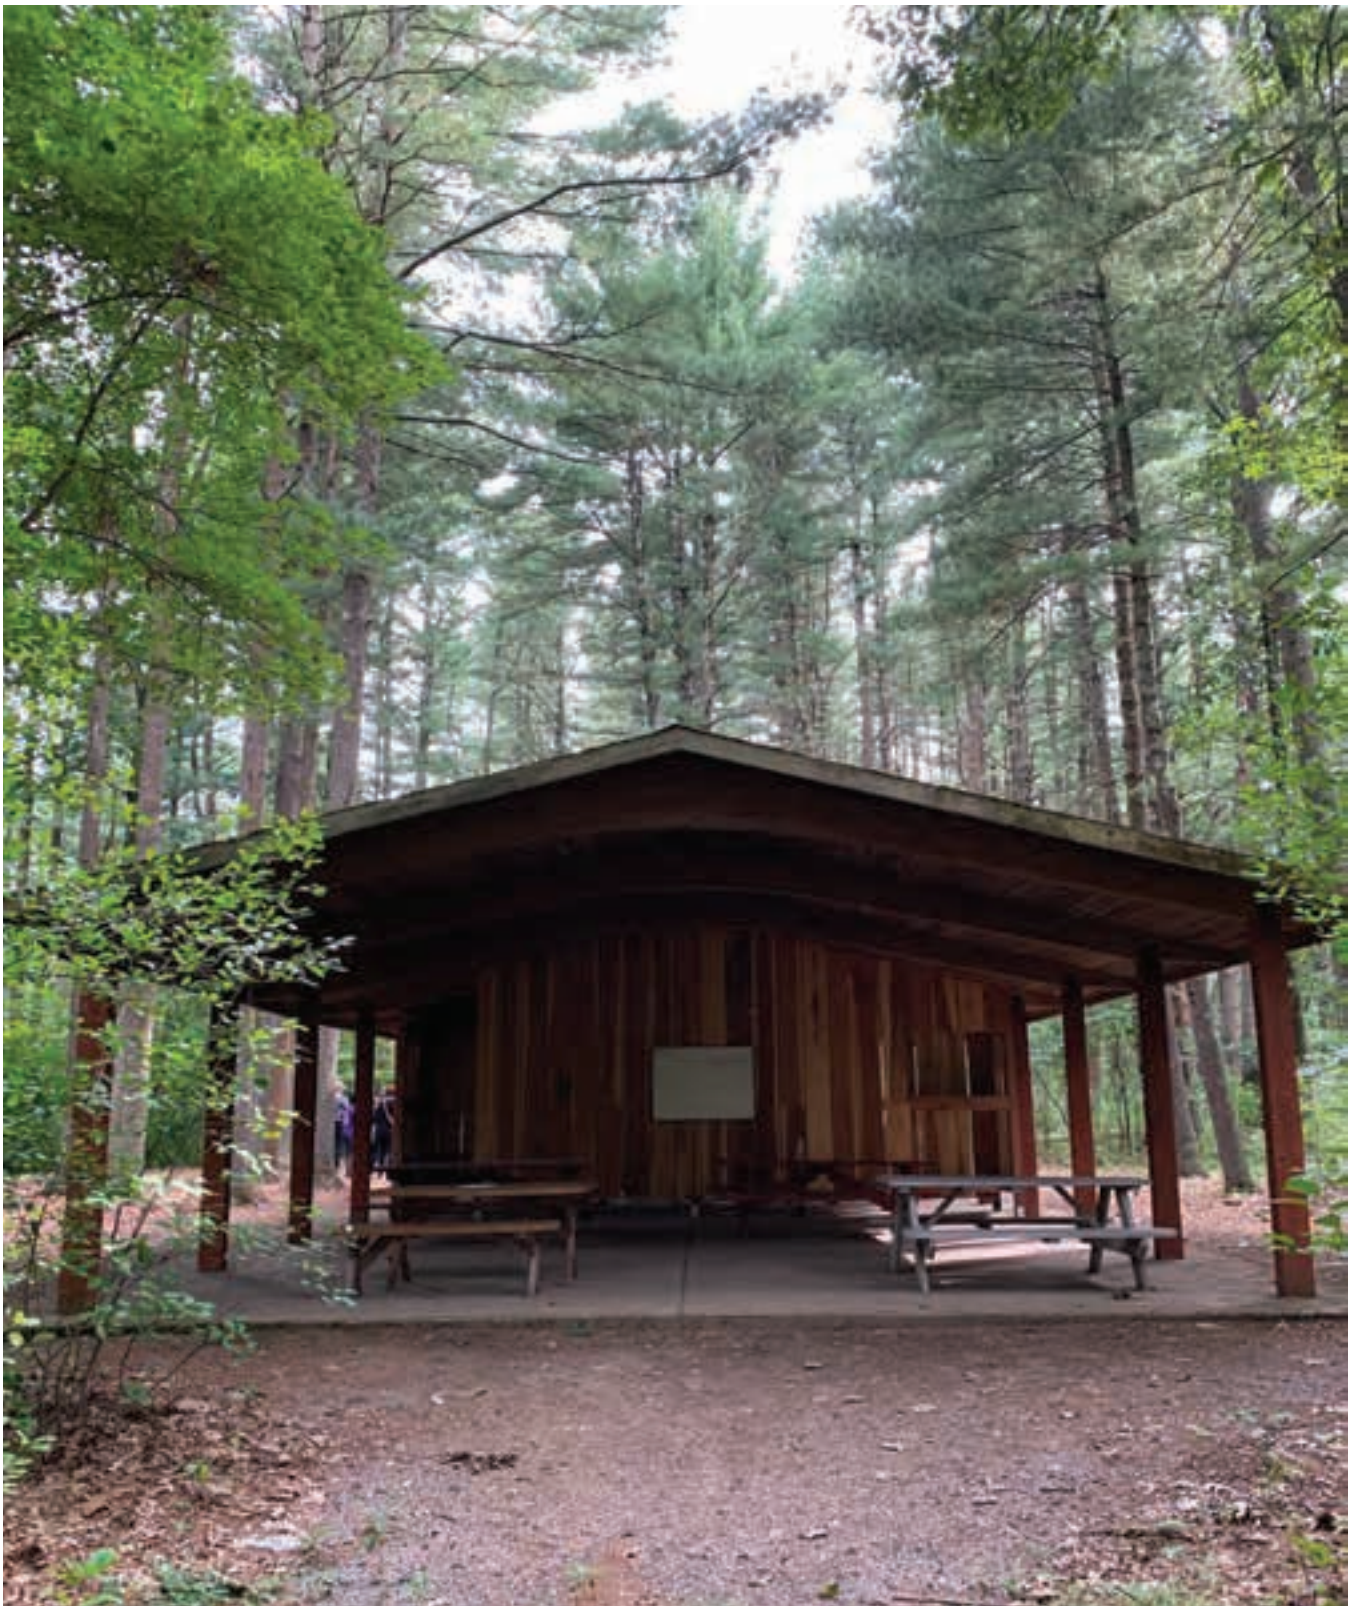
**Figure 2-96.** End elevation of a pavilion, showing a typical covered activity area with picnic tables. A lack of electric lighting creates dim conditions in cloudy/low light conditions.

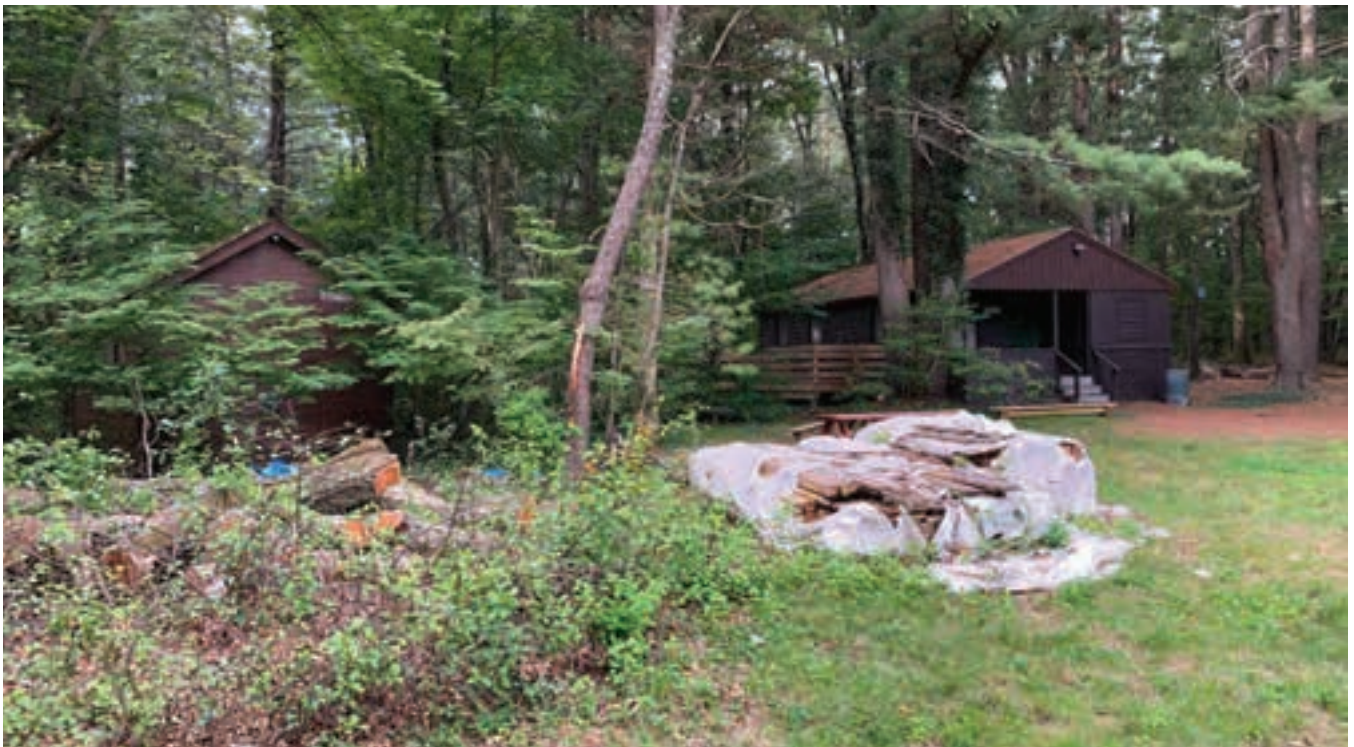
The structure has several materials in need of replacement or repair. For example, what appears to be a former entry porch has exposed metal flashing that is damaged and frayed, with sharp edges sticking out in an unsafe manner. The roof is also covered with forest debris and needs upkeep in addition to new edge trim and flashing.

Figure 2-98. The Camp's Nature Center

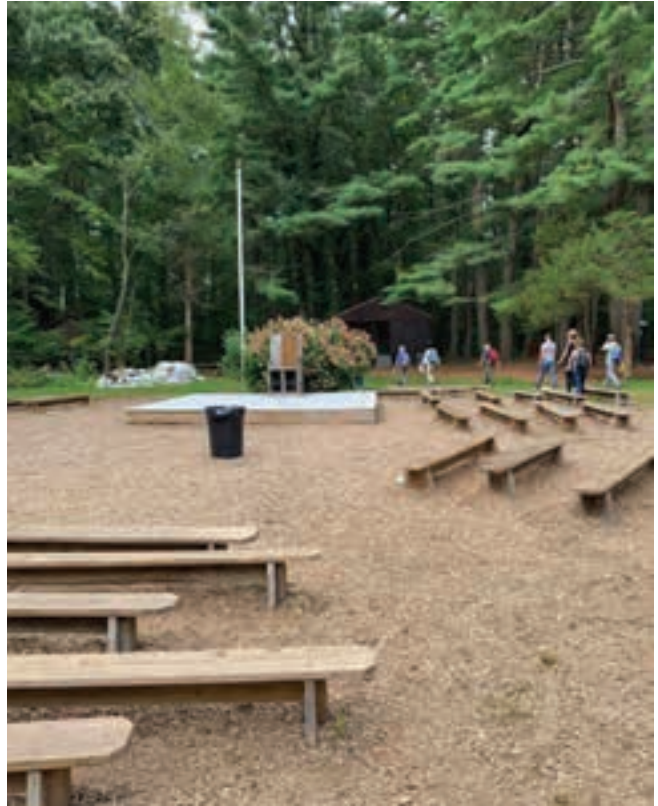
The existing stage platform is constructed with pressure-treated 2"x12" framing members with composite decking. The stage is currently inaccessible to disabled patrons and really too small to accommodate performances. YMCA staff have requested a larger elevated stage that can accommodate both accessibility and a wider range of performances.

Figure 2-99. Theater stage and seating

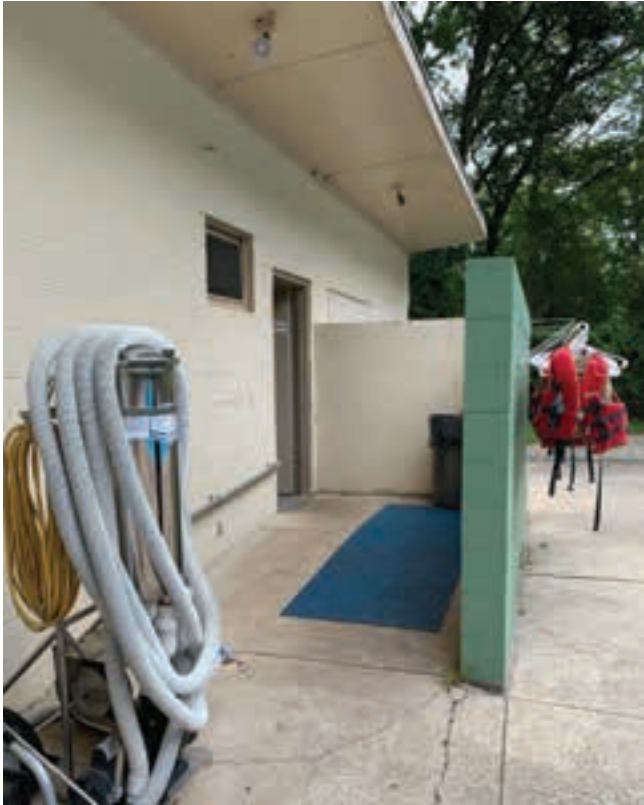
**Figure 2-101.** Restroom entry with a short, code-compliant ramp.

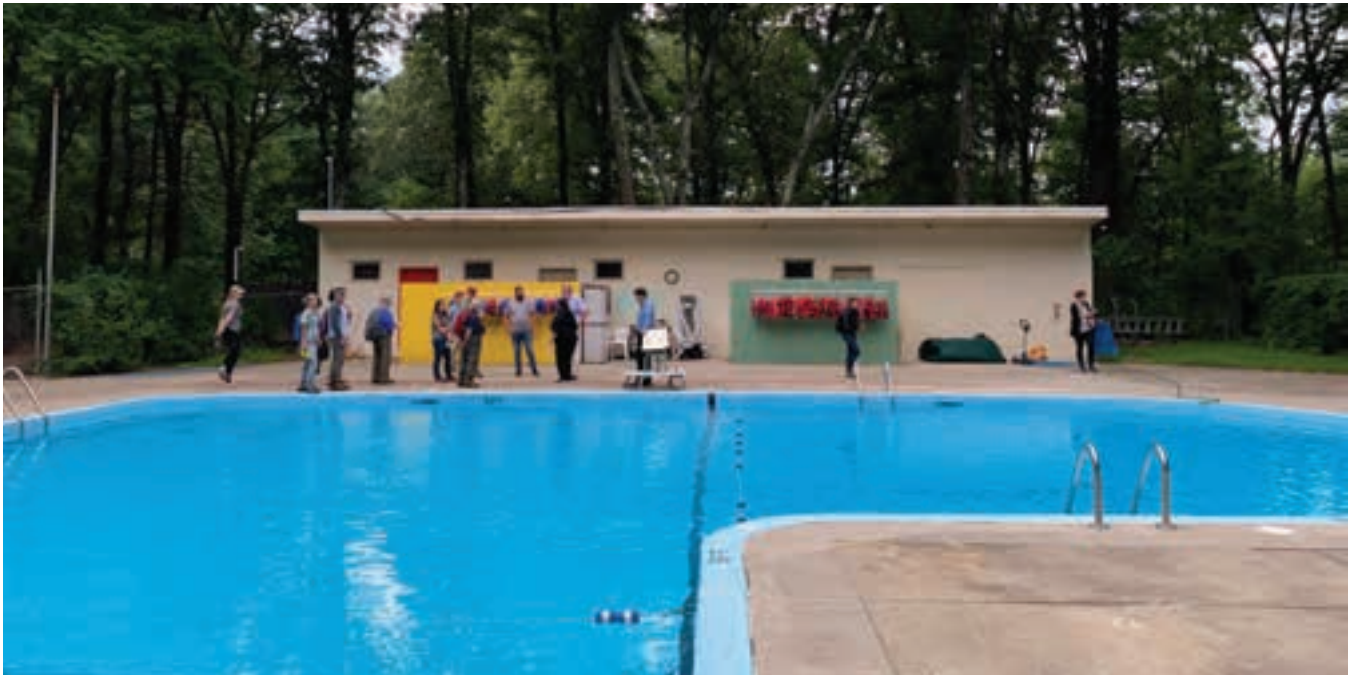
The 1,425 square foot, seasonal bath house is a single-story, load-bearing masonry structure housing girls and boys restrooms and space for pool equipment and storage. The concrete masonry unit walls support wood roof rafters and provide durable and easily cleanable finished interior and exterior surfaces. Signs of the building's age, which could be forty or fifty years old, include significant out-of-plane settlement between CMU blocks. More importantly, restrooms, including their underlit communal changing and showers areas, are dingy, do not provide privacy, and do not meet current accessibility standards. Outdoor changing stalls were recently added to address some of these shortcomings, but these have also proven problematic. In general, conditions suggest full facility replacement or modernization.

**Figure 2-102.** The YMCA Ponkapoag Outdoor Center's pool complex showing the in-ground pool, pool deck and bathhouse.

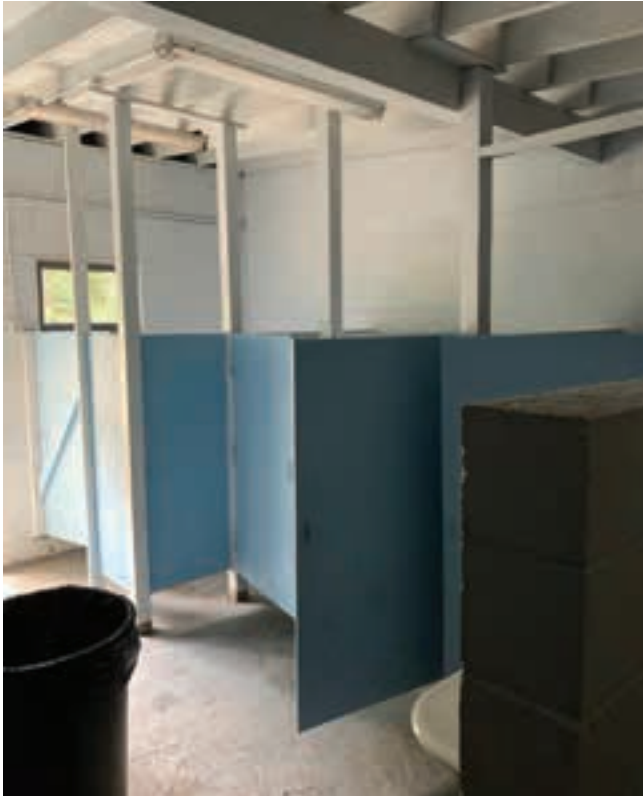
Figure 2-103. The restroom with wood toilet partitions.

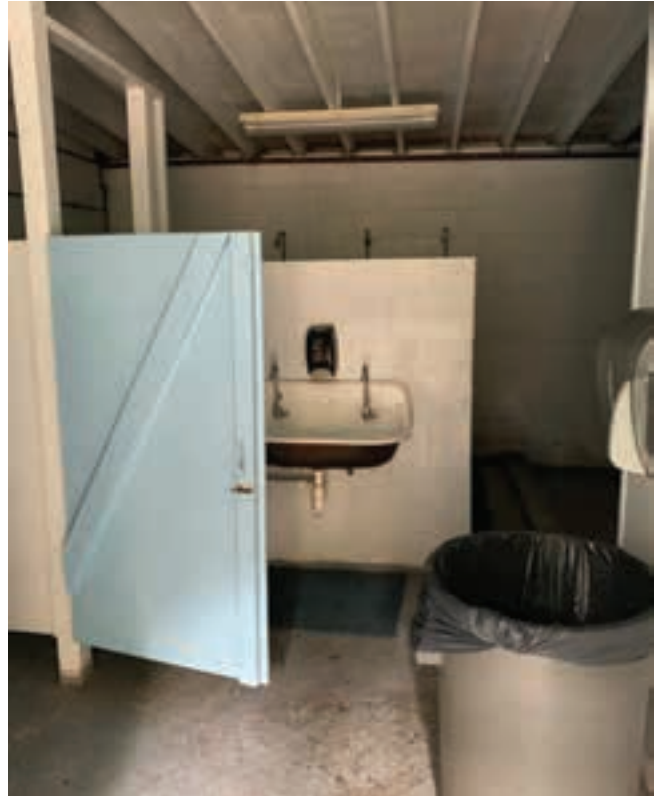
Figure 2-104. Image showing conflict between the restroom's toilet partition door swing and sinks.

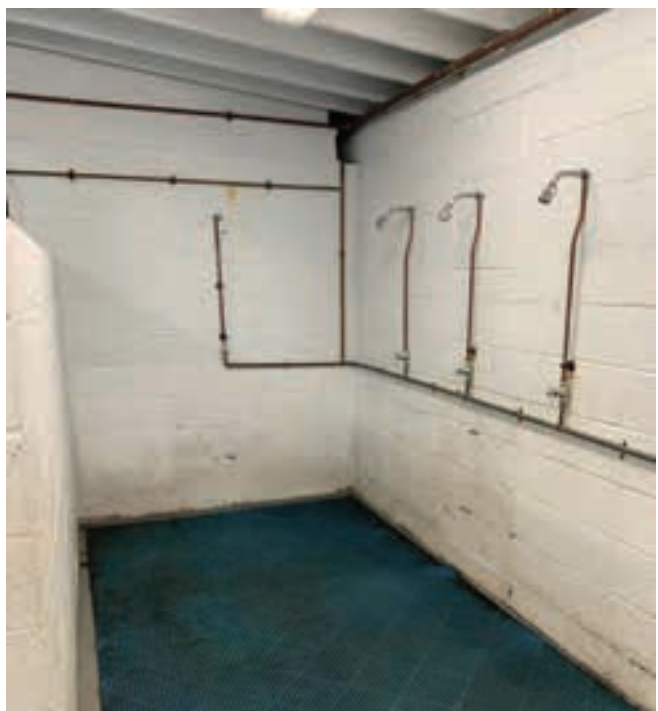
Figure 2-106. The communal shower area.

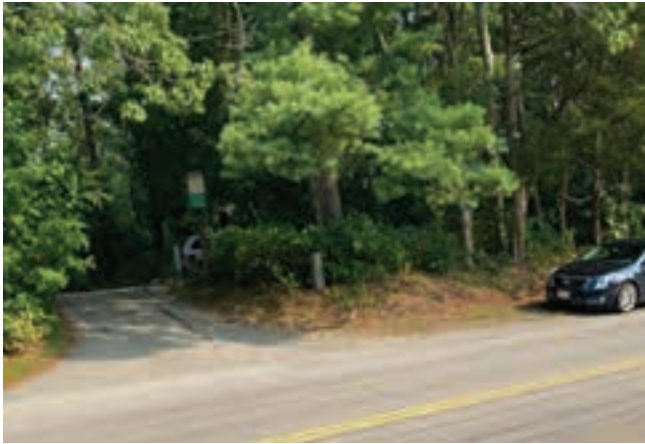
**Figure 2-113.** Southern entrance/Fisherman's Cove entrance includes no signage identifying main entranceway – existing conditions

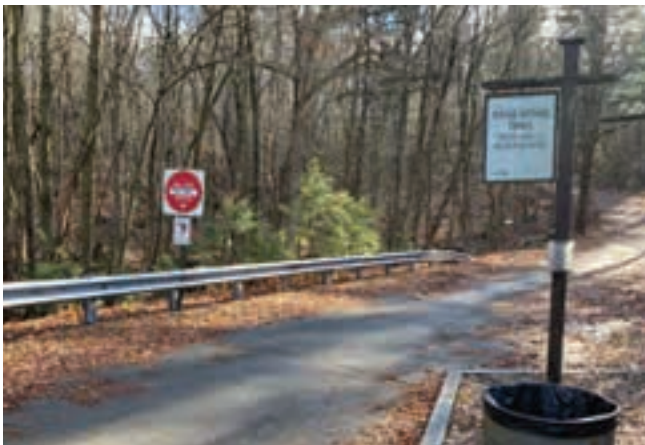
**Figure 2-114.** Northern entrance/I-93 signage is only easily visible after entering parking area – existing conditions

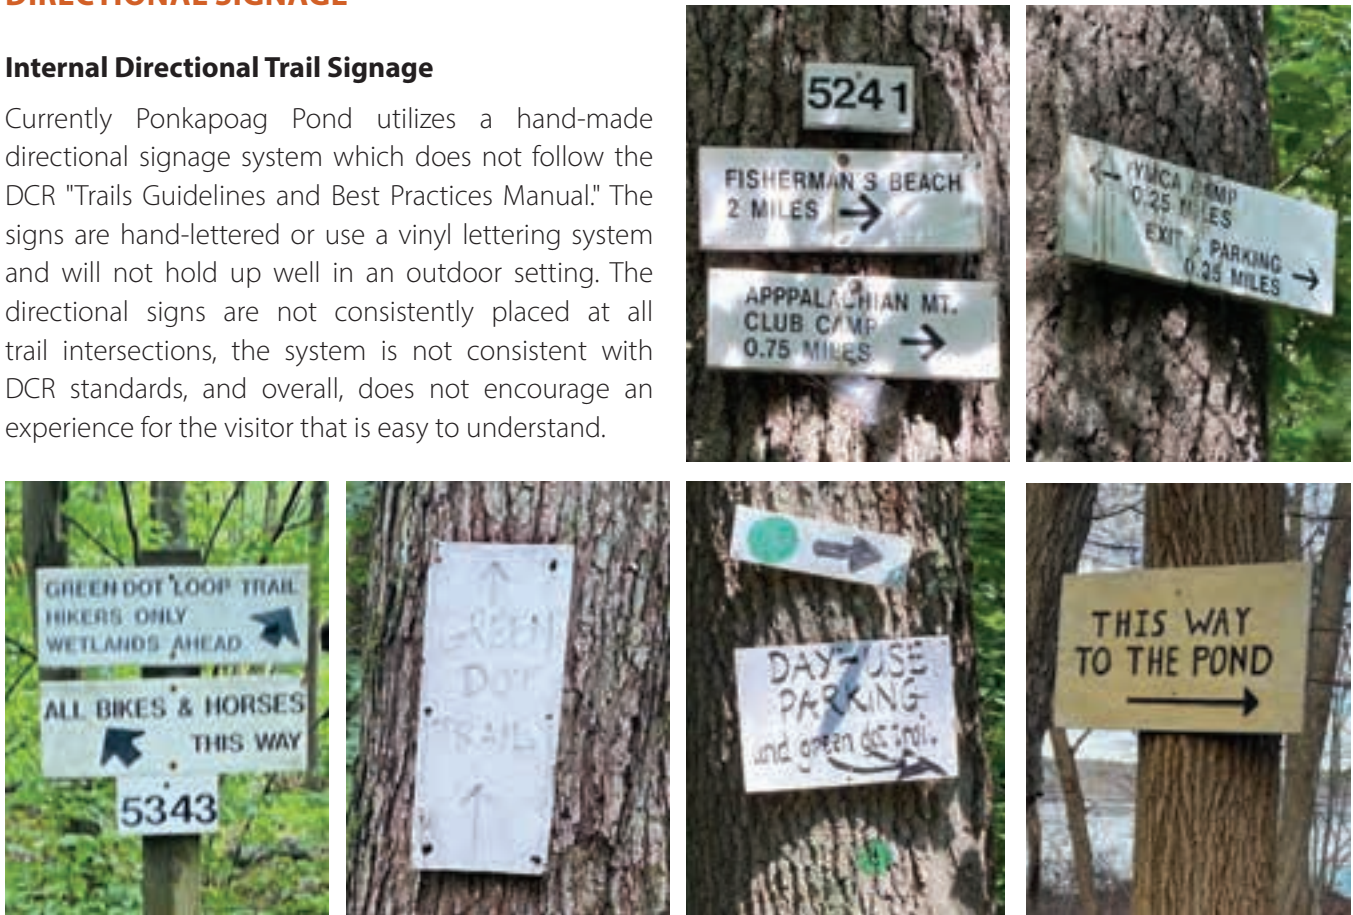
Currently Ponkapoag Pond utilizes a hand-made directional signage system which does not follow the DCR "Trails Guidelines and Best Practices Manual." The signs are hand-lettered or use a vinyl lettering system and will not hold up well in an outdoor setting. The directional signs are not consistently placed at all trail intersections, the system is not consistent with DCR standards, and overall, does not encourage an experience for the visitor that is easy to understand.

Figure 2-116. Internal Directional signage—existing conditions

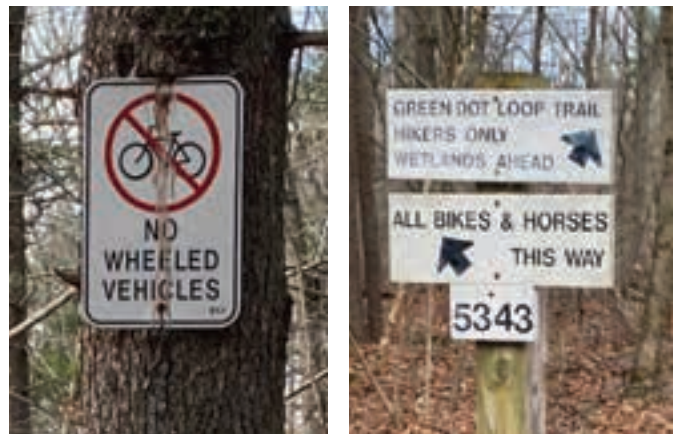
There are specific trails where biking and horseback riding are not allowed. Currently, signage identifying these specific trails is inconsistently communicated, and not clearly marked. Hierarchically, this information is hard to distinguish in the signage, and sometimes does not include iconography. With that, it is easily missed.

Figure 2-117. "Rules" signage on trails – existing conditions

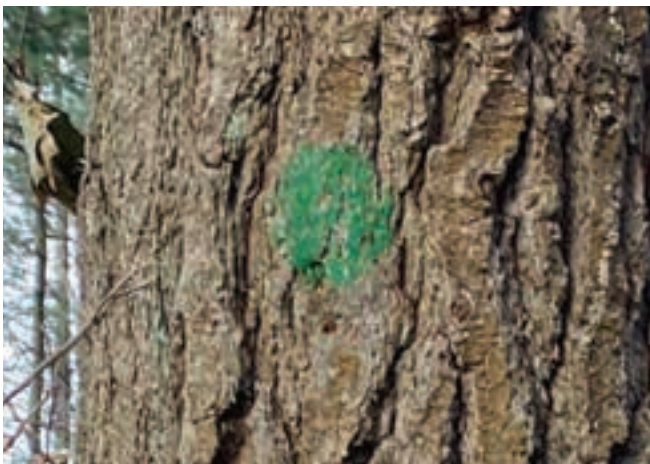
The Green Dot Loop trail is the one loop trail around Ponkapoag Pond that is marked in some areas of the park well, but in other areas of the park, the marks are weather-worn.

**Figure 2-119.** Green Dot Loop trail Reassurance Markers – existing conditions

Generally speaking DCR recommends using rectangular blazes, but in instances where locations have specific colors and/or shapes associated with their identity such as the Blue Hills Reservation, the DCR Manual does not recommend changing these.

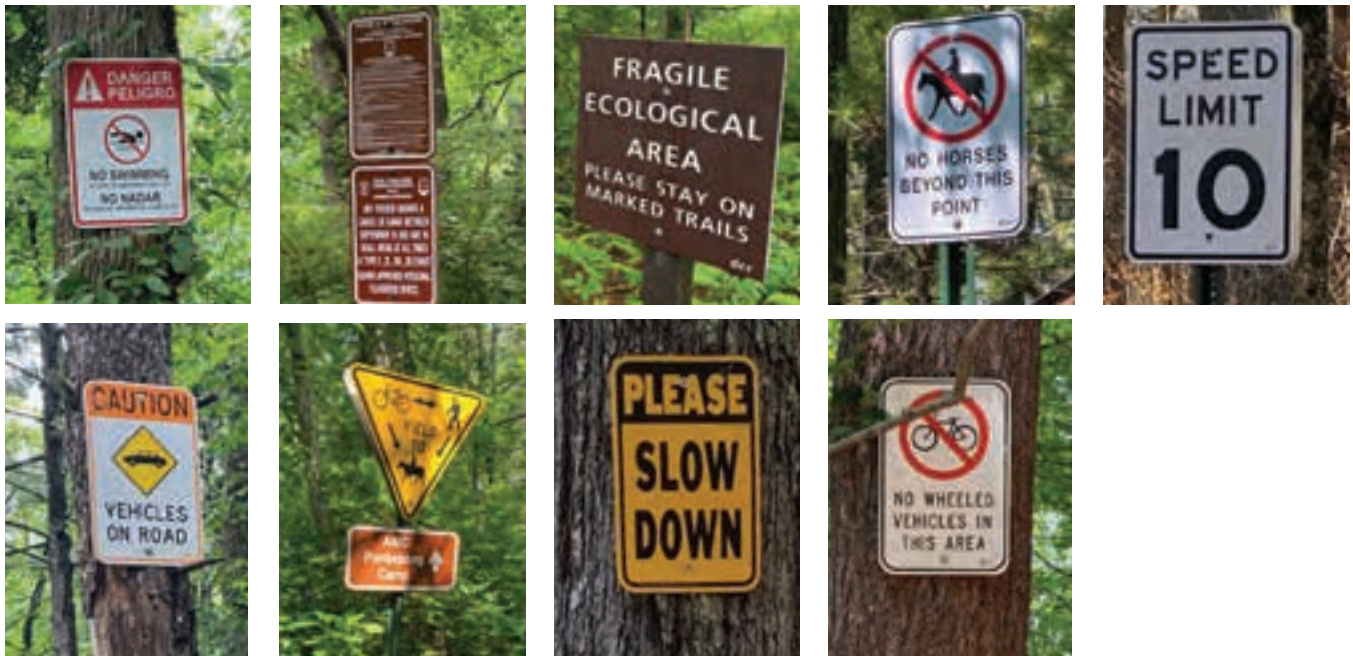
Overall, DCR Rules and Regulations signage is generally well maintained and follows the DCR guidelines. In some cases, the signage should be updated due to fading or graffiti. The "Trash Cans are not available/Carry in/Carry out" signs are not printed on standard DCR Rules and Regulations material. These signs are posted at locations throughout Ponkapoag Pond.

Figure 2-127. Rules and Regulation signage – existing conditions

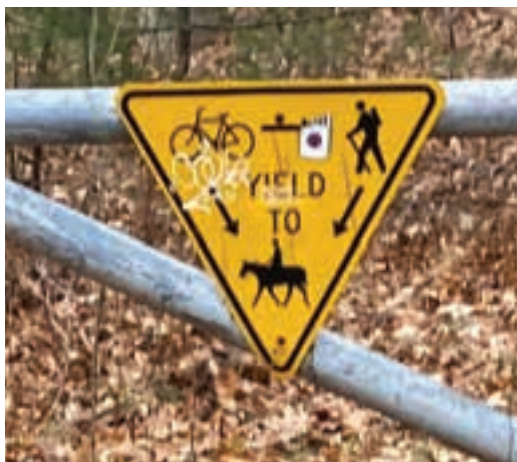
Figure 2-128. "Yield to" signage along road to YMCA Center with Graffiti markings

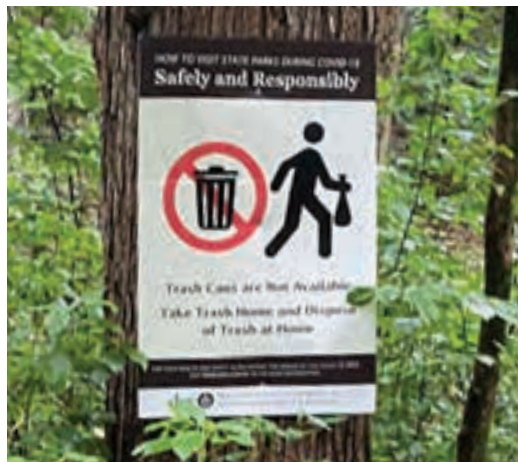
Figure 2-129. Signage printed a material not consistent with DCR Guidelines

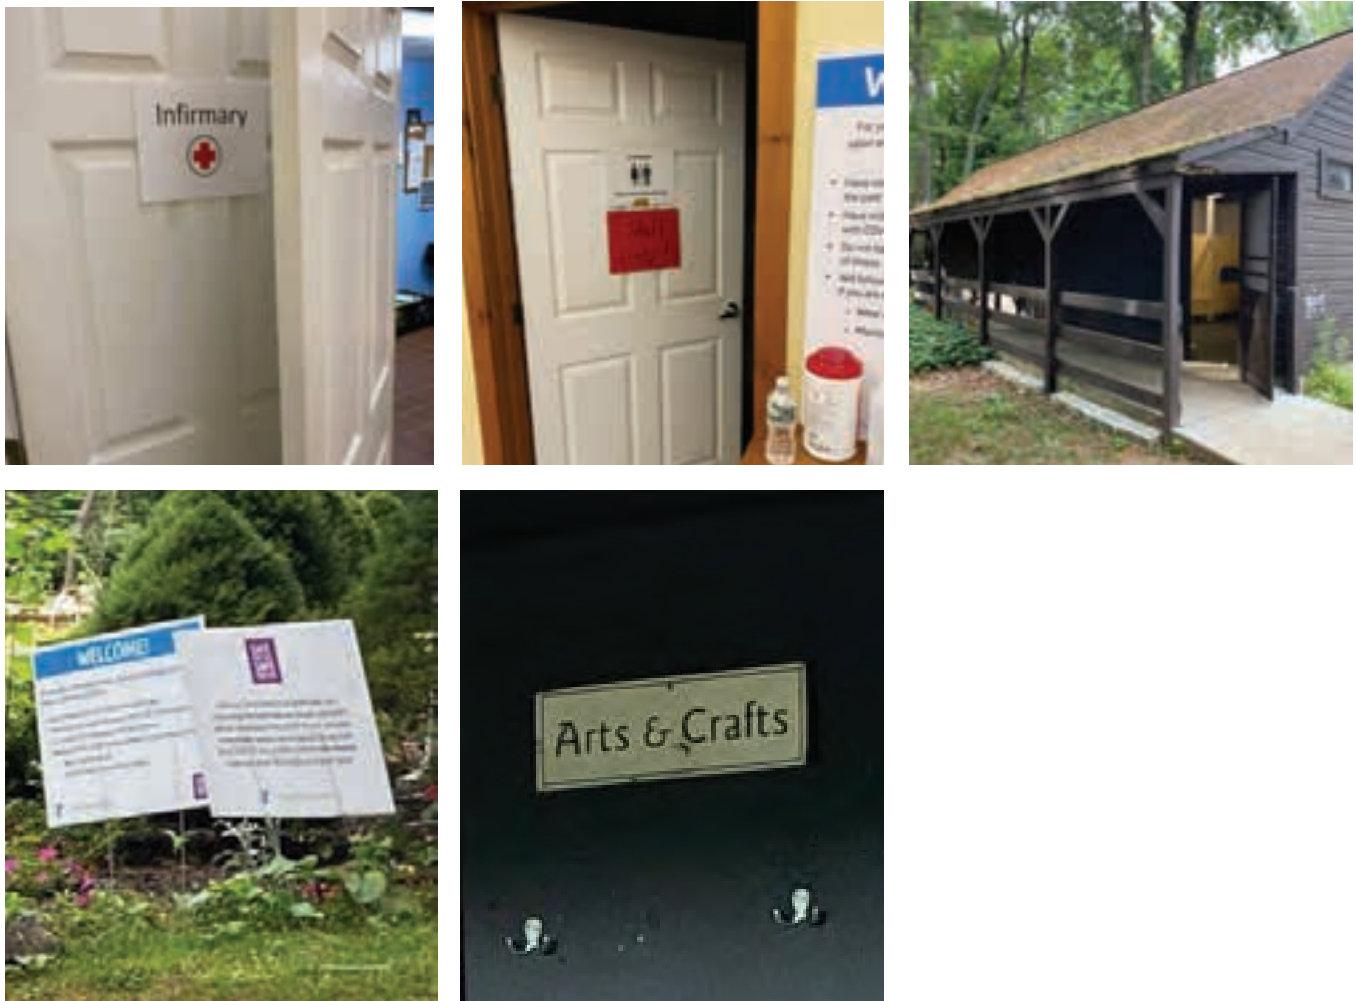
Currently, most of the facilities throughout the YMCA Ponkapoag Outdoor Center are not clearly marked, and the signage in the Main Building including for the Infirmary and the Main Office are poorly marked and require more permanent signage. Bathrooms are not clearly marked. Signage should be consistent, clear, well-made, and easy to understand.

Figure 2-135. YMCA Ponkapoag Outdoor Center signage – existing conditions

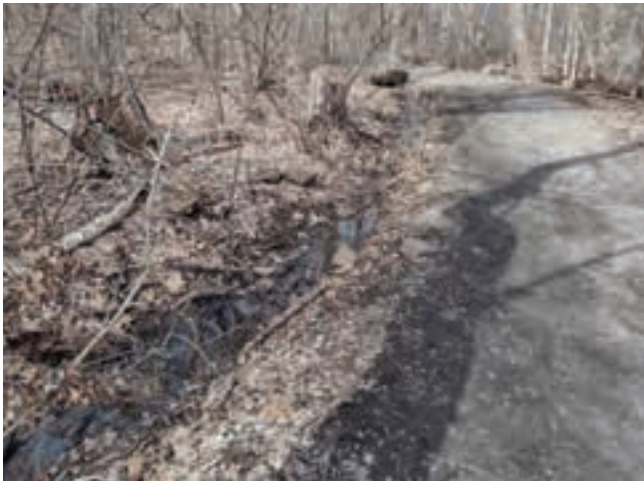
**Figure 3-7.** Vegetated swale along Green Dot Loop trail with a culvert at the low point to convey runoff to the other side of the trail.

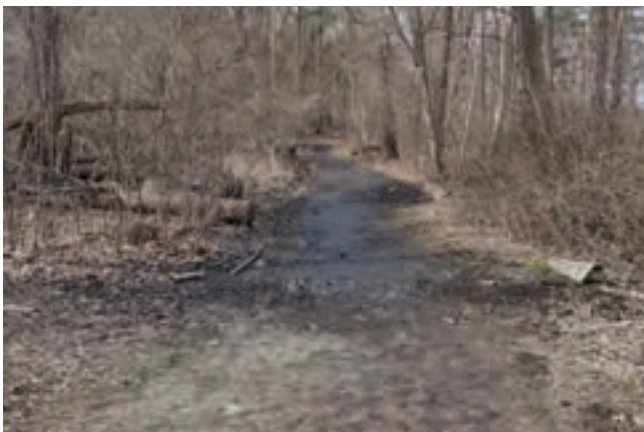
**Figure 3-8.** Trail is lower than the adjacent woodland causing runoff ponding on the trail and making it impassable.

For significant ponding or trail erosion, design and install vegetated swales or rain gardens along the upslope side of the trail that will help capture and treat stormwater. A culvert could be installed at the lower point to convey the runoff to the wooded area on the other side of the trail to dissipate runoff and naturally infiltrate. It is important to note that any ground disturbance, particularly digging, should be coordinated with an archeological exploration to verify there are no artifacts or sensitivity concerns.

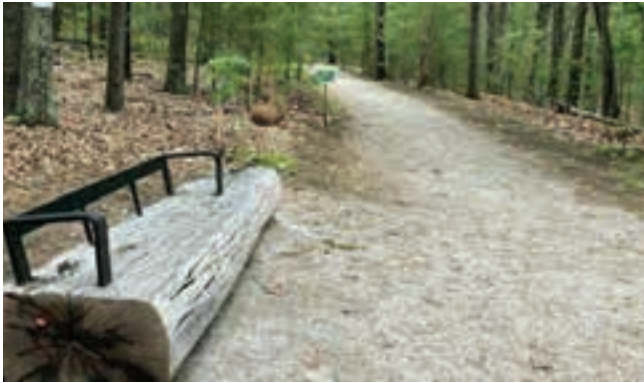
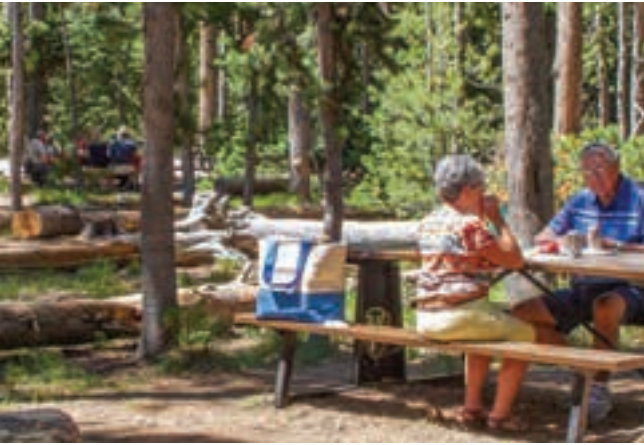
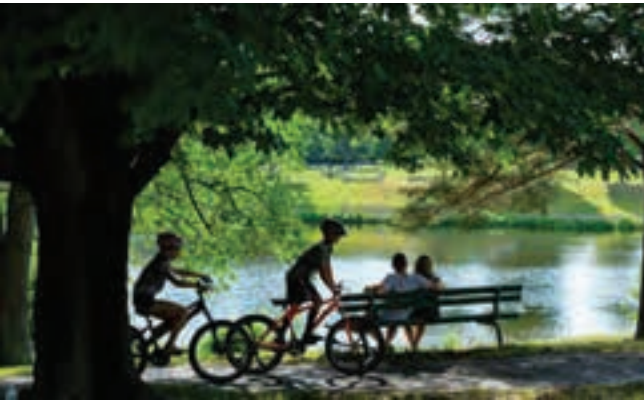
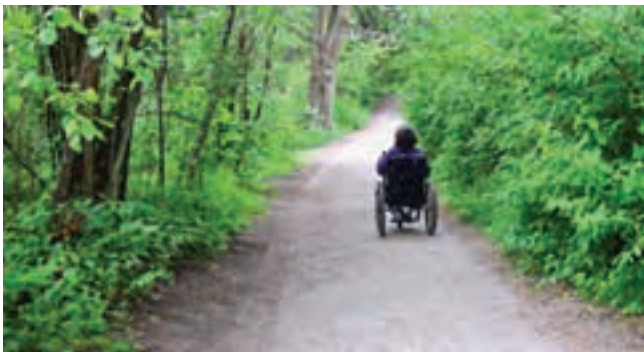
Figure 3-9. Precedent images for Green Dot Loop trail improvements

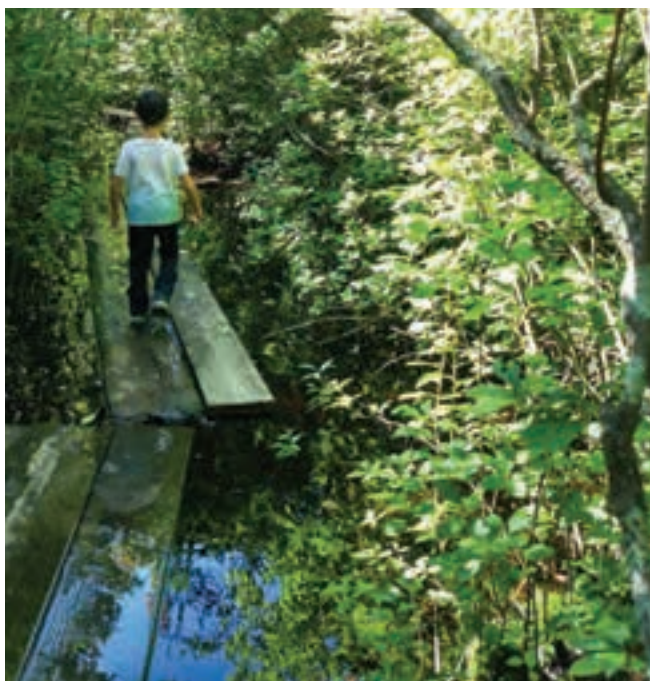
**Figure 3-10.** Existing unstable and submerged boardwalk at Ponkapoag Bog

6. The boardwalk should be constructed with railing to prevent visitors from accessing the sensitive ecological resources, and to keep children or adults from falling off the boardwalk into the wetland. A more substantial guardrail is needed if the boardwalk crosses deep water or attains considerable height. At a minimum, a four-inch rim along the edge of the decking is desirable if the boardwalk is to be used by wheelchairs.

7. Use Helical piles, which are an excellent alternative to friction piles, to create the foundation for the elevated boardwalk. Helical piles weigh less, are easier to install with portable equipment and result in less ground disturbance. The overall cost may be less than friction piles.

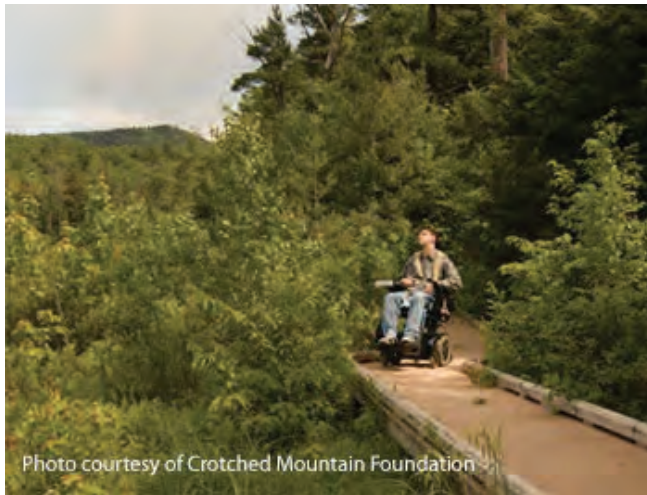
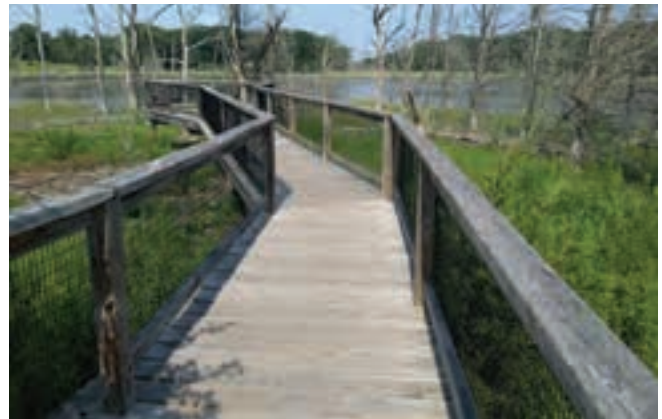
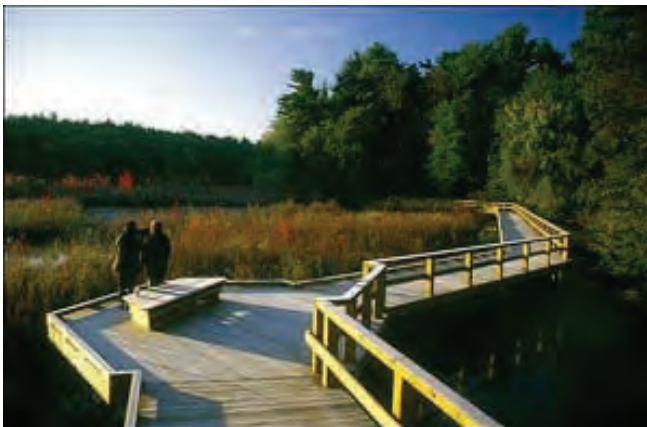
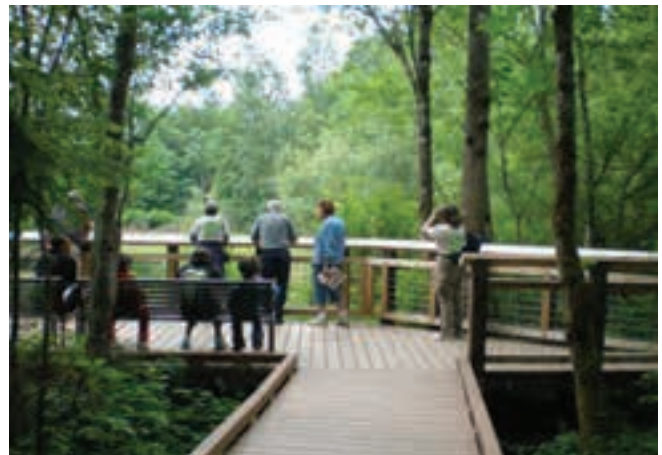
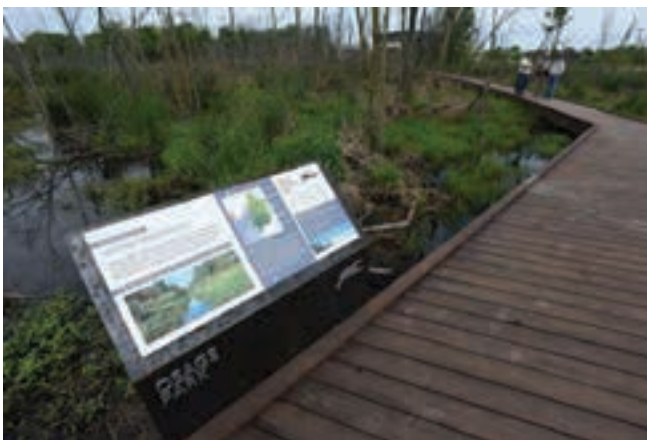
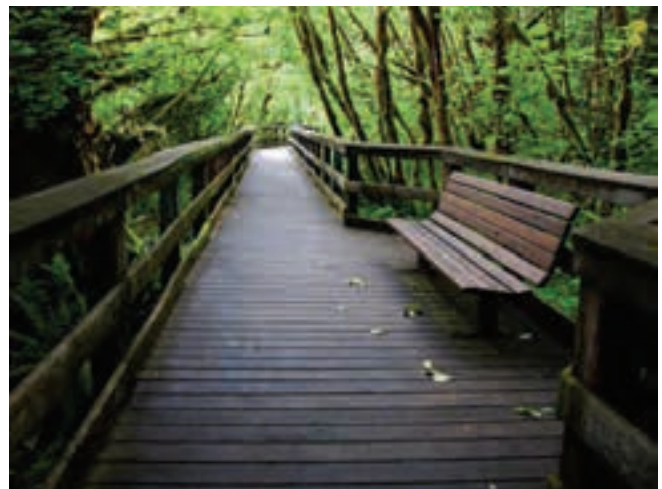
Figure 3-13. Precedent images of accessible boardwalk and observation platforms.

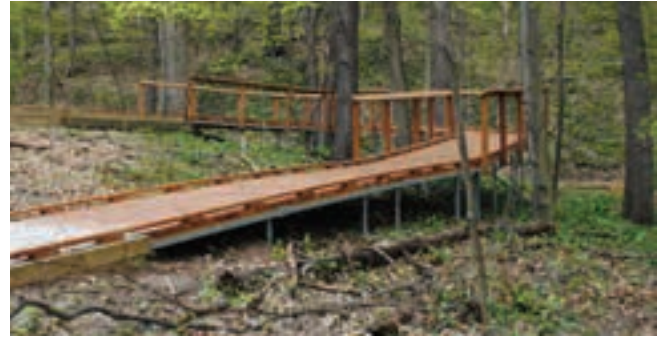
Figure 3-20. Precedent of accessible sloped walkway/ramp

3. Given the challenge to provide an accessible path between main facilities, accessible cabins, and the swimming area at the pond without significant regrading that would adversely affect the natural beauty of the site. It is recommended that DCR and AMC designate an accessible parking space adjacent to the Stose cabin and from this cabin provide an accessibly compliant sloped walkway/ elevated ramp to the boat dock and swimming area. This would reduce the extent and area of site disturbance and make the pond edge accessible.
