# Ponkapoag Pond Master Plan

Canton & Randolph, MA

### PART TWO EXISTING CONDITIONS ASSESSMENT

### PART THREE RECOMMENDATIONS AND OPPORTUNITIES

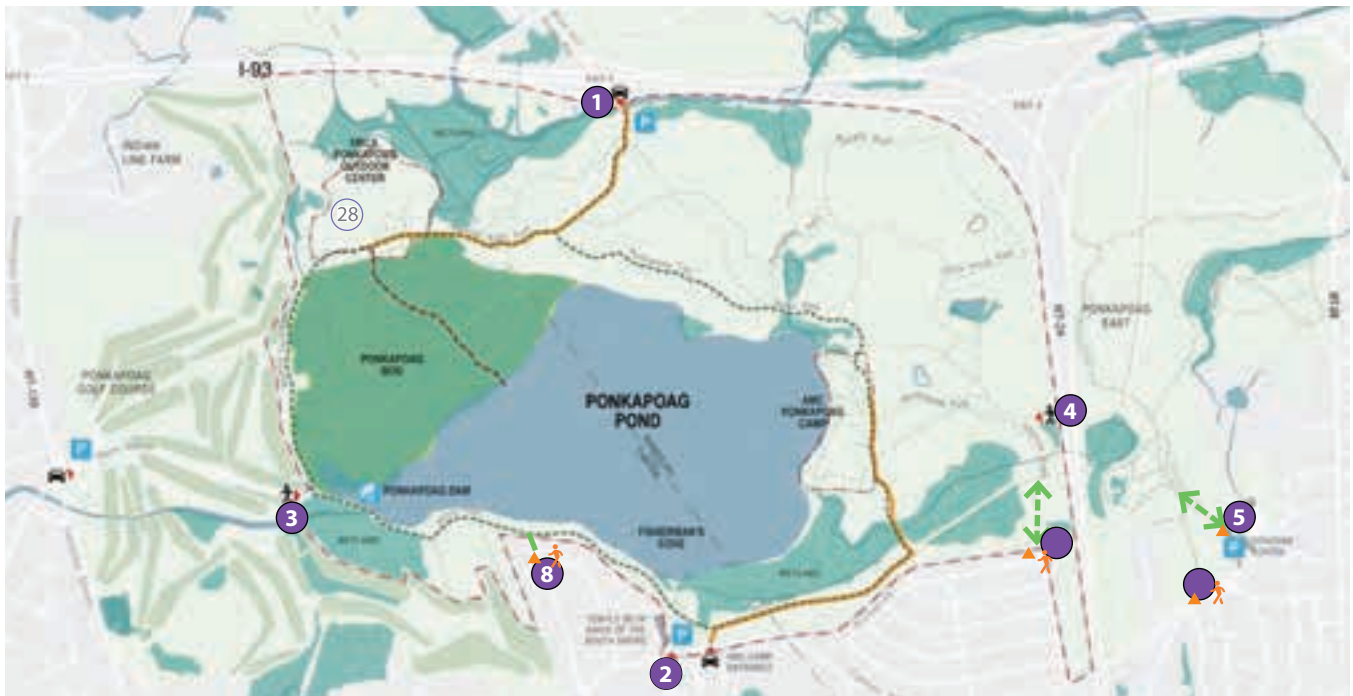
Figure 3-31. Site Plan: Entranceway Identification Signage

**2. Donovan School Parking Lot:** Currently there is no signage leading visitors from Donovan School to the park. DCR should work with the school to allow park visitors to use the parking lot for park access during weekend and school vacation. Add a Gateway Pillar both at the street entrance and the parking lot entrance, and a Welcome Wayside Orientation sign at the street entrance to strengthen the connection between the school and Ponkapoag Pond.

**3. At entrances 6 and 7 from Randolph neighborhoods, and entrance 8 from Canton neighborhood:** There is an existing trail, but no formal signage at these locations. Adding a Gateway Pillar to indicate visitors are entering DCR property and a Safety and Rules Sign to clearly mark what is and isn't allowed at the park is recommended. Entrance 6 is on a busy street, and it is important to consider the impact of a sign at this location. It may make more sense to add a trail Intersection Directional sign instead of a Gateway Pillar which would direct residents, but not call attention to the entrance.

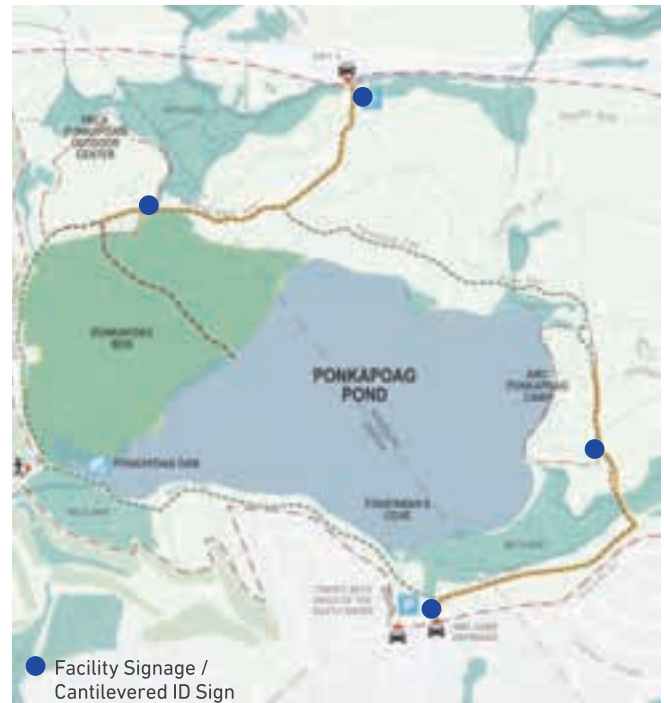
Figure 3-32. Site Plan: Facility Signage/Cantilevered ID Signage

A DCR Cantilevered ID sign would be located at (1) the northern entrance for the YMCA Ponkapoag Outdoor Center as well as at (2) the YMCA Camp onsite sign, and the AMC Ponkapoag Camp sign would be placed at (3) the Randolph Street entrance for the AMC Ponkapoag Camp as well as (4) the AMC Camp entrance. The YMCA sign would be co-branded with the YMCA as well as the DCR logo, and the AMC Ponkapoag Camp signs would include the AMC as well as the DCR logo. The Blue Hills Reservation must be identified on the sign.

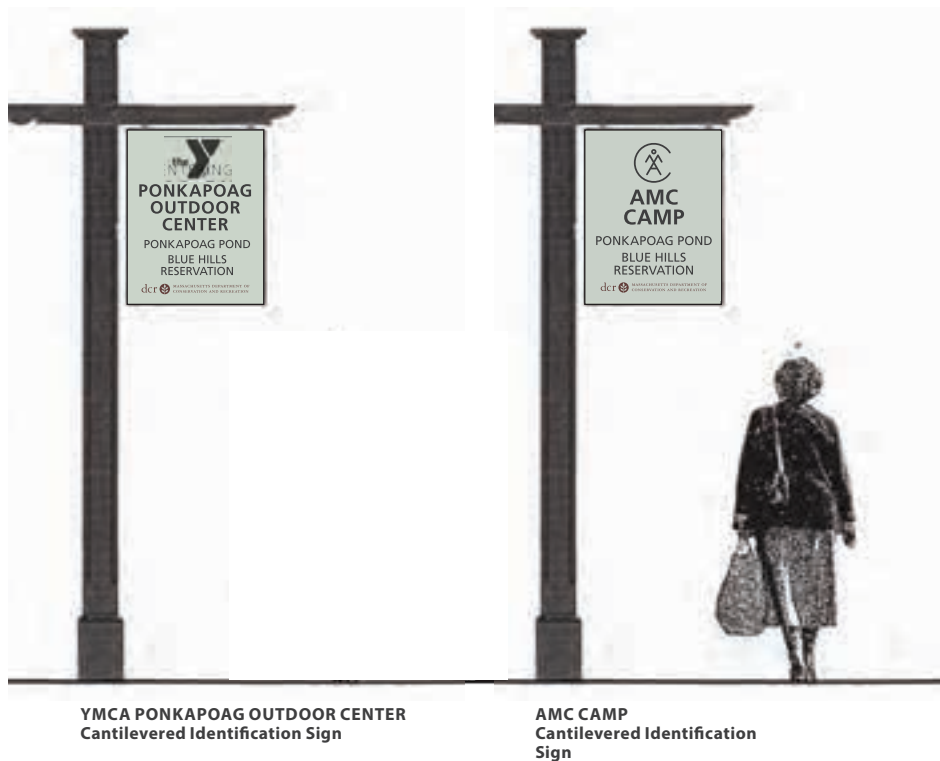
Figure 3-33. Proposed Facility Signage Sign Type Examples

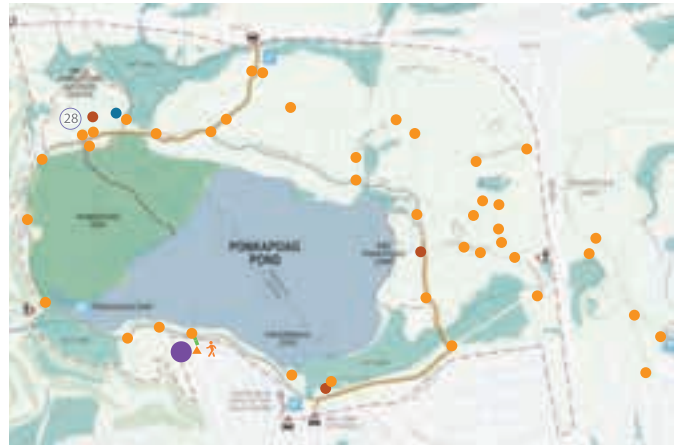
- Intersection Directional Signs
- Directional Internal Park Information Sign

Figure 3-38. Site Plan: Directional Signage

Directional Internal Park signs identify key attractions at the park and are placed at entranceways and key intersections to give visitors a quick understanding of direction. In terms of design, information, direction, and place identification shall be presented on a horizontal panel system utilizing 2" x 6" nominal or standard dressed pine. There are four options for structure size: 2 feet, 3 feet, 4 feet, and 6 feet, and the size of the sign is dependent on the location and distance from which it will be viewed.

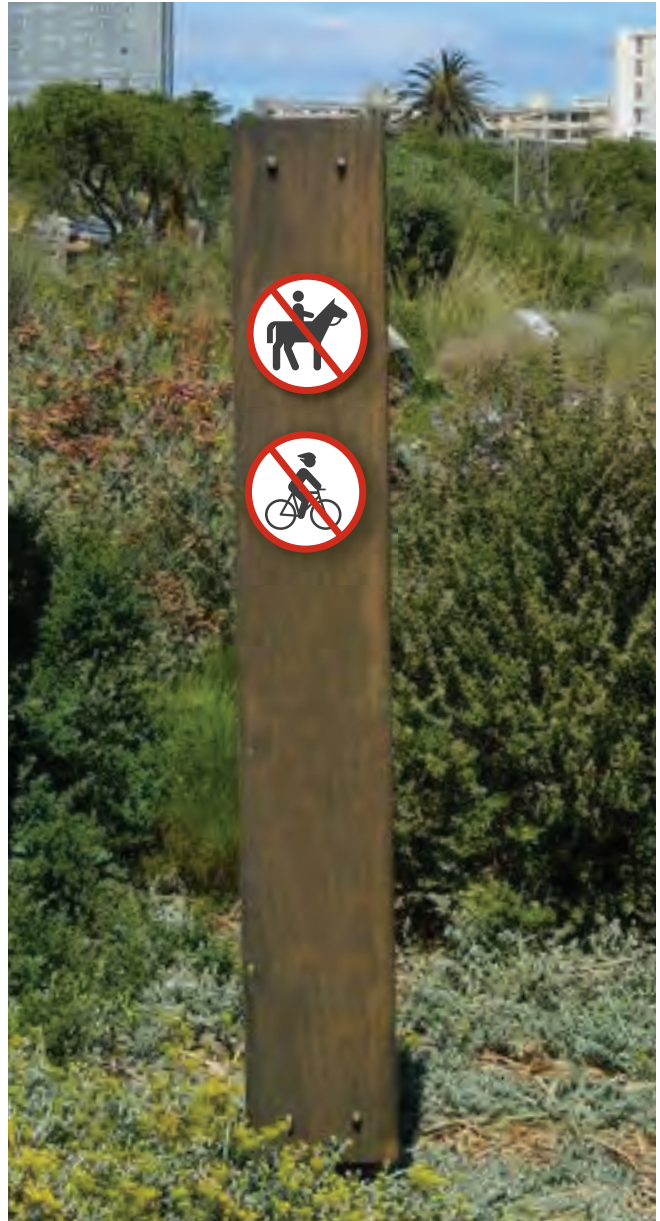
Figure 3-39. Proposed Rules & Regulations Trail Signage

In addition to the messaging on the Intersection Directional signs, additional sign markers could indicate restrictions through clear iconography. When necessary, these signs would complement Intersection Directional signs and similarly be mounted on 4" x 4" wood posts.

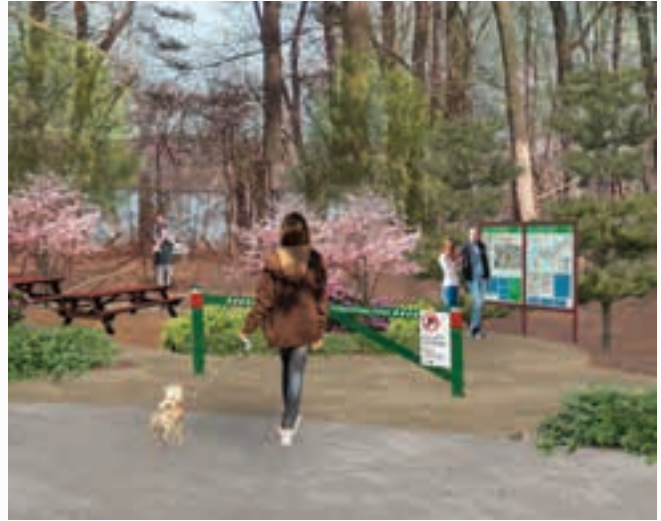
Figure 3-45. Proposed Entrance Gate at Fisherman's Cove

Currently, no entrance gates follow the DCR Graphic Standards. Ideally, Steel Gates include the name of the location. The DCR logotype and the gate number (if applicable) should be applied to the post, and the name of the location should be clearly marked. If possible, the intention would be to replace the entrance gates at the northern and southern gates as well as at the AMC Camp entryway.

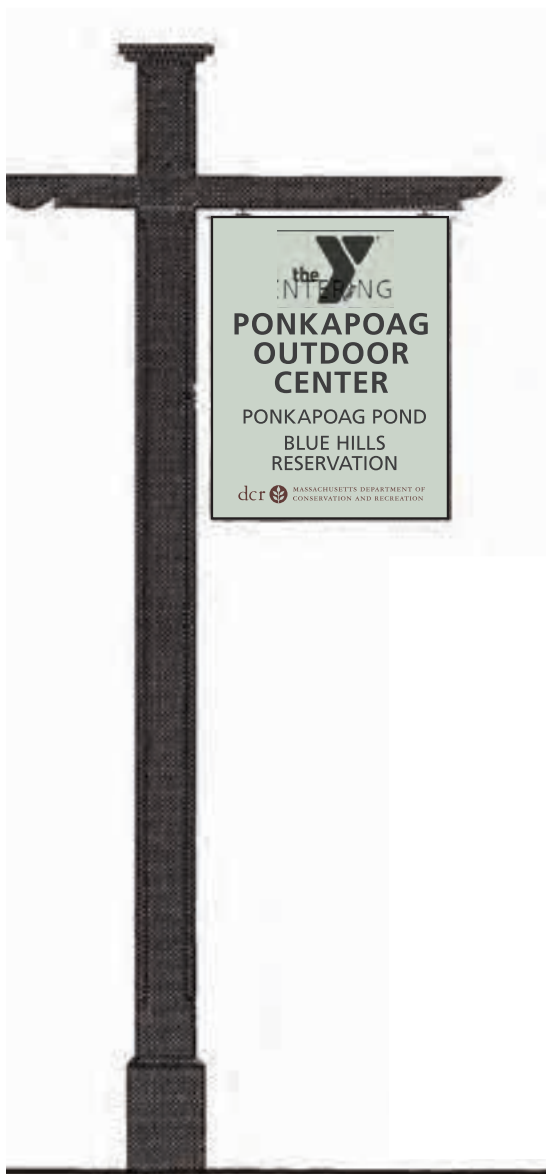
Figure 3-53. Proposed Sign Types at YMCA Camp: Site Facility Signage at YMCA CAMP

**Building Signage:** Building Facilities throughout the YMCA Camp are not clearly marked, and the signage in the Main Building, including the Infirmary and the Main Office, is poorly marked and requires more permanent signage. Update and add facility signage.

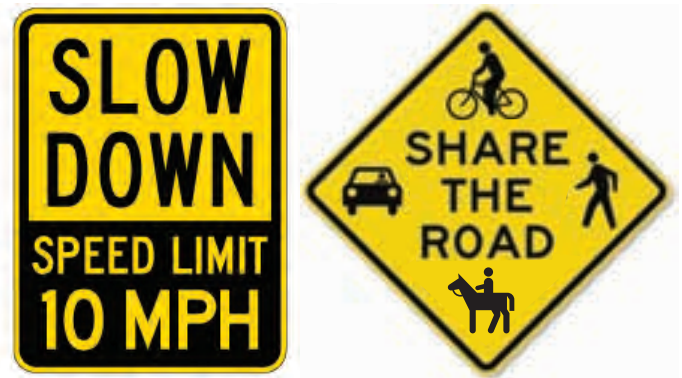
Figure 3-54. Proposed Traffic Rules Signs along road to YMCA Camp

**Traffic Signage:** Visitors are allowed to drive on the access road to drop off and pick up children at the camp. There is an ongoing problem with speeding cars going well above the posted limit of 10mph. When asked, drivers are often unaware they are traveling on a park road that hikers, bikers, and horses share with them. To reinforce the message to slow down, add "Share the Road" signage and "Slow Down / Speed Limit 10 mph" signage along this road to identify that visitors are in the park and sharing the road with hikers, bikers, and horses and to reinforce that they must slow down, and drive at a limit of 10 mph.

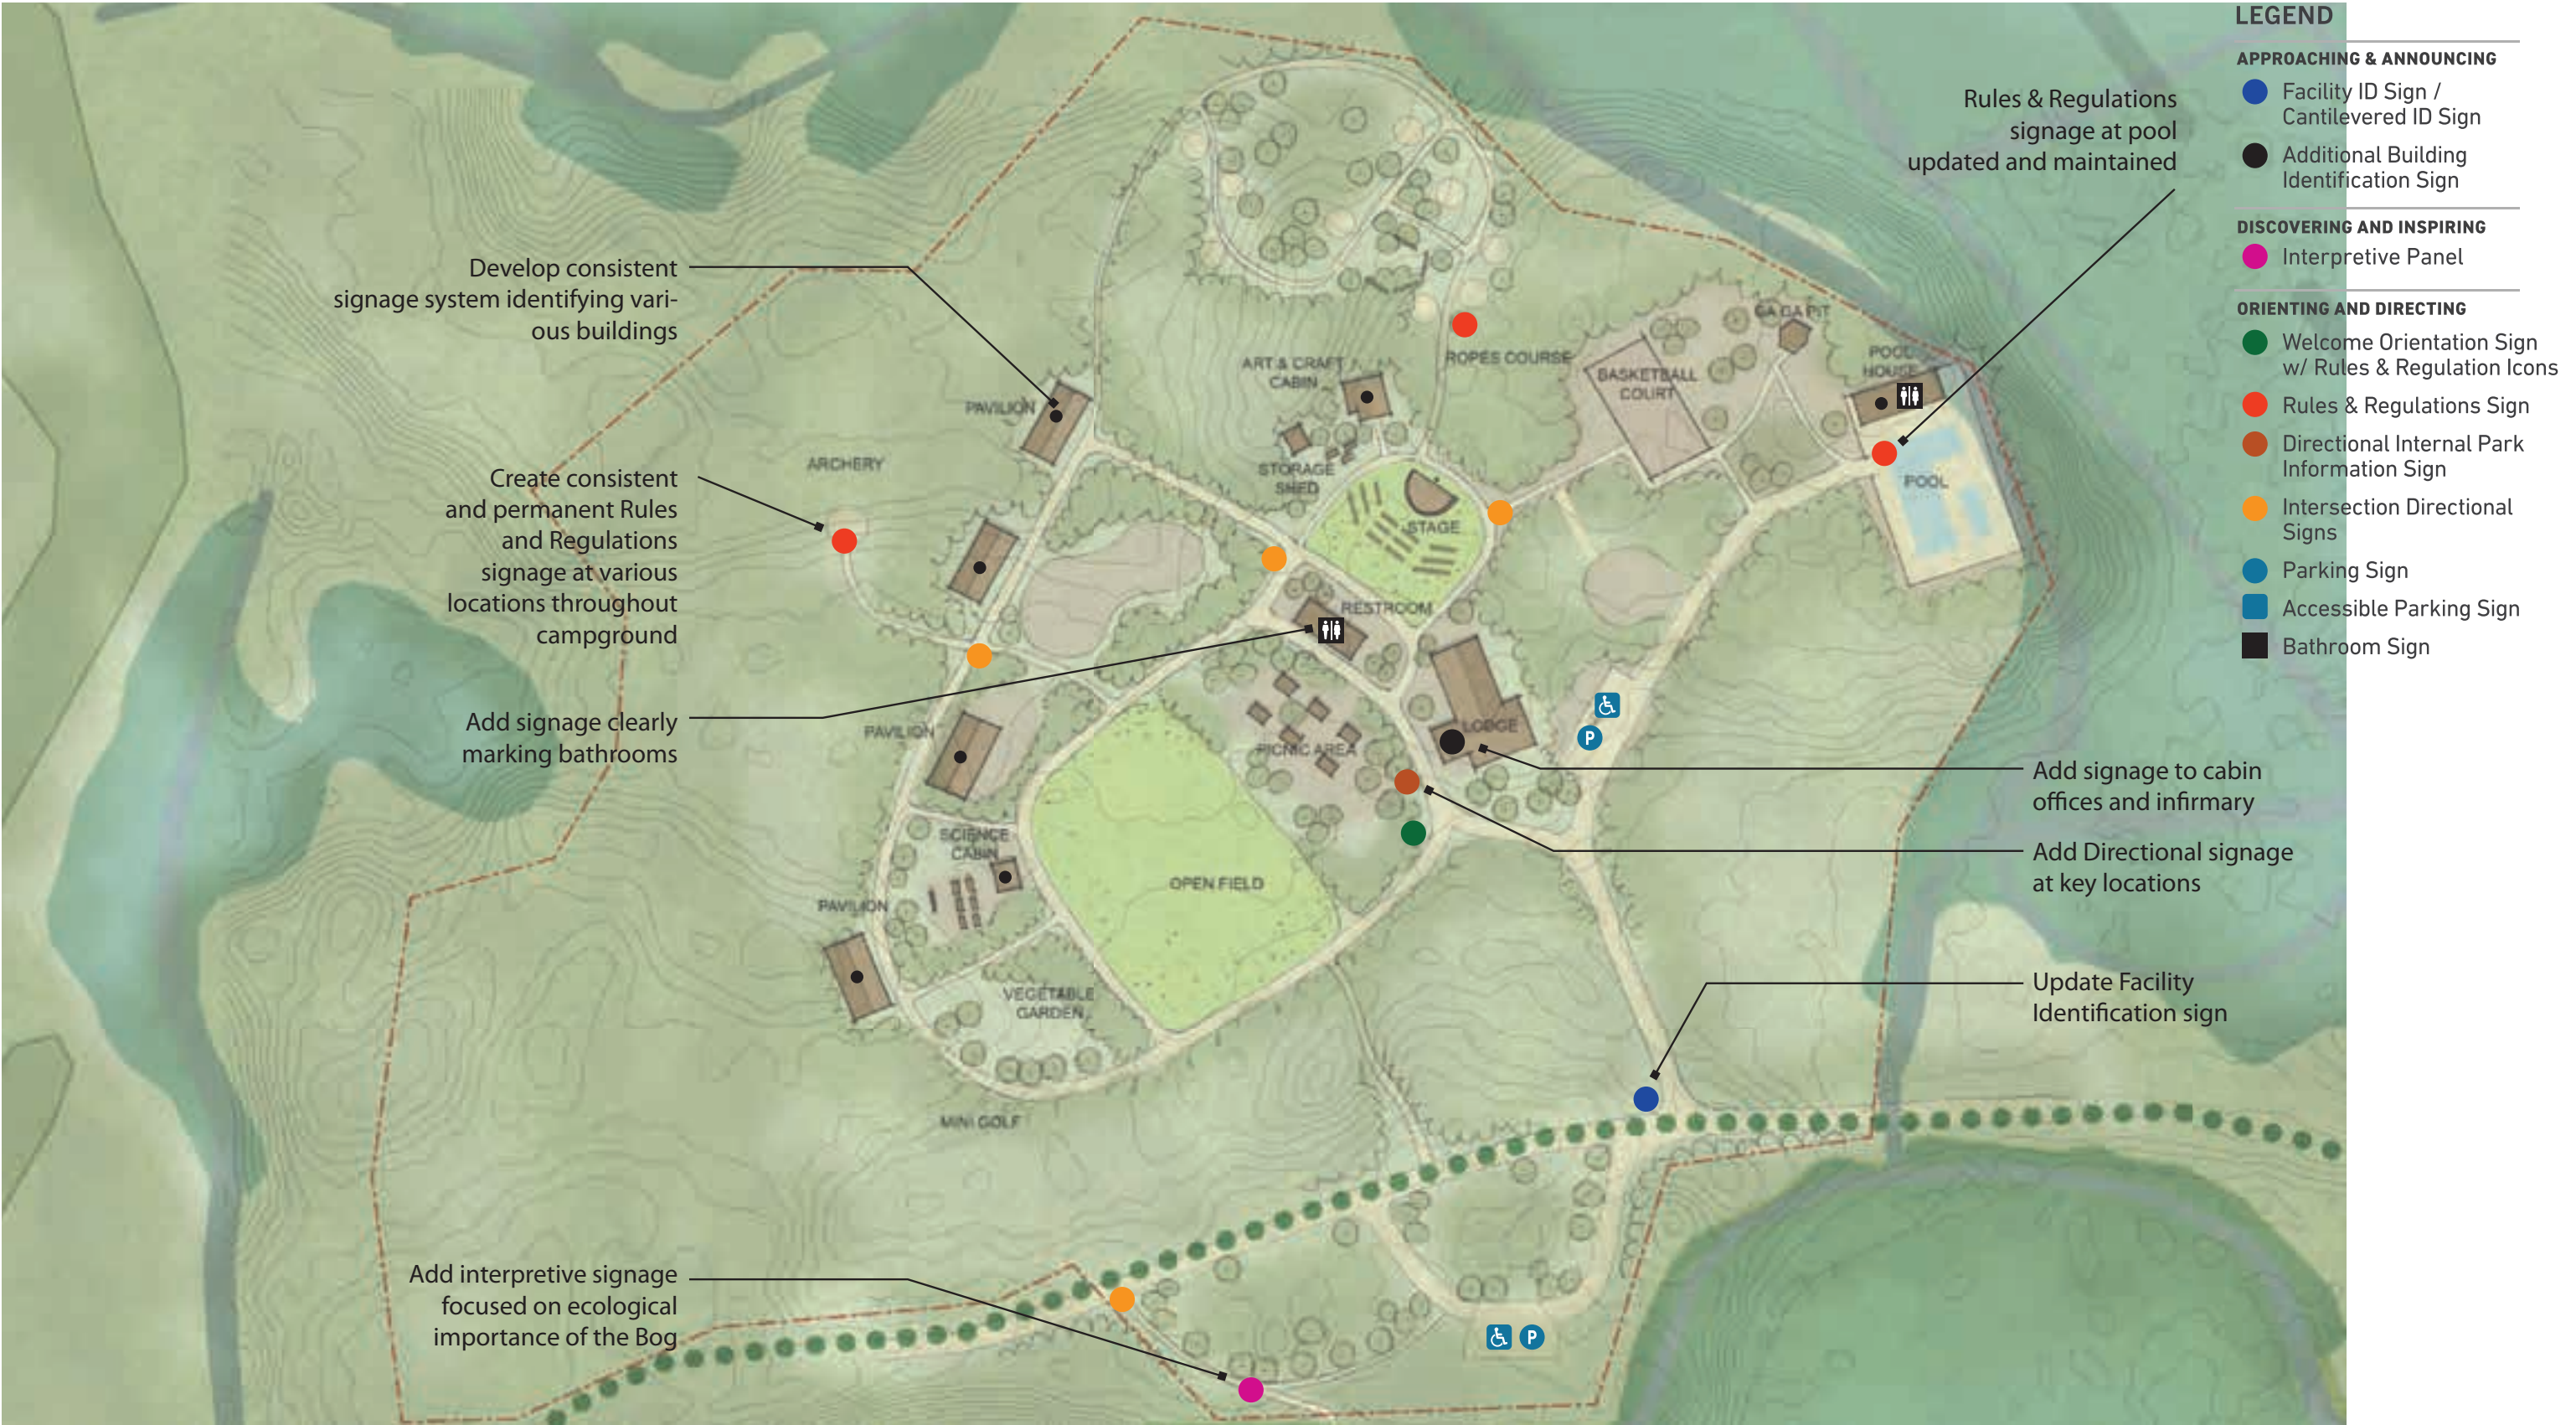
Figure 3-55. YMCA Ponkapoag Outdoor Center Signage Recommendations

**Entrance Gates:** Entrance Gates Signage at the Northern entrance to YMCA Camp does not follow DCR standards. Add or update steel gate to include the name of the location. The DCR logotype and the gate number (if applicable) should be applied to the post, and the name of the location should be clearly marked.
