**Report No. 24-064**

# Post-Fire Damage Inspection of Concrete Structures Phase III – In-Situ Experimental Phase

**University of Massachusetts Amherst**

**Research and Technology Transfer Section  
MassDOT Office of Transportation Planning**

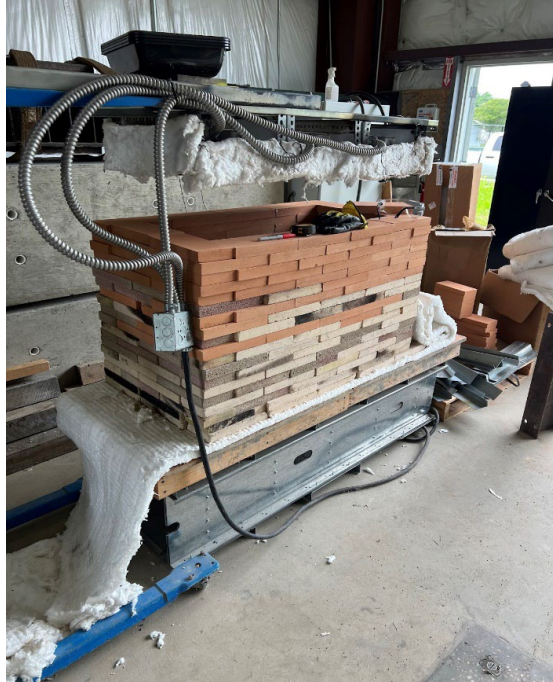
**Figure 2-4: Firebricks, heaters, and insulation setup**

The heaters were affixed to a forklift mount and subsequently lowered into the experimental setup (Figure 2-4). Firebricks were employed to construct an enclosed area. Following the lowering of the heaters onto the firebricks, the setup was enveloped in ceramic fiber insulation (Figure 2-5). The complete assembly was positioned on a layer of ceramic fiber insulation overlaying a wooden platform. This wooden platform was reinforced by galvanized steel beams.

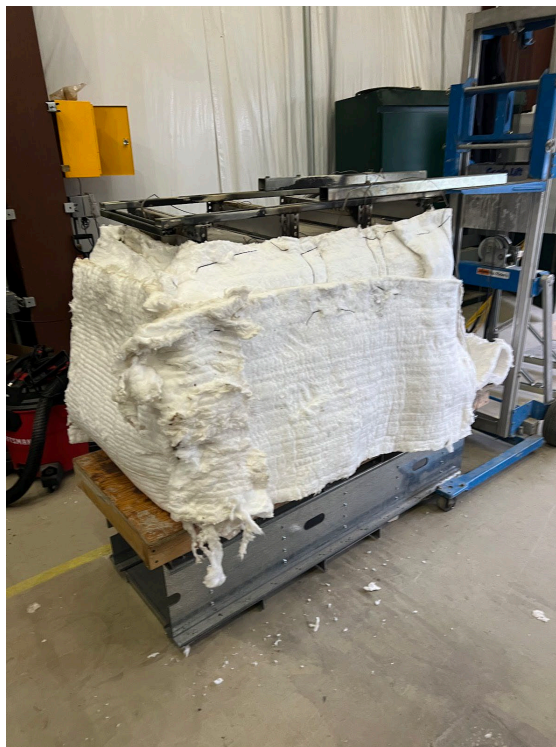
**Figure 2-5: Ceramic fiber insulation wrapped around the firebricks and heater setup**

The configuration comprising the firebrick and Watlow heater established an interior space measuring 2.5 ft in length, 13 in. in width, and 22 in. in height for testing purposes. The dimensions of the beam were chosen accordingly.

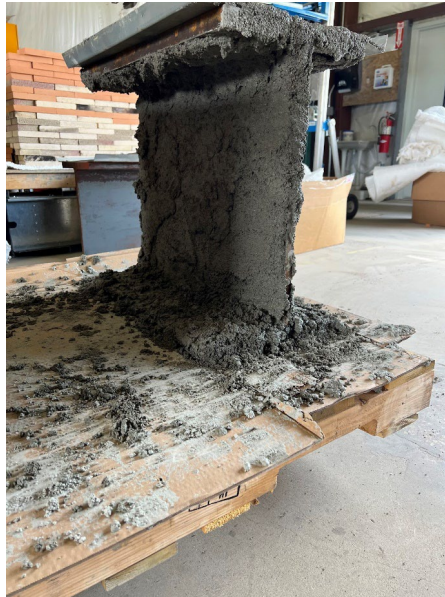
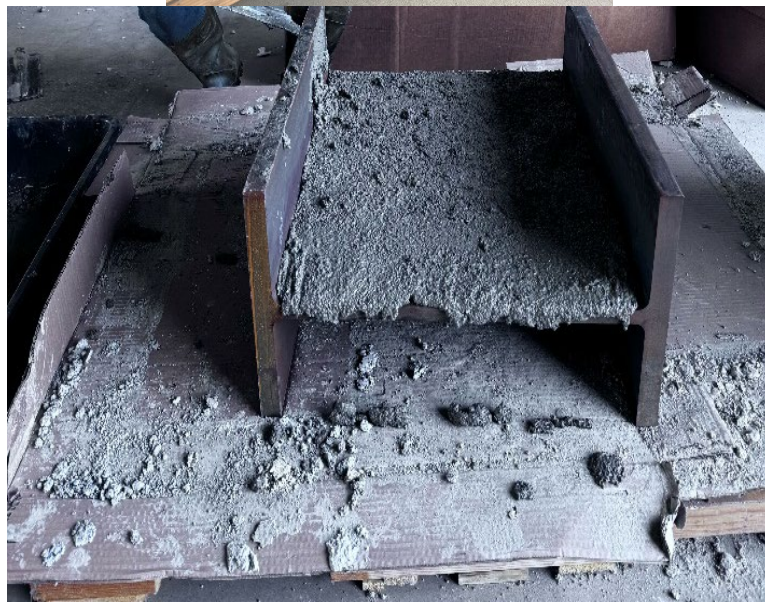
**Figure 2-14: Fireproofing process**

The only surface preparation done to the beams prior to fireproofing was wire brushing. This was done to eliminate dirt and debris that can interfere with the bond between steel and fireproofing. Pictures of the fireproofing process beams can be seen in Figure 2-14.

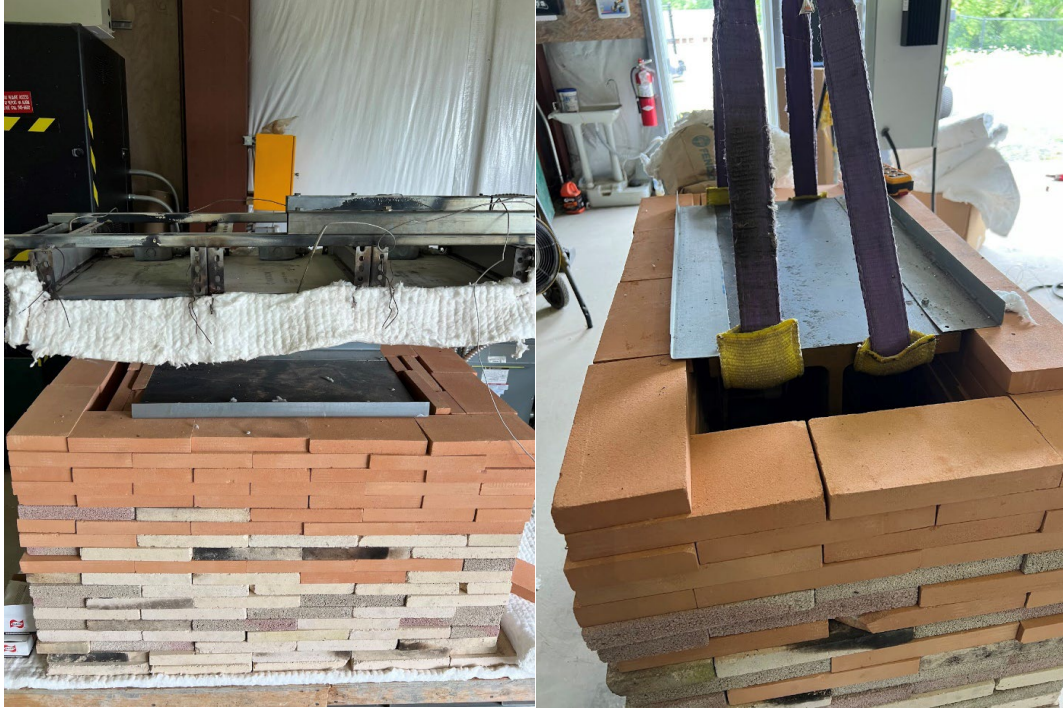
**Figure 2-21: Placement of the beam in the testing setup**

Testing started by lowering the beams into the firebrick setup. This was done by using an overhead crane and lifting straps. The beam was placed in the center of the heating spaces, and the gaps on the sides between the beam and the firebricks were filled in with extra firebricks (see Figure 2-21). The heaters were lowered onto the firebricks until the galvanized decking came into contact with the metal grate over the heaters.

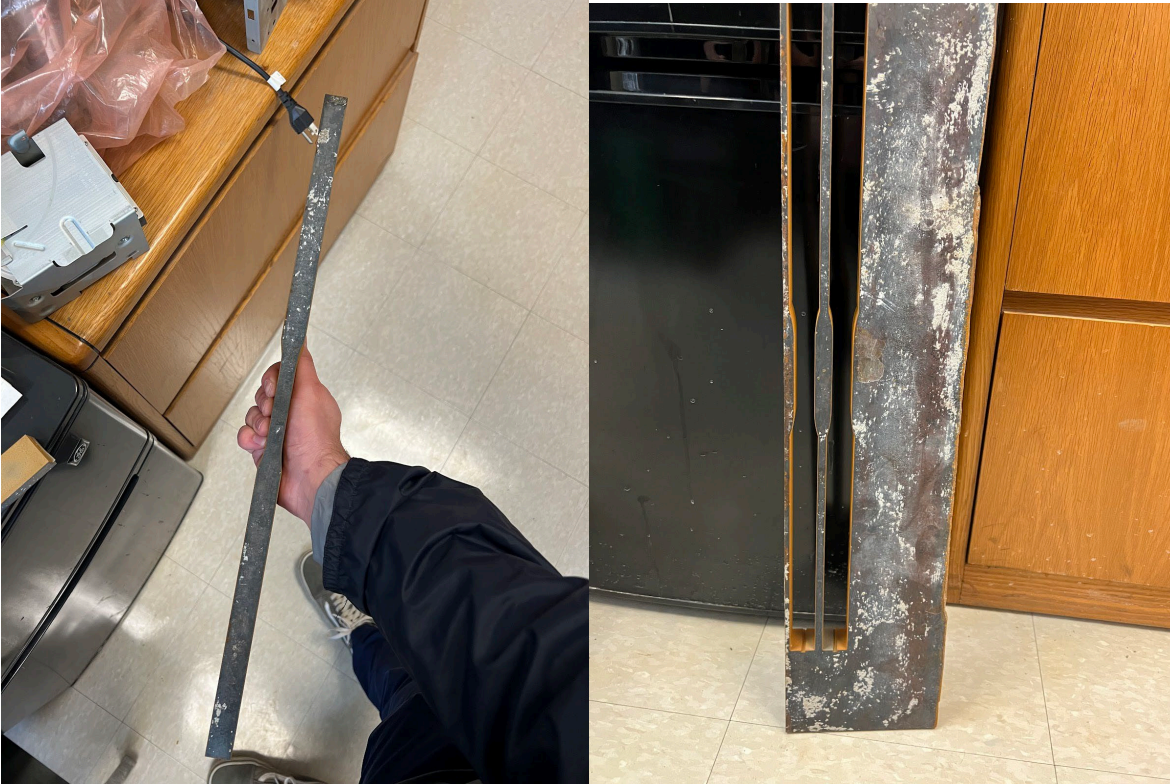
**Figure 2-23: Tension coupons**

The residual strength of the steel beams after being exposed to a fire event was also of interest. Following testing, the top flange of the control beam, the beam of scenario 1 and an untested beam were cut out. Two tension coupons were cut from the top flange of each beam using a water jet and tested to fracture. The tension coupon was dimensioned according to ASTM E8 (Figure 2-22) [39]. The coupons are highly elongated on the ends to ensure a secure grip in the tension testing machine (Figure 2-23).

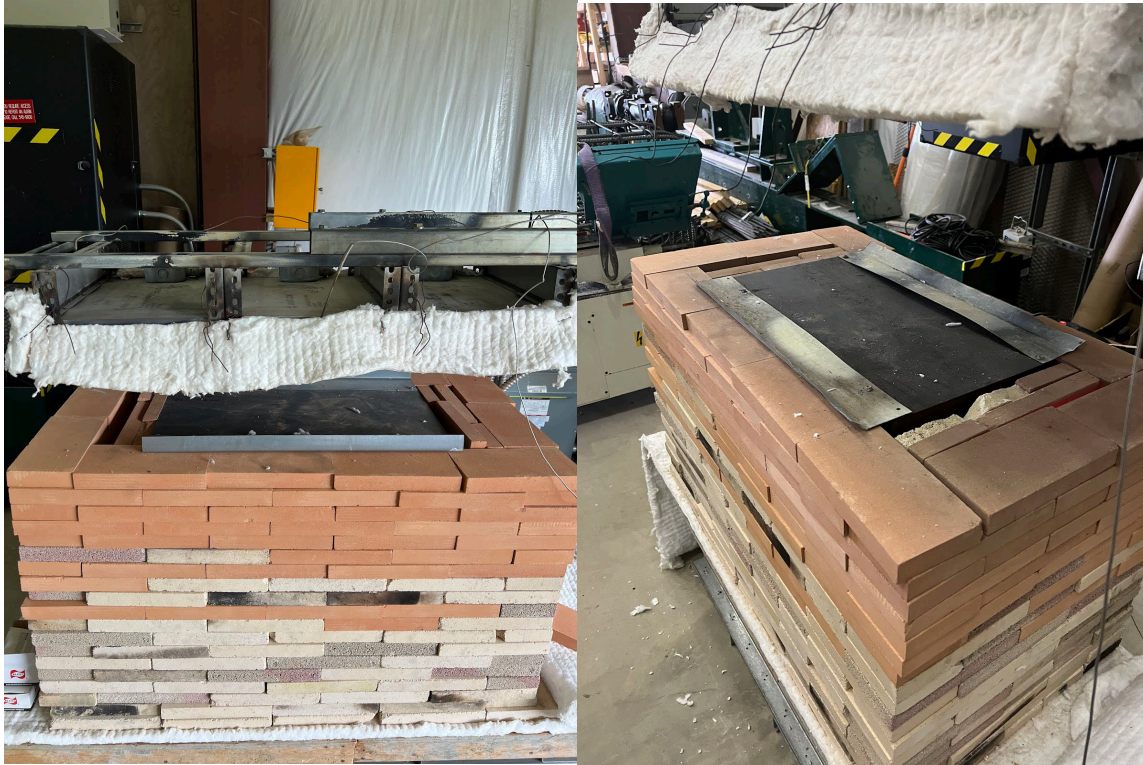
deformation during fire exposure, where mechanical constraints can lead to more severe localized damage.

**Figure 3-3: Condition of the top flange and decking before (left) and after (right) testing**

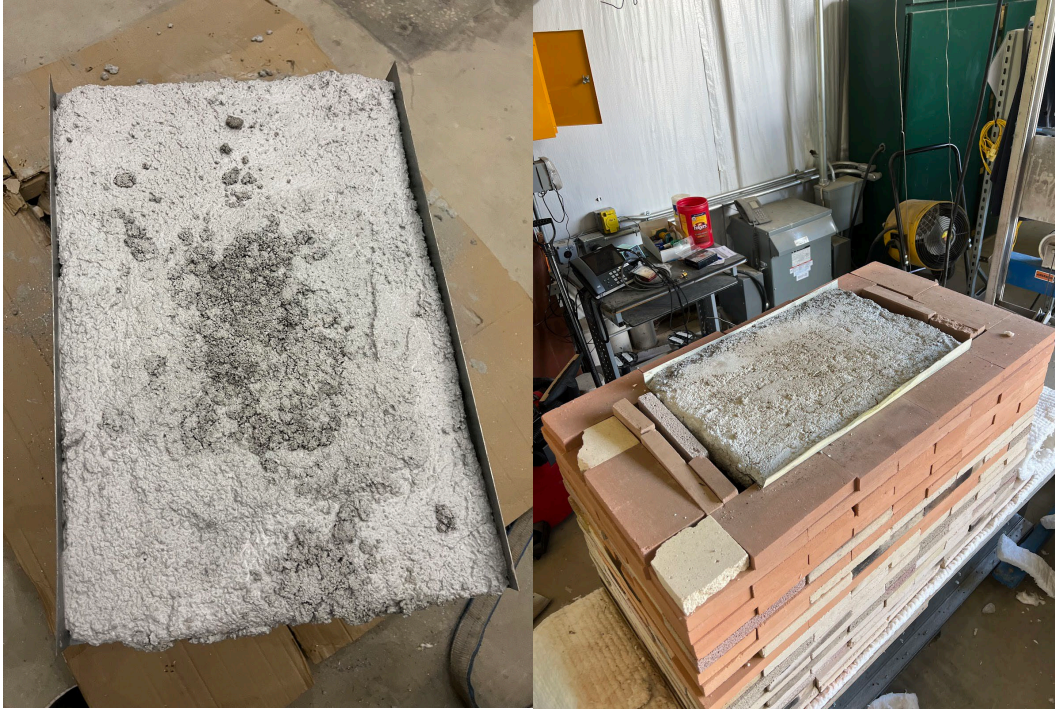
**Figure 3-7: Fireproofing on the scenario 1 beam before and after testing**

In addition to the thermal effects observed on the heated beams, there were noticeable physical changes, particularly in the fireproofing layer itself. During testing, the fireproofing on the top flange experienced a visible color change, which indicated the material's response to sustained high temperatures. This discoloration, as shown in Figure 3-7, suggests that the fireproofing underwent thermal stress during the fire exposure. Such color changes often serve as early indicators of material fatigue or alteration due to extreme heat, highlighting the impact of fire conditions on the protective layer.

This color shift may point to surface oxidation or thermal degradation, revealing that while the fireproofing successfully insulated the beam from excessive temperatures, it also experienced transformation under fire exposure. These physical alterations are critical to note, as they may affect the long-term performance and resilience of the fireproofing in real-world applications.

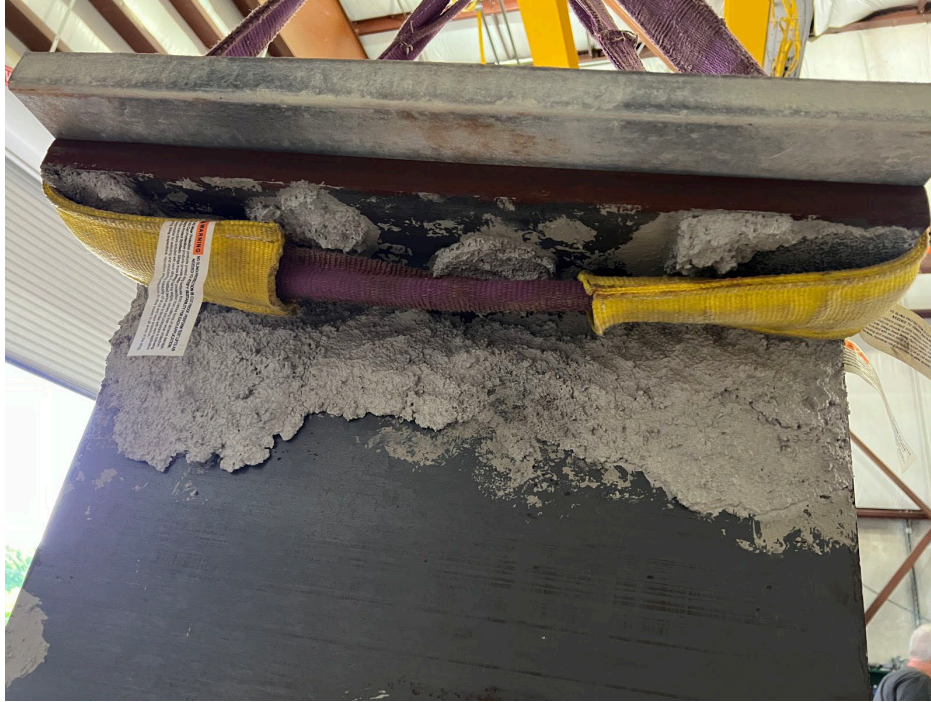
**Figure 3-9: Fireproofing chipped off the top flange of the scenario 2 beam**

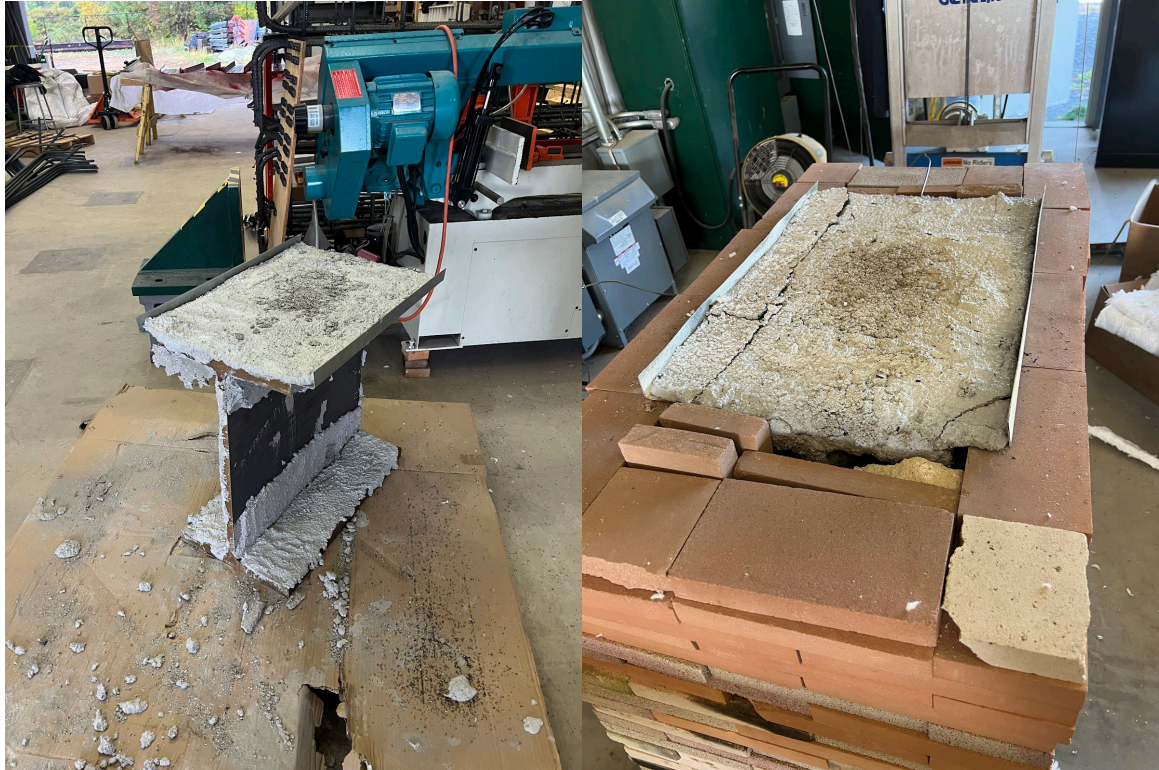
**Figure 3-13: Fireproofing on the scenario 3 beam before (left) and after (right) testing**

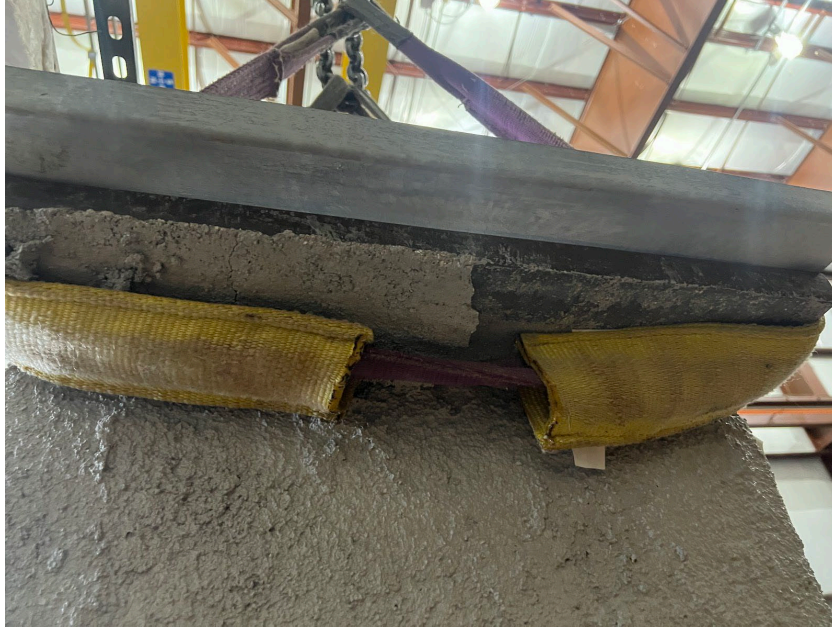
**Figure 3-14: Fireproofing damage on the underside of the top flange for scenario 3.**
